PERIODIC REVIEW

Elliot Tire Center Facility/Site ID #: 547

1 East Lincoln Street Yakima, Washington 98902

September 19, 2008

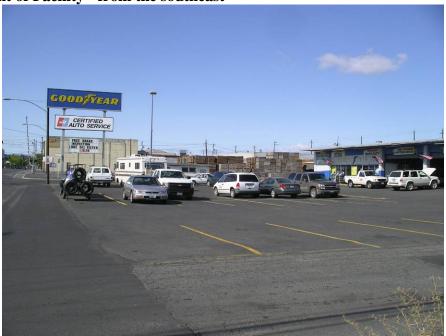
Photo 1: Front of Facility - from the southeast

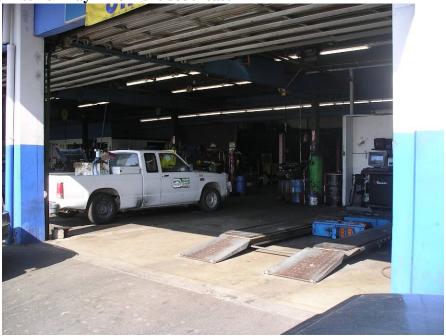
Photo 2: East Interior Bay - from the southeast

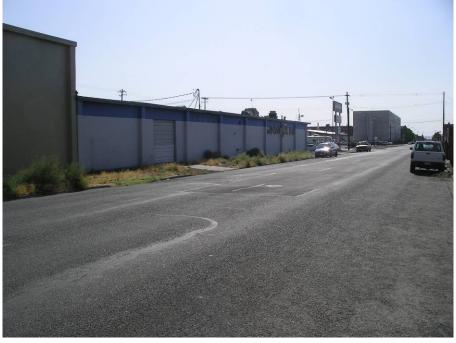
Photo 4: West Side of the Building – from the northwest
