PERIODIC REVIEW

Weyerhaeuser Everett Mill E Facility Site ID#: 12

515 East Marine View Drive, Everett, Washington

June 2016

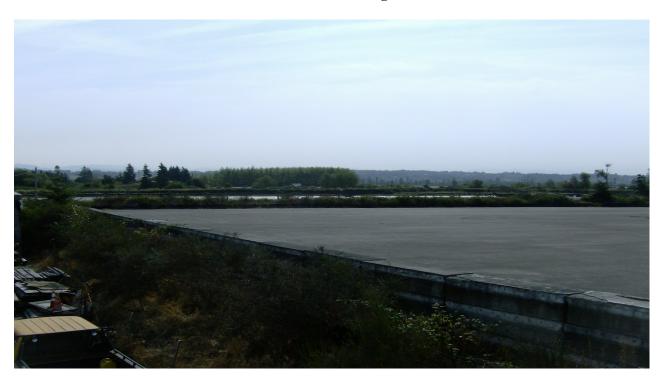
Based upon the site visit conducted on August 2015, the asphalt cover part of the remedy at the Site continues to eliminate exposure to contaminated soils by ingestion and contact. The asphalt appears in satisfactory condition and no repair, maintenance, or contingency actions have been required. The Site is operating as a Pacific Topsoil facility. A photo log is available as Appendix 6.5.

Photo 1: Paved containment area – NW corner looking SE

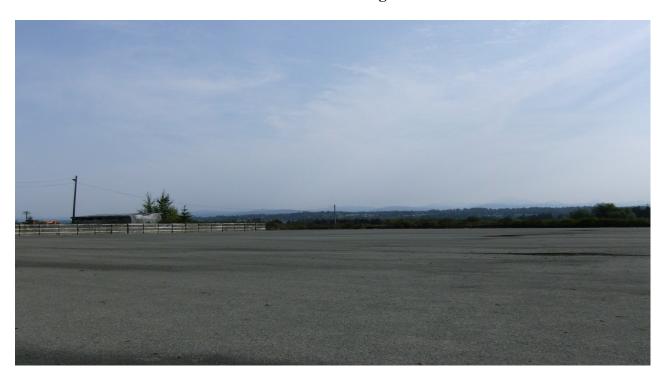
Photo 2: Paved containment area – SW corner looking to the NE

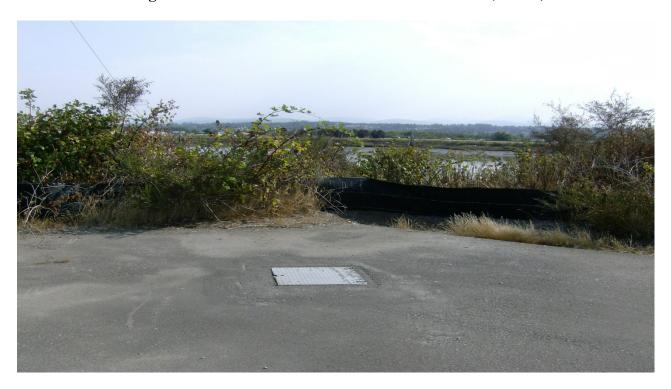
Photo 3: Monitoring location – northeast corner of containment area (PZ-3A)

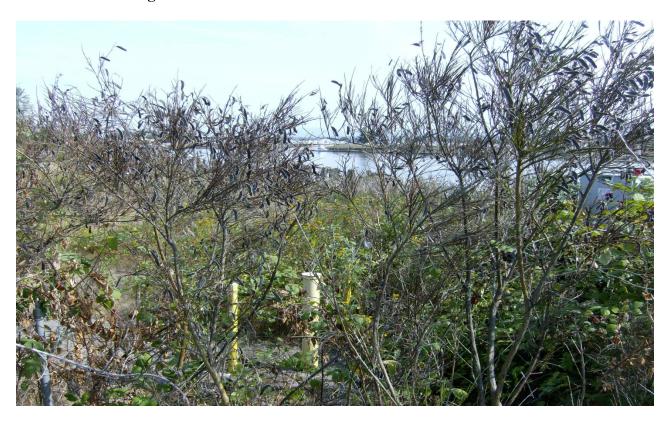
Photo 4: Monitoring location – northeast corner outside of containment area
