RE: 2209 East Lake Washington Boulevard – Indoor Air Testing

Shannon & Wilson performed indoor air testing at the 2209 East Lake Washington Boulevard property in Seattle, Washington (property) on behalf of the Washington State Department of Transportation (WSDOT).

SR 520 Montlake to Lake Washington  
I/C and Bridge Replacement  
Seattle, Washington

EXHIBIT 1

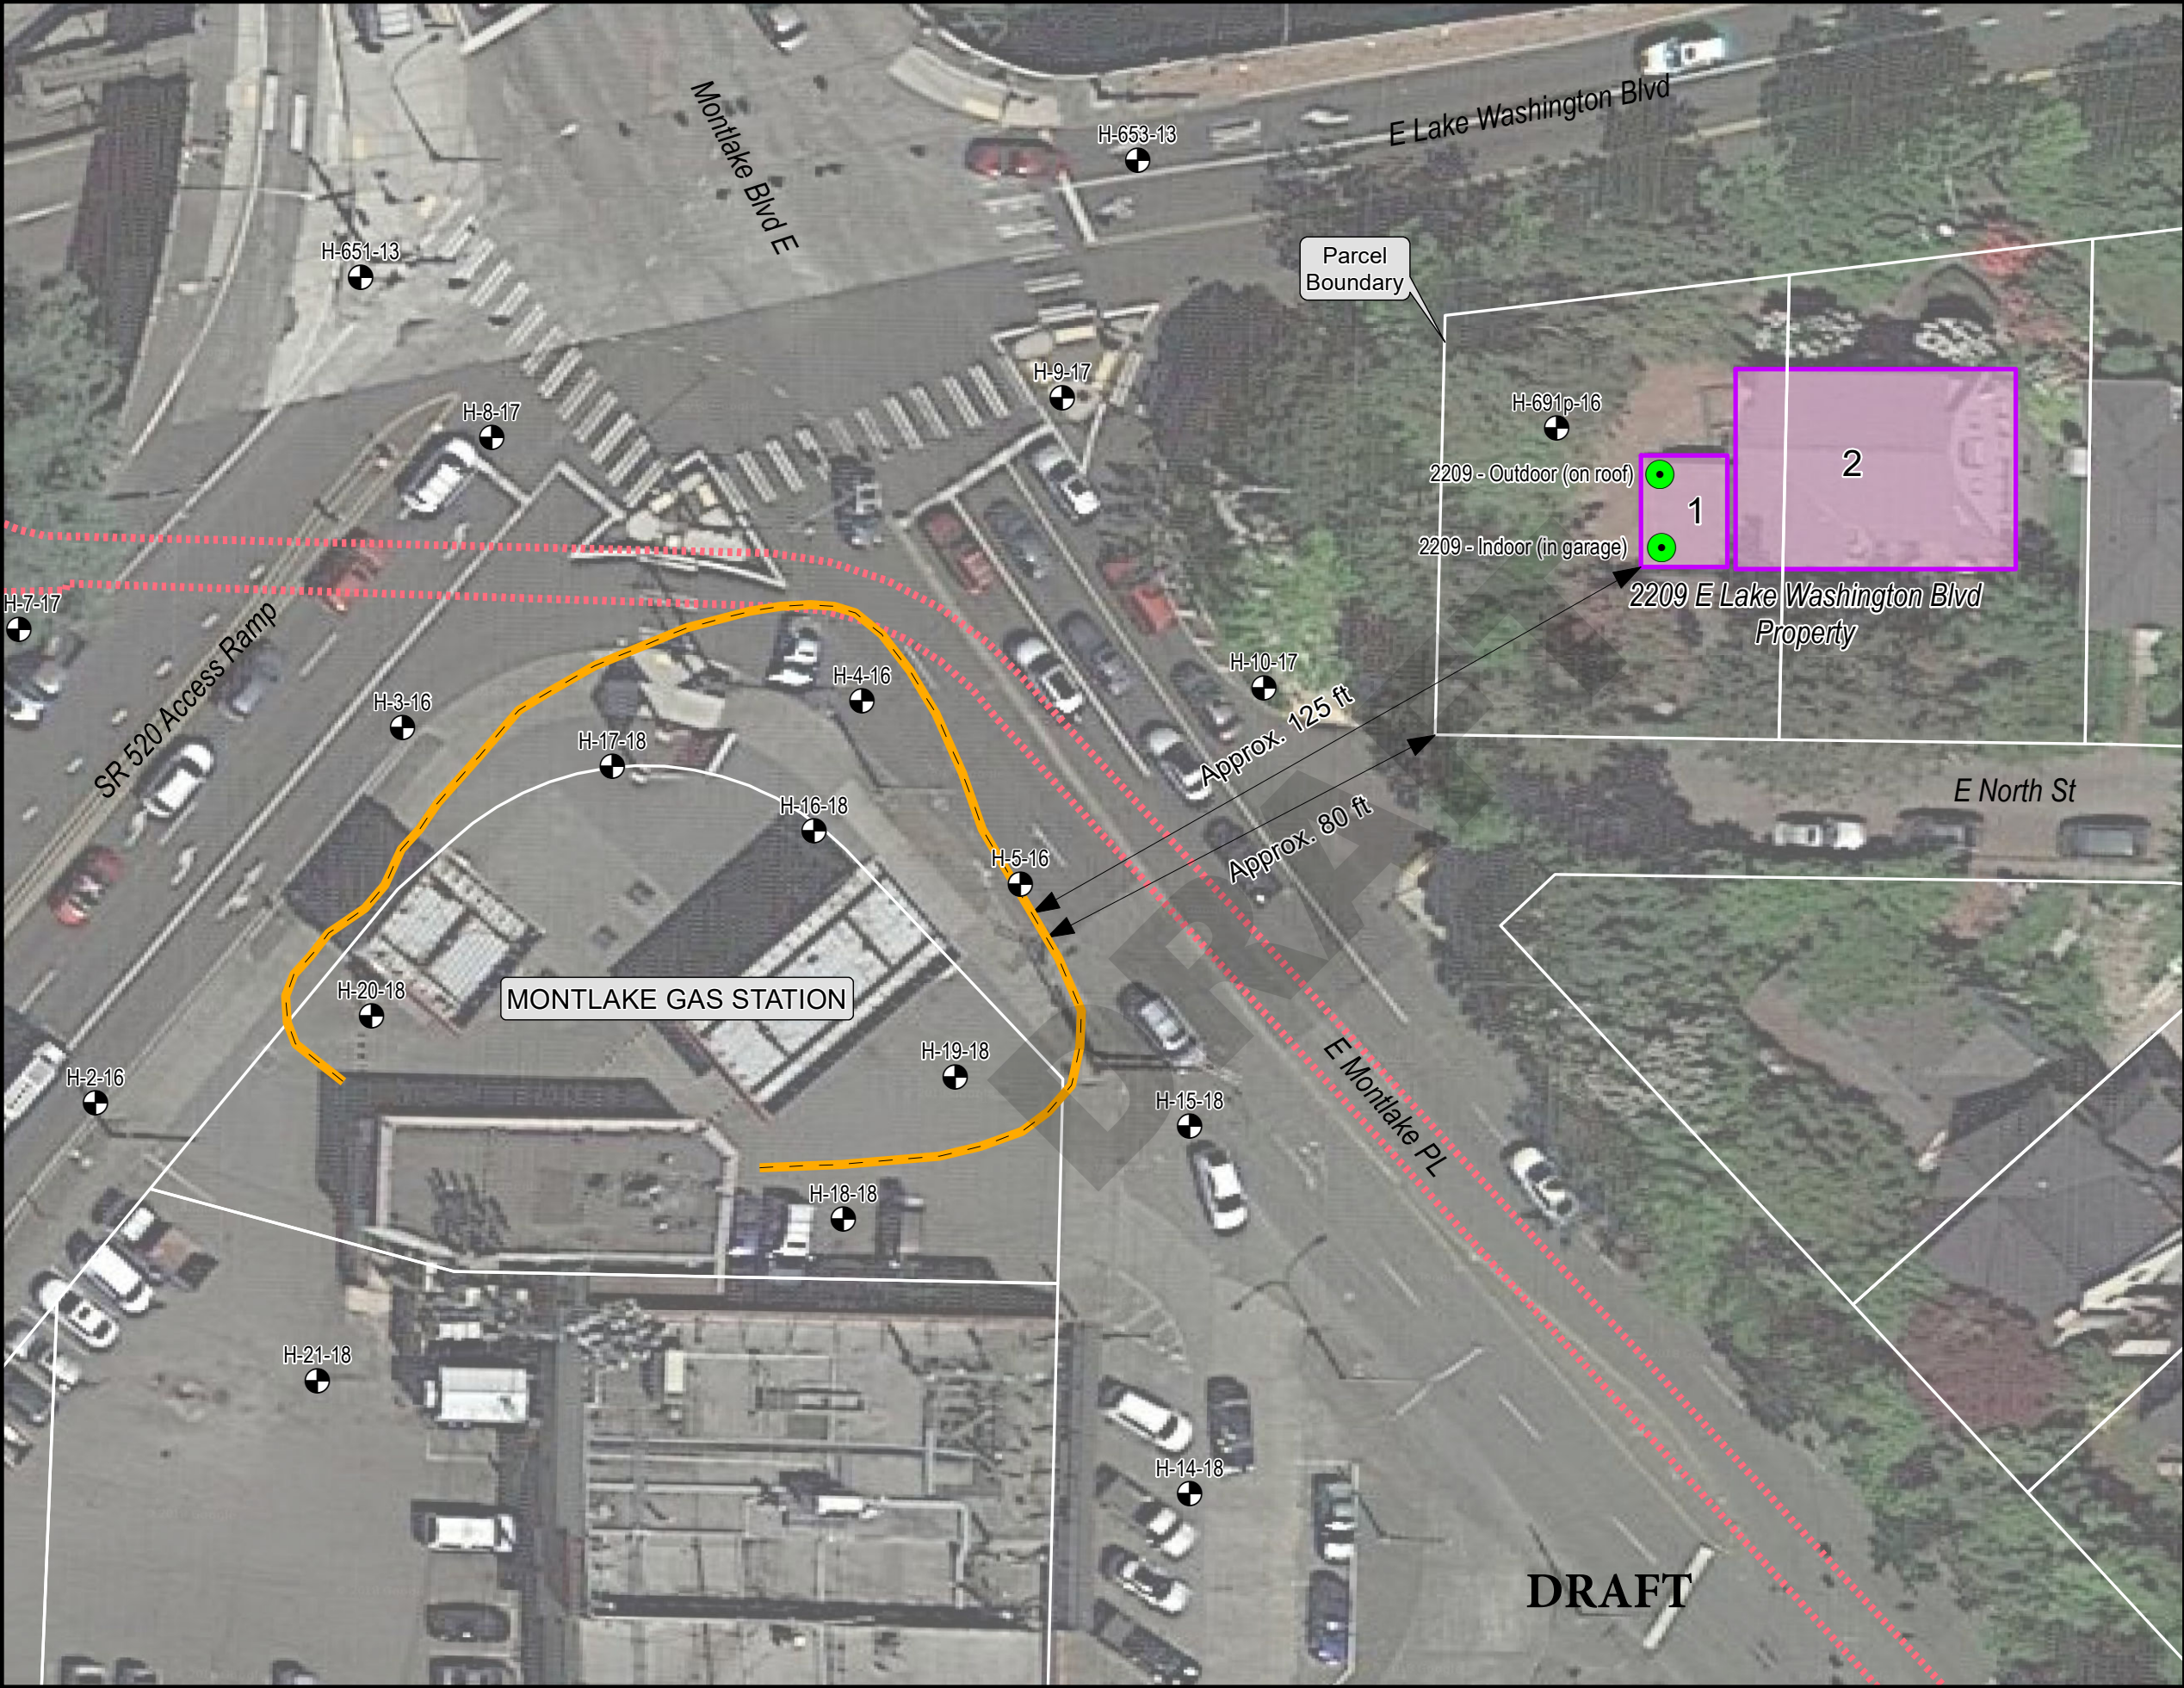
Soil and groundwater contamination, including gasoline and BTEX, have been identified at the Montlake Gas Station approximately 125 feet southwest of the nearest property building (the garage). Exhibit 1 shows the approximate location of soil and groundwater contamination with respect to the property. Since gasoline and BTEX readily partition from soil and groundwater into the vapor or gaseous phase, this creates the potential for migration of gasoline and BTEX as vapor through the subsurface. Chemicals vapors can potentially migrate from nearby soil and groundwater contamination into the indoor air of nearby or overlaying buildings. For this reason, we tested the indoor air of the property's garage.

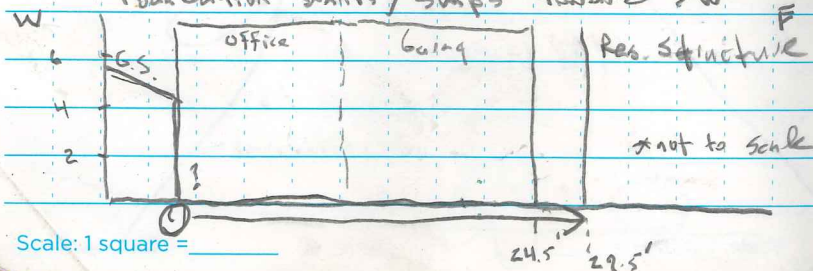
## Structure #1 - Garage

° Low air flow even with garage door and side door open

° W. Side is ~ 4-5' bgs

° E. Side is at ground surface

° V. faint odor (solvent-like?) in garage

° Stains on garage floor

° Numerous paints, finishes, stain removers, enamels + cracks, holes

° Foundation slants / sumps toward SW

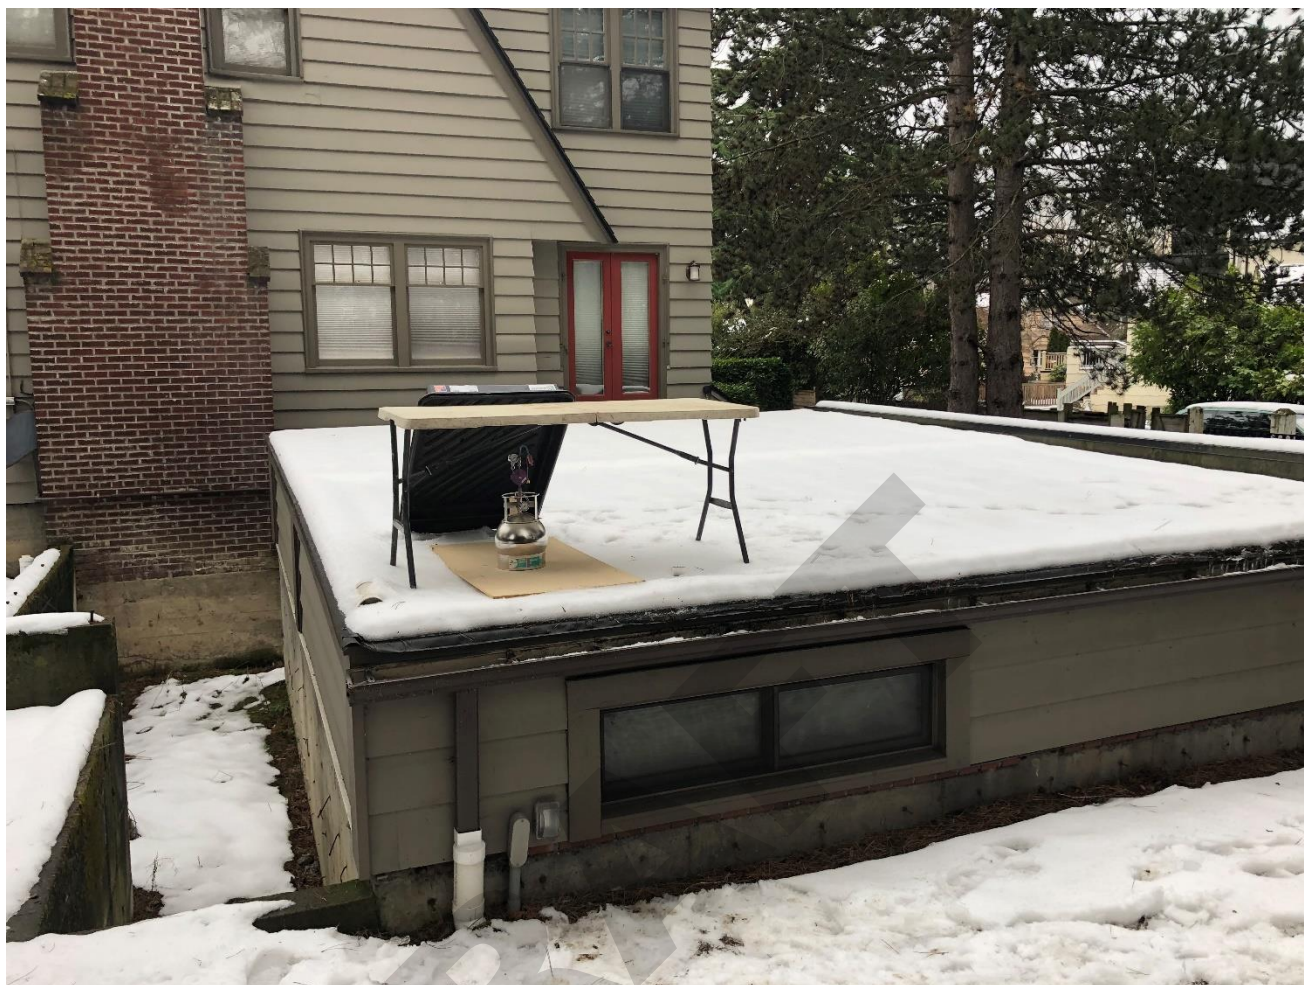
Ambient air sampling set up. SUMMA canister placed on top of a plastic base to keep it out of snow and underneath a table for rain protection. The SUMMA canister was placed on the northwest and upwind corner of the property garage.

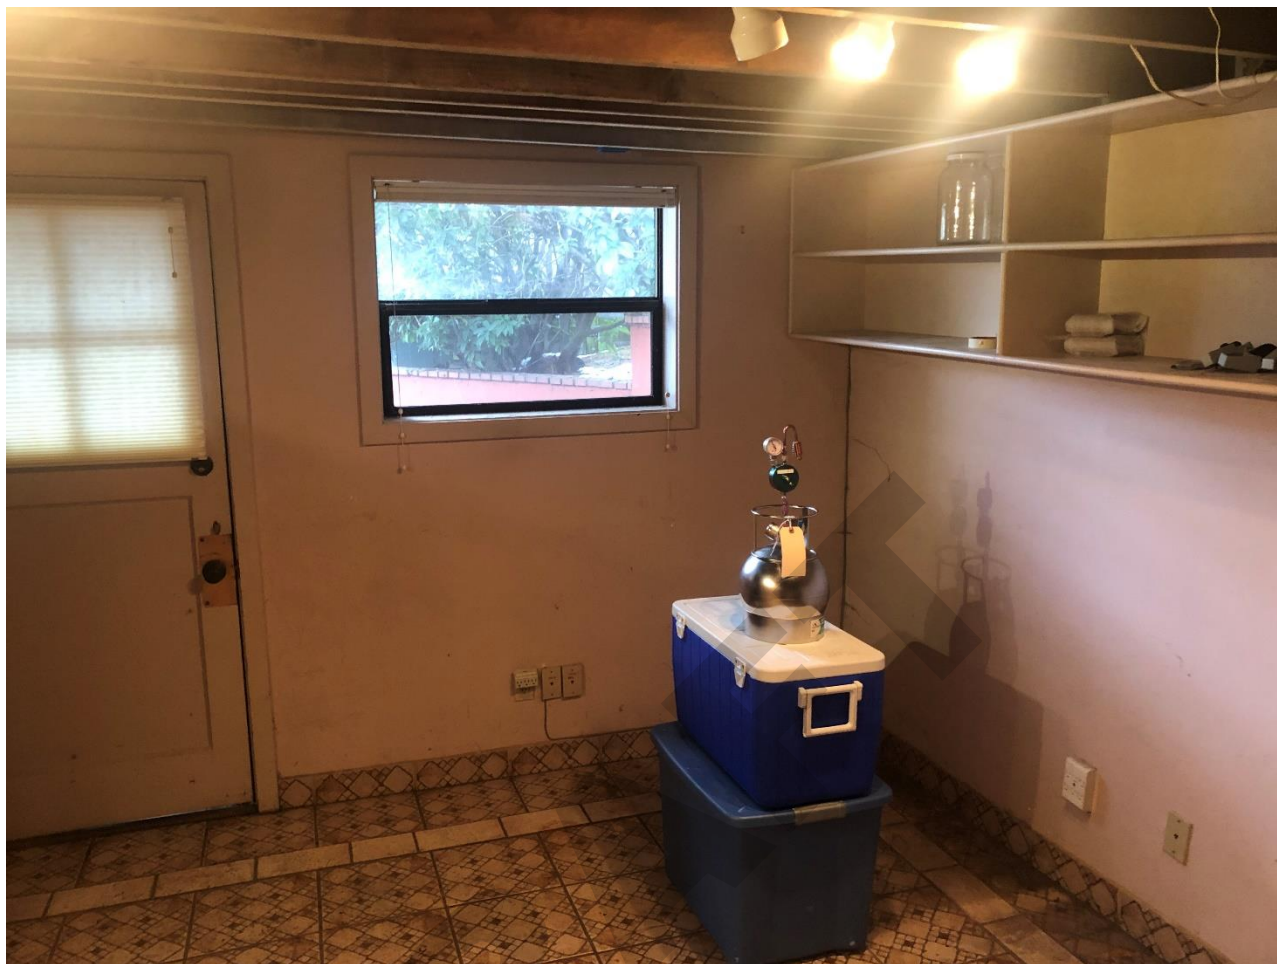
Indoor air sampling set up. SUMMA canister elevated above the garage floor and placed within the southwest corner of the property garage.
