Date: May 28, 2009
To: Ching-Pi Wang, Supervisor, TCP Uplands unit
From: Jerome Cruz, TCP
Subject: Weyerhauser Mill E site, Everett

Technical and Administrative Review Comments on the Weyerhaeuser Mill E formal MTCA cleanup site, 515 East Marine View Drive, Everett, Washington - Memo dated March 24, 2006

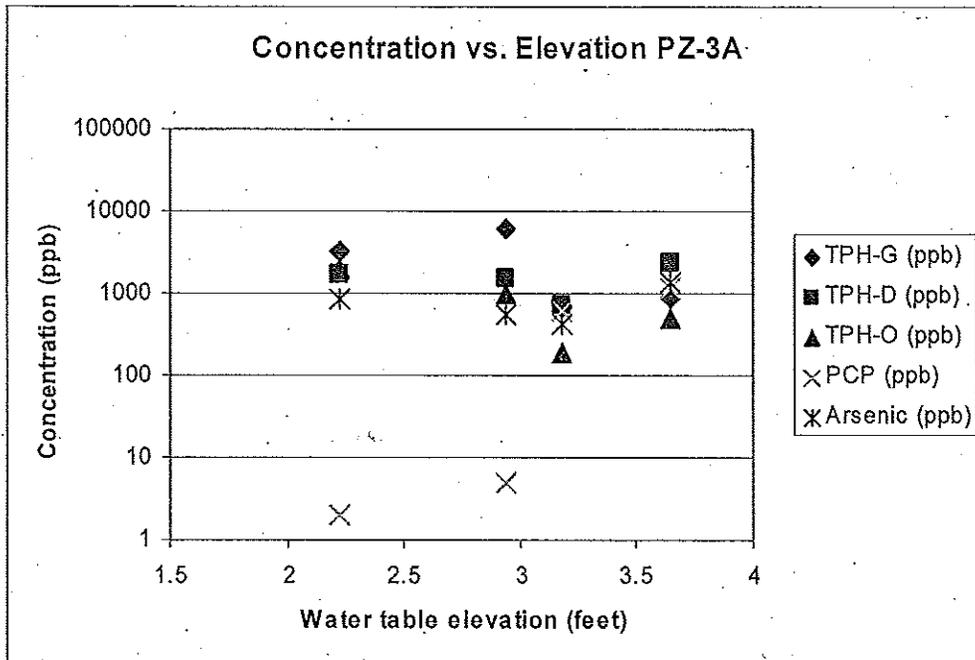
Figure 1. Contaminant concentration vs. water table elevation

Figures 1 – 3 depict the water table and contaminant concentration trends in well PZ-3A. Figure 1 shows concentration vs. elevation. Figure 2 shows the change in concentration with time since barrier wall and cap installation, and Figure 3 shows elevation vs. time. Except for PCP, there does not appear to be large variations in contaminant concentration with water table elevation (figure 1). Figure 2 shows that there was a significant reduction in PCP with time. However, the time series plot of the hydrocarbon contaminant concentrations seem to show increases but with a leveling off with time since cap installation. This can imply essentially constant petroleum hydrocarbon source term loading and thus vertical contaminant loading to the lower sand aquifer continues to occur. Although it has been characterized as below the cleanup standard, it is unknown if this is a standard protective of water quality and aquatic organism in the river receptor. Arsenic remains above cleanup levels. Finally, the water table beneath the cap still shows fluctuation, although as expected it is much lower than the water table in the upper sand outside of the wall. Note that the other piezometer information is not plotted in this graph, but the total results may be found in the monitoring reports.
