**Subject:** TWAFA Aboveground Site Conditions Memorandum

This memorandum provides information regarding current site conditions for each parcel included in the Taylor Way and Alexander Avenue Fill (TWAFA) Site, as required under section 5.1 of the Final Data Gaps Work Plan (DGWP) (DOF, 2020). Site conditions related to the following are discussed:

**TWAFA Site  
Tacoma, Washington  
Aboveground Site Conditions Memorandum**

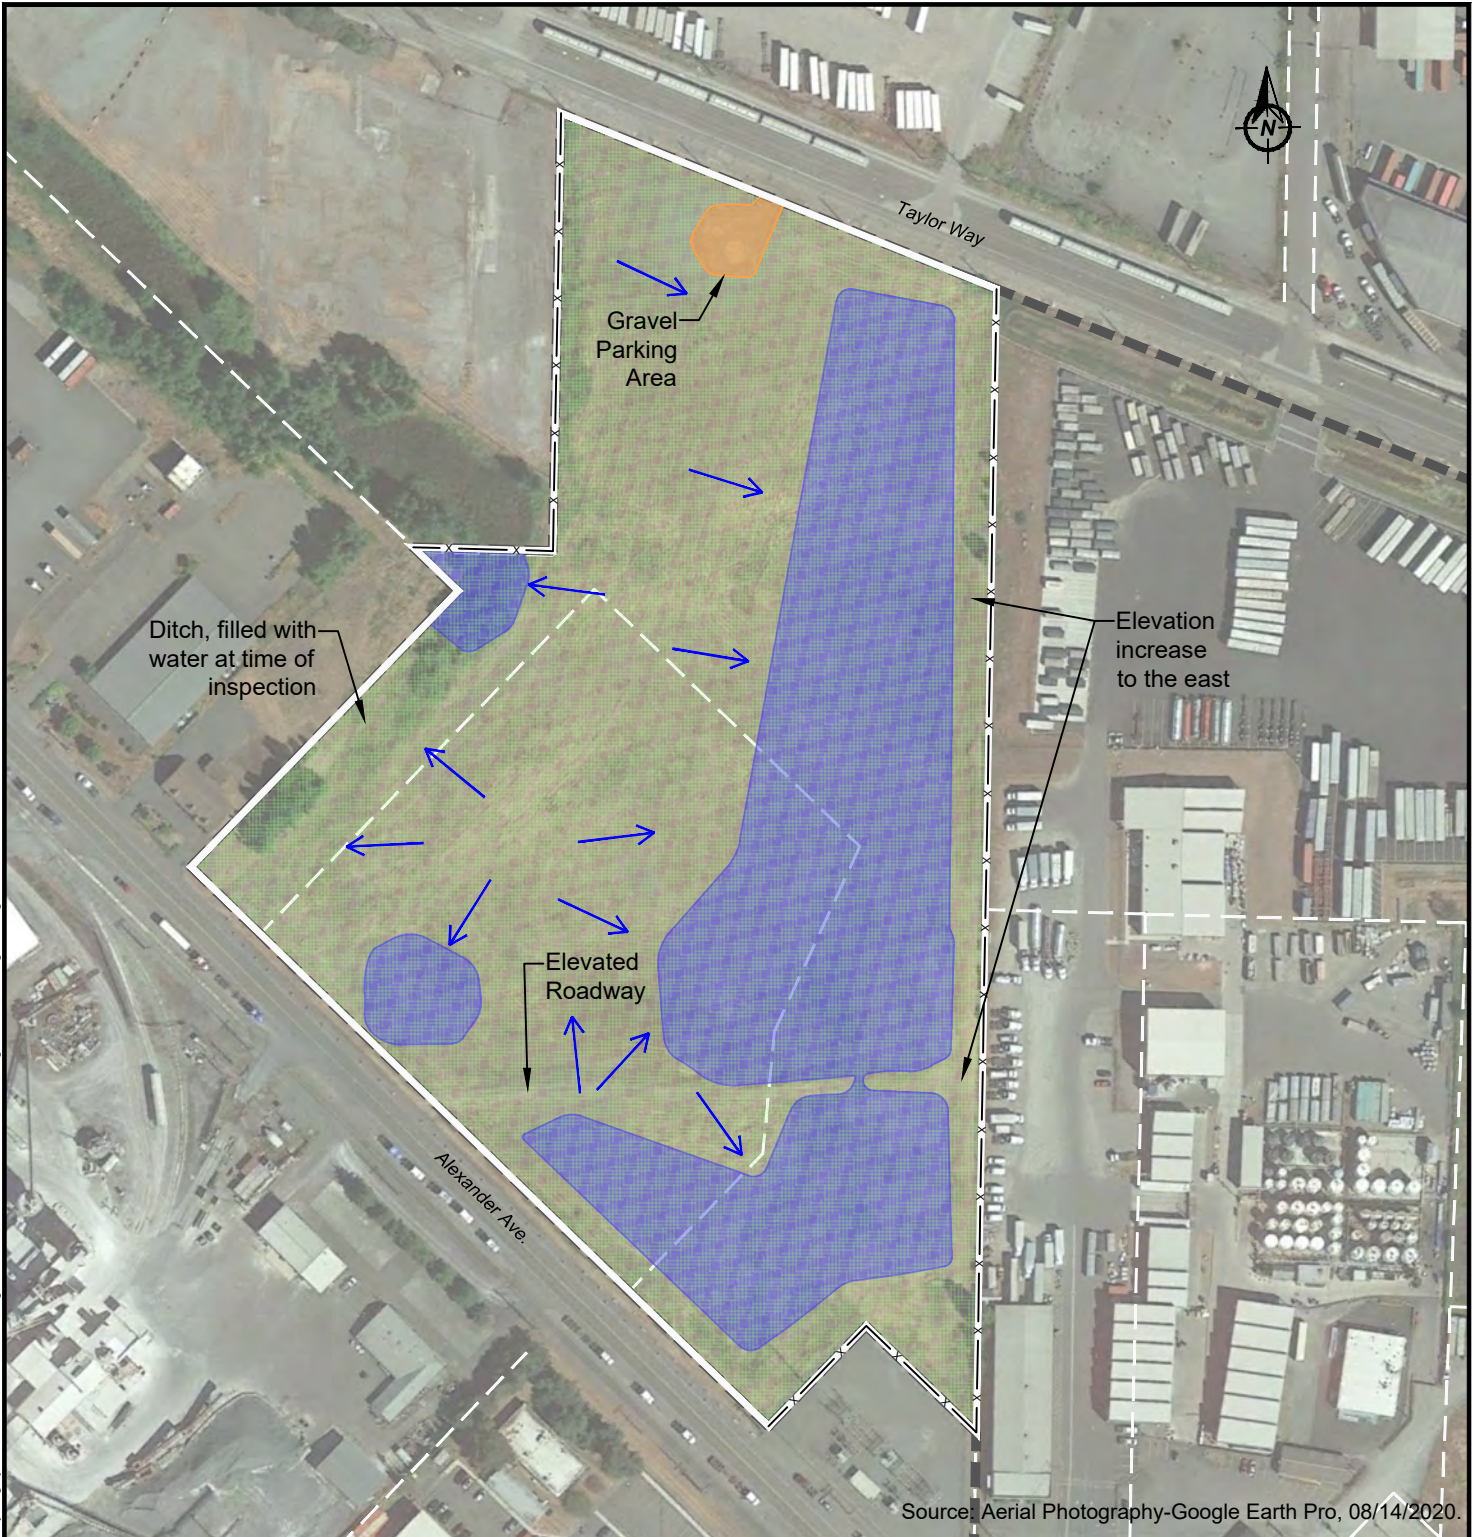
**FIGURE  
2**

The site inspection was completed by Dalton, Olmsted, & Fuglevand, Inc. (DOF) personnel on January 14, 2021, and DOF personnel were escorted by Scott Hooton of the PoT. Aboveground site conditions for the property are provided in Figure 2. The property was observed to be undeveloped, undulating, vegetated land with large areas of ponded water.

**General:** Low grasses and blackberry plants were observed across most of the property, and one area of cattails, where ground surface was lower. Several shallow ditches and depressions were observed. No buildings, above ground structures, catch basins, utilities, or paved areas were present on the property. A small gravel area (approximately 5,000 square feet) on the north side of the property, off Taylor Way, is used for parking while on site. A slightly elevated road traverses the property, entering from the south off Alexander Avenue and crossing northeast to the eastern side of the property where the site grade raises up several feet (Picture 2). The eastern side of the property is raised in elevation several feet higher than the rest of the property and debris was noted as eroding out of the bank at the location of the elevation transition (Picture 5).

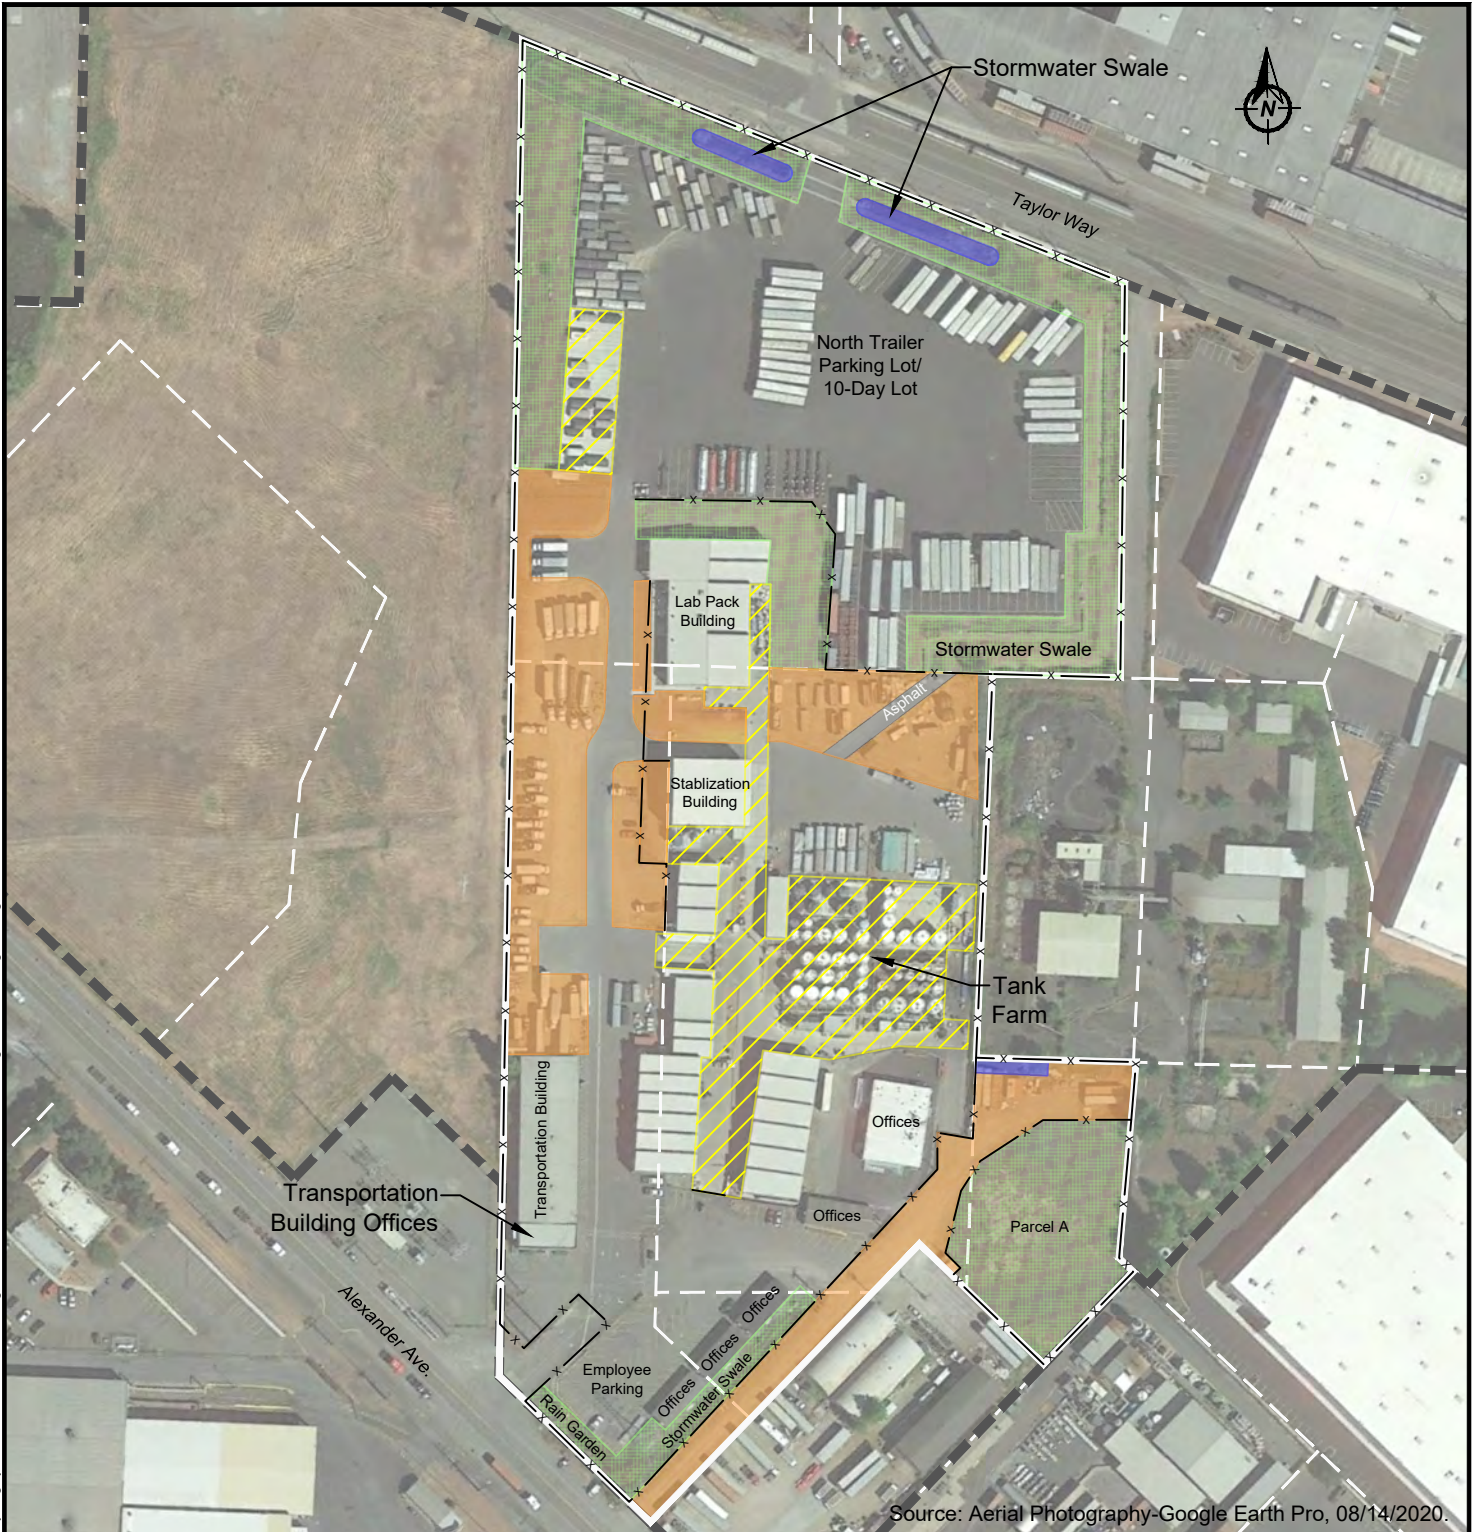
**FIGURE  
3**

Inspection of the property was completed on January 14, 2021 and February 3, 2021. The Burlington Environmental (BE) property includes several operational areas of the property: Parcel A, North Truck Parking, Permitted Transfer, Storage, and Disposal (TSD) Facility, Transportation Services, and the Offices/Parking. Aboveground site conditions are shown on Figures 3 and 4.

**Defining characteristics:** The property is mostly paved or developed. Several buildings exist, though the only location on the BE property recommended for evaluation of the potential for vapor intrusion risk is the transportation office. The vapor pathway is expected to be incomplete for all other structures due to structures having existing vapor mitigation systems or verification testing performed, are open-air construction style, or are elevated from the ground allowing for natural ventilation of potential vapors.

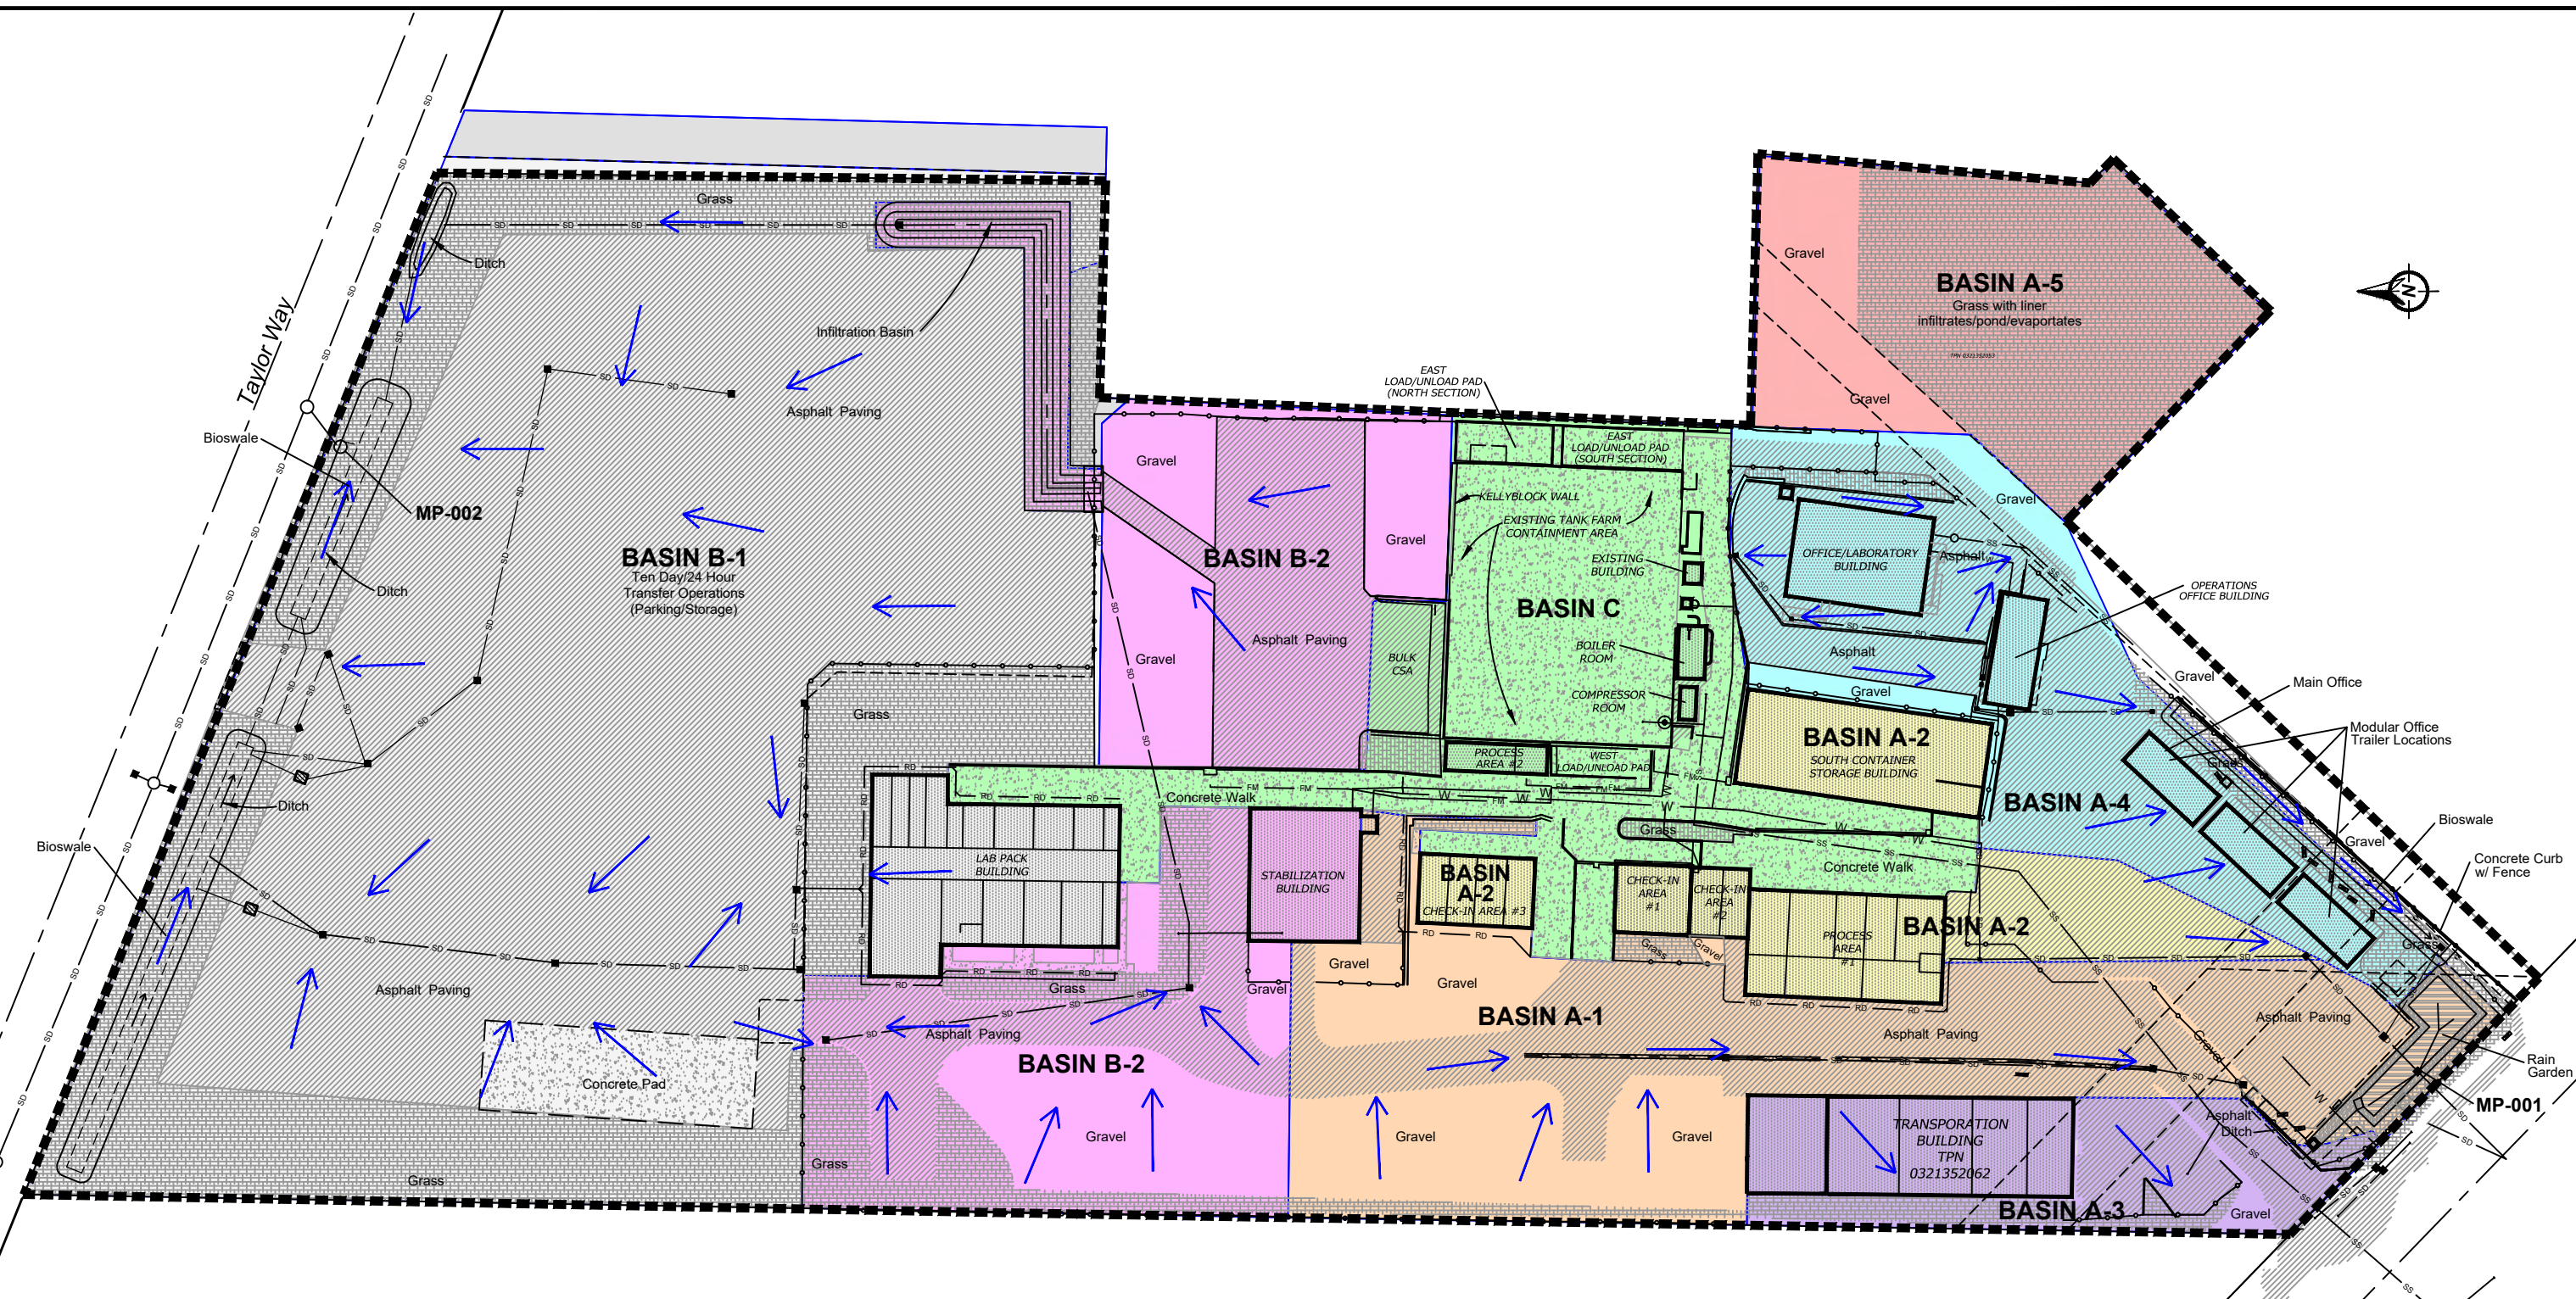
**FIGURE  
4**

Contaminated and contact stormwater are contained and treated prior to discharge to the City of Tacoma Public Owned Treatment Works (POTW). General industrial stormwater is allowed to flow into swales and rain gardens for treatment before discharge to the City of Tacoma stormwater conveyance system. Best management practices (BMPs) are present between general industrial stormwater areas and the contaminated and contact stormwater areas, preventing stormwater comingling between the two areas. These areas are shown on Figure 4.

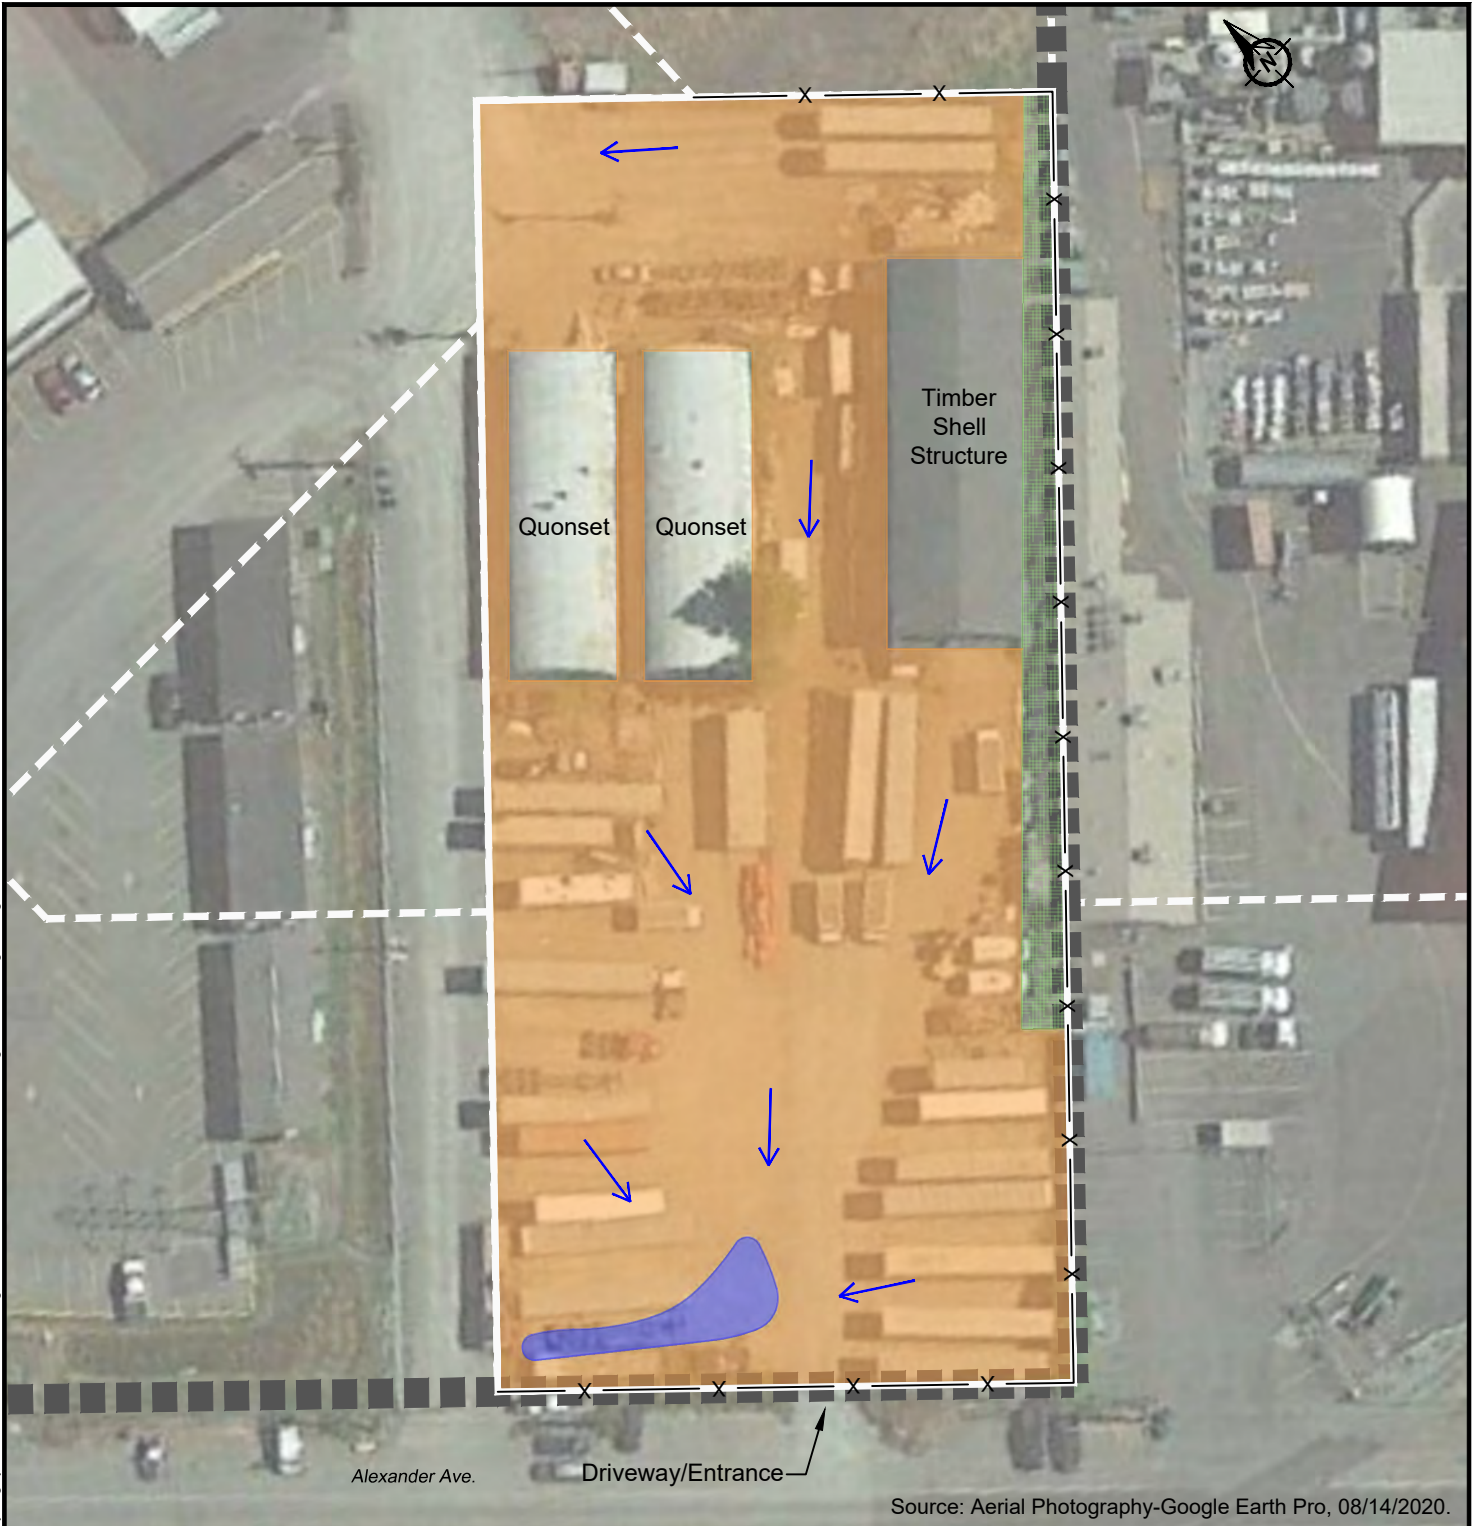
**FIGURE  
5**

provided in Figure 5. The property is improved with three light industrial outbuildings used for semi-truck trailer repair and modification.

**Defining characteristics:** The property is in active use. The property is relatively flat with hard surfaces that appeared to be in poor repair or unpaved in most of the parcel. Inspecting during the drier season may allow for better pavement inspection, though access would be challenging due to trailer parking and material storage. A subsurface LNAPL capture trench was documented as present on this parcel in the Data Gaps Work Plan (DOF, 2020) but was not inspected as part of the site inspection because truck trailers were parked on top of this area.

**General:** The property outside of the buildings is used for trailer parking and material storage related to trailer repair. The property is flat and the surface finish appeared to be concrete inside the buildings and gravel across the remainder (interior of buildings were not toured as part of the site inspection). No catch basins or stormwater infrastructure was observed during the site visit and water ponding was present in the southwest corner of the parcel, indicating stormwater surface flows to this area. No other structures were observed during the site inspection.

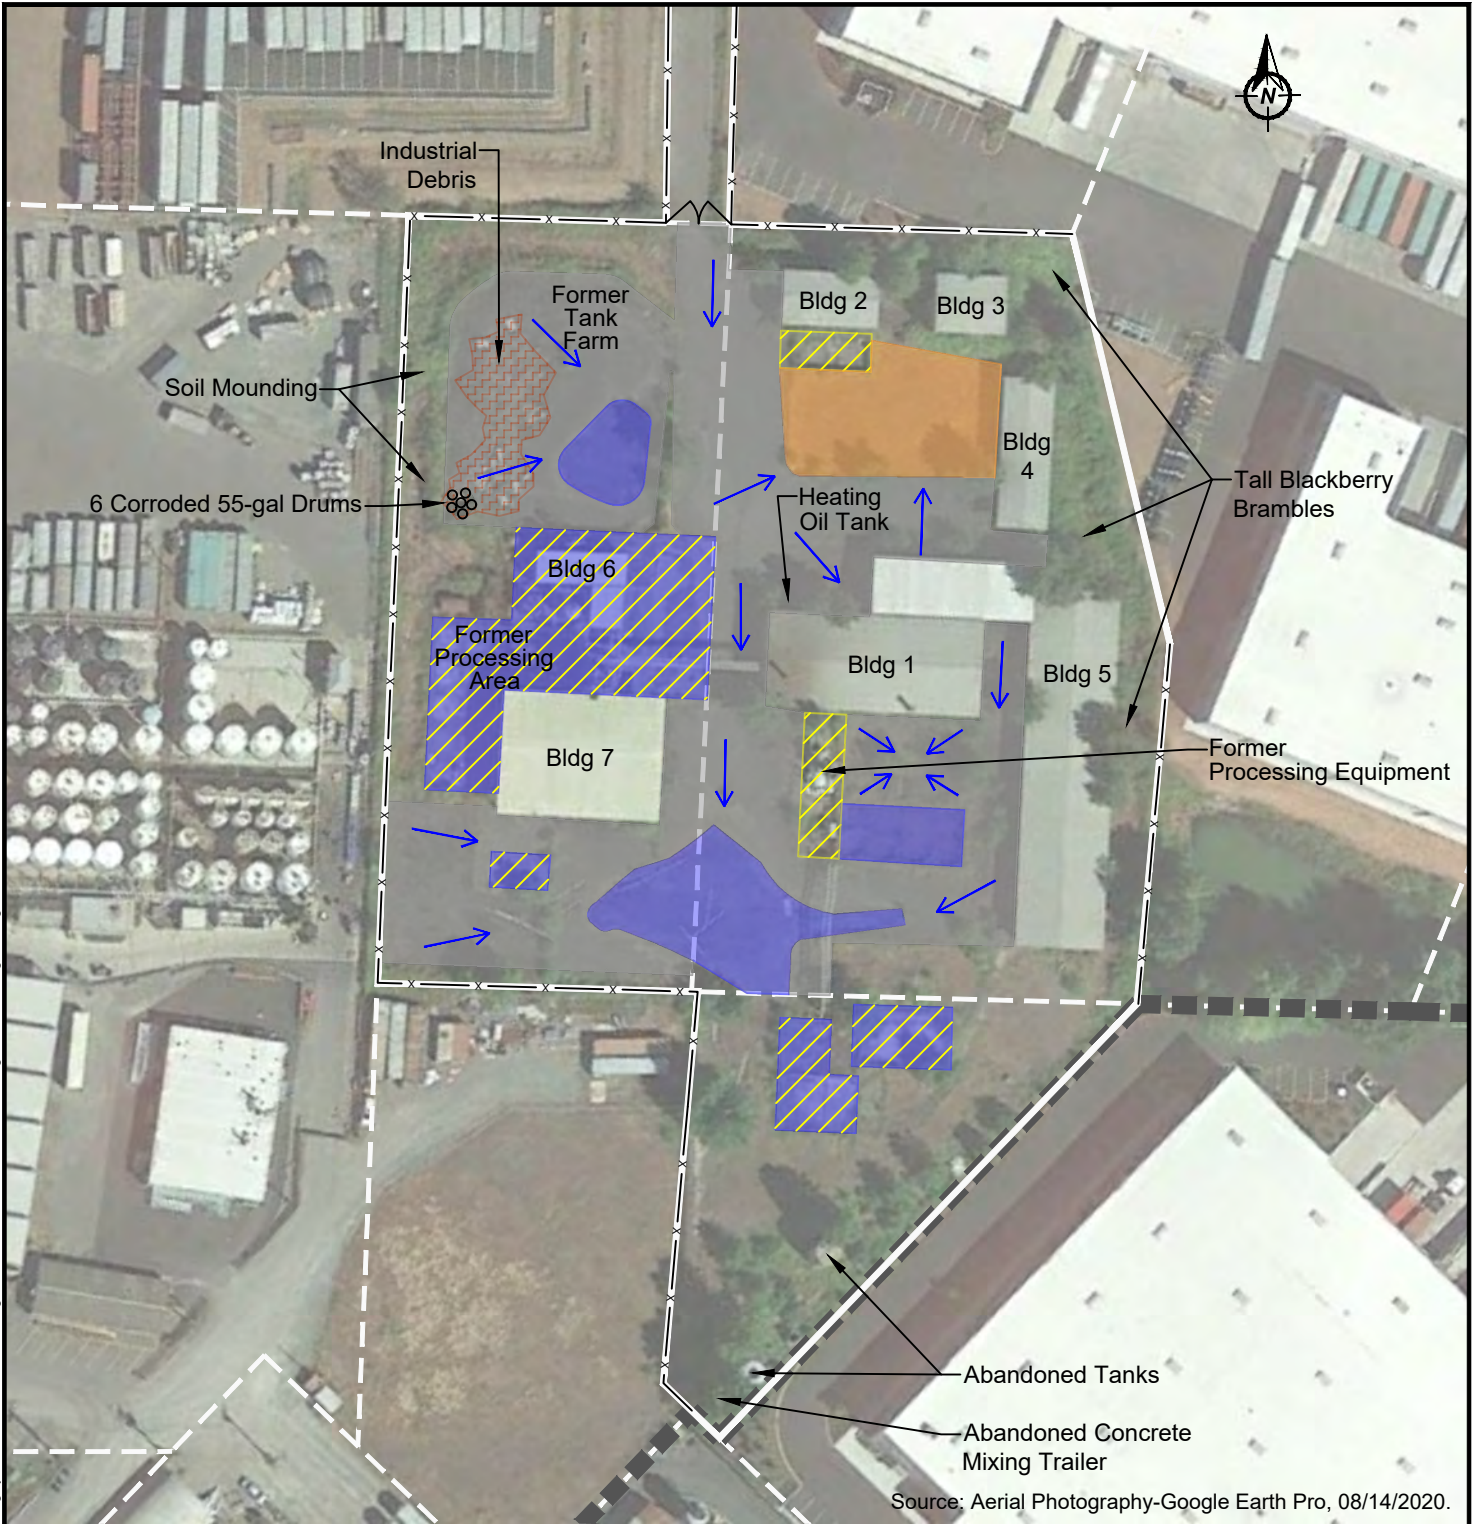
**FIGURE  
6**

**Buildings:** As described in the Data Gaps Work Plan (DOF, 2020), the property has five buildings (Buildings 1-5) and two open-air overhang structures (Buildings 6 & 7), as shown in Figure 6. None of the buildings or structures on the property are in use or will be used in their current condition. All buildings were unsecured and were accessible, but some have limited access due to trash and debris present inside of them. The buildings have been severed and stripped of utilities, windows are broken and/or missing, interior walls and finished surfaces are in poor and/or damaged condition, and abundant debris is present in most buildings. Thus, future use of the existing buildings and/or structures will require, at least, some level of remodel/modification. However, the buildings appeared to be structurally sound during the site inspection and Pierce County indicated they have no intention of demolishing the structures. Soil vapor sampling for the property will be completed under the Data Gaps Work Plan (DOF,

**Defining characteristics:** The property is abandoned, in disrepair, and not fully secured. There are numerous aboveground structures and debris present across the property.

**General:** The property is mostly paved with asphalt, though concrete was observed in some areas, and most of the peripheral areas of the property are covered in vegetation (blackberries, grasses, and some trees and shrubs). The approximate outline of paving as observed during the site inspection is shown on Figure 6. The outline of the former tank farm area at the north end of the property was still in place, though only partially surrounds that area and is open on the east side. Soil mounding was observed west of the former tank farm area, adjacent to the western property line. This was the only mounded soil identified during the site inspection.

Stormwater ponding was observed in the south end of the former tank farm area, in the former processing area, in the southern end of the asphalt paved area, and inside several containment areas at the south end of the property. No stormwater ponding was observed in the gravel areas surrounding the paved areas, although some of the areas could not be inspected due to brush growth along the western, northern, and eastern property lines. No catch basins or evidence of subsurface stormwater infrastructure was observed during the site inspection, though sumps were present in some buildings.

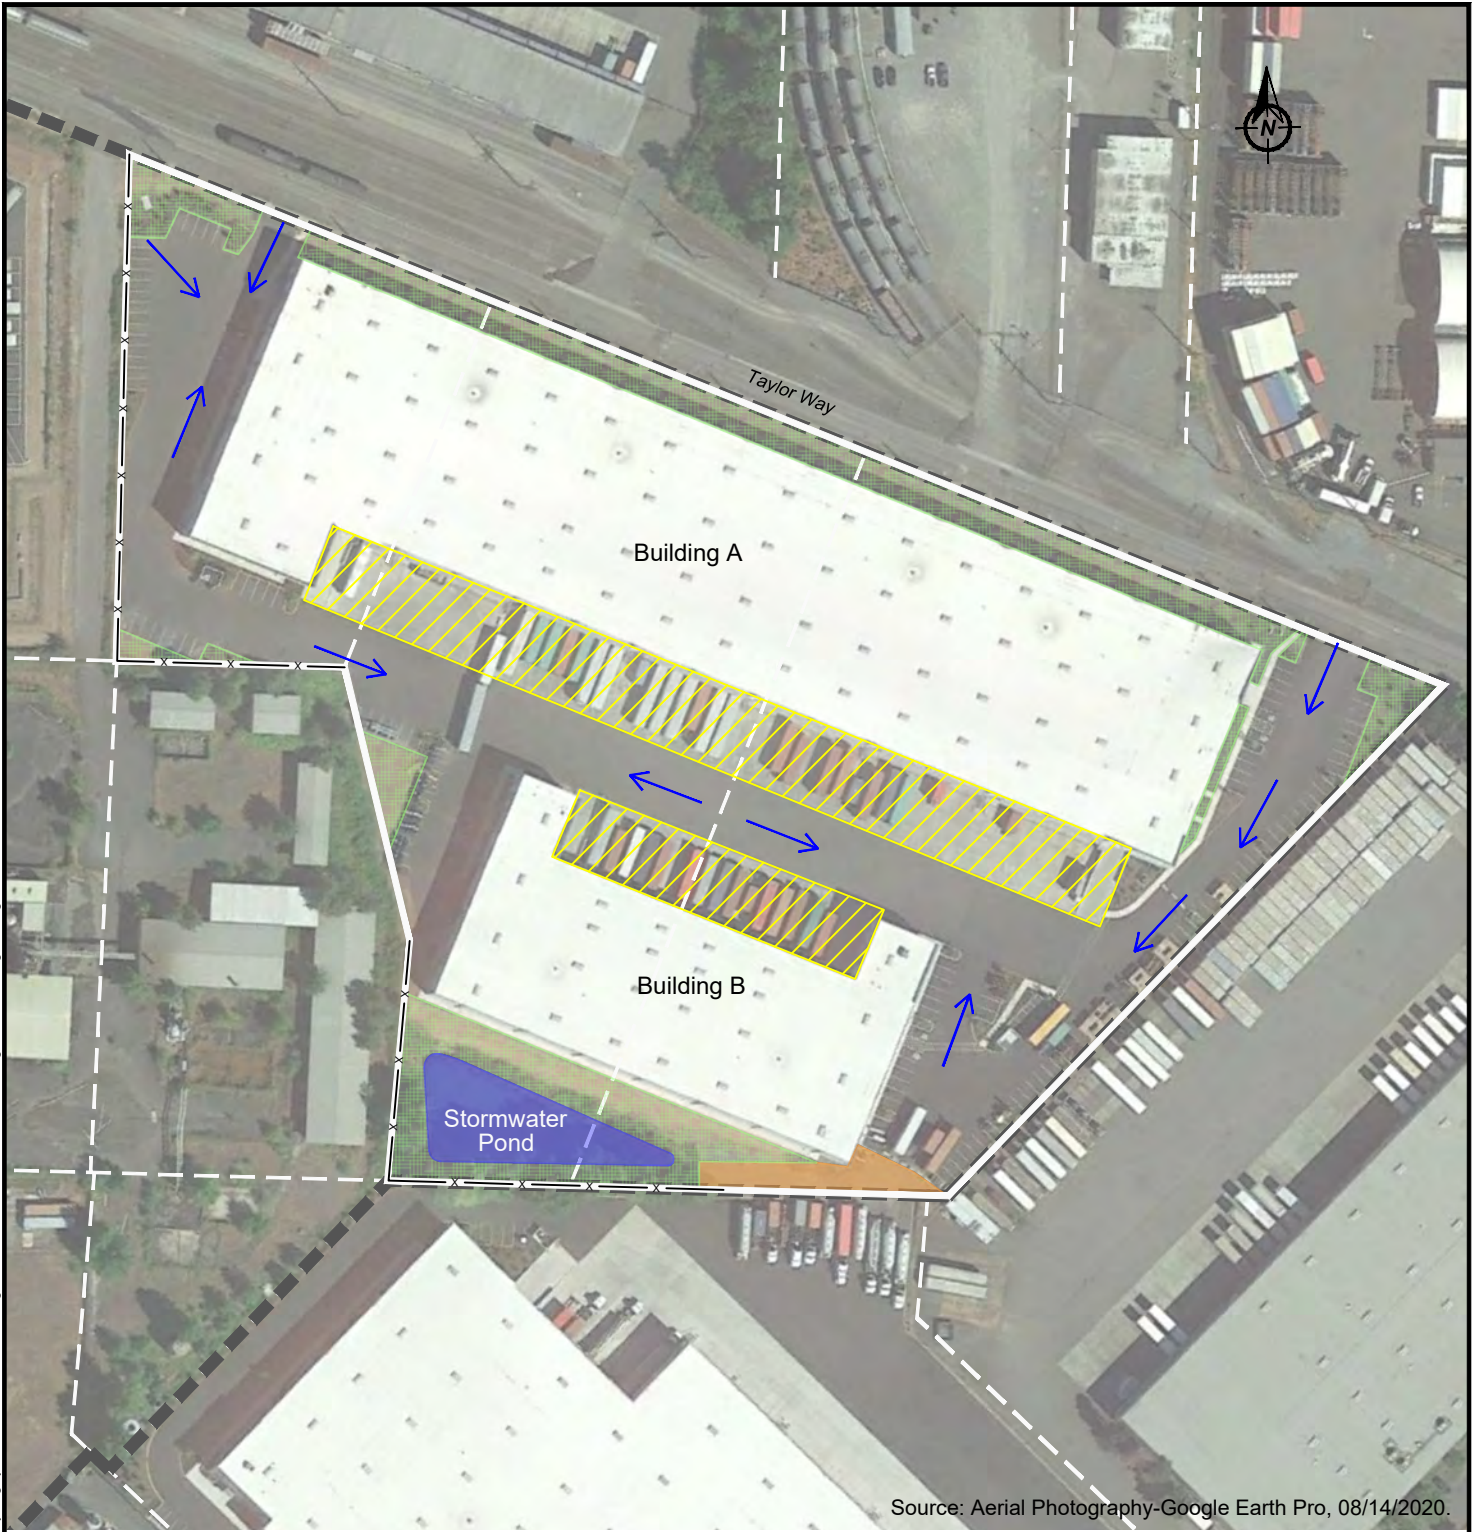
**FIGURE  
7**

**Buildings:** The property is improved with two recently constructed (2019) concrete tilt-up structures, primarily used for warehousing purposes. The northern building is 155,000 SF and the southern building is 51,900 SF and the two structures share a 175,000 SF paved truck court.

**Defining characteristics:** The property is newly developed, in active use, and mostly paved apart from small areas of landscaping and stormwater management features.

**General:** A stormwater retention pond is present at the south end of the property. Stormwater catch basins were observed throughout the site, but alignment and flow of stormwater, including discharge were not confirmed as part of the site inspection. DOF will request additional information about the stormwater pond construction from the PoT as part of ongoing data gaps work.

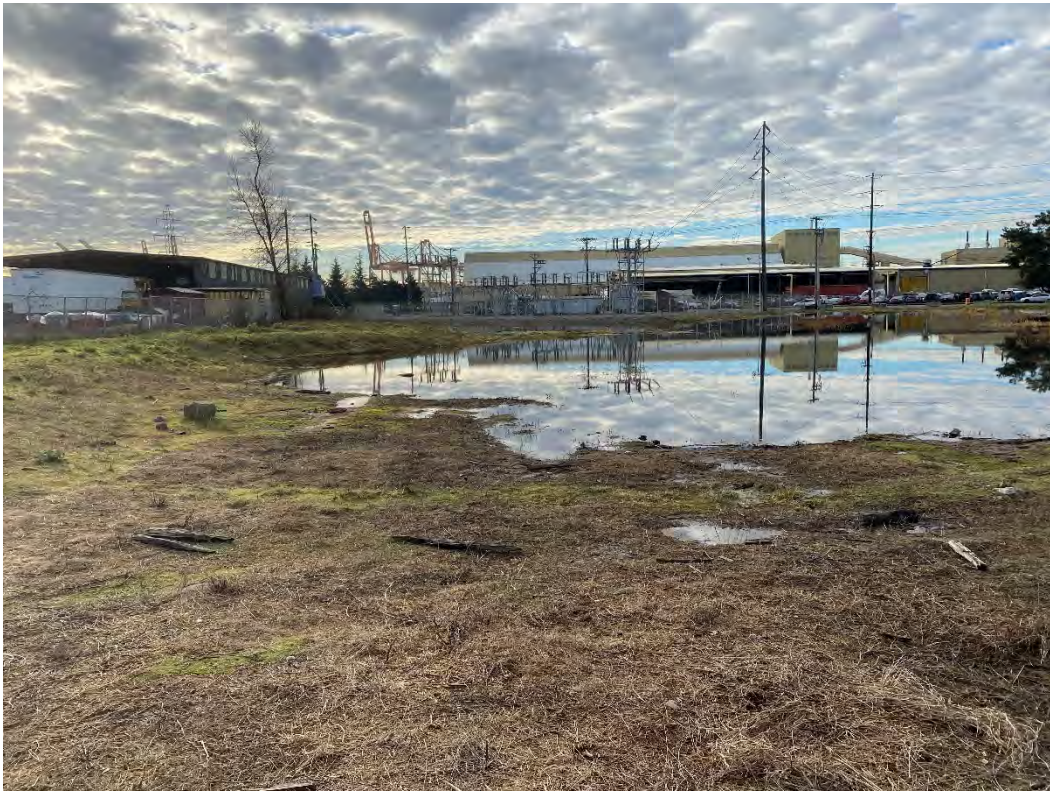
*Picture 3 Ponding in southeast corner on 1205 Alexander Ave & 1300 Taylor Way Property*

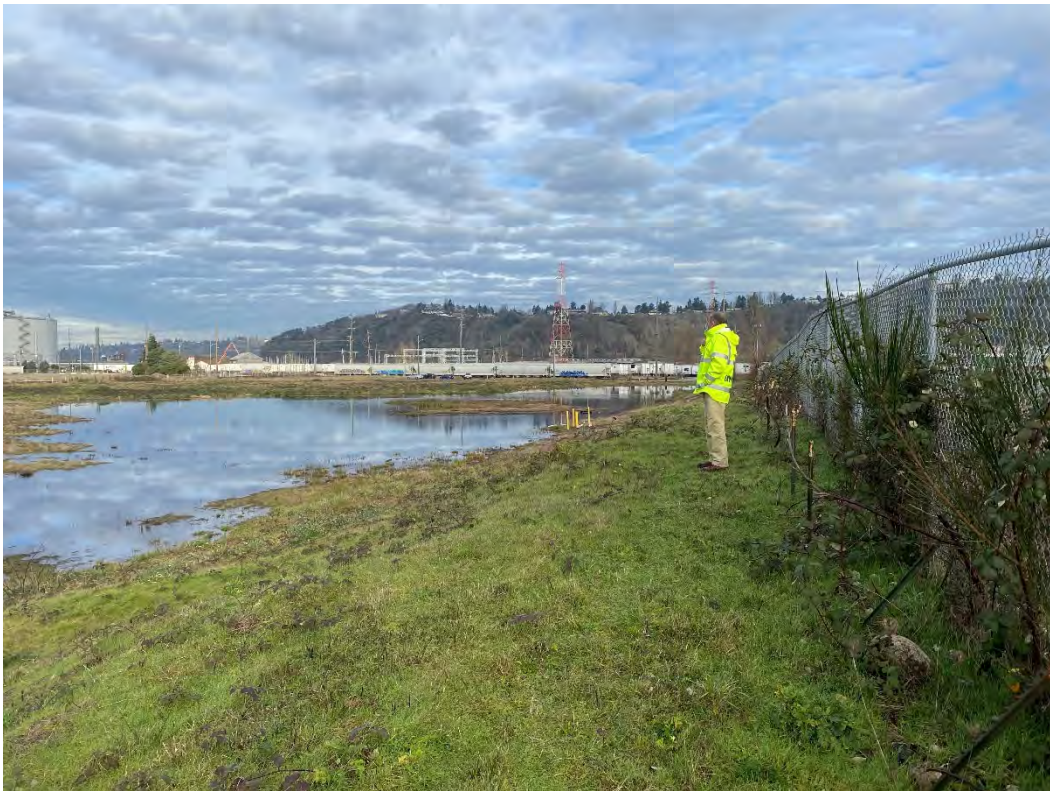
*Picture 4 Slope and Ponding on east side of 1205 Alexander Ave & 1300 Taylor Way Property*

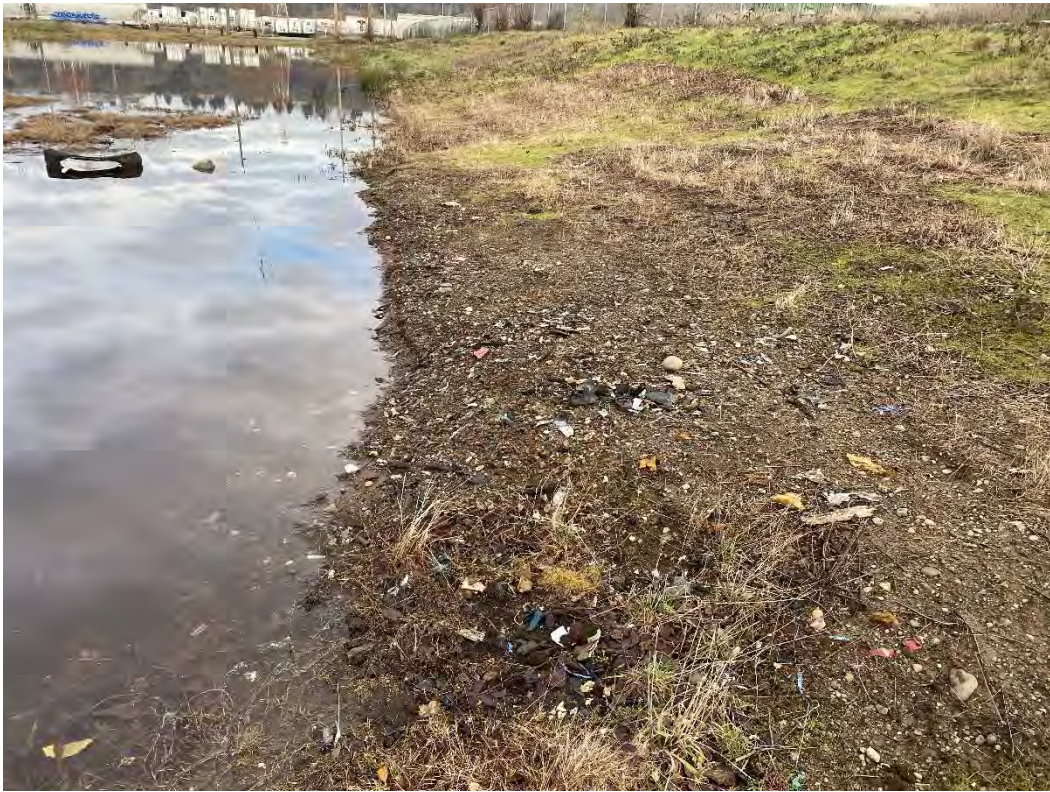
*Picture 5 Debris in eastern slope on 1205 Alexander Ave & 1300 Taylor Way Property*

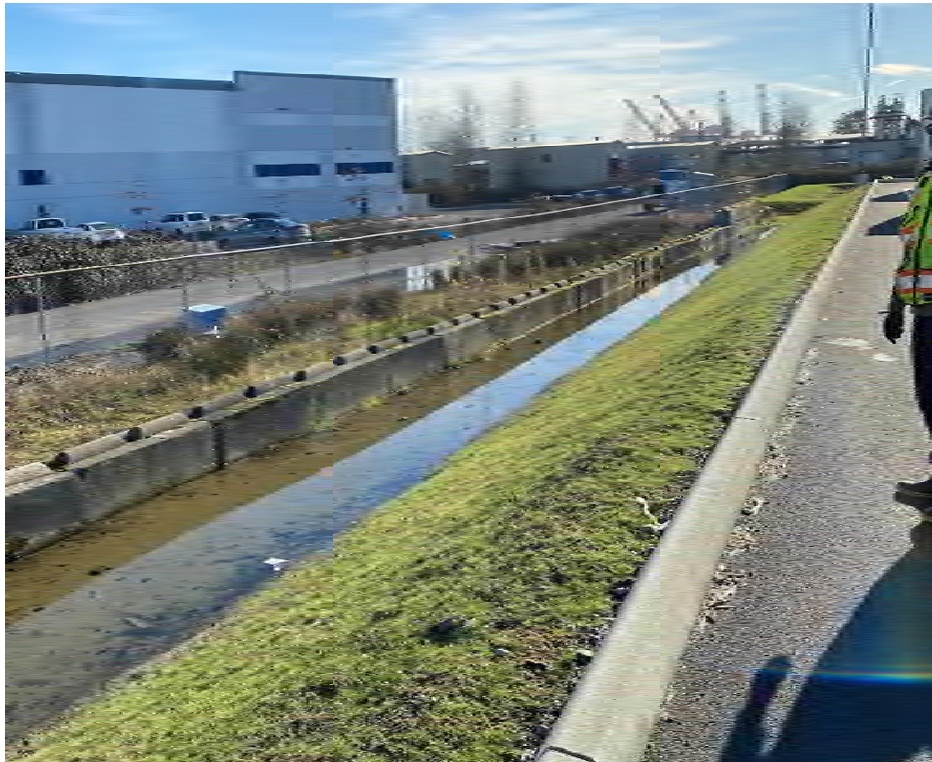
*Picture 9 Pondered stormwater along eastern property line, adjacent to northern trailer parking lot on Burlington Environmental Property*

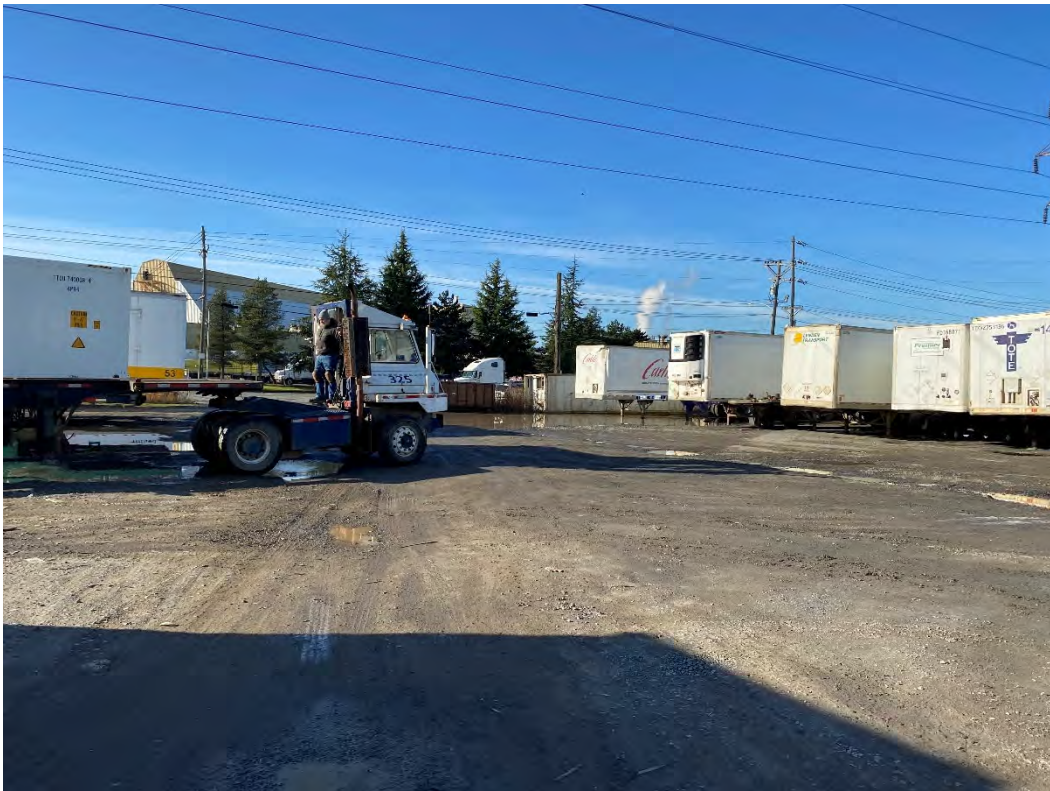
*Picture 14 Ponded water and trailer parking on south end of Potter Property*

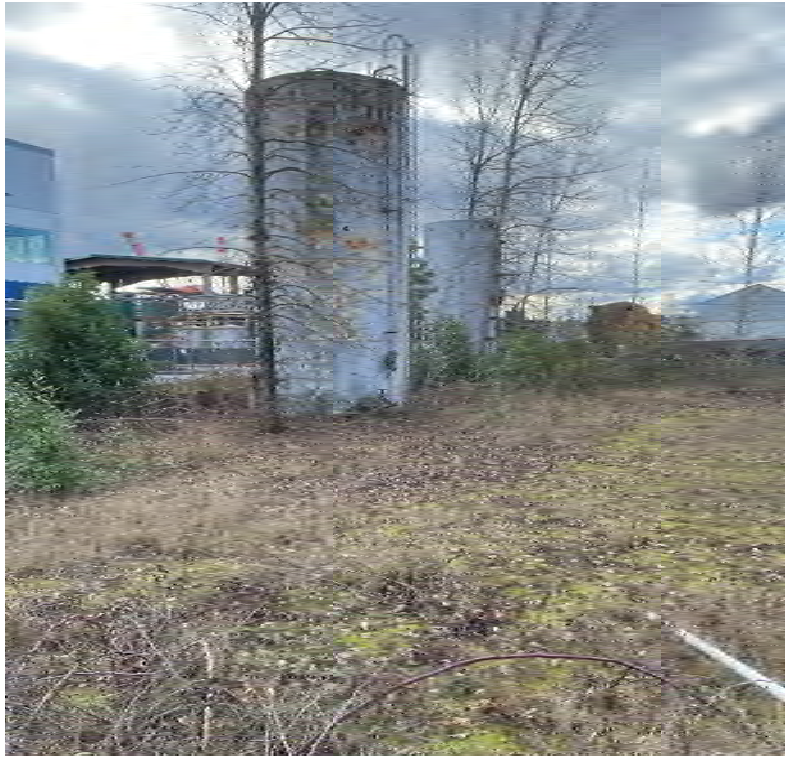
*Picture 17 Abandoned tanks on south end of CleanCare Property*

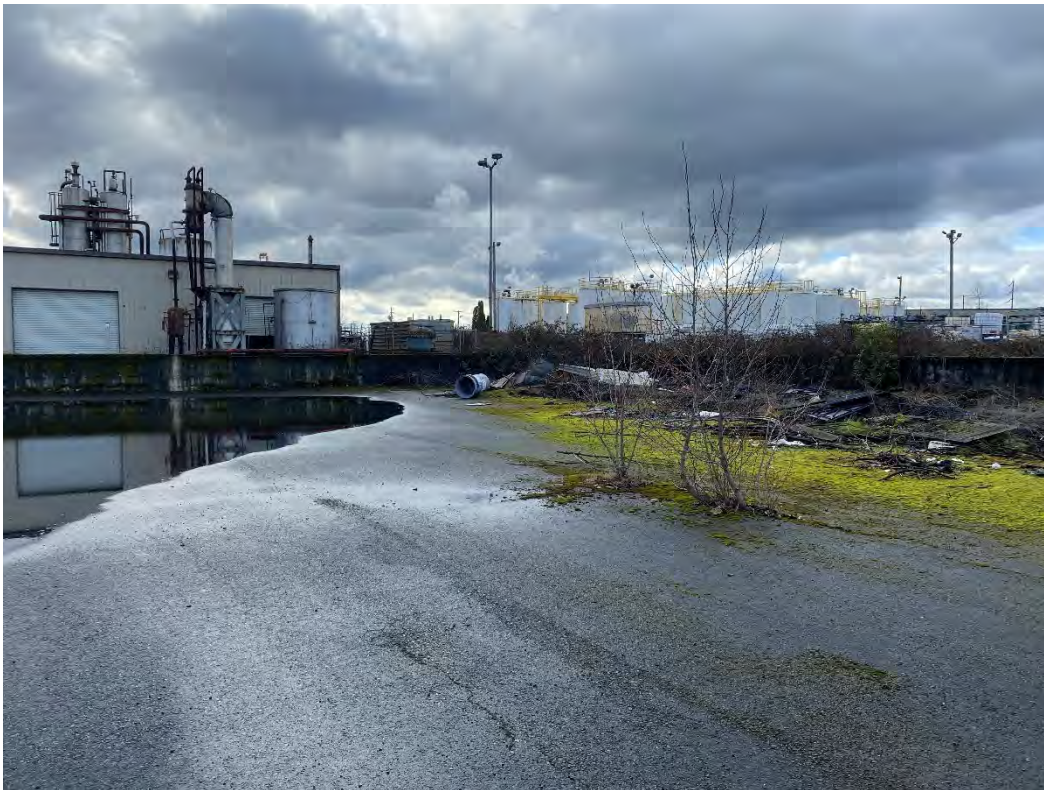
*Picture 18 Ponded water and debris in the former tank farm area of the CleanCare Property*
