**Subject:** TWAFA Aboveground Site Conditions Memorandum

This memorandum provides information regarding current site conditions for each parcel included in the Taylor Way and Alexander Avenue Fill (TWAFA) Site, as required under section 5.1 of the Final Data Gaps Work Plan (DGWP) (DOF, 2020). Site conditions related to the following are discussed:

**TWAFA Site  
Tacoma, Washington  
Aboveground Site Conditions Memorandum**

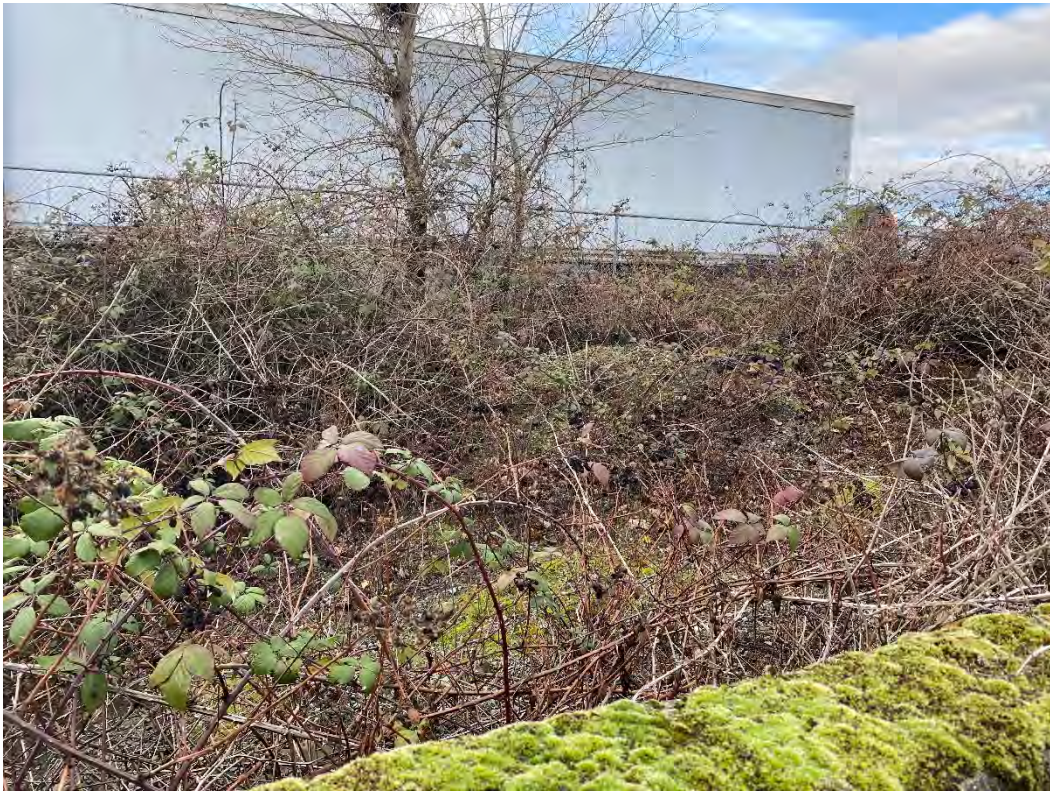
**General:** The property is mostly paved with asphalt, though concrete was observed in some areas, and most of the peripheral areas of the property are covered in vegetation (blackberries, grasses, and some trees and shrubs). The approximate outline of paving as observed during the site inspection is shown on Figure 6. The outline of the former tank farm area at the north end of the property was still in place, though only partially surrounds that area and is open on the east side. Soil mounding was observed west of the former tank farm area, adjacent to the western property line. This was the only mounded soil identified during the site inspection.

Picture 19 Soil mounding along western property line, west of the former tank farm area on the CleanCare Property

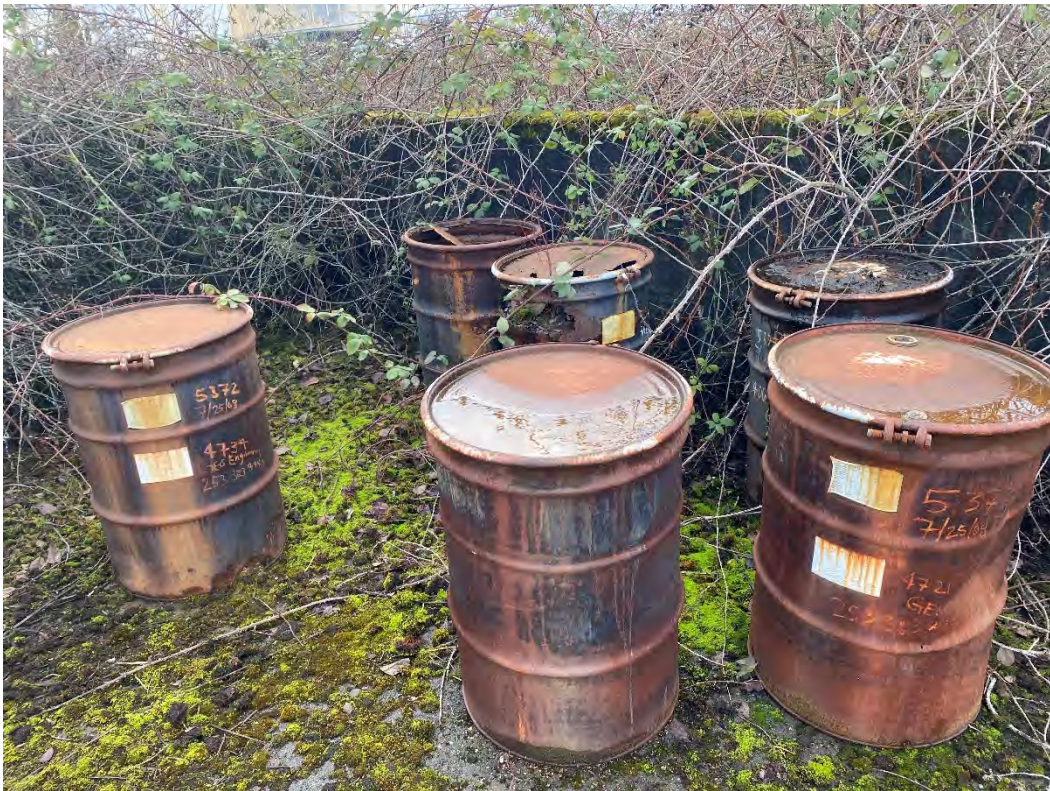
Picture 20 Corroded drums in southwest corner of former tank farm area on CleanCare Property

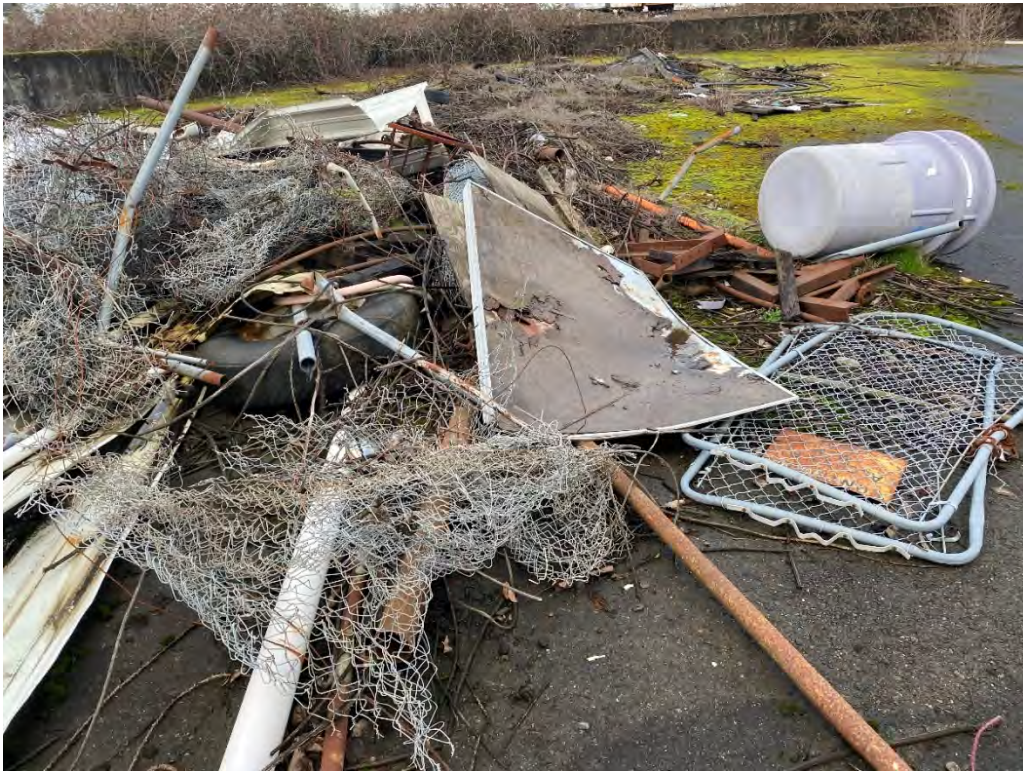
*Picture 21 Debris in the former tank farm area of the CleanCare Property*

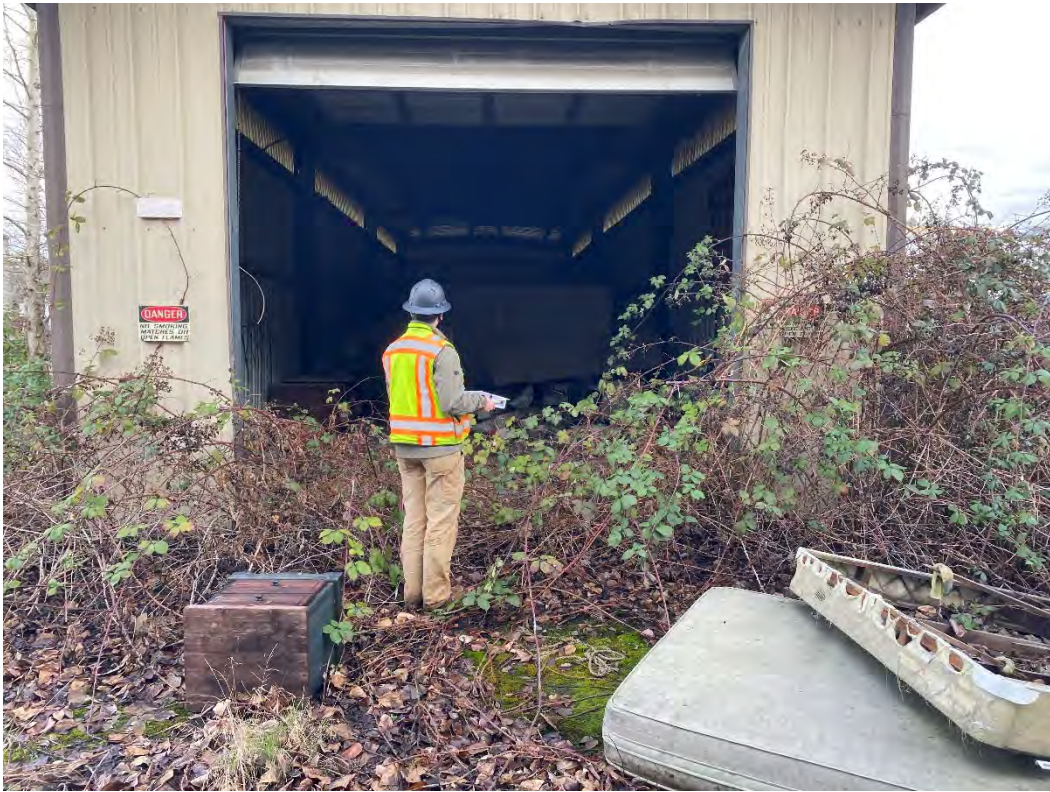
*Picture 25 Debris inside and outside south end of building 3 on CleanCare Property*

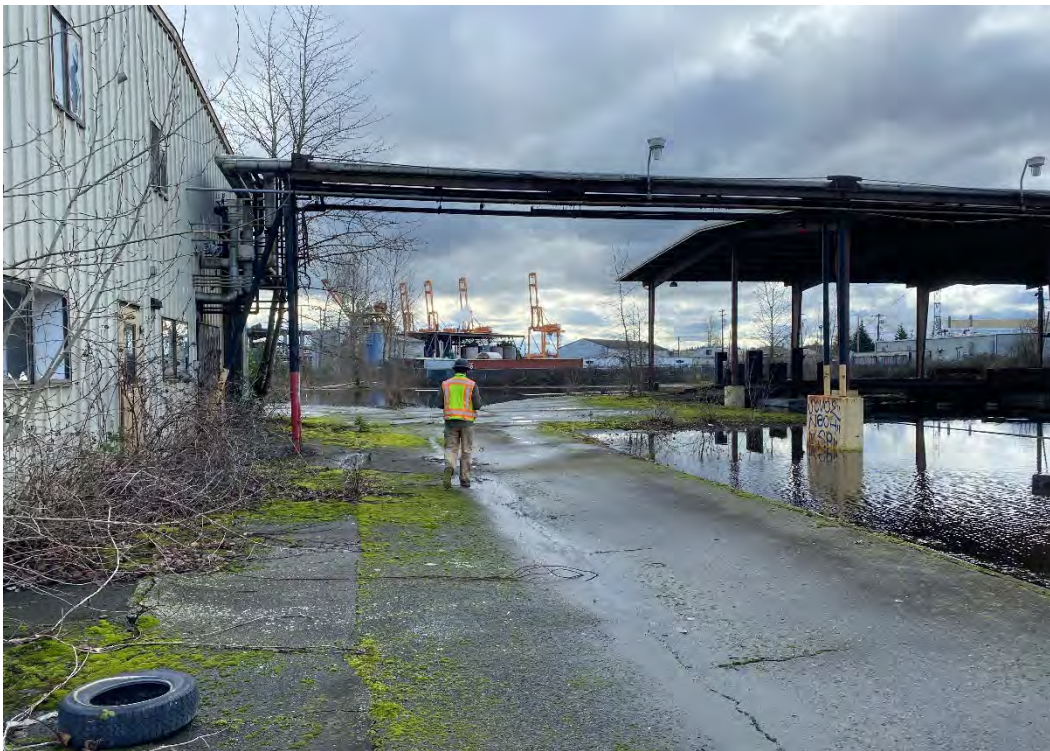
*Picture 30 Ponded stormwater and former processing pipe rack overhead on CleanCare Property*

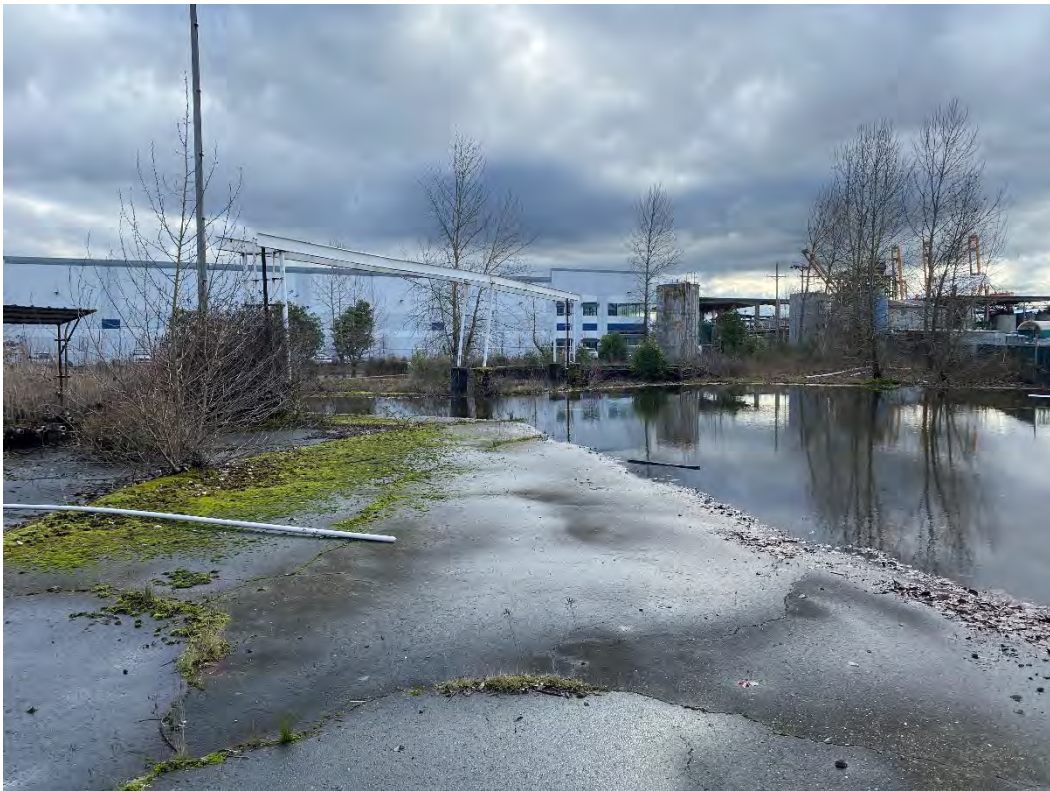
*Picture 32 Ponded stormwater southwest of building 1, abandoned tanks in background on CleanCare Property*

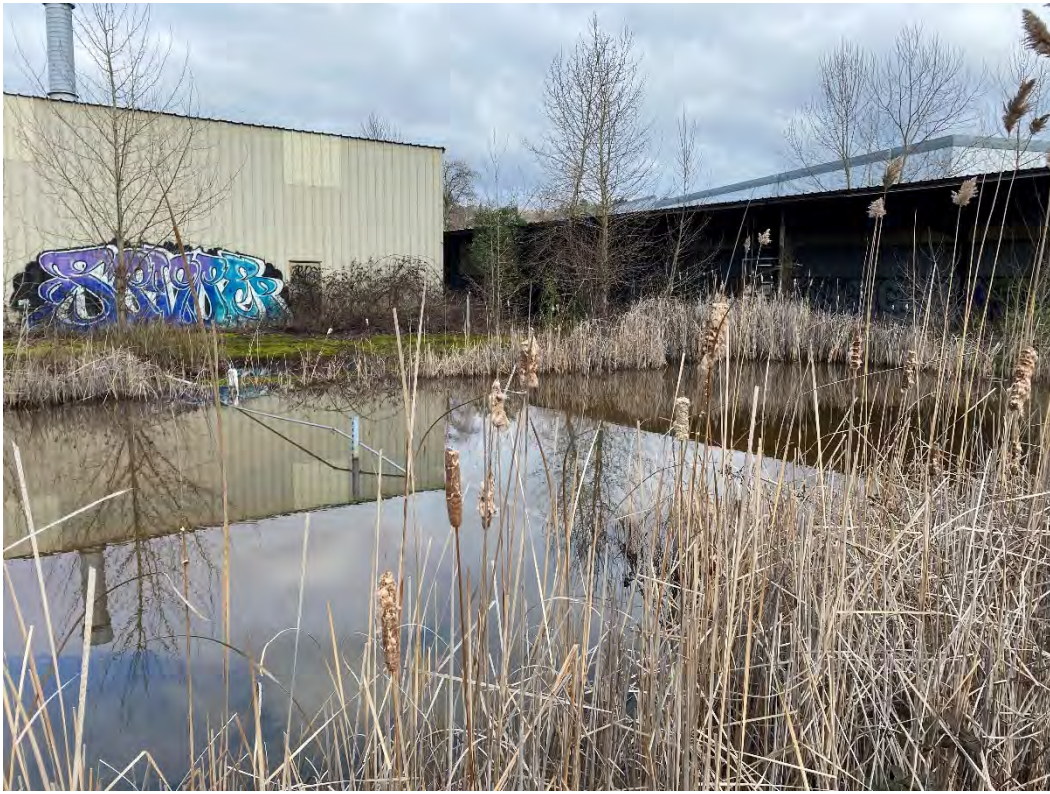
*Picture 33 Former concrete containment area south of building 1 full of stormwater on CleanCare Property*

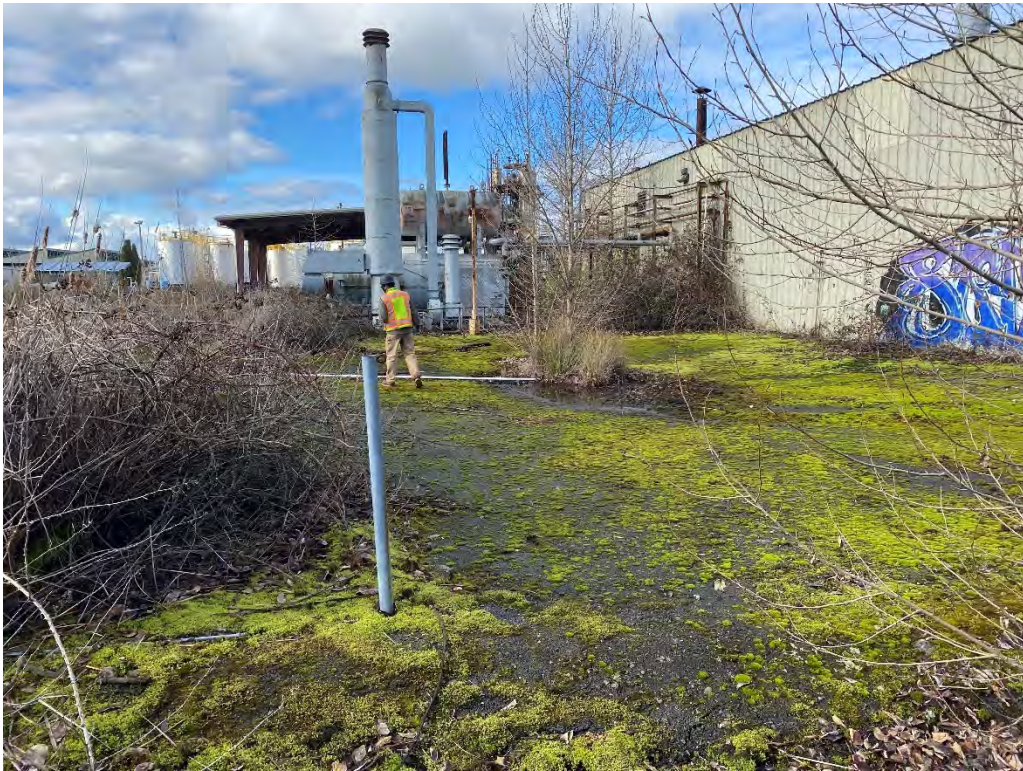
*Picture 35 Asphalt depression south of building 1 and north of containment area shown in Picture 34 on Cleancare Property*

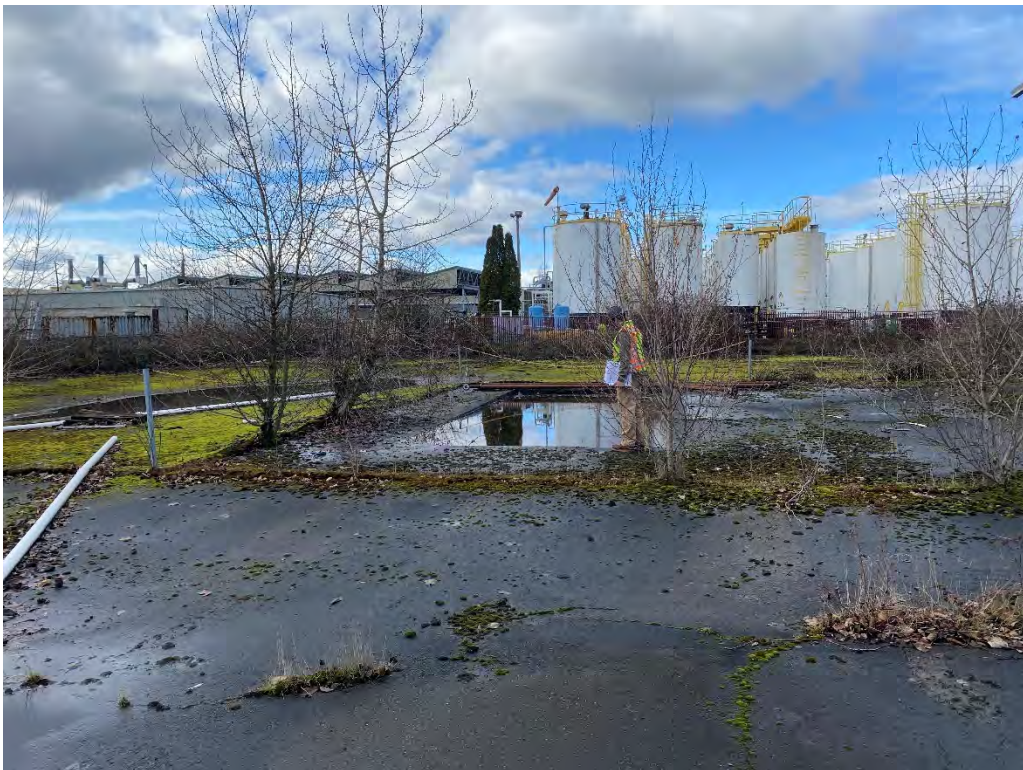
*Picture 36 Ponded stormwater in concrete containment area south of former process area on CleanCare Property, Burlington Environmental tank farm in background*

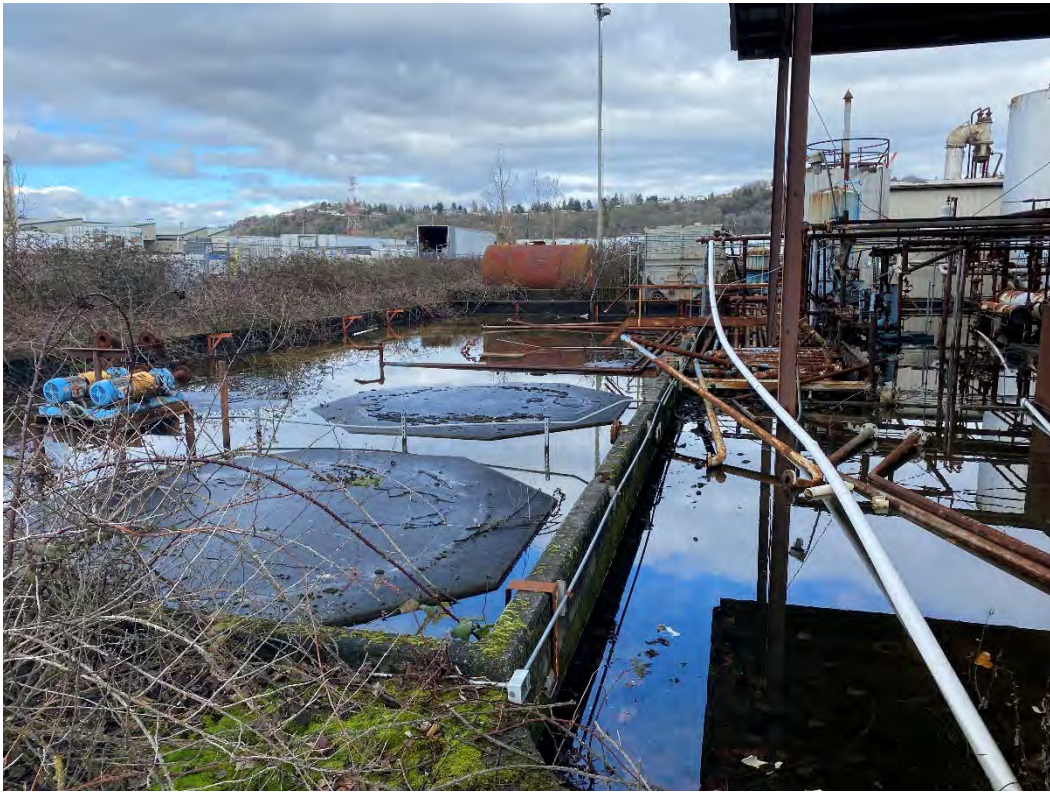
*Picture 37 Former process area (containment and abandoned equipment) with ponded stormwater on CleanCare Property*

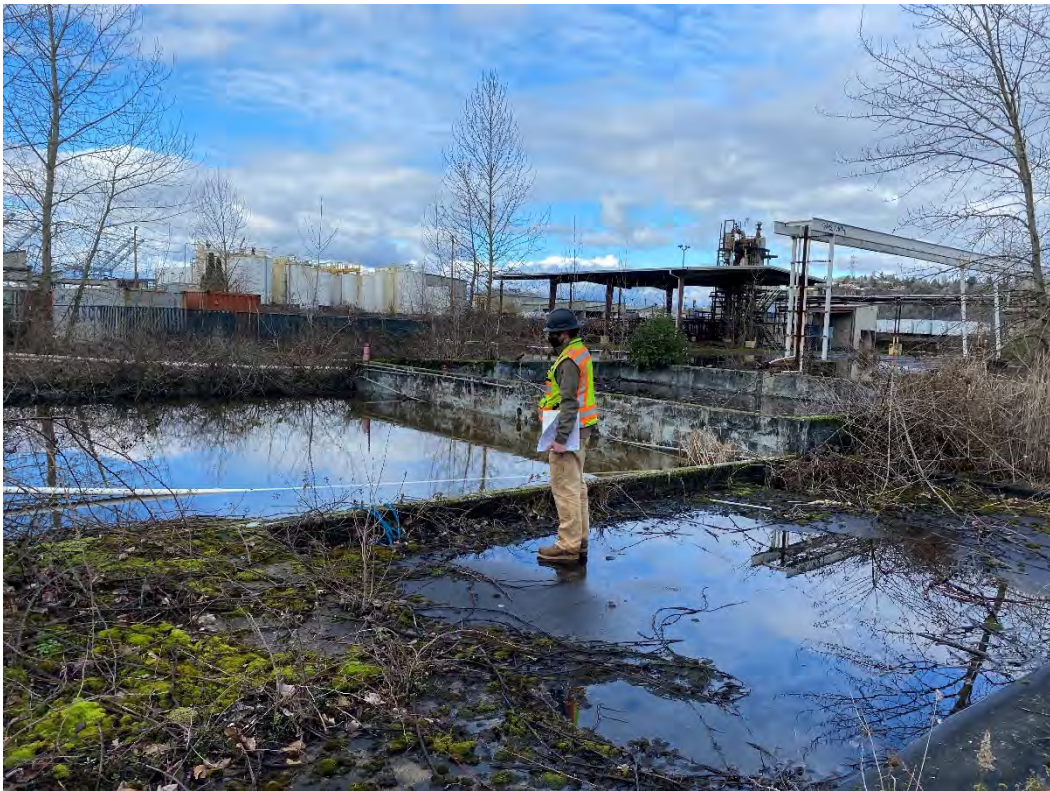
*Picture 38 Containment area with stormwater southwest of building 5 on CleanCare Property*

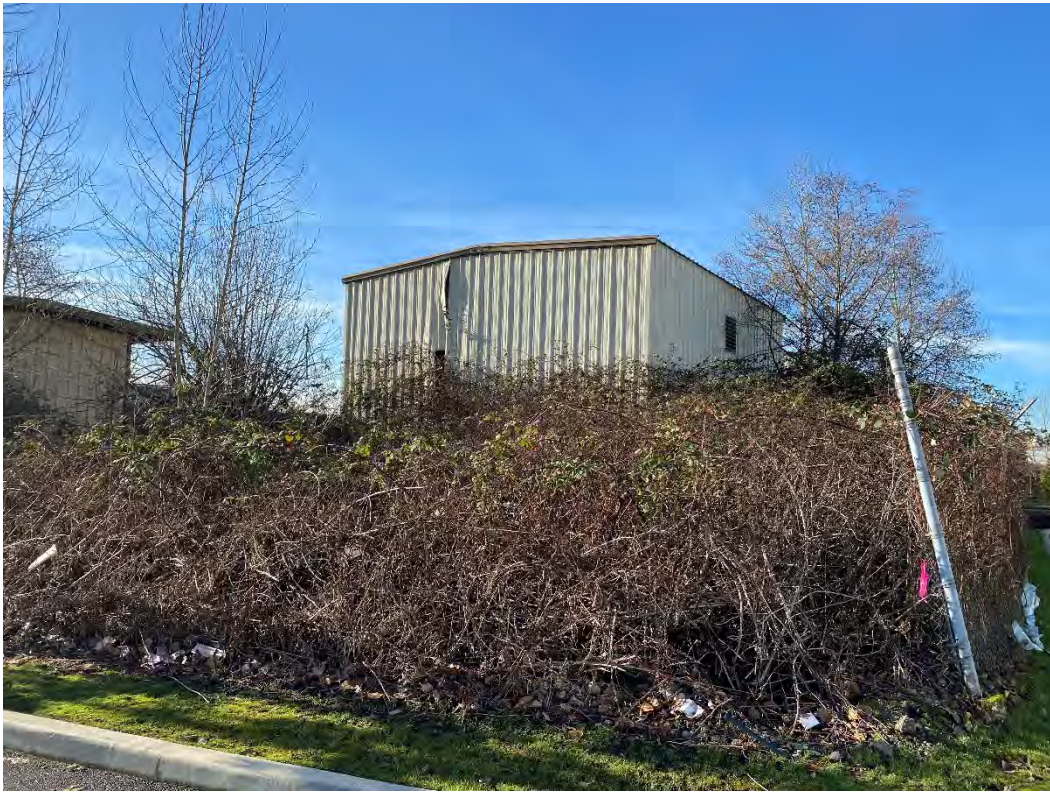
**Access:** The property was mostly accessible during the site inspection; the interior of buildings was not sought during the inspection. The property is mostly fenced; fencing was missing in one area between the property and the former CleanCare parcel and there is an open driveway entrance onto the property from Taylor Way. The property is owned by PoT; the access agreement for AO PLPs to perform invasive sampling work is pending a defined schedule and scope of work, to be determined by this inspection and accompanying well evaluation.

*Picture 41 Looking west from 1514 Taylor Way Property toward CleanCare Property, building 3 in background, fencing missing*
