From: Tasya Gray, Taylor Way and Alexander Avenue Fill Area (TWAAFA) Agreed Order Potentially Liable Parties Group Project Coordinator

Date: March 5, 2021

Subject: TWAAFA Existing Groundwater Monitoring Network Evaluation and Recommendations Memorandum

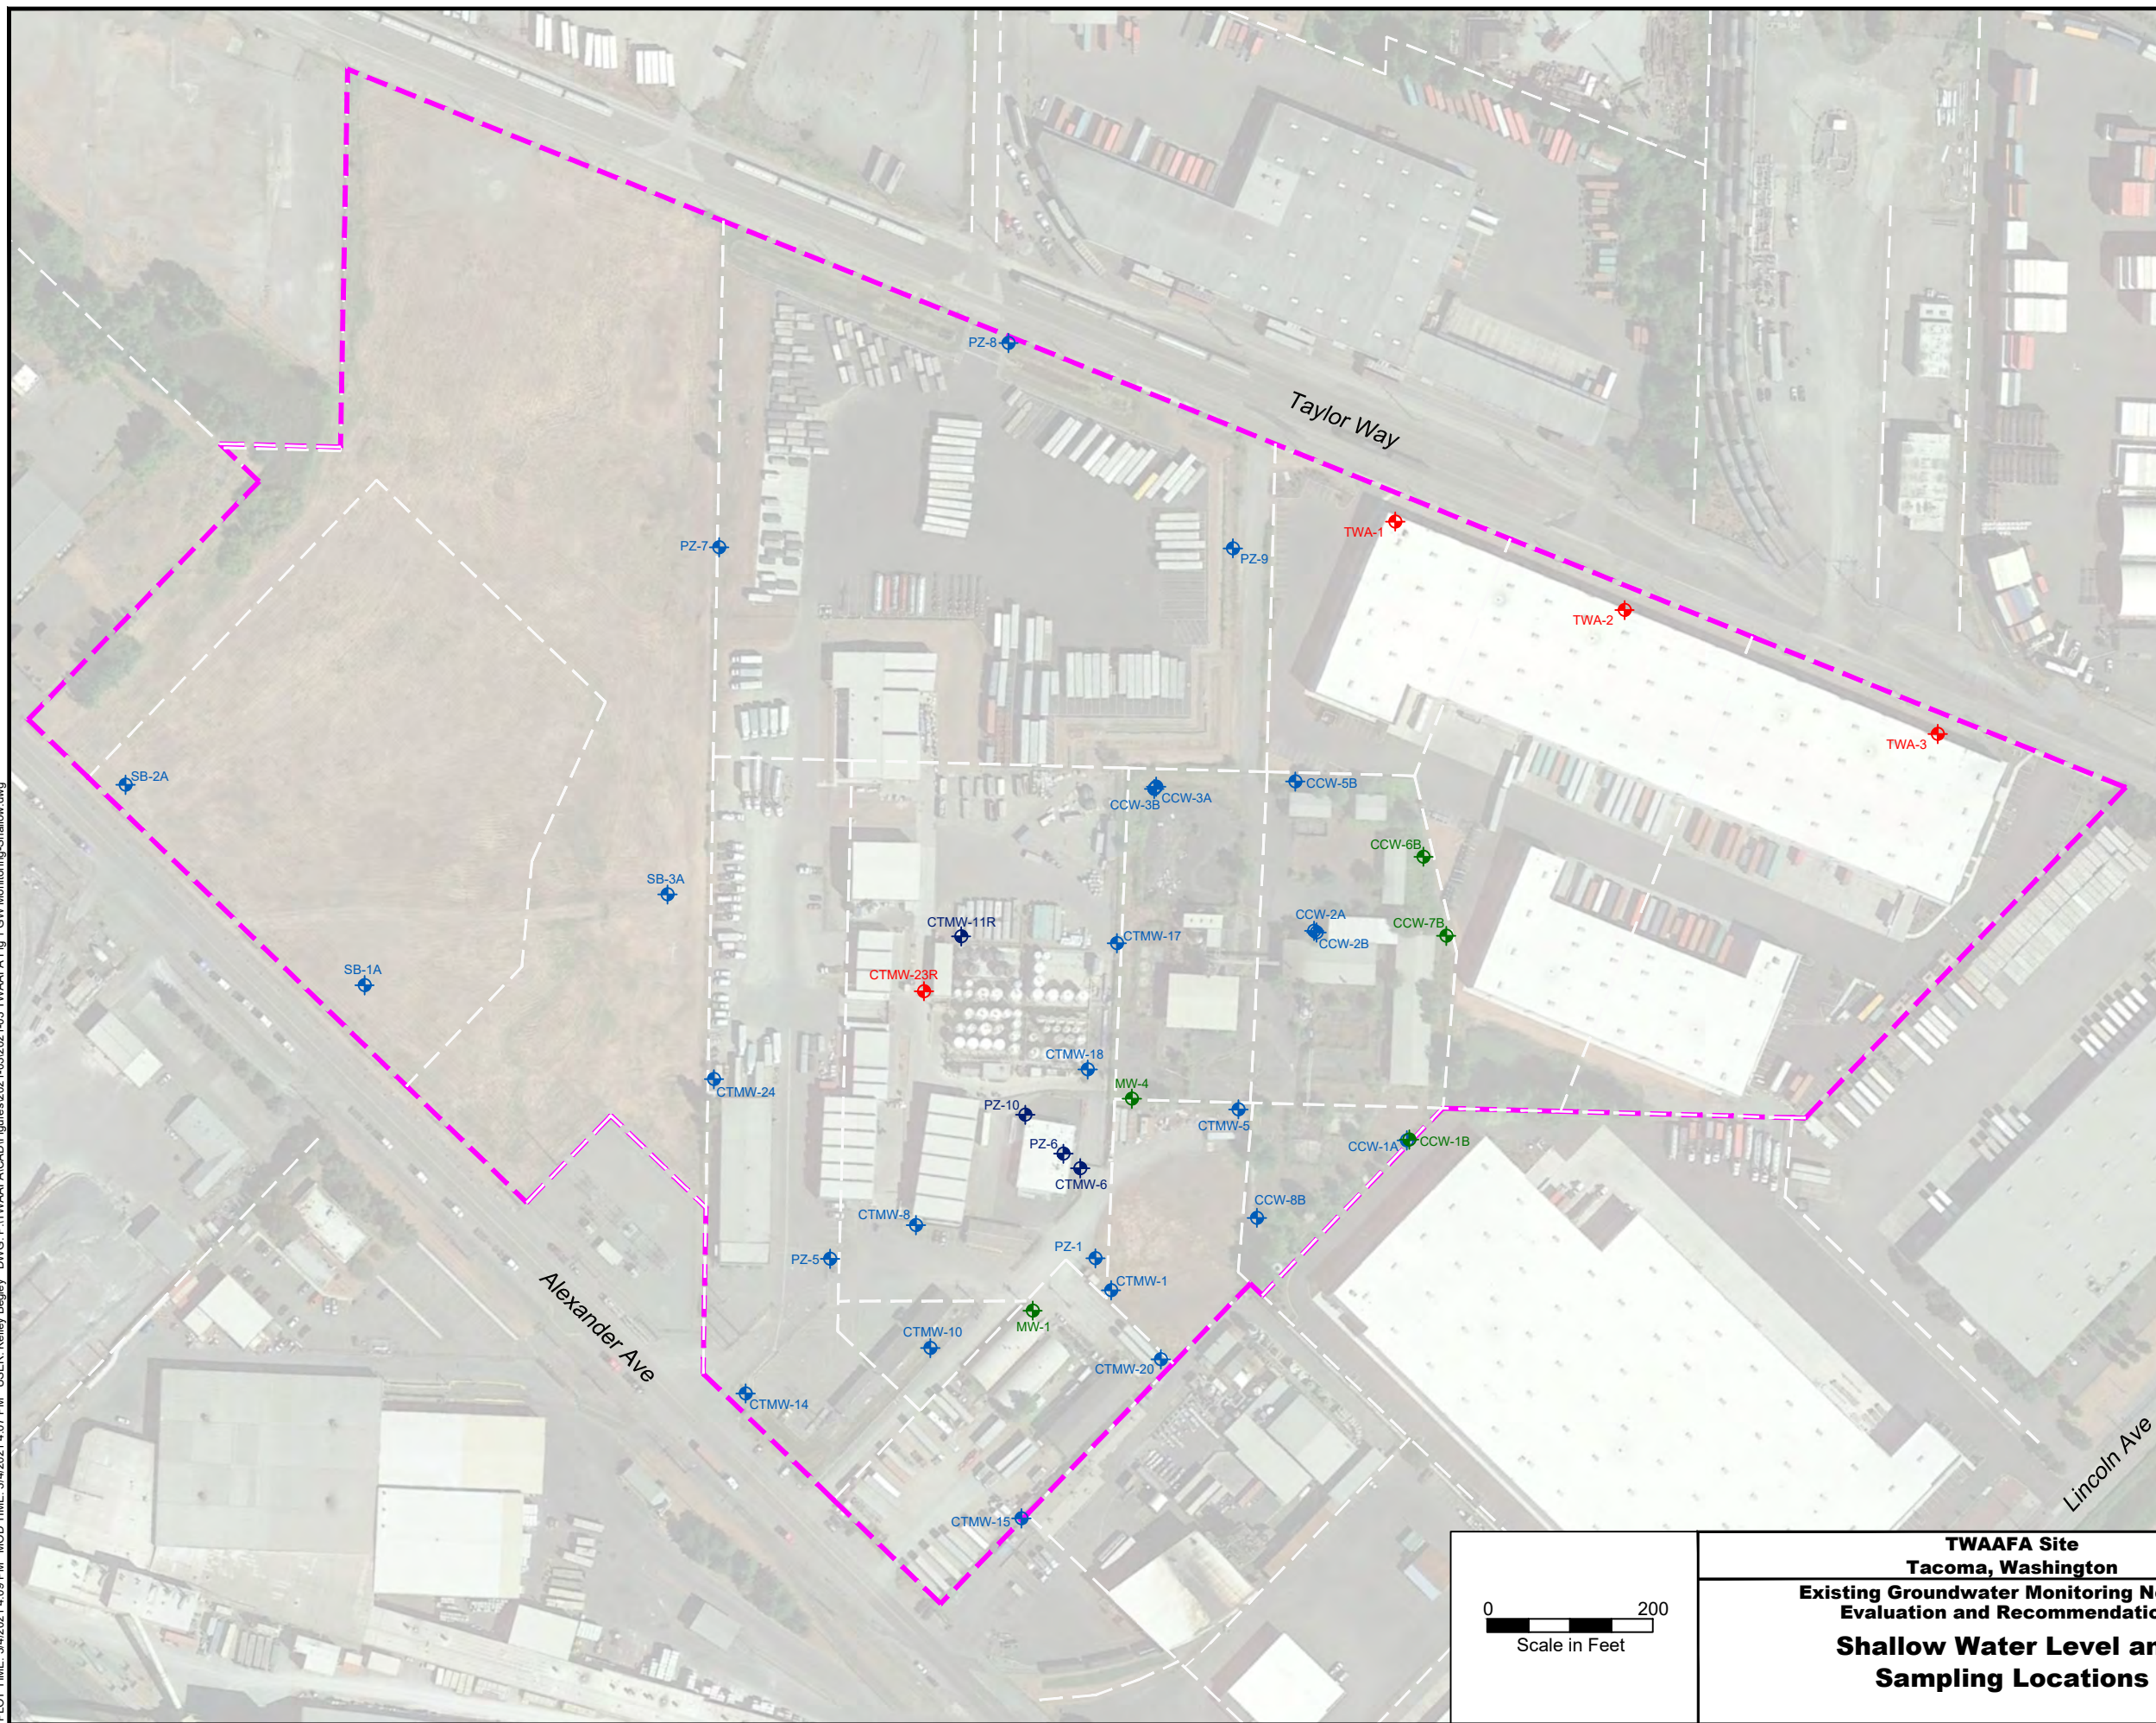
**FIGURE
1**

- CTMW-6, PZ-6, and PZ-10 – Well/piezometers were abandoned in 2019 due to new construction of office building in this location. These three well/piezometers were only proposed for shallow zone water level elevation monitoring in the Plan. As shown in Figure 1 multiple other shallow zone wells still exist surrounding this area of the

TWAAFA site to allow for accurate mapping of groundwater elevations and therefore reinstallation of these wells for the purpose of water level measurement is not recommended.

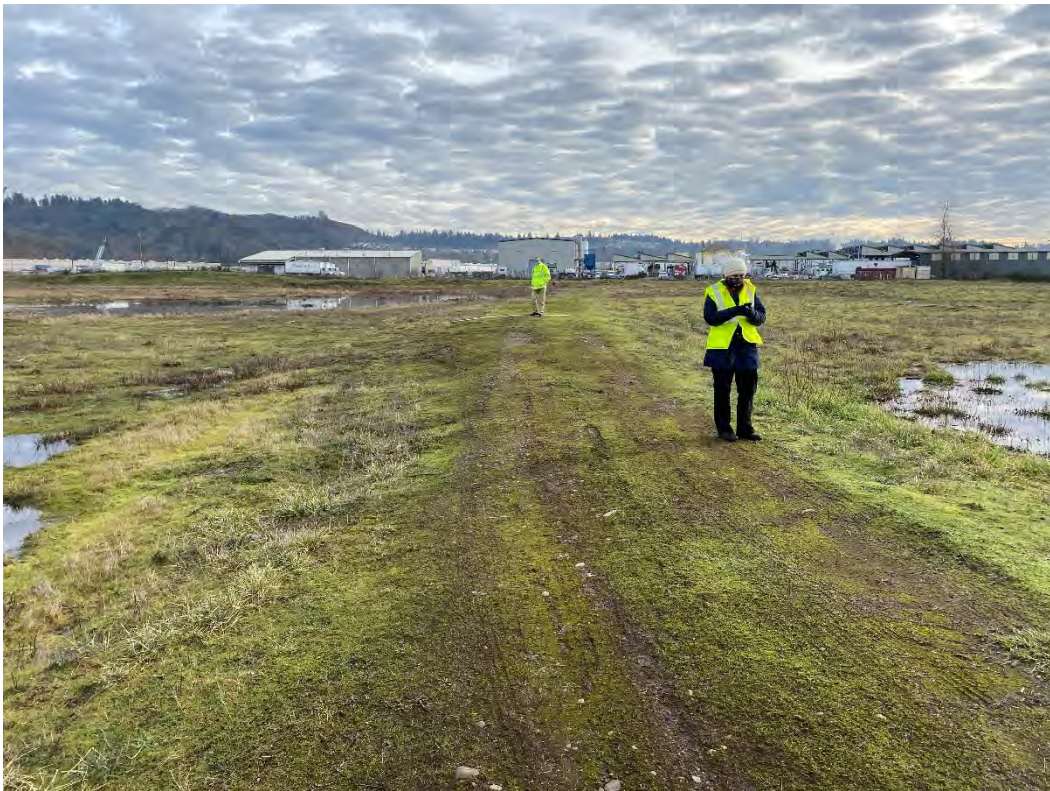
Picture 2 Elevated roadway on 1250 Alexander Ave & 1300 Taylor Way Property

No wells were recommended for abandonment based on current assessment, though additional evaluation of internal casings on wells on the former CleanCare property may alter this recommendation. An additional well was located on the Port of Tacoma 1205 Alexander Avenue (Hylebos Marsh) property. Based on records and measurement of total well depth it was

identified as historical well SB-2, installed in 1991. This well was previously thought to have been potentially abandoned. It is paired next to SB-2A (Picture 2).

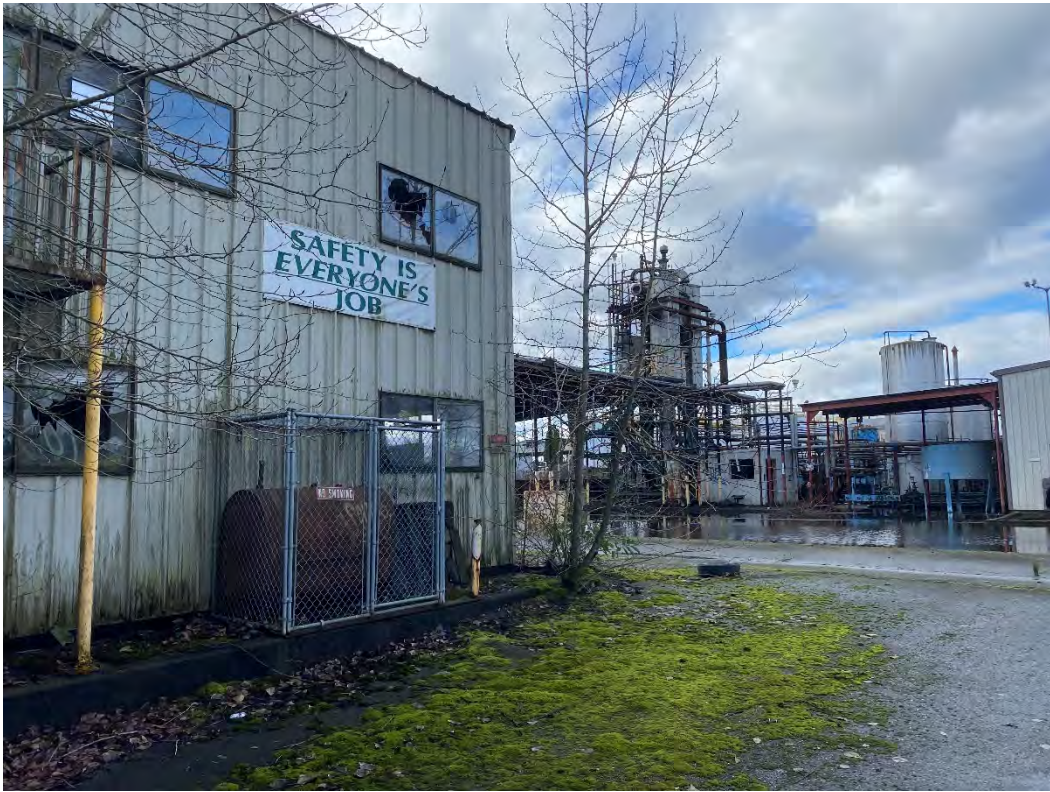
Picture 29 Heating oil tank inside fence on north side of building 1, abandoned process equipment in background with ponded stormwater on CleanCare Property

- CCW-1B was part of a cluster with wells CCW-1A and CCW-1C. This area is next to the eastern property fence line, where the other two CCW-1 wells were found. They were both flush mount wells in an unpaved area where the ground was fairly uneven and covered with low vegetation and some shrubs. The area appeared to have been potentially disturbed near the fence where landscaping outside the property appeared more recently installed (Pictures 29 and 30).

- The concrete surrounding the flush mount monument of well CCW-1A was dislodged and the monument itself was loose, but still had its lid (Picture 29). The well casing inside was capped and appeared in good condition.
