**RE: SUMMARY REPORT SUBSURFACE INVESTIGATIONS AND CLEANUP
ACTION
MUSCATEL MIDWAY PROPERTY
23418 PACIFIC HIGHWAY SOUTH
KENT, WASHINGTON
FARALLON PN: 2532-001**

SUMMARY REPORT SUBSURFACE INVESTIGATIONS AND CLEANUP ACTION

**Muscatel Midway Property
23418 Pacific Highway South
Kent, Washington**

Farallon PN: 2532-001

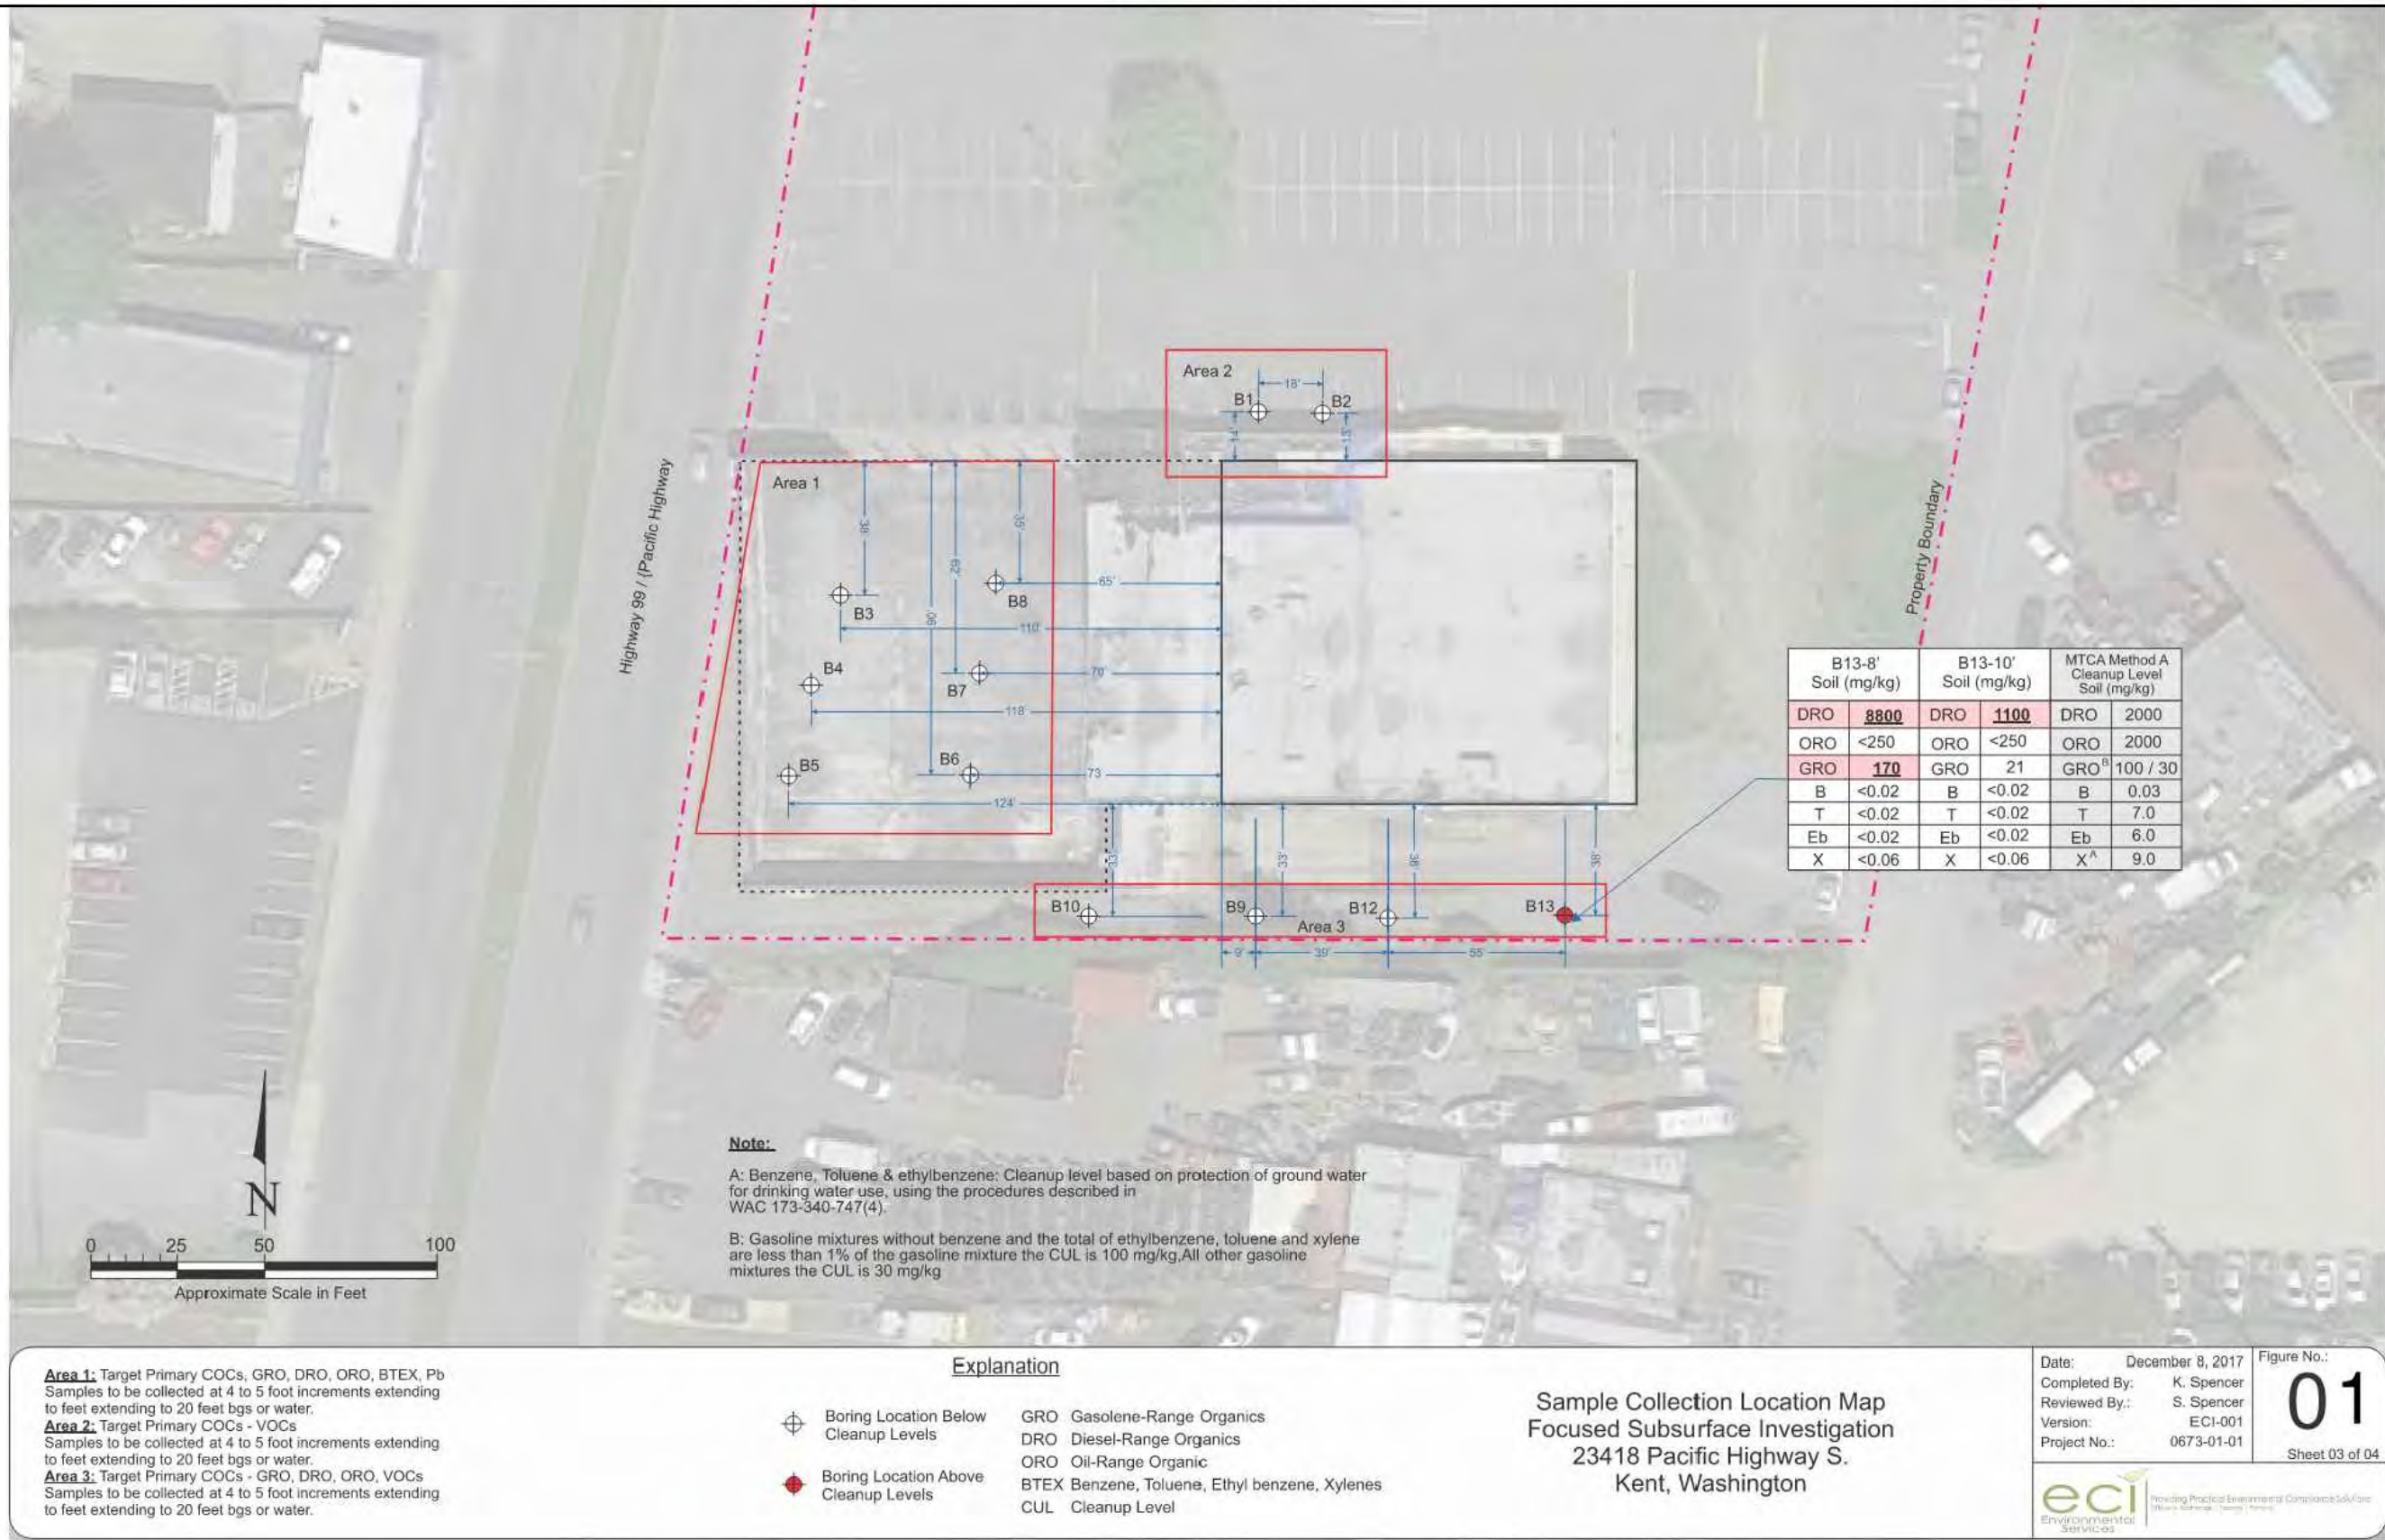
The ECI (2017) subsurface investigation identified potential impacts from historical operations in the following areas of the Muscatel Midway Property (Figure 1):

The subsurface investigation included advancing a total of 12 borings (Borings B1 through B10, B12, and B13) (Figure 1) to depths ranging from 7 to 12 feet bgs. Groundwater was not encountered to the total depth explored of 12 feet bgs. DRO and GRO were detected at concentrations exceeding MTCA Method A cleanup levels in the soil sample collected at a depth of 8 feet bgs from boring B13, which was advanced along the southern property boundary of the Muscatel Midway Property (Figure 1). DRO, GRO, and the other COCs were not detected at concentrations exceeding MTCA Method A cleanup levels in the other soil samples collected at the Muscatel Midway Property. Based on the results of the subsurface investigation, ECI (2017) concluded that source of DRO and GRO at concentrations exceeding MTCA Method A cleanup levels in soil at the southern property boundary appeared to be from the south-adjacent Former Southgate Oil Property.

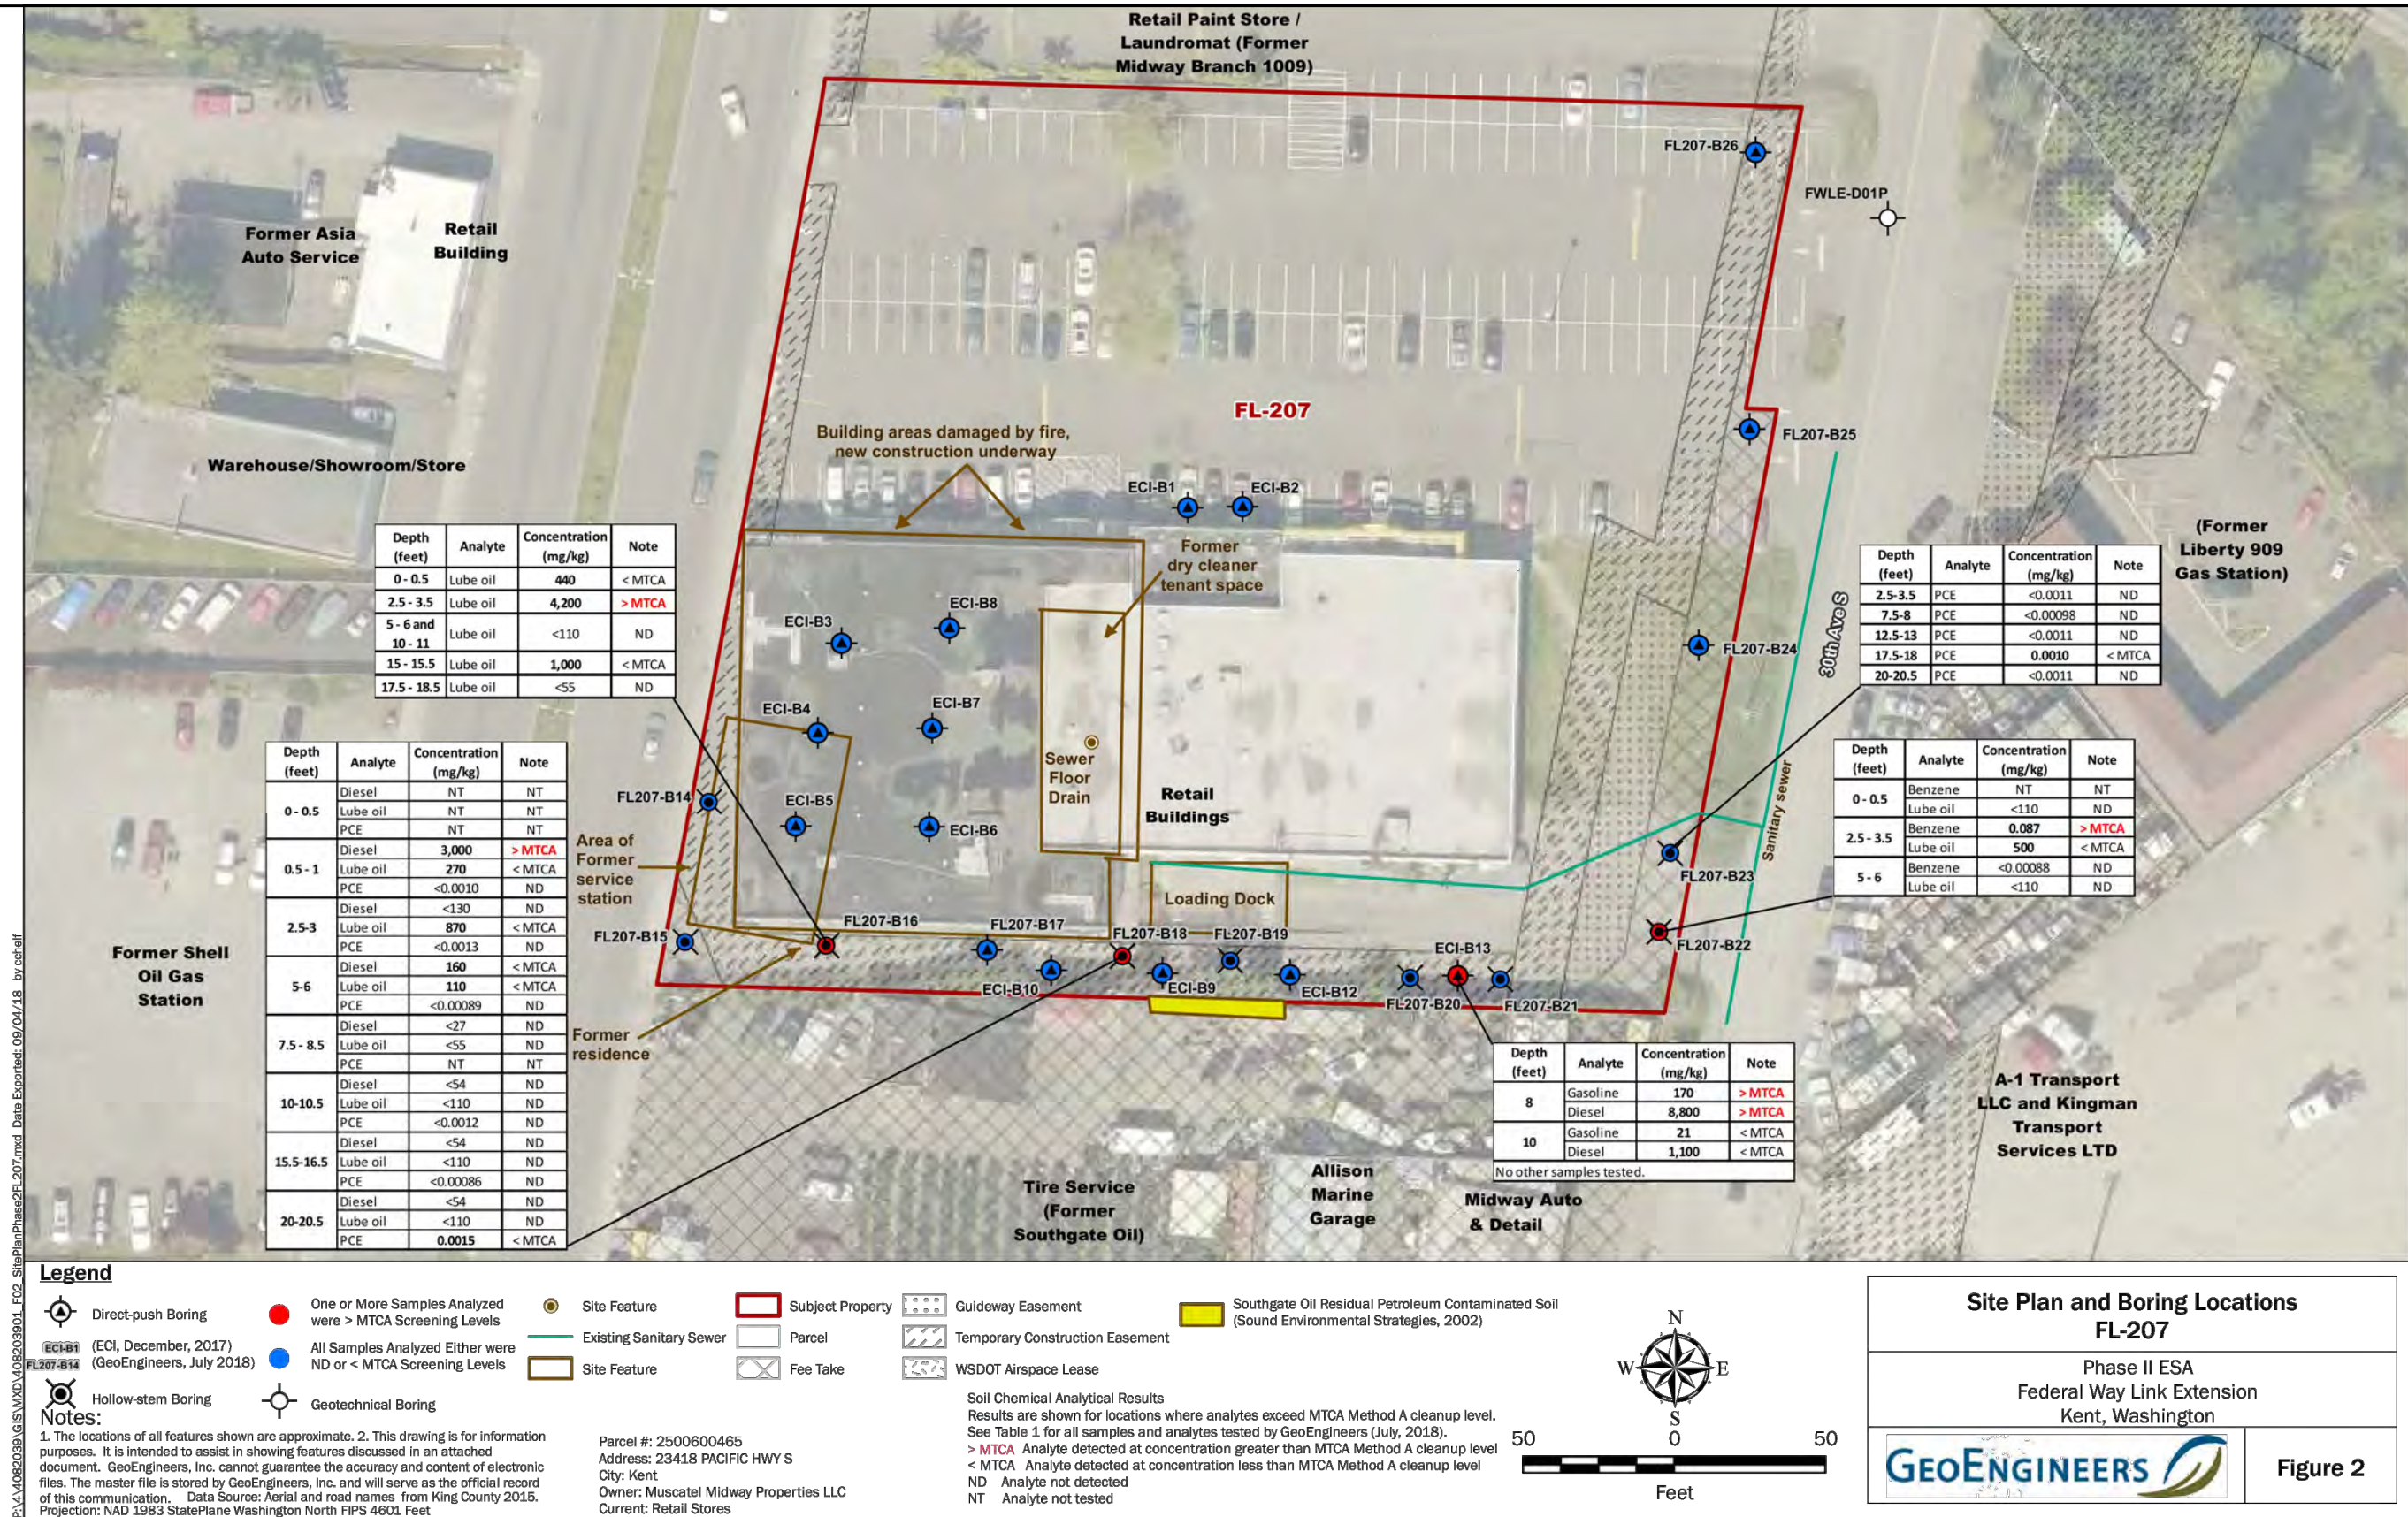
GeoEngineers (2018a) conducted a subsurface investigation of the Muscatel Midway Property in July 2018 as part of the expansion work associated with Sound Transit's Federal Way Link Extension. GeoEngineers (2018a) advanced 13 borings (FL207-B14 through FL207-B25) to evaluate subsurface conditions for potential impacts on the Muscatel Midway Property at the areas previously investigated by ECI (2017) and along the eastern portion of the Muscatel Midway Property (Figure 2). The borings were advanced to depths ranging from 8 to 31 feet bgs. Groundwater was not encountered to the total depth explored of 31 feet bgs. DRO, ORO, and benzene were detected at concentrations exceeding MTCA Method A cleanup levels in soil along the southern portion of the Muscatel Midway Property at the following borings (Figure 2):

- Boring FL207-B16 (ORO at 2.5 to 3.5 feet bgs);
- Boring FL207-B18 (DRO at 0.5 to 1.0 feet bgs); and
- Boring FL207-B22 (benzene at 2.5 to 3.5 feet bgs).

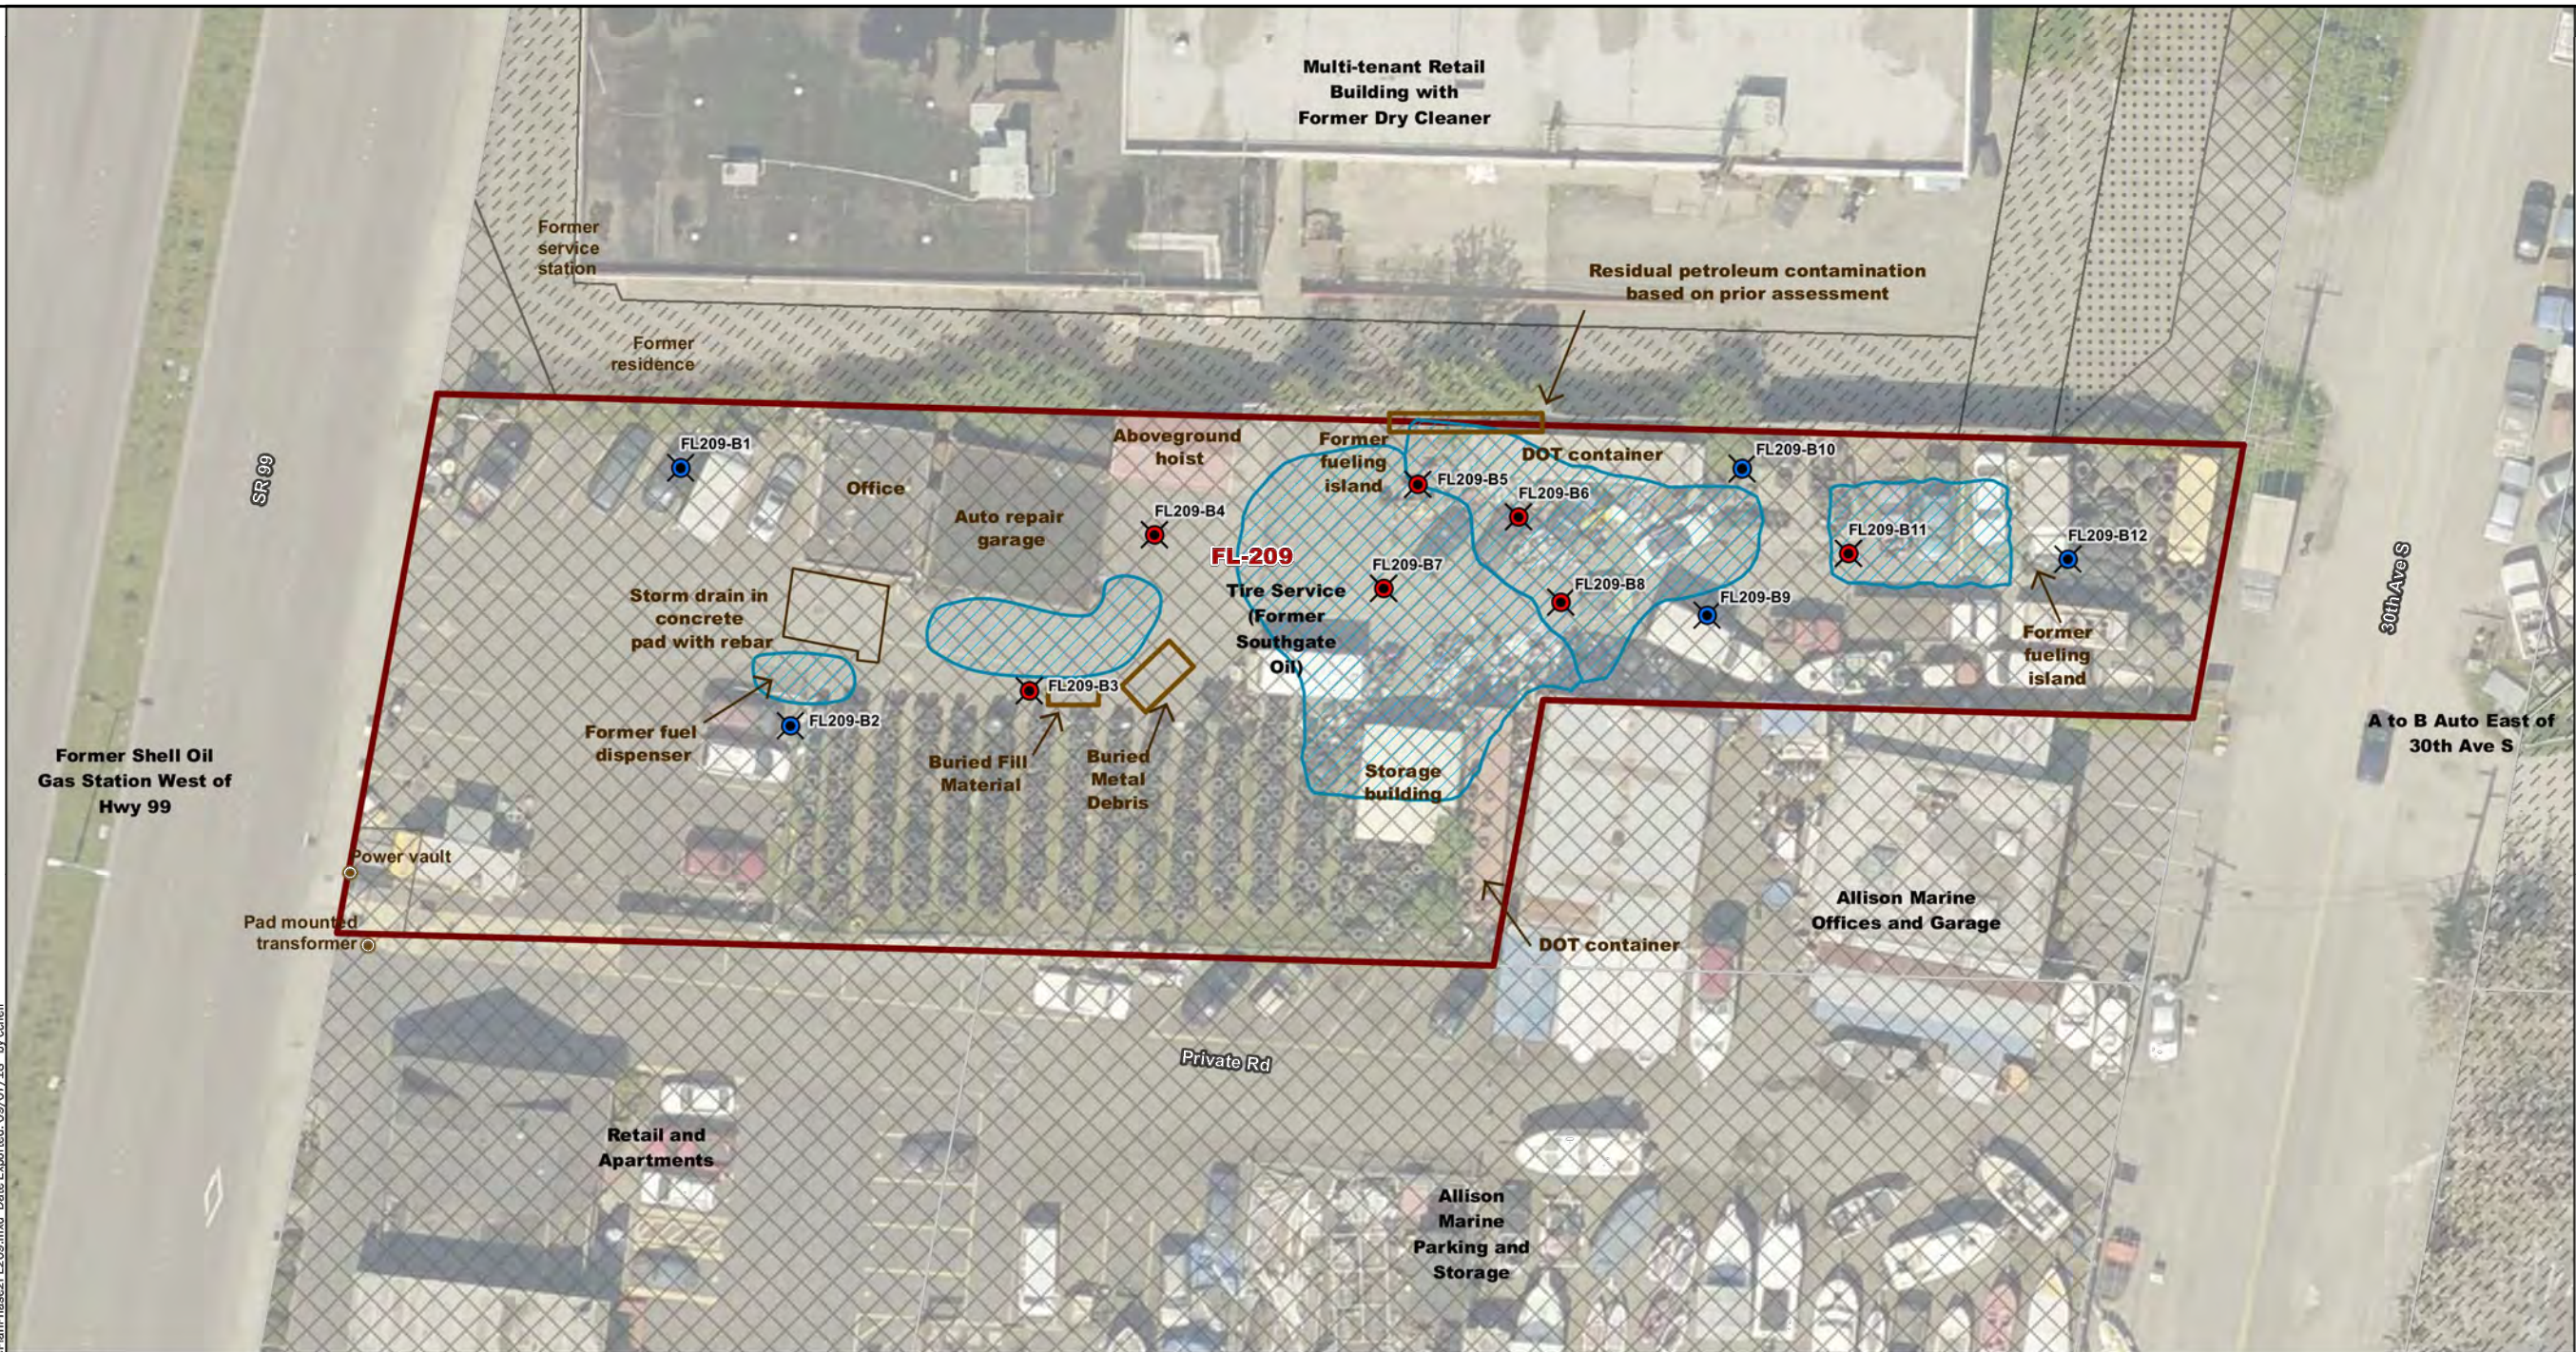
FIGURE 3

GeoEngineers (2018b) documented that the cleanup action conducted by others in 2000 and 2002 at the south-adjacent Former Southgate Oil Property included excavation of approximately 1,119 tons of soil with concentrations of TPH exceeding MTCA Method A cleanup levels. The analytical results for soil samples collected from the base and sidewalls of the 2002 excavation detected DRO at a concentration exceeding the MTCA Method A Soil Cleanup Level on the north sidewall at a depth of 10 feet bgs at the property boundary shared with the Muscatel Midway Property (Figure 3).

GeoEngineers (2018b) conducted a subsurface investigation at the Former Southgate Oil Property in June and July 2017 that include the advancement of 12 borings to depths ranging from 11 to 30.5 feet bgs (Figure 3). Groundwater was not encountered during advancement of the borings. The results of the subsurface investigation conducted by GeoEngineers (2018b) confirmed that the prior cleanup action work on the Former Southgate Oil Property was not completed to the maximum extent practicable and that soil with concentrations of TPH exceeding MTCA Method A cleanup levels remain at a depth of 14 feet bgs along the shared property boundary of the Former Southgate Oil Property and the Muscatel Midway Property (Figure 3).

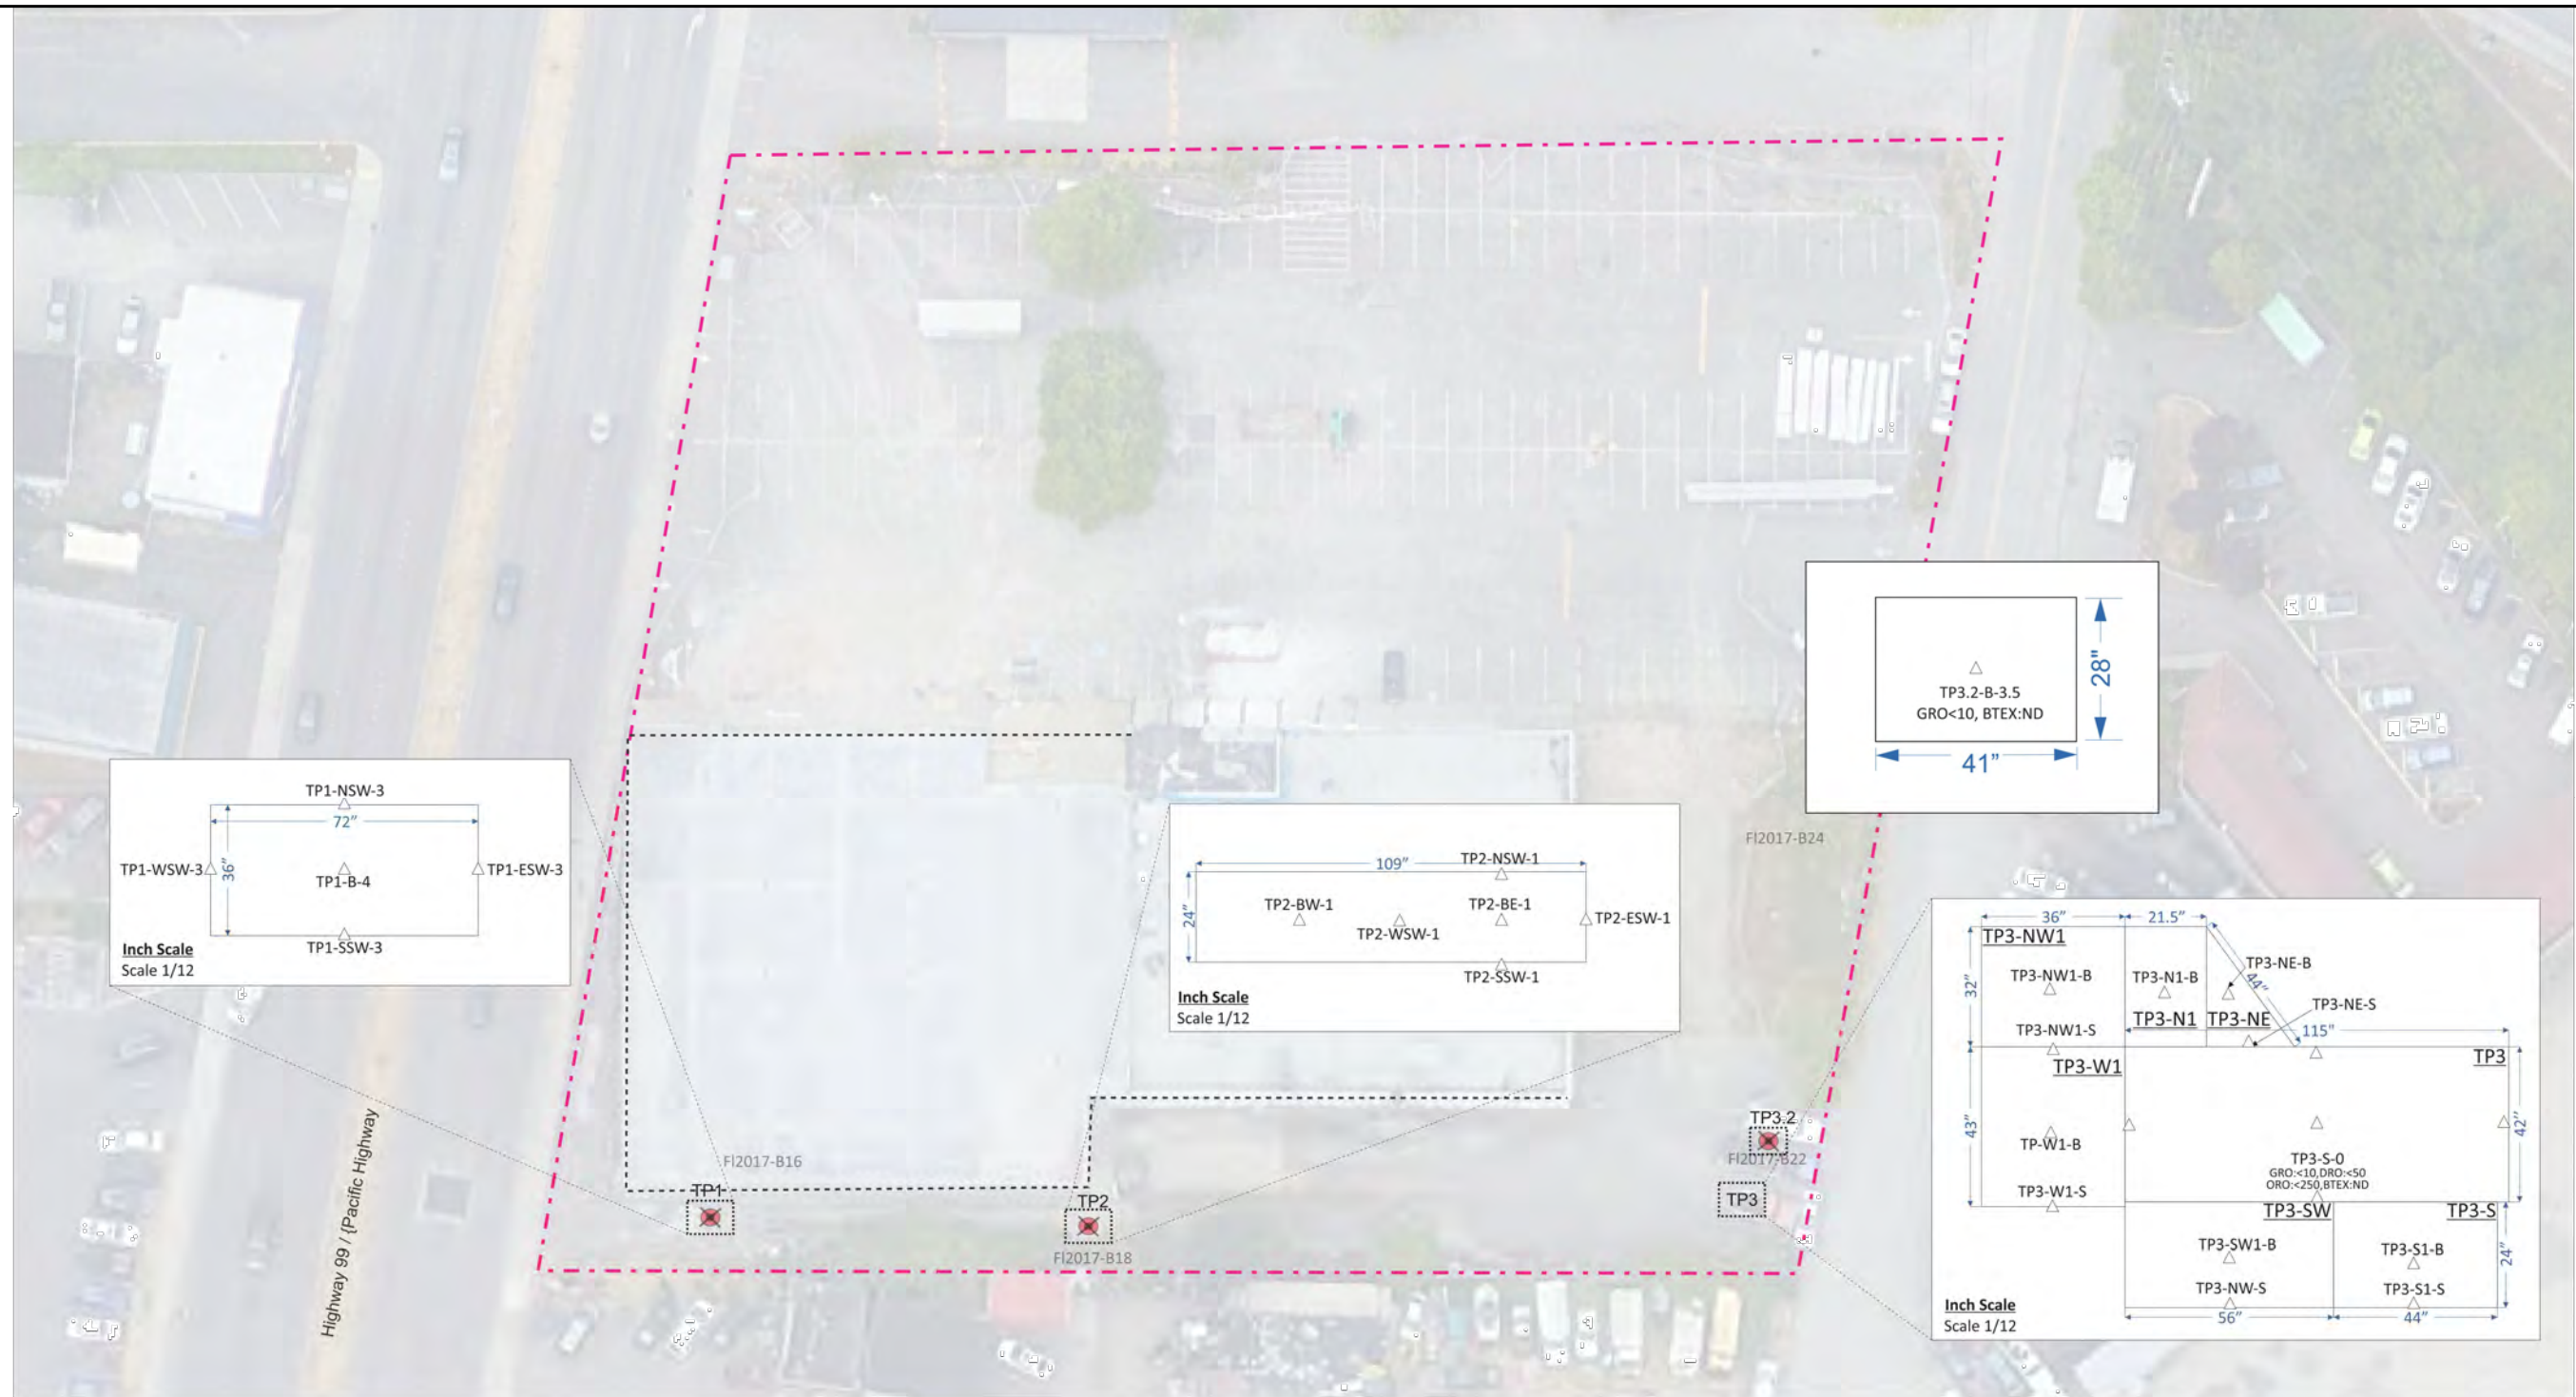
FIGURE 4

Subsequent to the soil removal conducted at the Muscatel Midway Property in January 2019 (as documented in ECI 2019b and discussed below), ECI (2019a) conducted additional investigation at the Muscatel Midway Property in February 2019, which included excavation of four test pits at previous borings FL207-B16, FL207-B18, and FL207-B22 where COCs were detected at concentrations exceeding MTCA Method A cleanup levels in soil (Figure 4). The test pits included:

- Test Pit 1: At previous boring FL207-B16 and measuring approximately 6.0 feet wide by 3.0 feet long and 4.0 feet deep;
- Test Pit 2: At previous boring FL207-B18 and measuring approximately 9.0 feet wide by 2.0 feet long and 1.5 feet deep;
- Test Pit 3: Proximate to previous boring FL207-B22 and measuring approximately 12.6 feet wide by 8.3 feet long and 1.0 to 4.0 feet deep; and
- Test Pit 3.2: At previous boring FL207-B22 and measuring approximately 3.4 feet wide by 2.3 feet long and 3.5 feet deep.

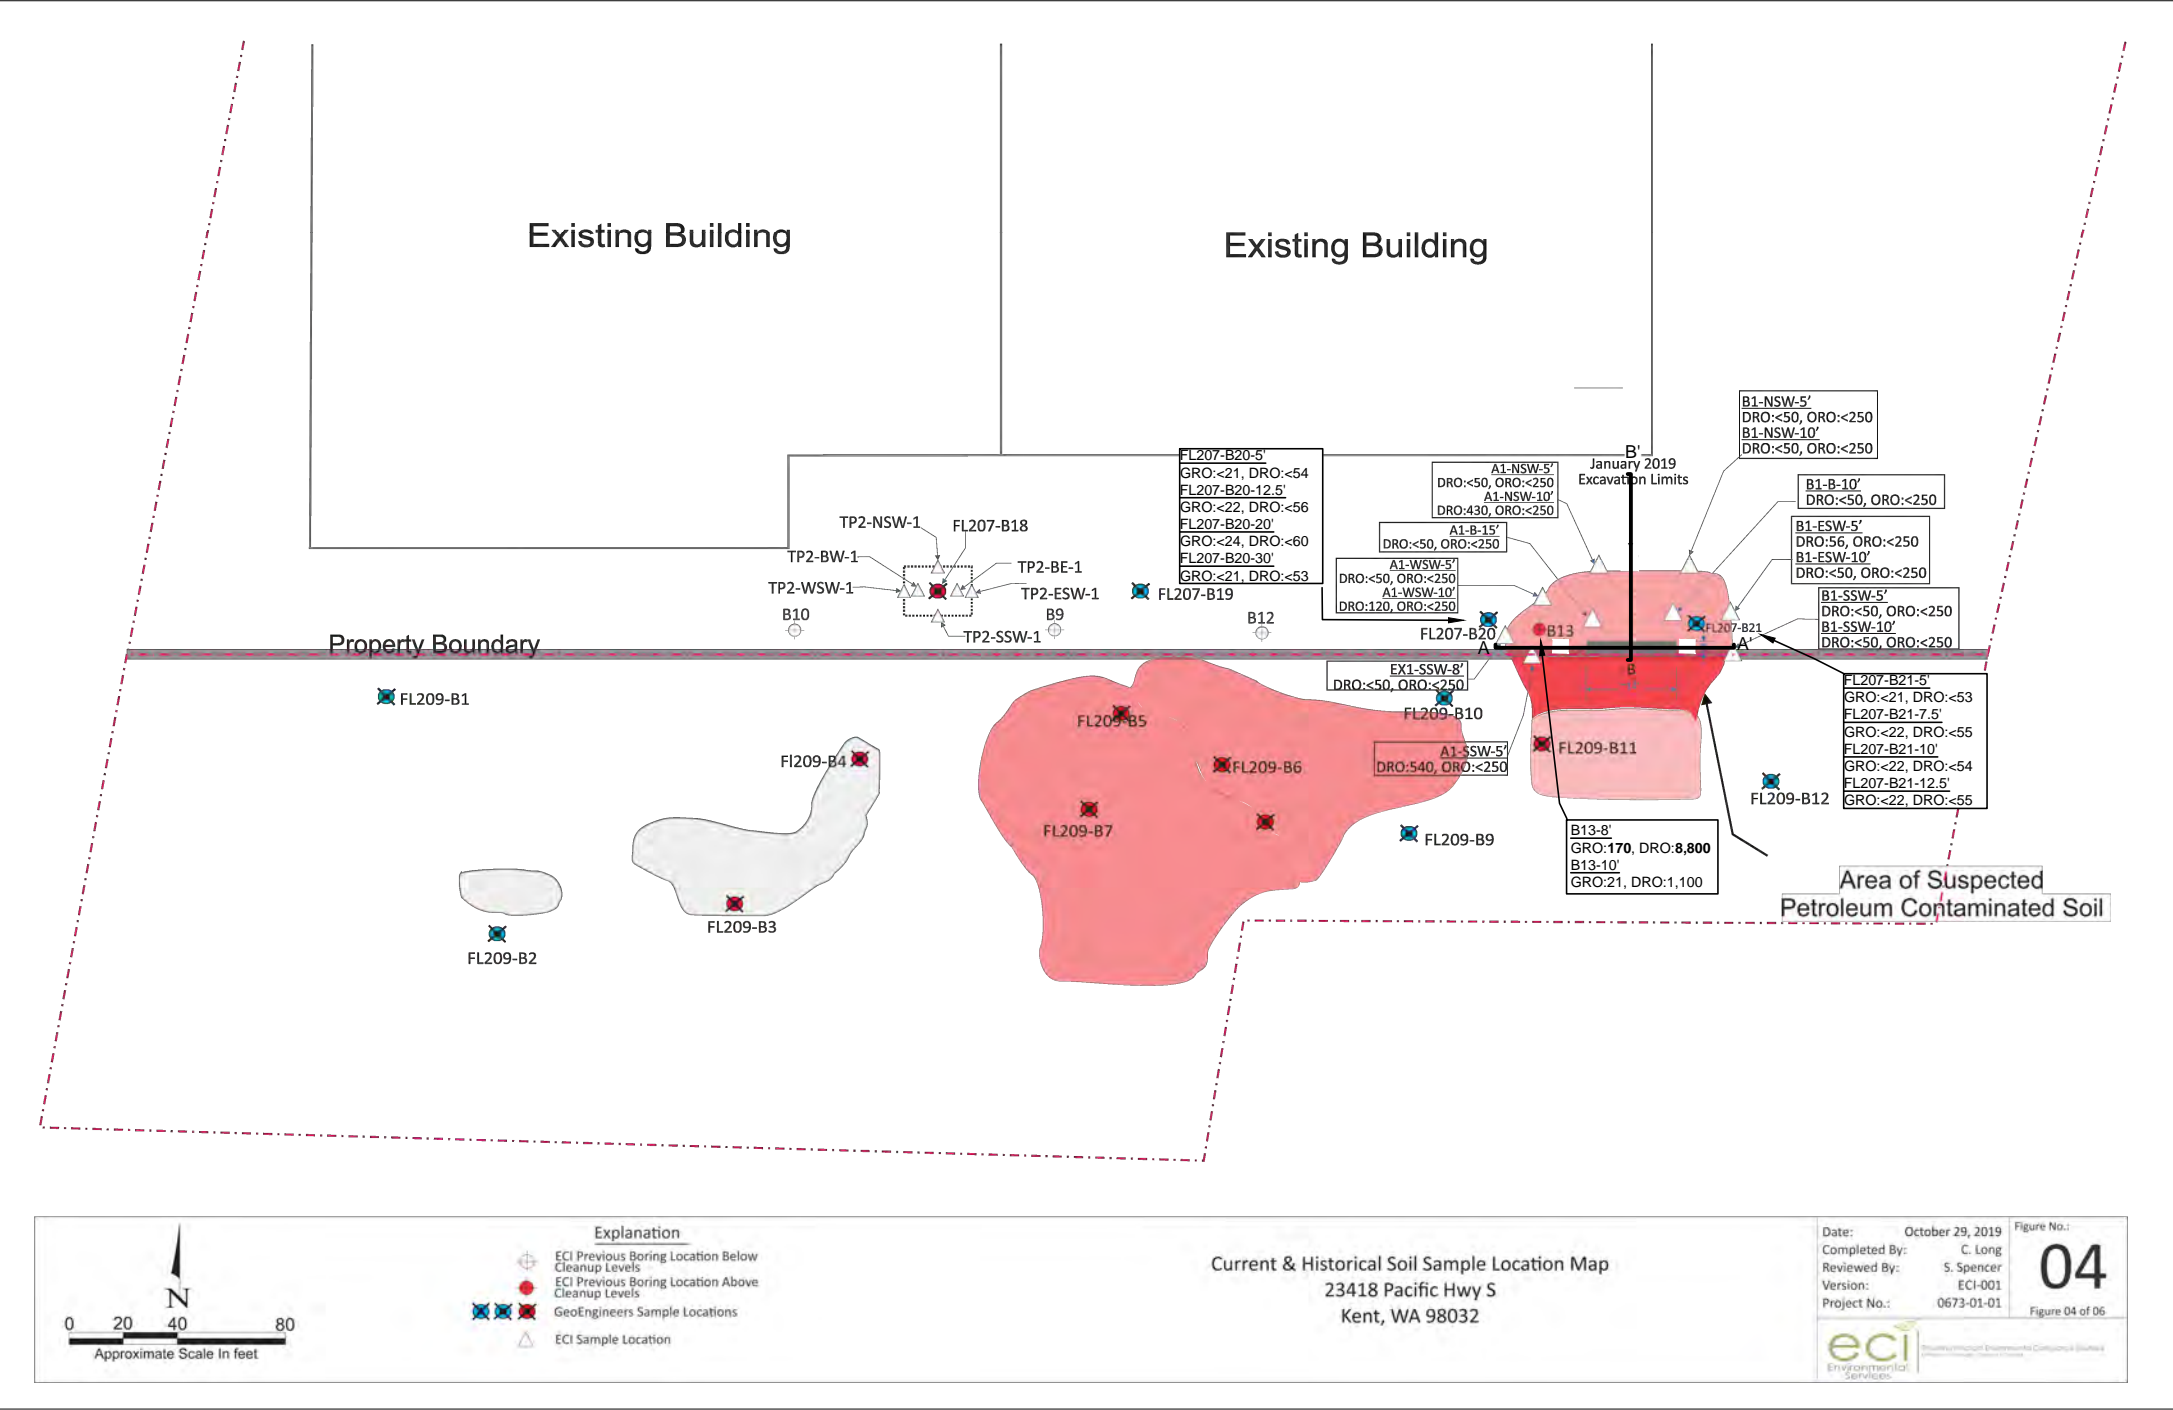
FIGURE 6
SITE PLAN
MUSCATEL PROPERTY
23418 PACIFIC HIGHWAY SOUTH
KENT, WASHINGTON

Subsequent to the investigation conducted by ECI (2018a) in February 2019, ECI (2019b) conducted additional characterization at the Muscatel Midway Property in September 2019. The purpose of the additional characterization was to further evaluate the extent of soil with the blue-gray staining and associated petroleum-like odor that was identified beneath the retaining wall along the shared property boundary between the Muscatel Midway Property and the south-adjacent Former Southgate Oil Property during the cleanup action activities conducted by ECI in January 2019 (Figures 6 through 8) (ECI 2019b).

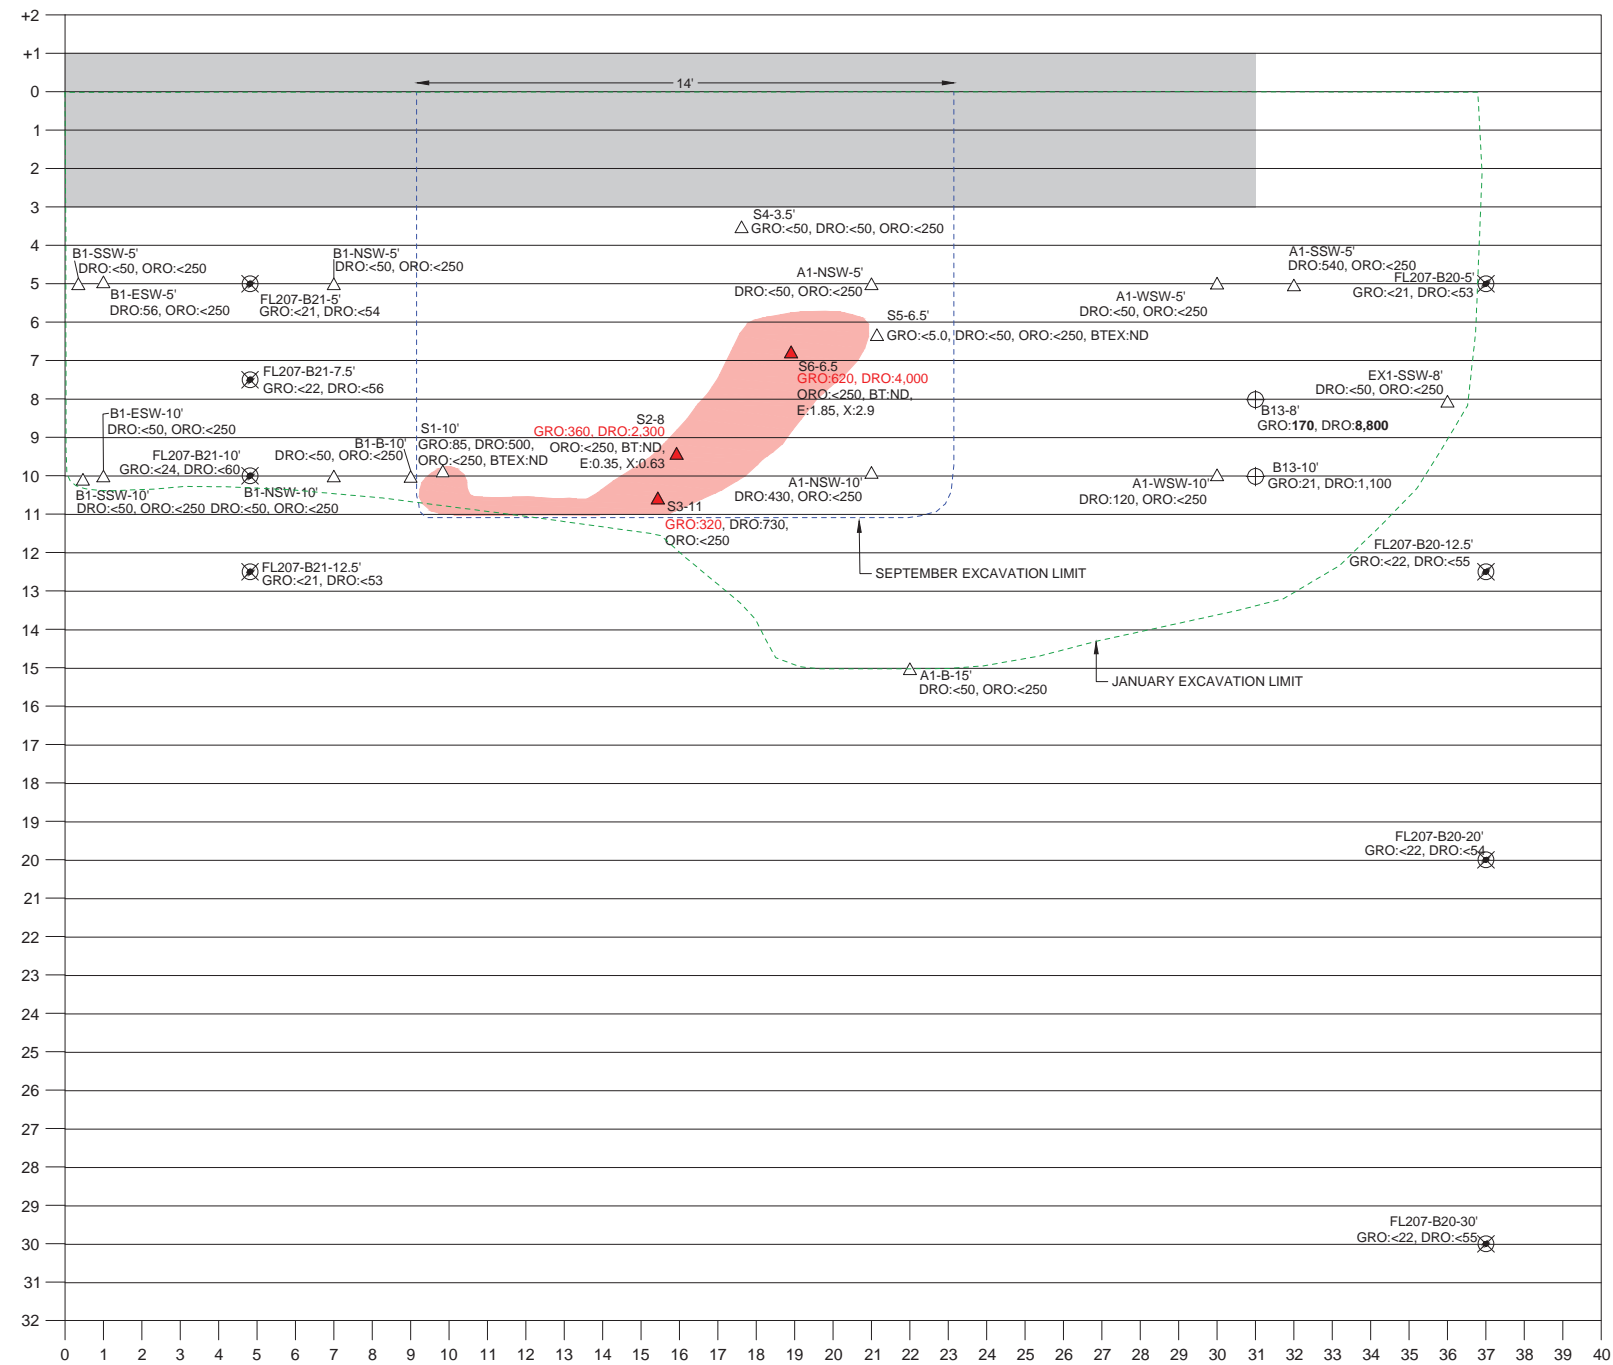
FIGURE 7
CROSS SECTION A'-A
MUSCATEL PROPERTY
23418 PACIFIC HIGHWAY SOUTH
KENT, WASHINGTON

COCs were not detected at concentrations exceeding MTCA Method A cleanup levels in a total of 14 confirmation soil samples collected from the final limits of the excavation (Figures 7 and 8). However, field observations noted by ECI (2019b) during the excavation activities indicated that soil with a "blue-gray staining and associated petroleum-like odor" remained in-place beneath the retaining wall along the southern property boundary between the Muscatel Midway Property and the south-adjacent Former Southgate Oil Property (Figures 6 through 8). ECI (2019b) did not collect soil samples along the southern property boundary from the soil with the noted staining and petroleum-like odor.
