**RE: SUMMARY REPORT SUBSURFACE INVESTIGATIONS AND CLEANUP
ACTION
MUSCATEL MIDWAY PROPERTY
23418 PACIFIC HIGHWAY SOUTH
KENT, WASHINGTON
FARALLON PN: 2532-001**

SUMMARY REPORT SUBSURFACE INVESTIGATIONS AND CLEANUP ACTION

**Muscatel Midway Property
23418 Pacific Highway South
Kent, Washington**

Farallon PN: 2532-001

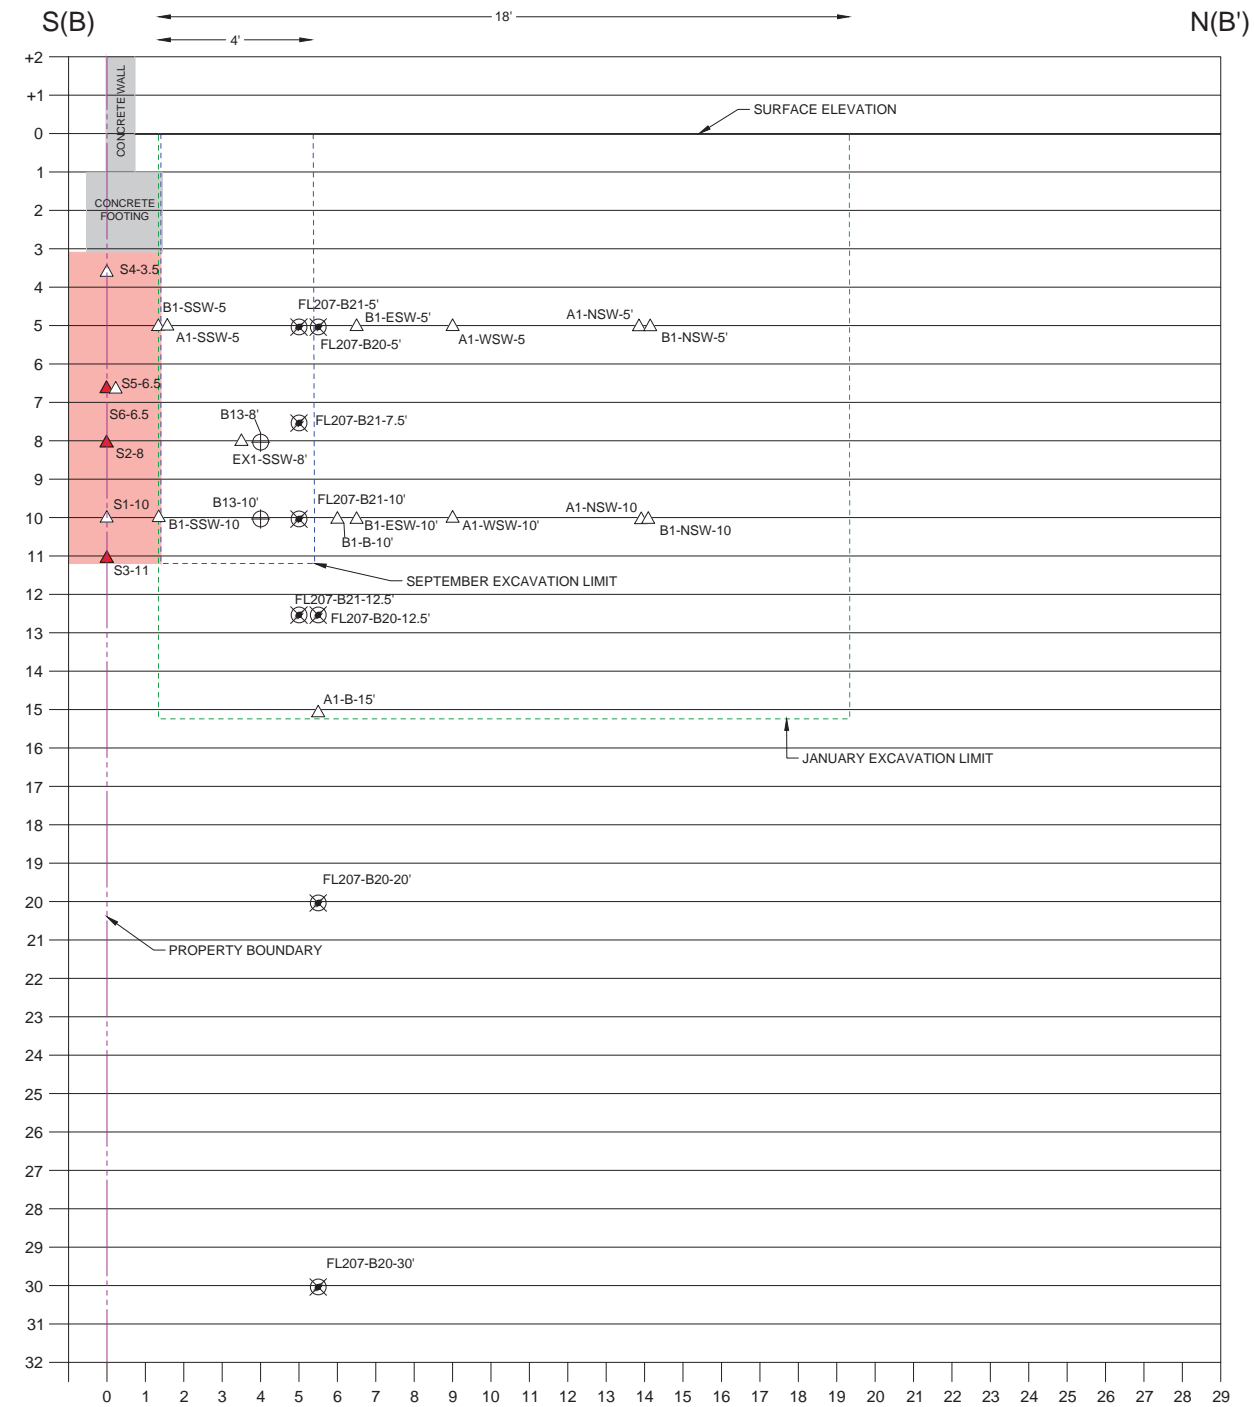
FIGURE 8
CROSS SECTION B-B'
MUSCATEL PROPERTY
23418 PACIFIC HIGHWAY SOUTH
KENT, WASHINGTON
FARALLON PN-2532-001

COCs were not detected at concentrations exceeding MTCA Method A cleanup levels in a total of 14 confirmation soil samples collected from the final limits of the excavation (Figures 7 and 8). However, field observations noted by ECI (2019b) during the excavation activities indicated that soil with a "blue-gray staining and associated petroleum-like odor" remained in-place beneath the retaining wall along the southern property boundary between the Muscatel Midway Property and the south-adjacent Former Southgate Oil Property (Figures 6 through 8). ECI (2019b) did not collect soil samples along the southern property boundary from the soil with the noted staining and petroleum-like odor.

Excavation of the soil with concentrations of COCs exceeding the applicable MTCA Method A cleanup levels was not conducted by ECI due to the potential of undermining the retaining wall foundation (ECI 2019b). A 14-millimeter polyvinyl chloride liner was placed along the south sidewall of the excavation prior to backfilling to prevent recontamination of soil on the Muscatel Midway Property. The trench excavation was backfilled with the original excavated material and repaved with asphalt (ECI 2019b).

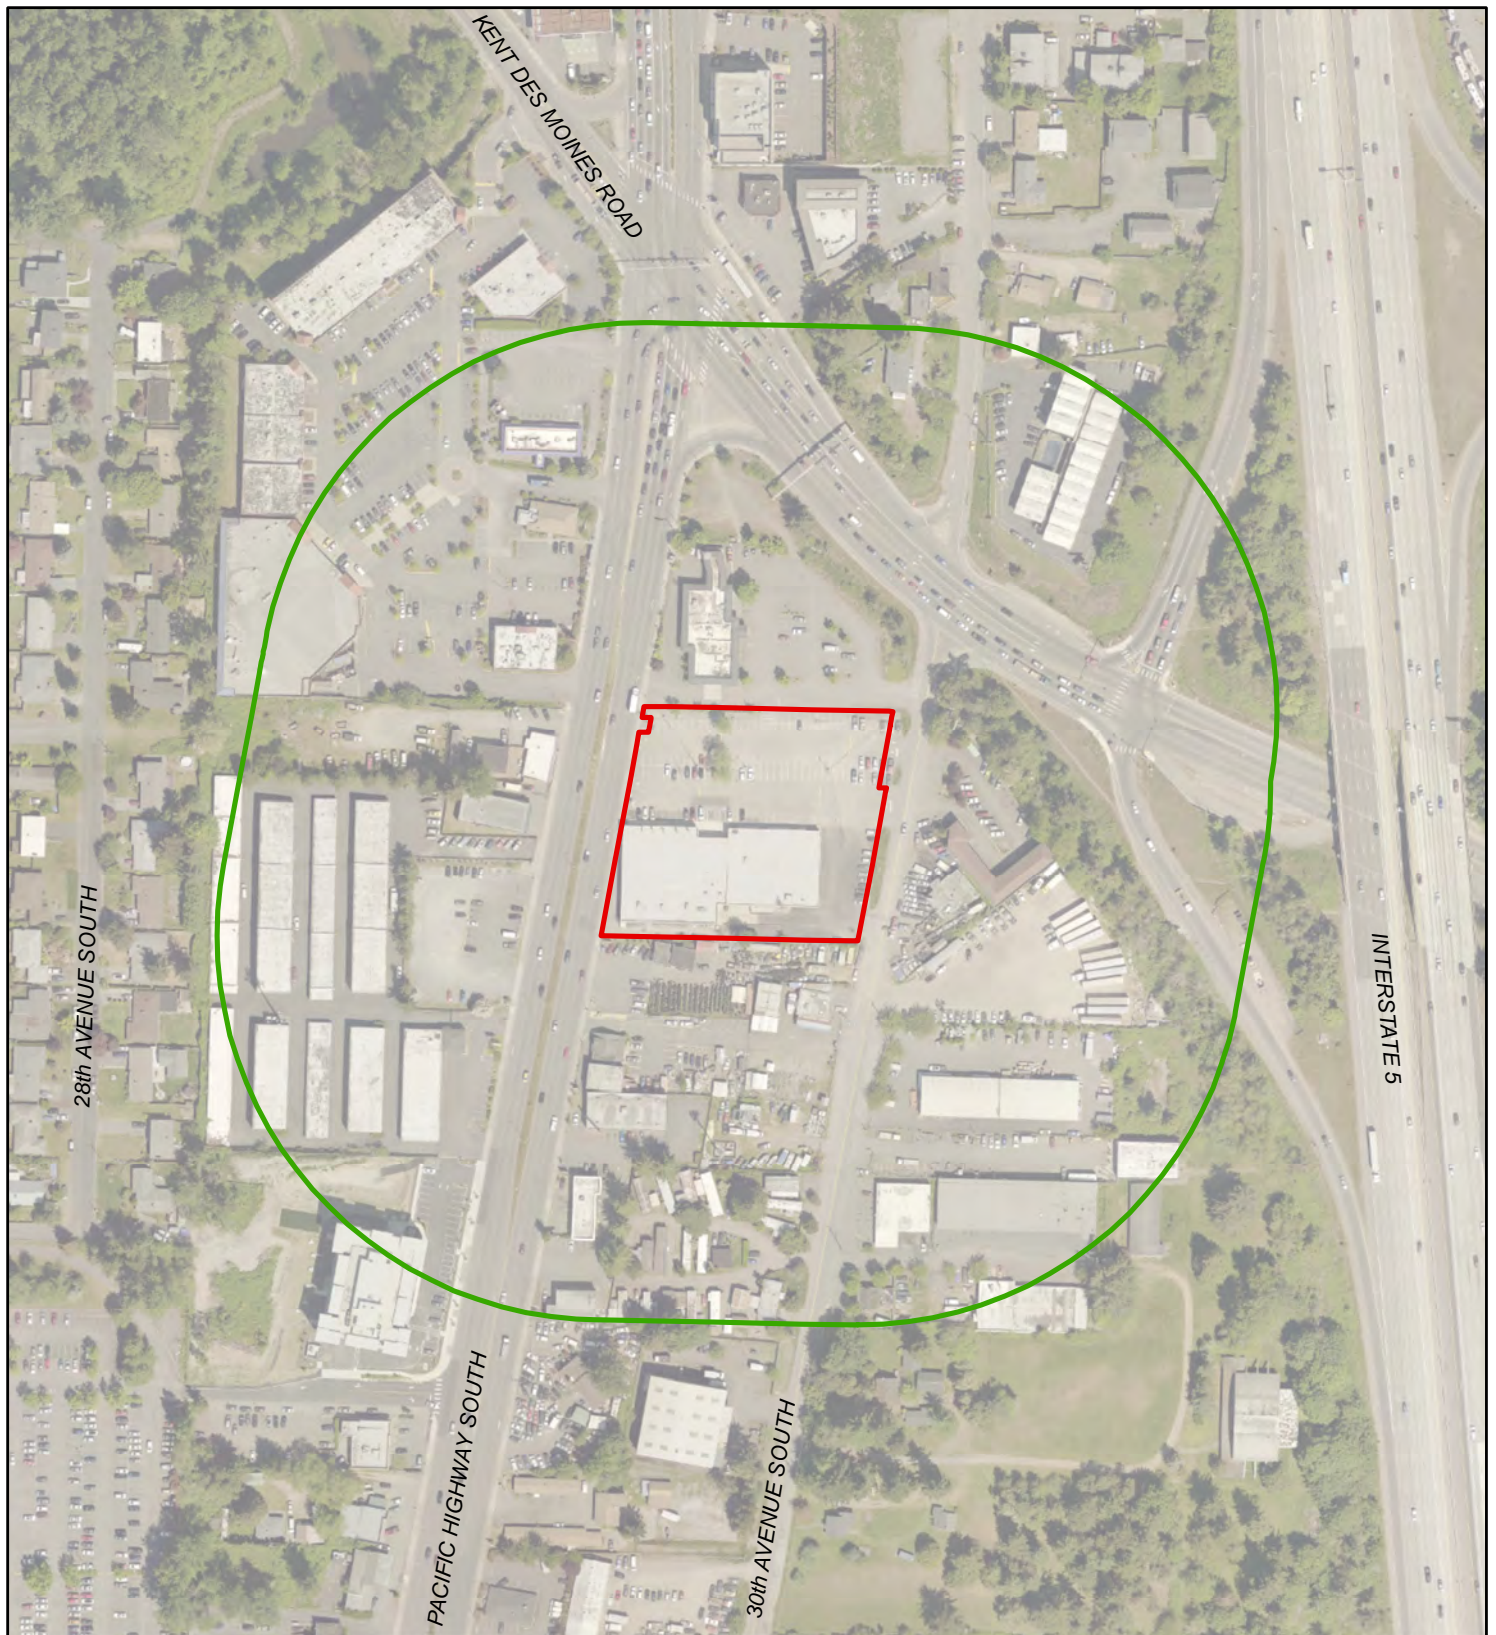
FIGURE 9

Based on the criteria for TEE exclusion in WAC 173-340-7491(1)(c)(i), the Muscatel Midway Property is excluded from a TEE because there is less than 1.5 acres of contiguous undeveloped land on the Muscatel Midway Property or within 500 feet of any area of the Muscatel Midway Property, and the Muscatel Midway Property is not contaminated with any of the hazardous substances listed in WAC 173-340-7491(1)(c)(ii). An aerial image showing a 500-foot buffer proximate to the Muscatel Midway Property is shown on Figure 9. No further consideration of terrestrial ecological impacts is required under MTCA. The Ecology *Terrestrial Ecological Evaluation Form* completed for the Muscatel Midway Property is provided in Attachment A.
