# Supplemental Focused Subsurface Investigation Report

March 3, 2019

**23418 Pacific Highway South  
Kent, Washington**

ECI Project No.: 0673-01-03

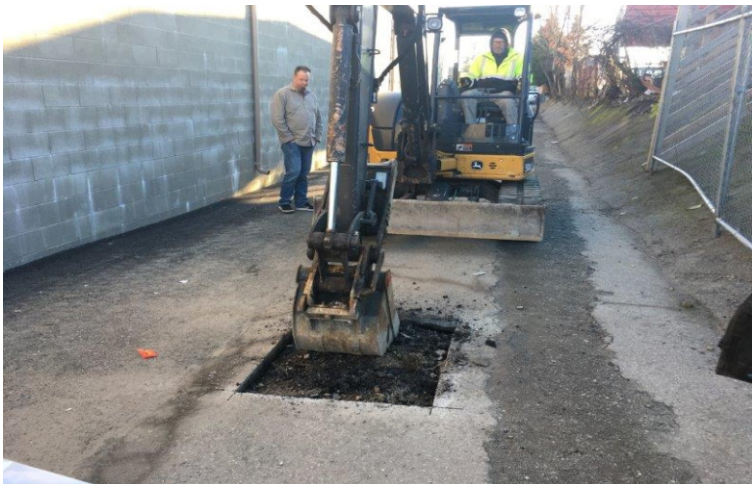
Photograph One: Breaking into Test Pit 1

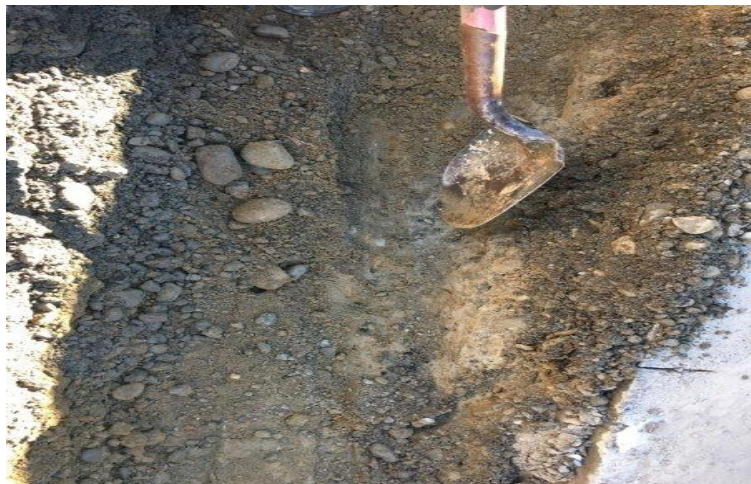
Photograph Two: Slight discoloring in Test Pit 2

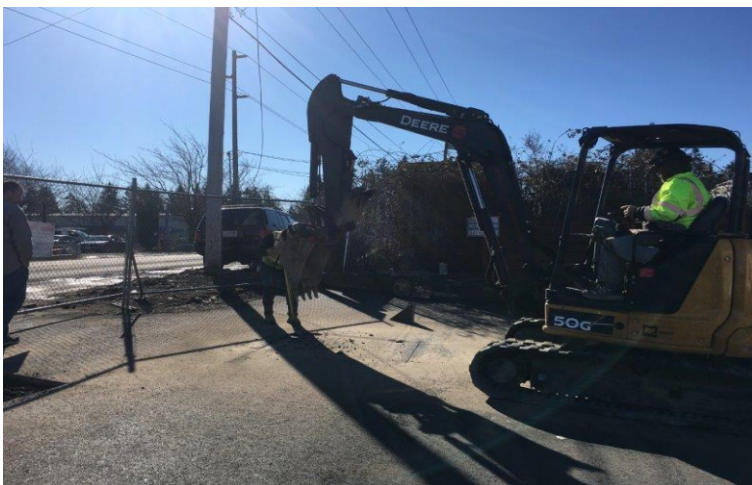
Photograph Three: Breaking into Test Pit 3

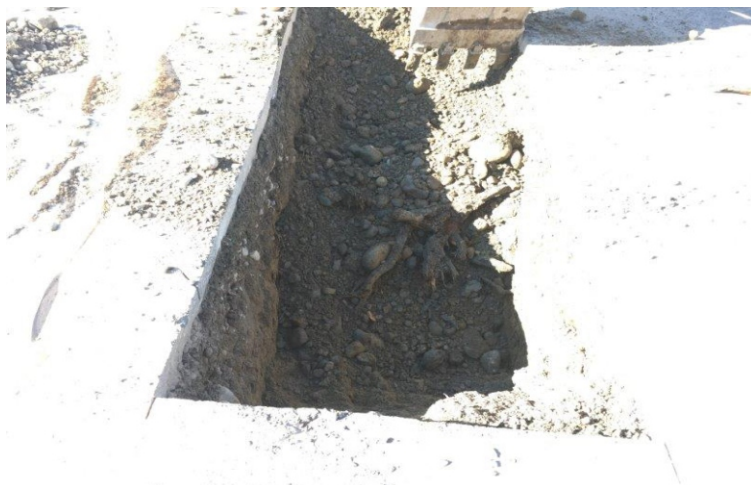
Photograph Four: Roots being dug up from Test Pit 3

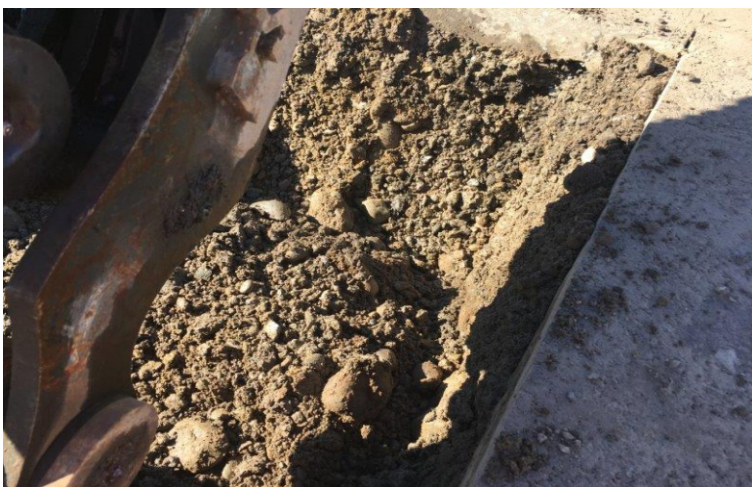
The asphalt covering the area of TP3 was cut and upon removal, a strong gasoline like odor was detected by ECI and CGI professionals. A surface sample of the soil (TP3-S-0) was collected and sent to the mobile lab on site to be analyzed for GRO and BTEX. The top layer of contaminated soil was removed and placed on a sheet of plastic. This top layer of soil consisted of gray colored moist sandy gravel on top of brown medium sand. At a depth of 1-foot bgs, the odor was no longer observed.

Photograph Five: Gasoline Contaminated Soil Test Pit 3

Based on the analytical results of the samples collected in the area of Test Pit 3 and TP3.2, ECI concluded that the GRO contamination observed was localized to the area encompassed by Test Pit TP3 and that the contaminated soil was removed for disposal.

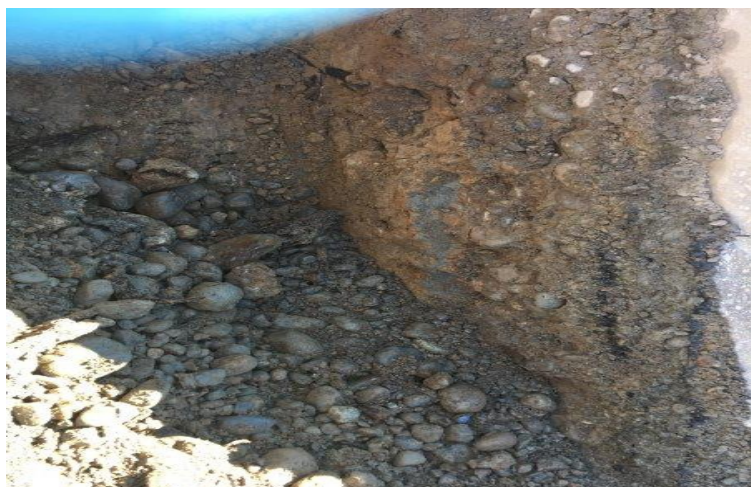
Photograph Six: Discolored Lenses of Soil in Test Pit 3

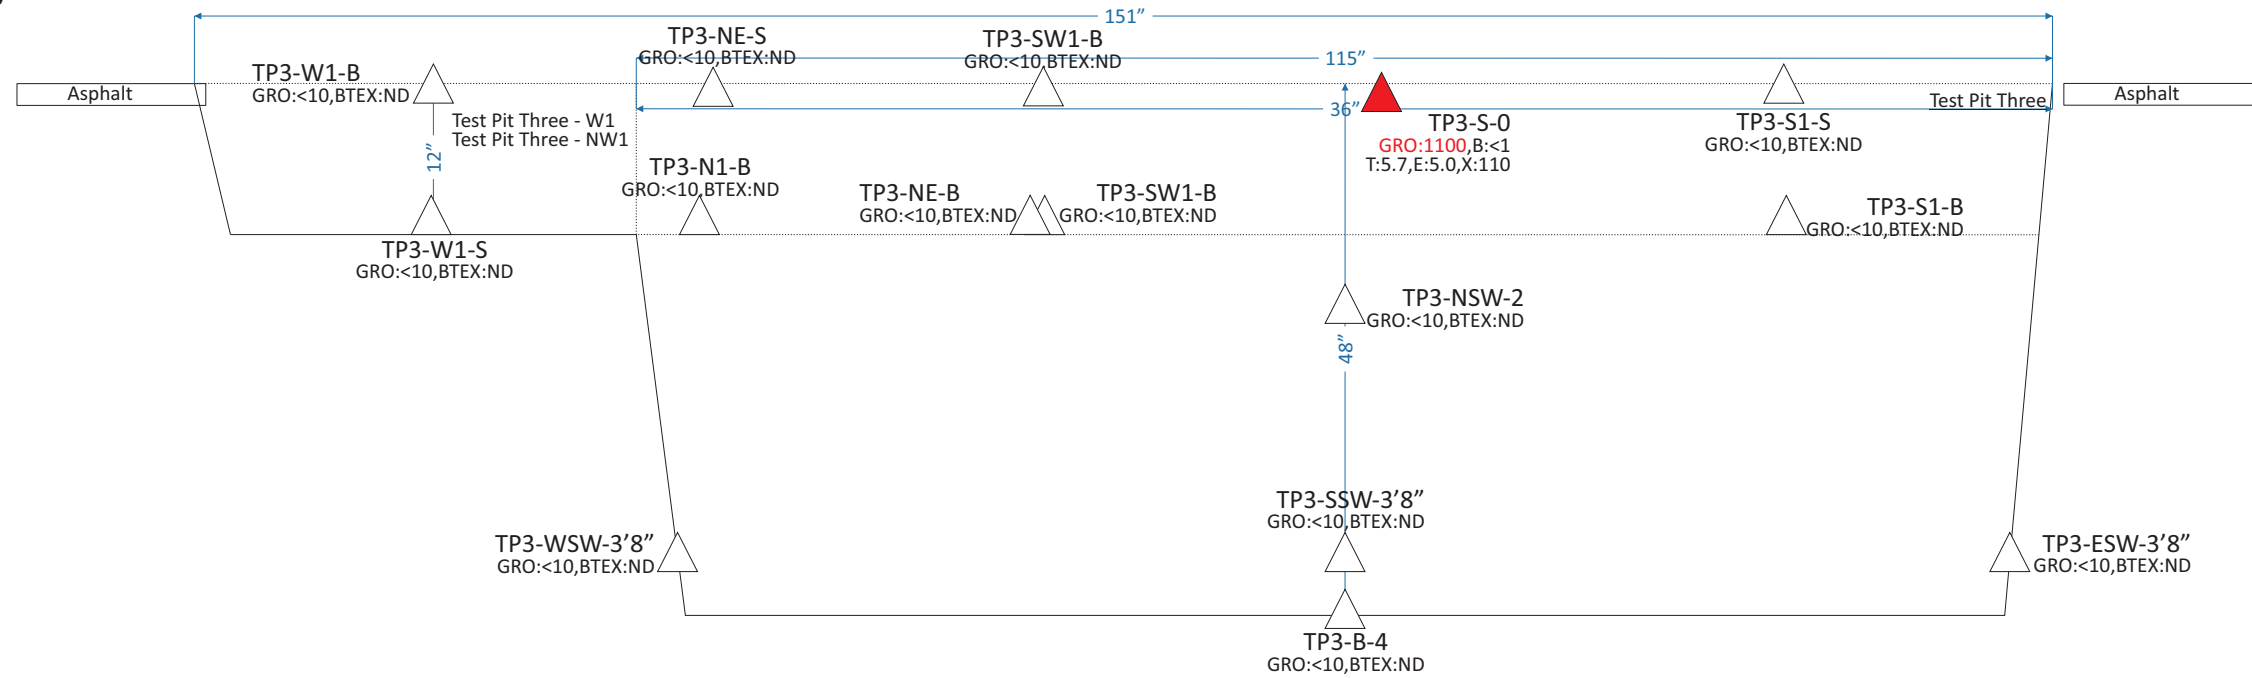
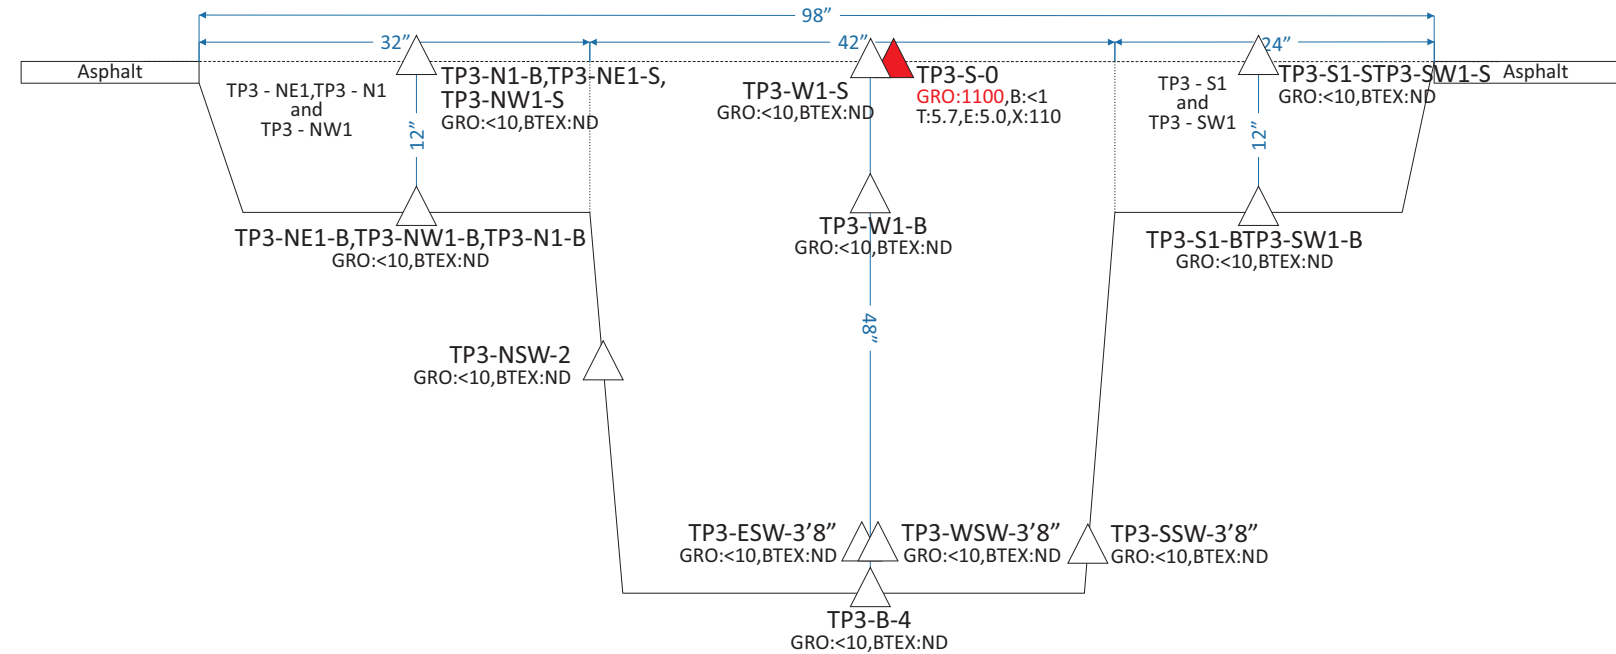
# Test Pit 3 Cross-Section

To further delineate the extent of the contamination observed, the test pit was extended to a depth of 4 feet bgs. Four sidewall samples were collected at depths of 3.66 feet on the east, south, and west sidewalls, and at a depth of 2 feet bgs on the north sidewall. A bottom sample was collected from the middle of the test pit at a depth of 4 feet bgs. A map of the Test Pit showing the sample locations is presented on Figure 8 in Appendix A. A cross-section of the test pit is presented on Figure 9 in Appendix A.
