STATE OF WASHINGTON  
DEPARTMENT OF ECOLOGY

November 20, 2012

**Re: Further Action at the following Site:**

- **Site Name:** Chehalis Power LP Generation Facility
- **Site Address:** 1813 Bishop Road
- **Facility/Site No.:** 3336951
- **Cleanup Site ID No.:** 11776
- **VCP Project No.:** SW1246

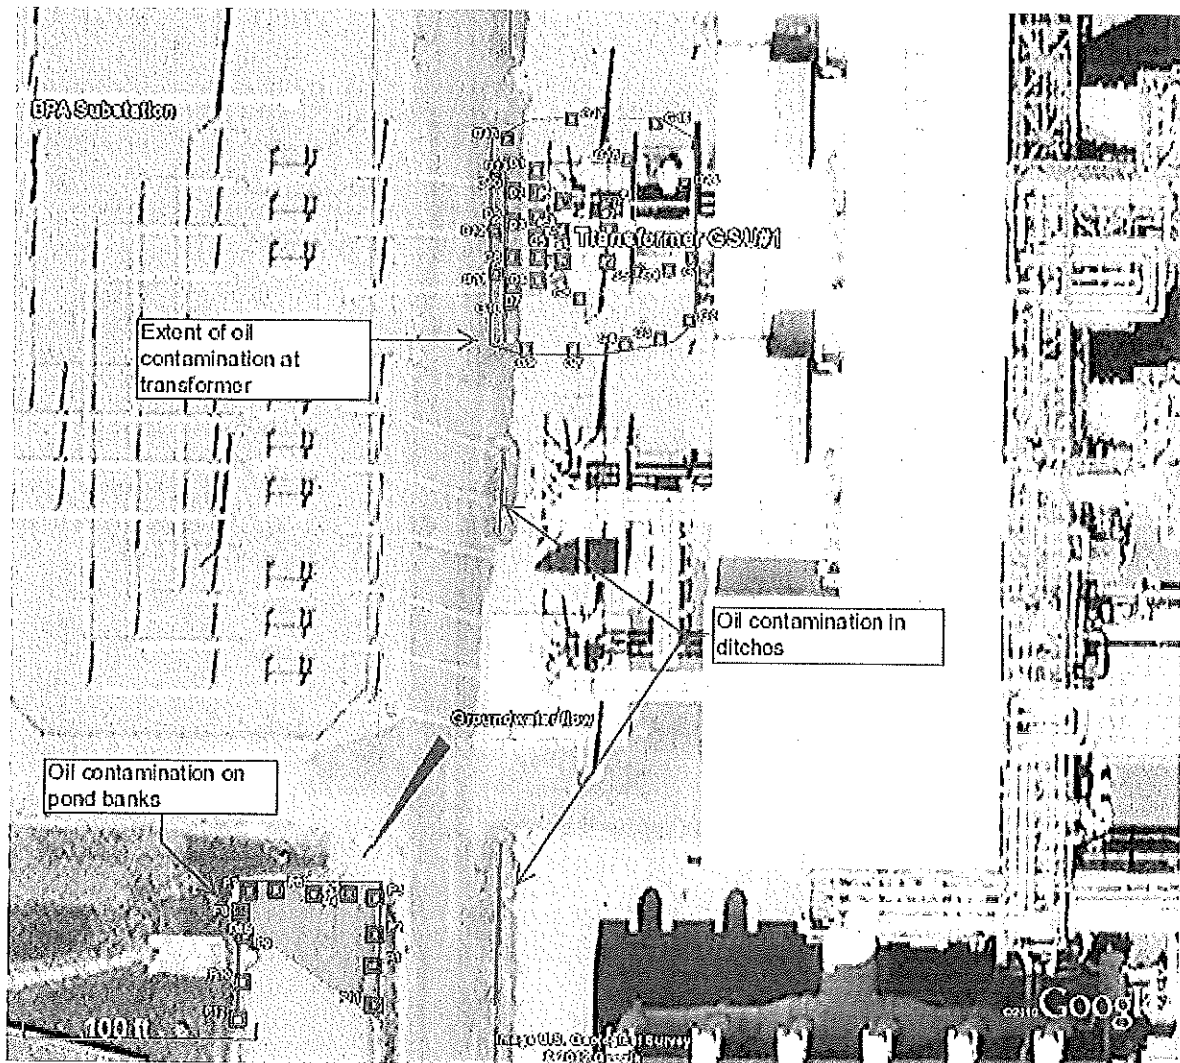
1. **Stormwater Pond and Ditches:** The stormwater pond and ditches were cleaned up through oil skimming, pumping, and soil excavation. Contaminated water was pumped into an AST for temporary storage (see Section 4 of this letter for details). A total of 23 soil samples were collected from the stormwater ditches on January 27, 2011, and 12 soil samples were collected from the stormwater pond on February 4, 2011 after the cleanup effort. Soil analysis results indicated that one location in the stormwater ditch and one location in the stormwater pond detected concentrations above the MTCA cleanup level for mineral oil. Additional excavation was conducted at these locations and two more confirmation samples, one each from stormwater ditch and pond, were collected on March 2, 2011, and the results met the MTCA Method A cleanup level for soil. One water sample from the stormwater pond also indicated that the stormwater in the pond met MTCA Method A cleanup level (Note: no surface water criteria exists for mineral oil, so the data were compared against MTCA Method A cleanup levels for groundwater). Since the stormwater system is permitted through Ecology's Industrial Stormwater NPDES Permit (WAR008707), the subsequent required quarterly monitoring indicated that the stormwater met the permit limitations and met the MTCA Method A cleanup level. The characterization of the stormwater system (water, bank liners and soil) was sufficient.

Fig. 2 Sampling locations for soil around the GSU#1 containment, and for the Stormwater pond

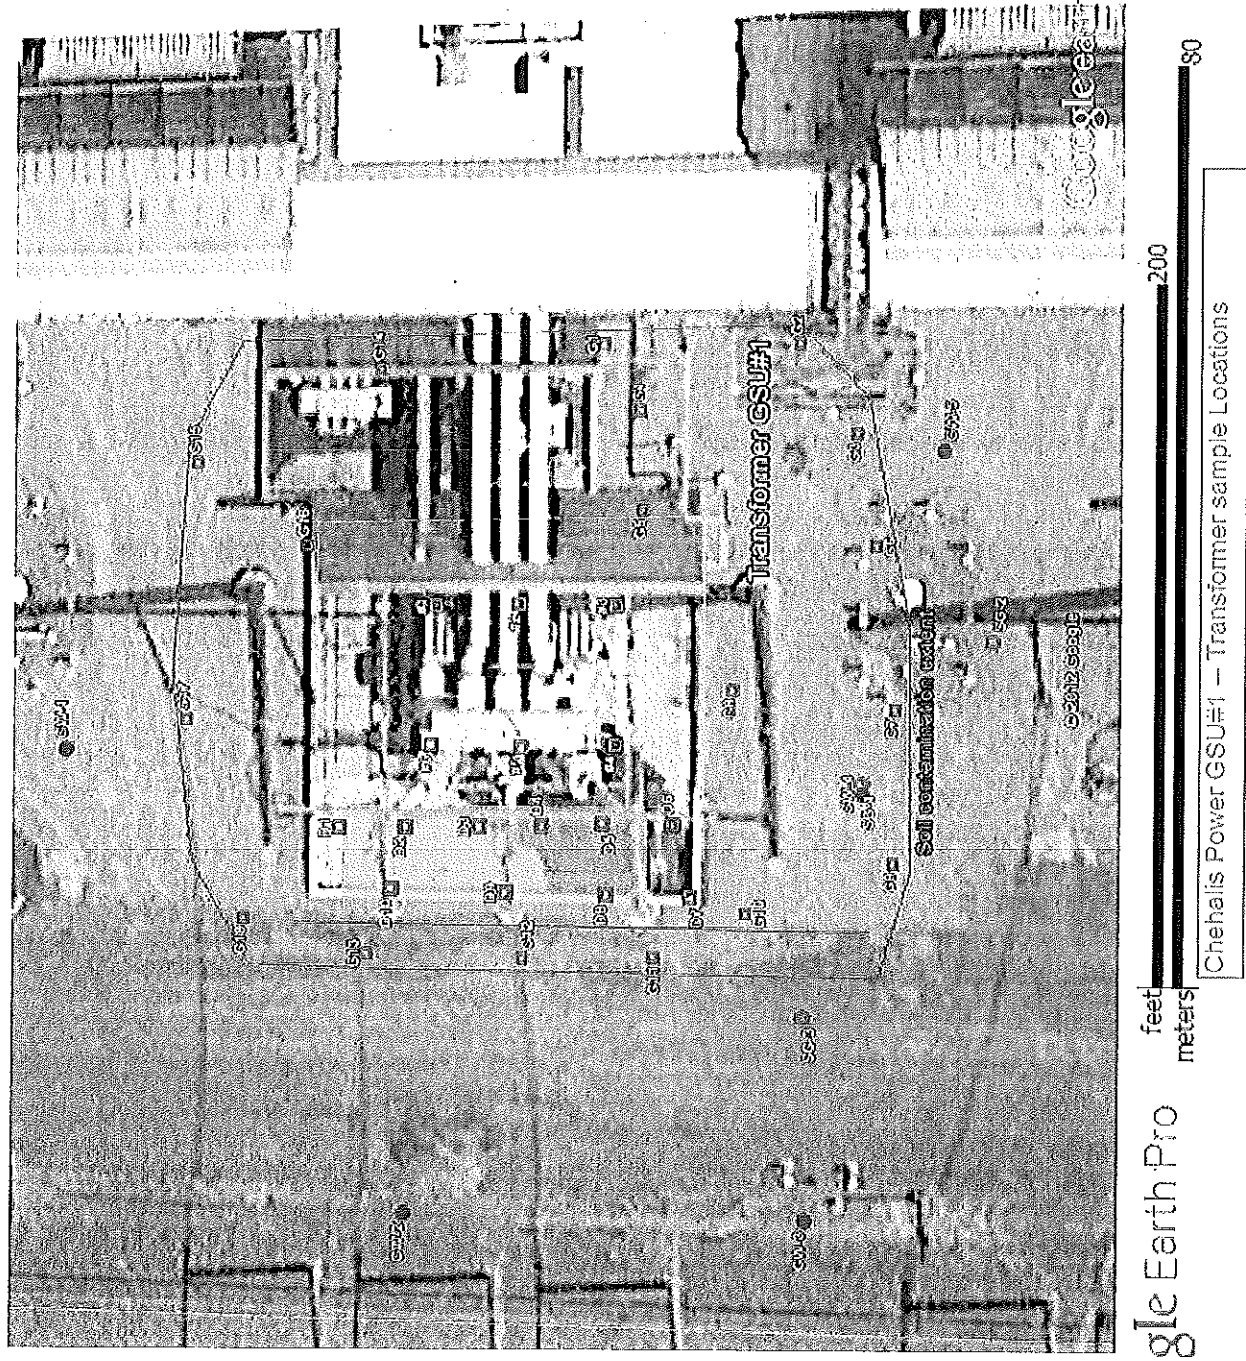
2. **Soil Around GSU #1:** Three separate confirmation soil sampling efforts were conducted to evaluate the cleanup of soil contamination surrounding the GSU#1 (see Fig. 3 of **Enclosure A**), and the results demonstrated that soil contamination still exists in a limited area under the extension portion of the newly enlarged GSU#1 containment structure.

The soil cleanup and confirmation sampling demonstrated that no soil contamination went beyond the extent of the 70 foot by 80 foot area surrounding the GSU#1 containment. However, soil contamination remains in the area now covered under the extended portion of the enlarged GSU#1 containment structure. The sample from 20 inches bgs detected mineral oil at 28,100 mg/kg, which exceeded the MTCA Method A cleanup level.

1. Soil contamination was found in a limited pocket in the area under the newly extended portion of the GSU#1 containment. The concentration of mineral oil at 20 inches depth was 28,100 mg/kg, exceeding the MTCA cleanup level. The contaminated soil is now covered under the enlarged concrete containment structure. Additional remediation is needed. Alternatively, an environmental covenant may be put on the Site if additional remediation is deemed infeasible, in which case, please provide a brief feasibility study and disproportionate cost analysis that evaluates alternatives for cleanup in this area.

Fig.3 Soil Confirmation sample locations and groundwater Site Investigation Surrounding GSU#1

Soil Sample: 1) #1-6, Jan. 28, 2011 from under old containment; 2) D1-D10, Feb. 5, 2011 from construction pits under the extension of the containment; 3) G1-G18, Feb. 21-22, 2011, from surrounding the newly constructed containment; 4) GW1-GW5, groundwater wells, SG1-SG3, surface soil, both on July 2011.
