STATE OF WASHINGTON
DEPARTMENT OF ECOLOGY

Re: Opinion pursuant to WAC 173-340-515(5) on Remedial Action for the following Hazardous Waste Site:

- **Site Name:** West View Mart
- **Site Address:** 971 Ault Field Road, Oak Harbor, WA 98277
- **Facility/Site No.:** 53233419
- **Cleanup Site ID No.:** 9580
- **VCP Project No.:** NW2373

Description and Diagrams of the Site

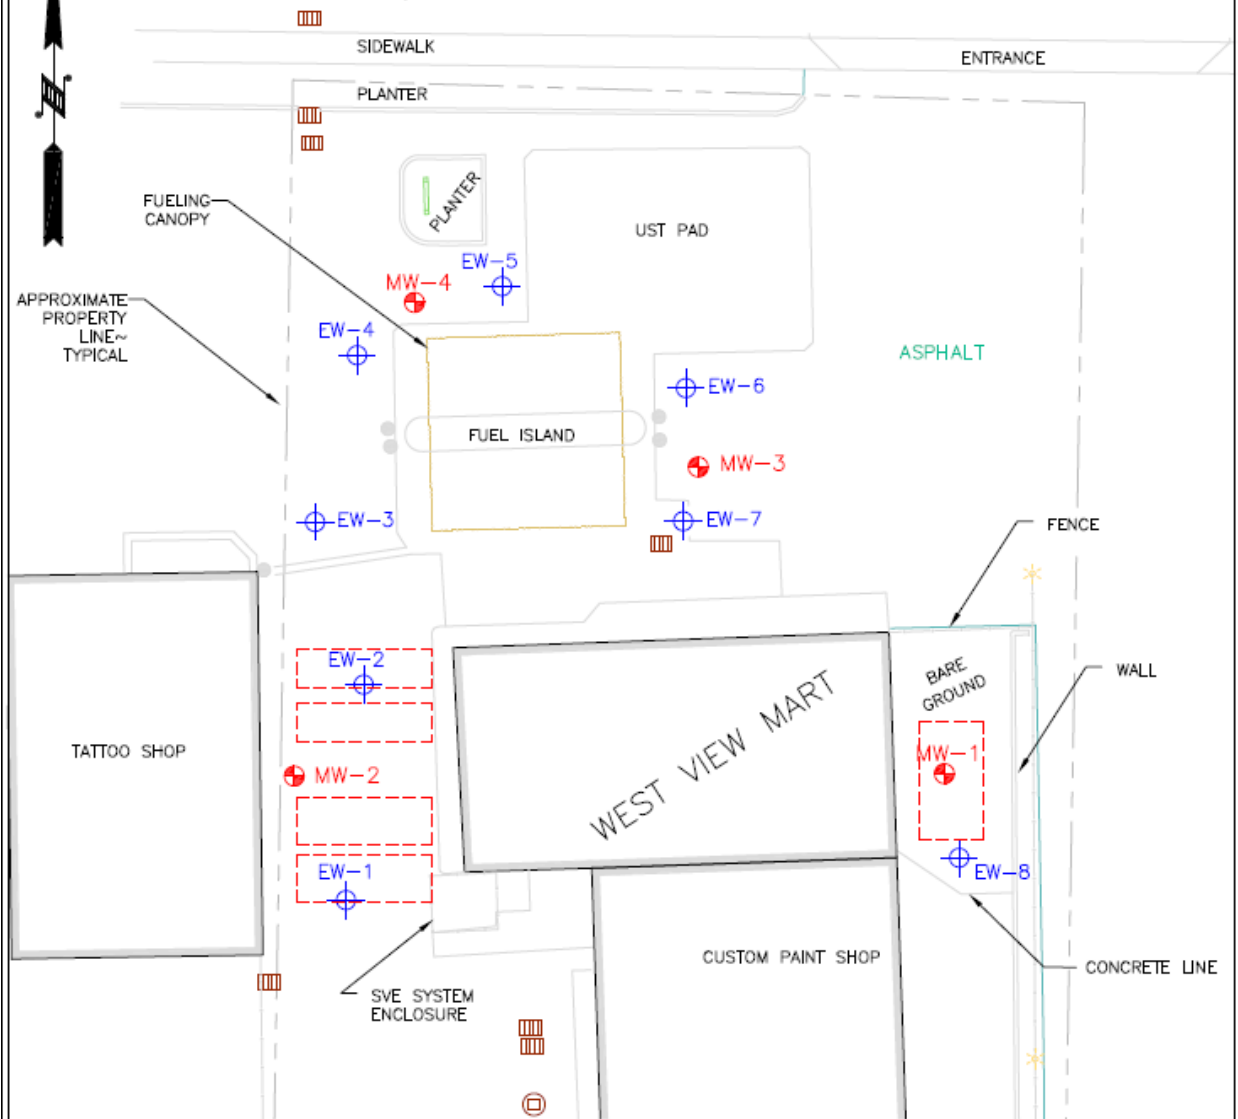
FIGURE 2
 SITE PLAN

Eight (EW-1 through EW-8) of the nine VES wells were decommissioned in 2020. One of the VES wells, EW-9, could not be located. Locations of the VES wells are shown on **Figure 2**.

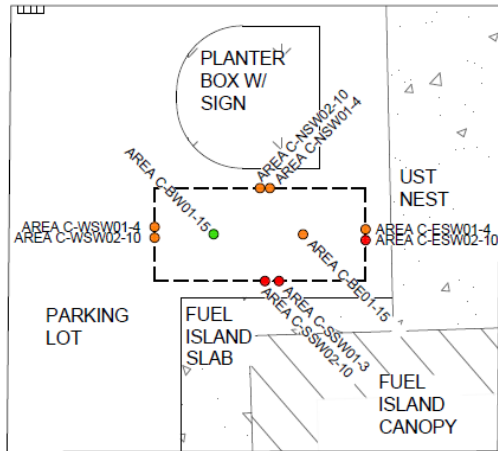
3 Remedial Excavation of Area C

Area C was located northwest the station building and the fuel island (**Figure 8**). Contaminated soil was removed, with inaccessible soil containing TPH-G concentrations (3,400 to 4,400 mg/kg) above the Method B cleanup level remaining in the east and south sidewalls at depths of 3 and 10 feet bgs.

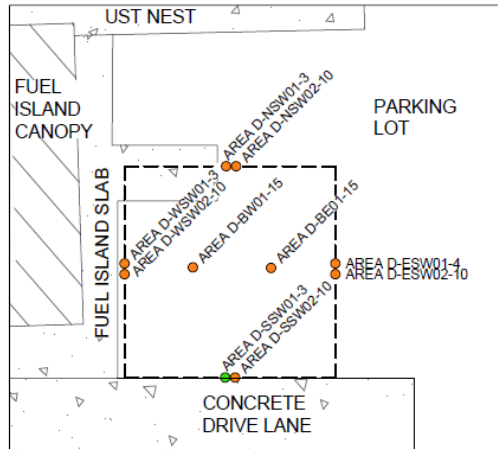
4 Remedial Excavation of Area D

Area D was located north of the station building and east of the fuel island (**Figure 8**). All soil in Area D contaminated with TPH-G and BTEX was removed to below Method B cleanup levels.
