**PHASE I ENVIRONMENTAL SITE ASSESSMENT  
UNITED STATES POSTAL SERVICE**

**FORMER GENERAL MAIL FACILITY  
2445 3RD AVENUE SOUTH  
SEATTLE, WASHINGTON 98134**

**October 15, 1997**

RE: Final Phase I Environmental Site Assessment  
Former General Mail Facility  
Seattle, Washington

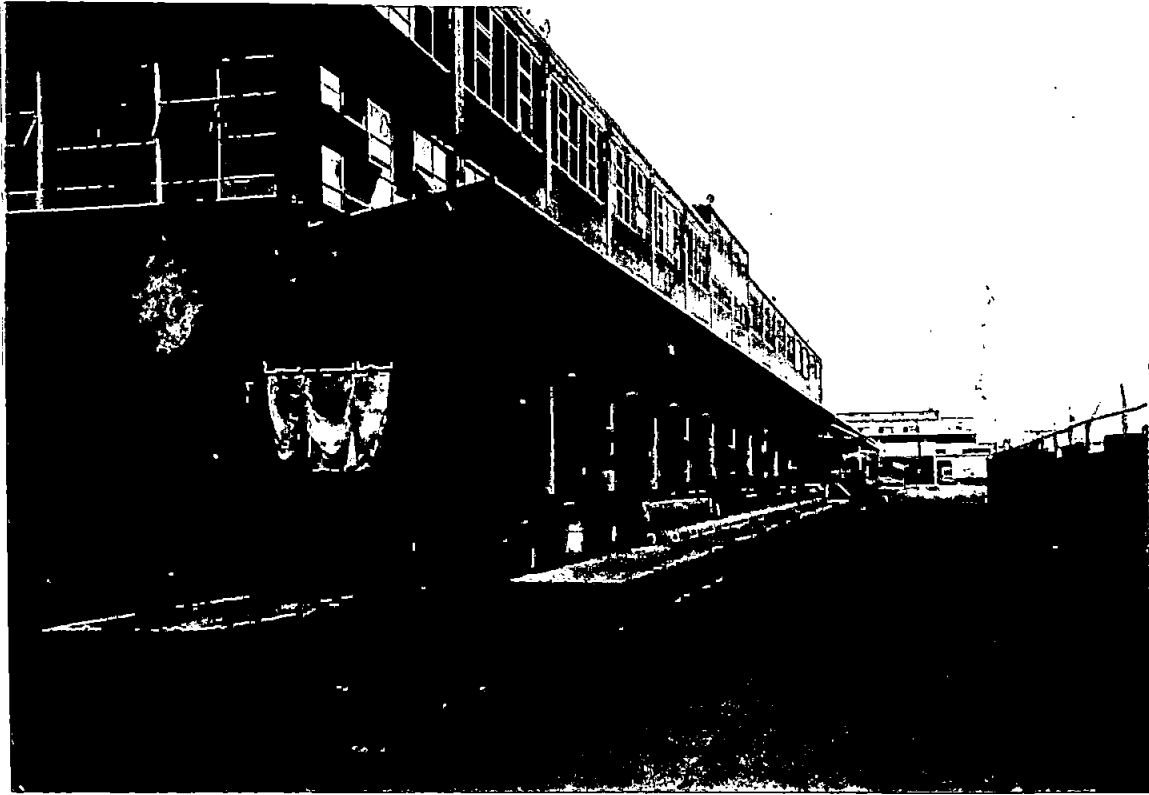
Photograph 1: View to the south along the west side of the GMF building. The railroad loading platform occupies this corner of the building, and AOC #5 is located just beyond the left side of the photograph.

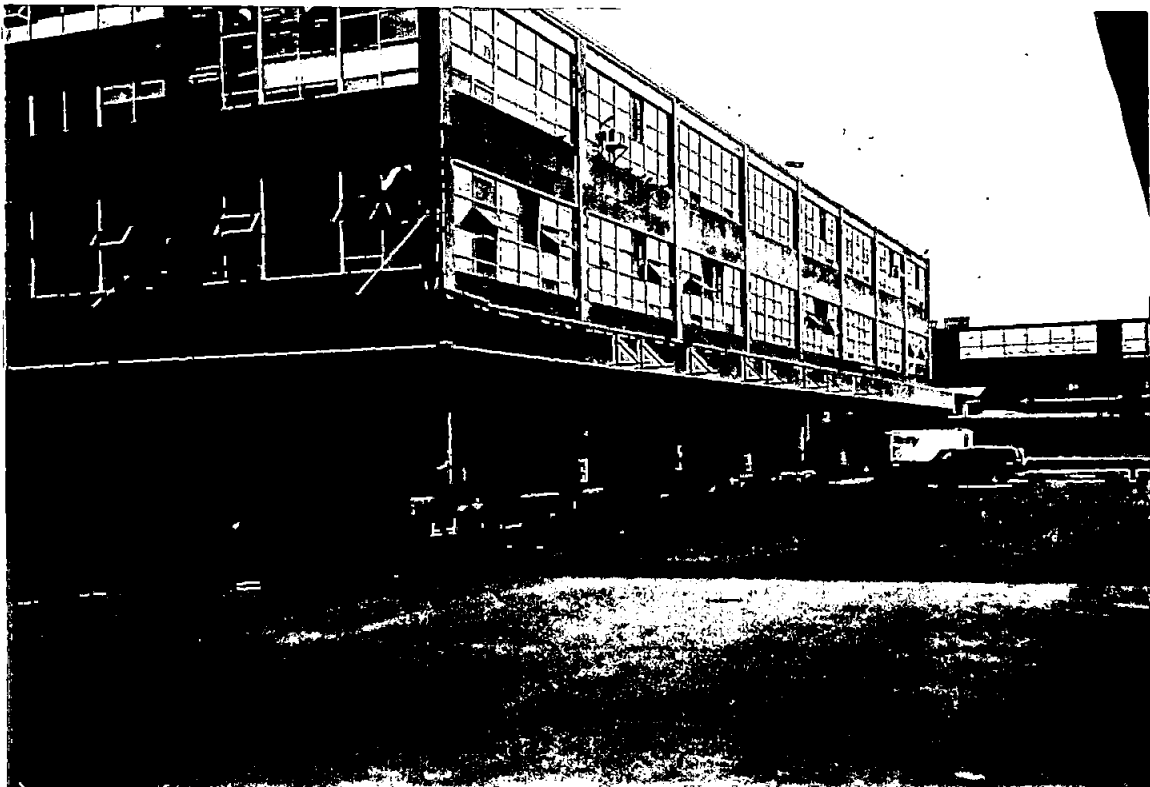
Photograph 2: View to the west along the north side of the GMF building: AOC #1 is located in the foreground. Truck loading platforms are located along both visible sides of the building.

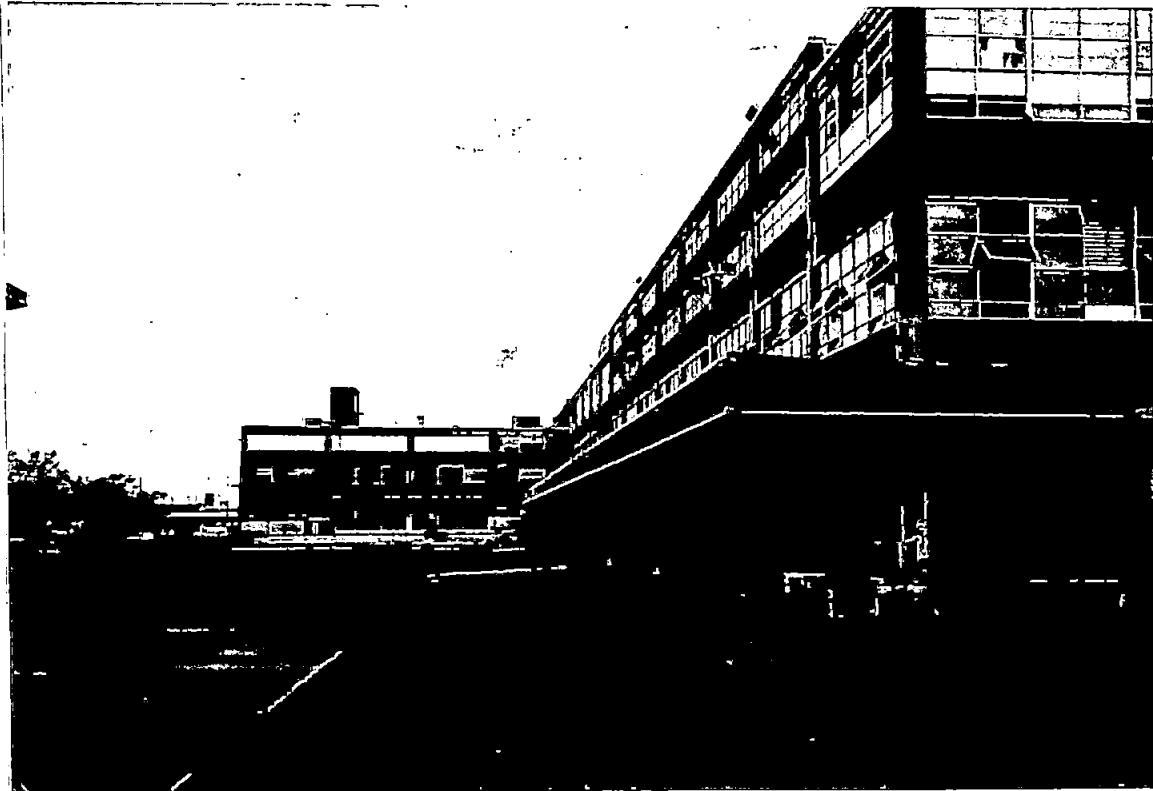
Photograph 3: View to the south along the east side of the GMF building. AOC #1 is in the left side of the photograph.

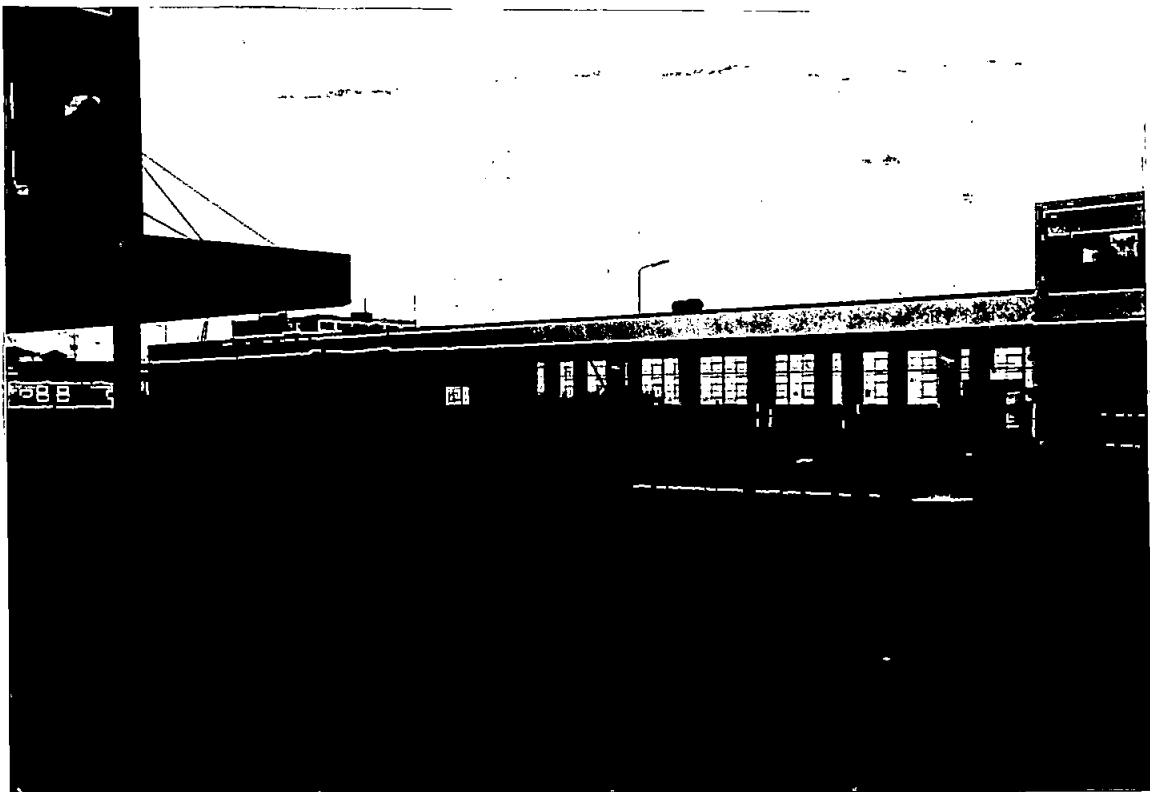
Photograph 4: View to the northwest towards the VMF building. The northeast corner of the VMF building is visible in the left side of the photograph. AOC #1 is located in the foreground, and AOC #2 toward the right side of the photograph in front of the VMF building.

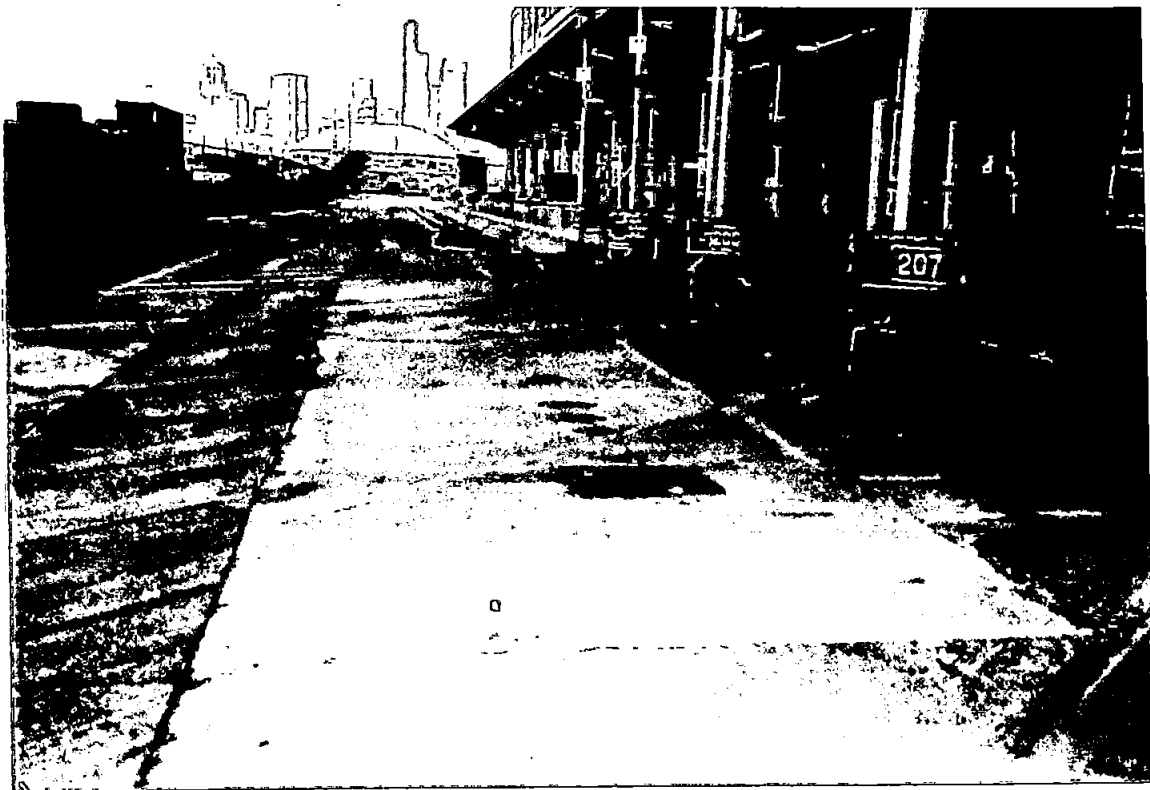
Photograph 6: View to the north along the west side of the GMF building. AOC #4 is located in the foreground. The edges of the new concrete are visible and define the approximate edge of the excavation. See Figure 2 for a more detailed description of features.

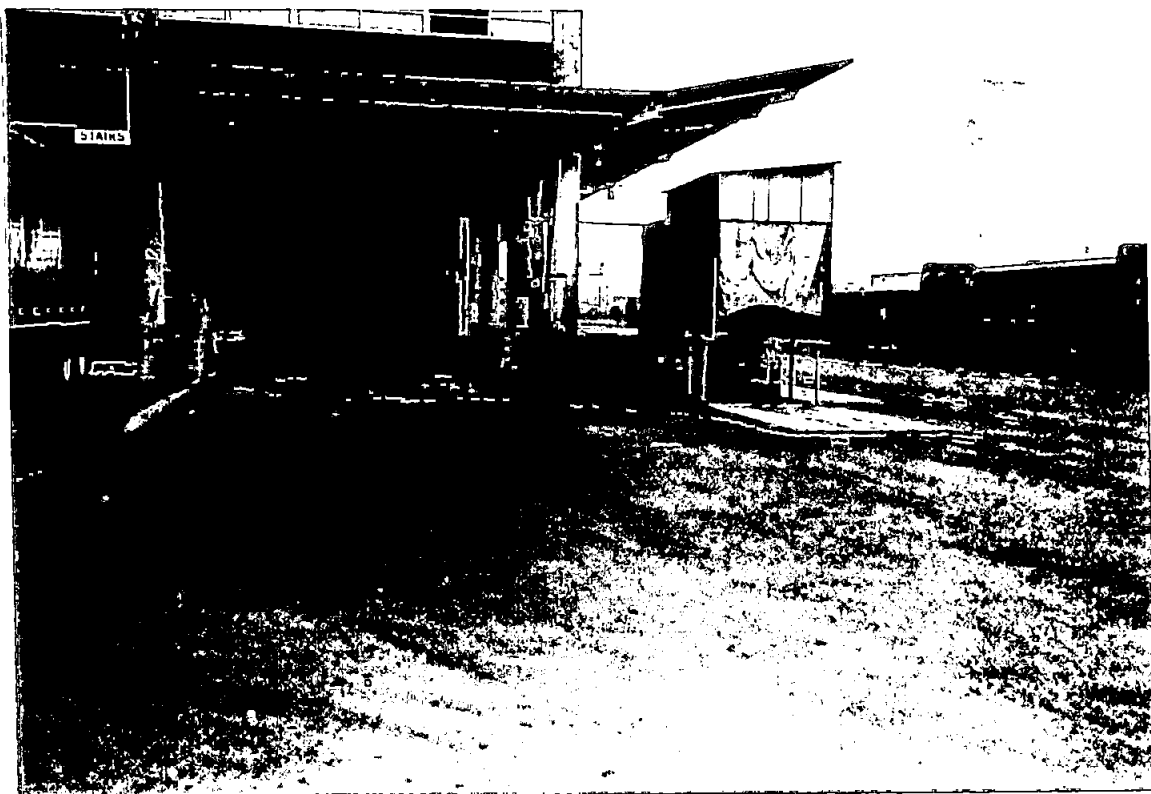
Photograph 7: The northwest corner of the GMF building and railroad loading platform. The dark empty space in the background is the location of a railroad loading spur shown in Figure 3. AOC #4 is visible in the foreground, where the edge of the new asphalt is the approximate edge of the excavation.

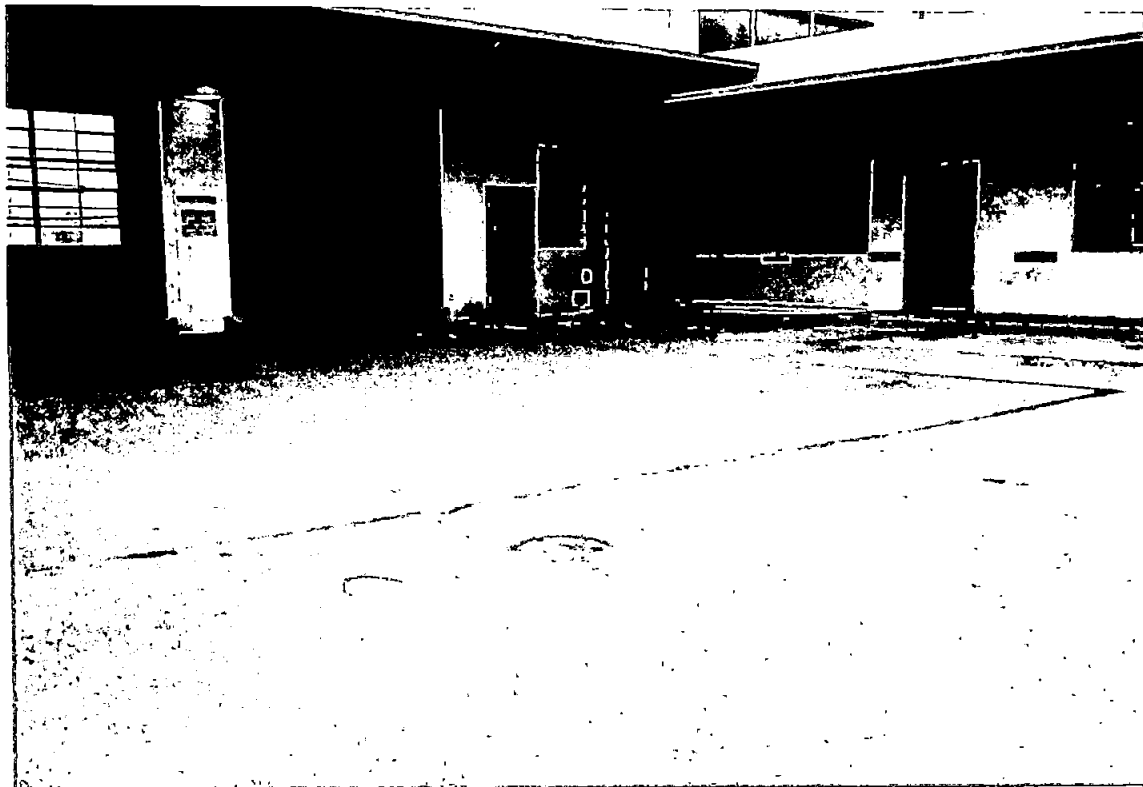
There are two below-grade hydraulic lift pits located in adjacent maintenance bays 2 and 3. Each pit consists of two separate vaults, an east-west rear piston vault, and a north-south, L-shaped front piston vault (see Figure 4). The vaults are approximately 8 feet deep. During the site visit, ICF KE inspected the vaults. They are constructed of concrete that appears to be in good condition. The rear piston vaults have metal siding over the concrete on the sides of the vault. The pistons and other operable hardware have been removed from all four vaults. Less than a foot of water/oil/sludge was observed in the bottoms of the vaults.

According to USPS personnel formerly at the Site, during the last few years that the lifts were used (approximately 1989-1991), approximately five gallons per week of hydraulic oil was required as makeup oil; approximately this amount would leak from the system (Dames & Moore 1997 and Ubis 1997). However, it is not known whether this oil simply leaked from the

vaults, from where it would later be pumped, or whether the oil actually leaked through the vaults or from underground piping into the subsurface.

Photograph 8: View to the northeast towards inside of the "L" of the VMF building. The two underground hydraulic lift pit were located in the two bays seen in the left side of the photograph, and AOC #2 is seen in the foreground, where the edge of the new asphalt is the approximate edge of the excavation.

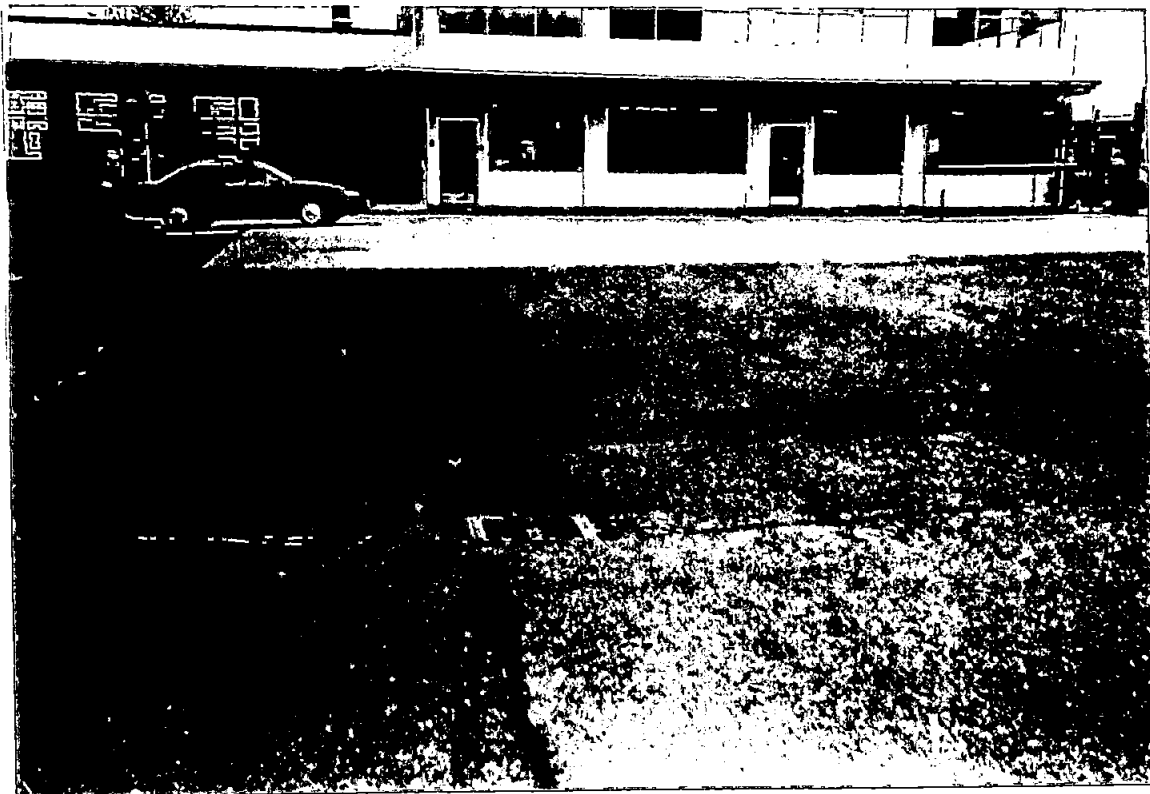
Photograph 10: View to the north towards the east end of the VMF building. AOC #1 can be seen in the foreground, including a stormwater drain in the center of the photograph, a UST observation well to the left of the drain, and capped MW-2A to the right of the drain.

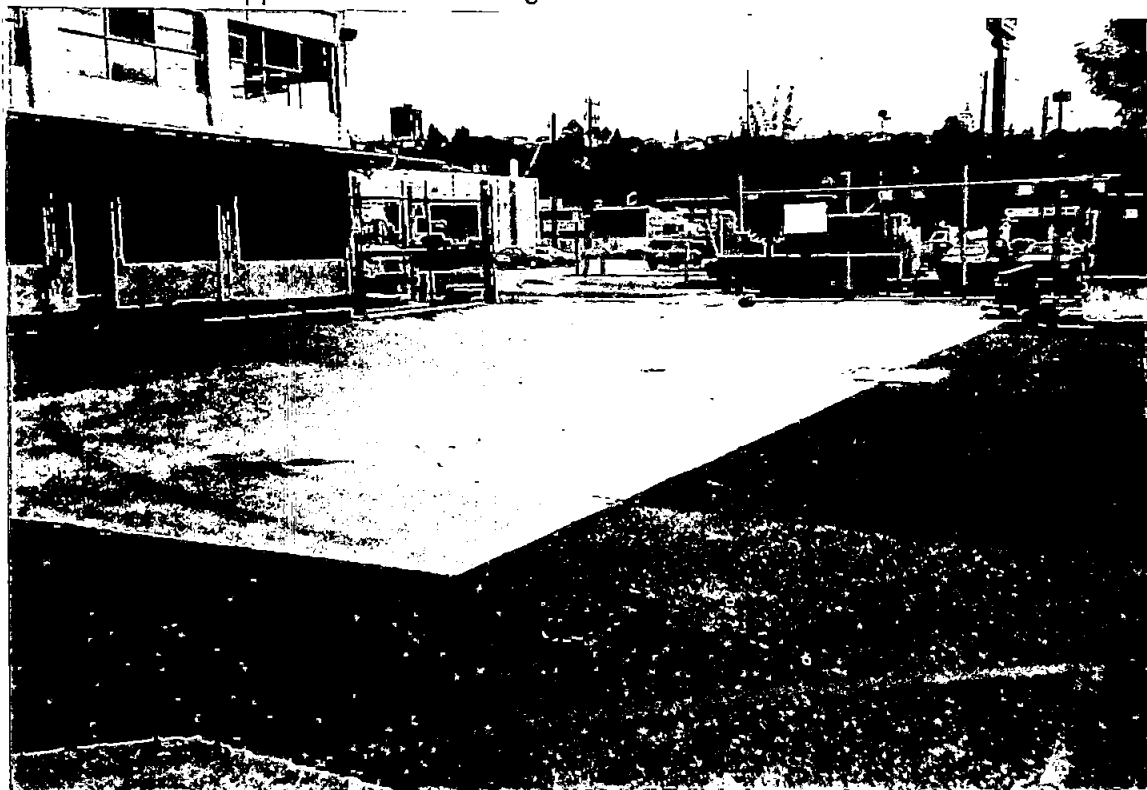
Photograph 11: View to the northeast towards the east end of the VMF building. The north end of AOC #1 can be seen in the foreground, including the extraction well beneath the square metal plate in the right side of the photograph, a UST observation well just to the left of the extraction well, and another UST observation well in the left foreground.

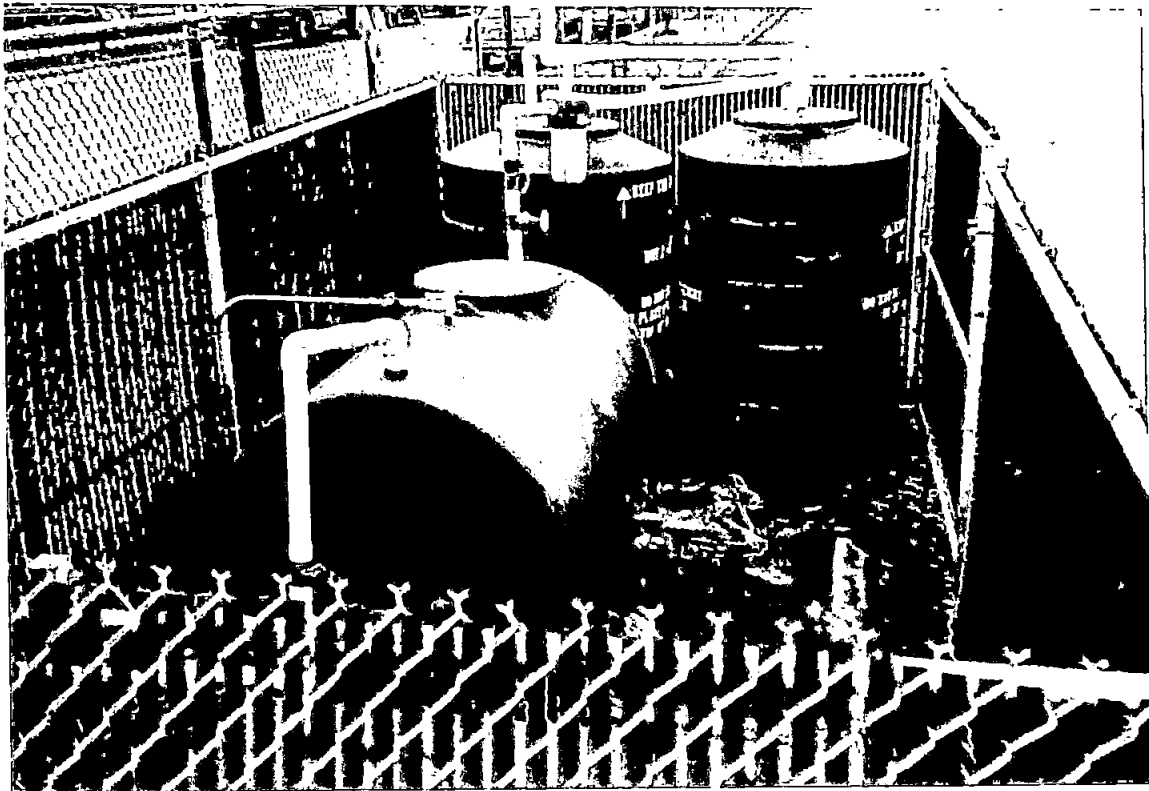
WDOE was notified of the diesel leak in 1987. In response, WDOE requested that the USPS install a ground water interception trench and extraction system. The USPS contracted with Sverdrup Corp. to conduct an investigation and install the requested remedial system. The Sverdrup Corp. installed the ground water interception trench, a large-diameter ground water extraction well, and a free-product recovery and ground water treatment system (see Figure 4). Most of the extraction and treatment system is still in place. In addition, they installed eight shallow monitoring wells (four in the immediate vicinity of the tanks) to monitor ground water quality around the tanks (URS 1994). The extraction and treatment system consisted of a pump to skim-free product from the water surface. This product was pumped into a product holding tank. The current contents of the holding tank are unknown. Another pump pumped ground water into a surge tank, through particulate filters, and through two granular activated carbon units, before discharging the water to the sanitary sewer (Dames & Moore 1997). The system was started on June 24, 1987, and ran until the end of January 1988. According to an agreement with WDOE, the system was to be run until the layer of free product measured less than 1/8-inch thick (WDOE 1988). During the last two months of operation, no free product was recovered (Sverdrup 1988). According to meters on the product tank, a total of approximately 2,300 gallons of product was recovered during the operation of the system (Dames & Moore 1997). WDOE also stated that continued ground water monitoring, as well as the installation of several new wells beyond the boundaries of the existing wells, would be required (WDOE 1988). No additional wells were installed. Ground water monitoring was apparently conducted from the existing monitoring wells in 1987 and 1988 by Resources Conservation Company. Results of this monitoring were not located.

Photograph 14: The groundwater treatment system still in place on the east side of the Site. The treatment system was used for several months in 1987 before it was shut down.
