Site 956

Draft Limited Site Characterization Report

For Limited Characterization of a Petroleum Release at the
DeBocks Texaco Facility,
Grandview, WA

March, 1996

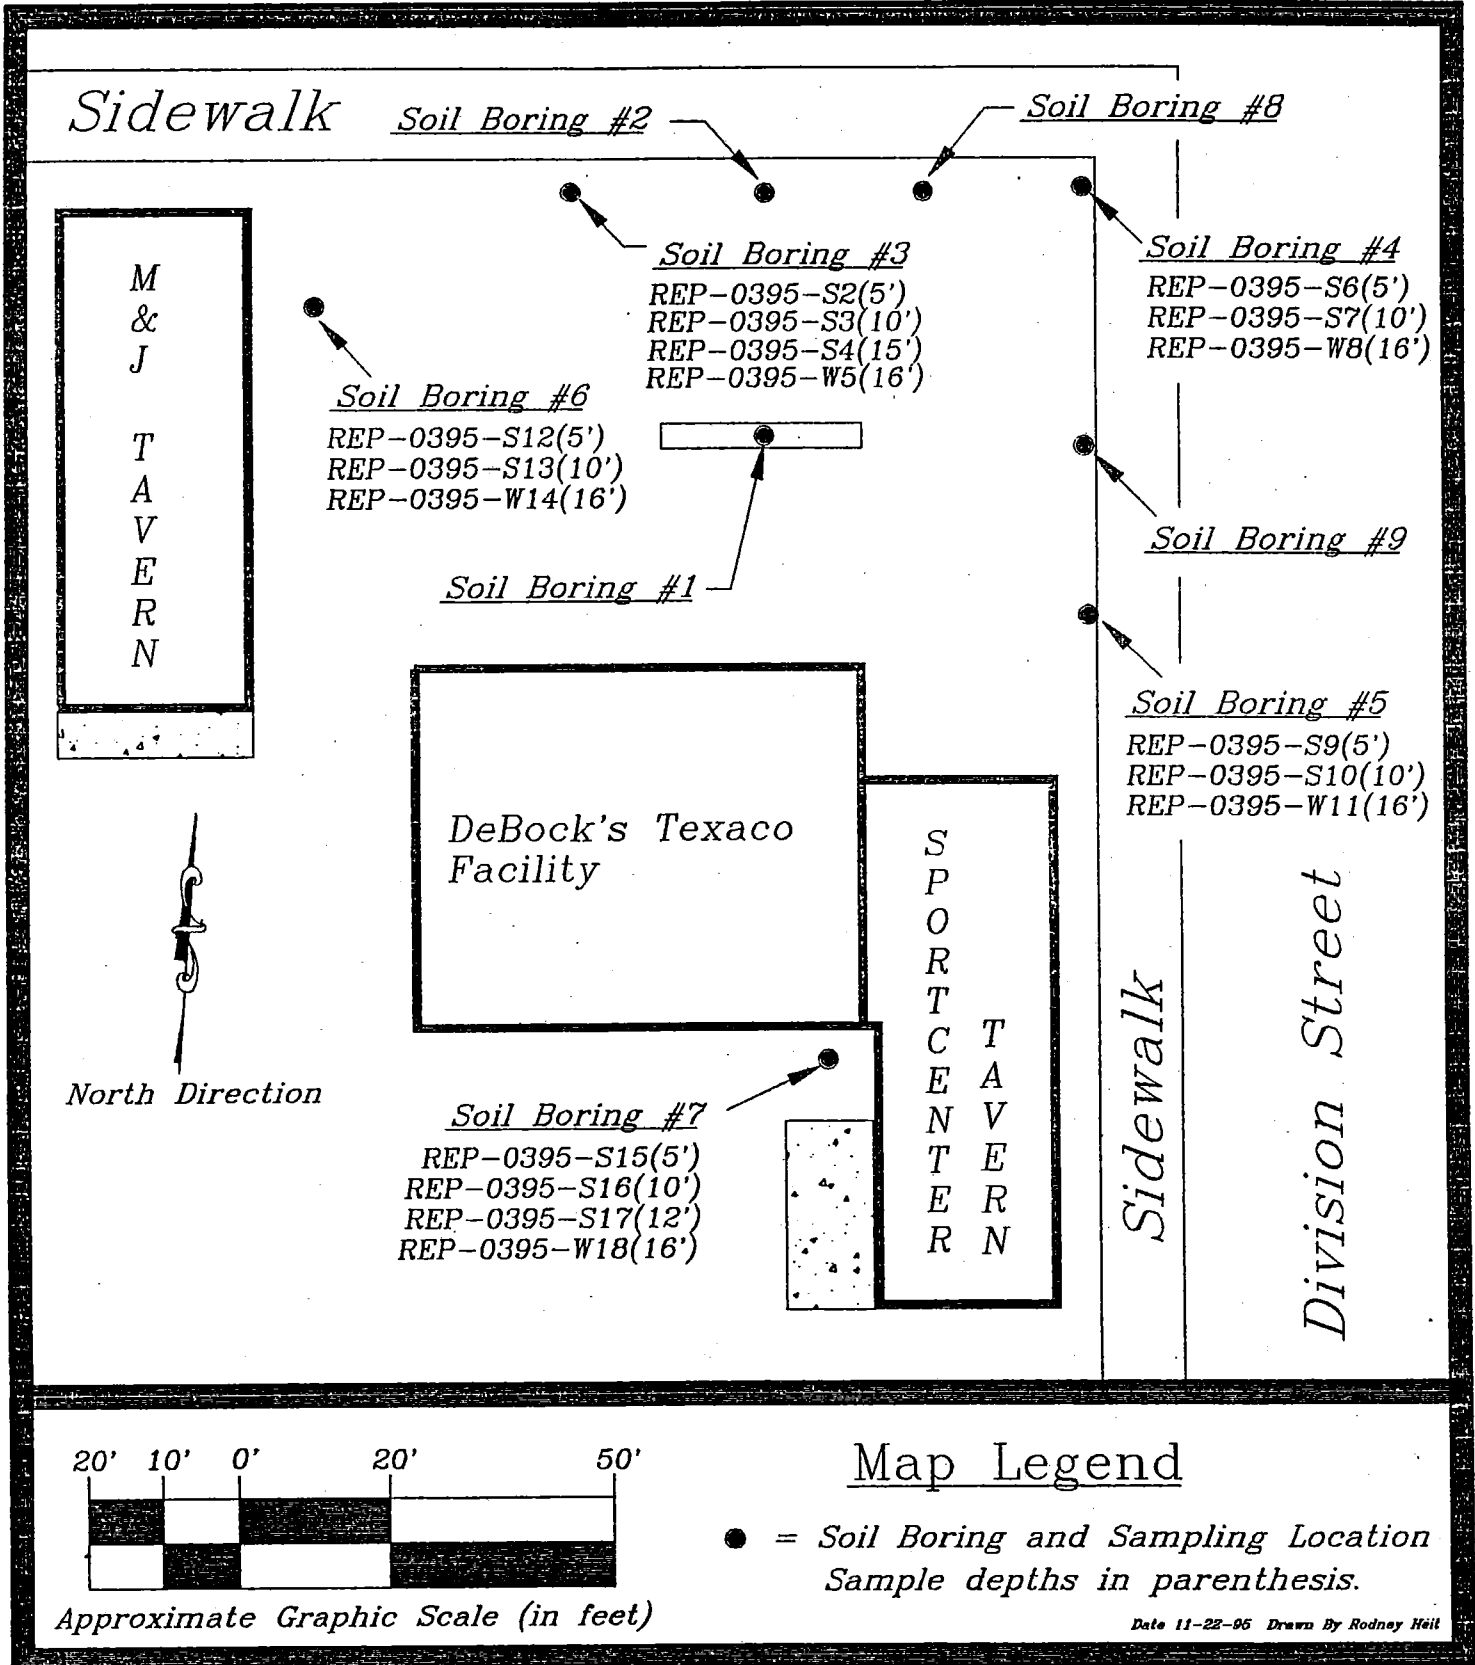
Figure 3. Soil Boring and Sampling Locations

Soil Boring #1 (SB#1) was attempted at the original location of the fuel dispenser island as shown by Figure 3. Upon attaining a depth of five (5) feet BGS, Sage encountered objects which prevented further boring at this location. Since adequate depths were not attained at this location the boring was abandoned and no samples were collected. Review of WSI documentation indicates that petroleum impacted soil extended from the ground surface down to depths greater than fourteen and one-half (14.5) feet BGS.

Soil Boring #3 (SB#3) was established along the northern property border at the location shown by Figure 3. Stained soils were encountered at a depth of ten (10) feet BGS. Sage collected two (2) soil samples (REP-0395-S2, S3 and S4) at depths of five (5), ten (10) and fifteen (15) feet BGS. In addition, Sage collected one (1) groundwater sample (REP-0395-W5) from the boring.

Analysis of soil sample REP-0395-S3 found no detectable petroleum hydrocarbons. However, analysis of soil sample REP-0395-S4 found:

gasoline range petroleum hydrocarbons at a concentration of 1,800 parts per million (ppm),
no detectable (less than 0.1 ppm) benzene,
no detectable (less than 0.1 ppm) toluene,
ethylbenzene at a concentration of 1.7 ppm,
xylenes at a concentration of 4.1 ppm and
no detectable (less than 25 ppm) total lead.

Comparison of the analytical results (Appendix E) with the Method A soil Cleanup Levels (Cleanup Levels) of WAC 173-340-740 (Appendix F) indicates that remedial action is required at this location to reduce gasoline range petroleum hydrocarbon concentrations to acceptable levels.

Analysis of groundwater sample REP-0395-W5 found:

gasoline range petroleum hydrocarbons at a concentration of 67.4 ppm,
benzene at a concentration of 4.2 ppm,
no detectable (less than 1.2 ppm) toluene,
ethylbenzene at a concentration of 1.58 ppm,
xylenes at a concentration of 3.43 ppm and
total lead at a concentration of 0.064 ppm.

Comparison of the analytical results (Appendix E) with the Method A Groundwater Cleanup Levels (Cleanup Levels) of WAC 173-340-720 (Appendix F) indicates that remedial action is required at this location to reduce gasoline, benzene, ethylbenzene, xylene and total lead concentrations to acceptable levels.

Soil Boring #4 (SB#4) was established at the northeast corner of the subject property as shown by Figure 3. Stained soils were encountered at a depth of eleven (11) feet BGS. Sage collected two (2) soil samples (REP-0395-S6 and S7) at depths of five (5) and ten (10) feet BGS. In addition, Sage collected one (1) groundwater sample (REP-0395-W8) from the boring.

Analysis of soil sample REP-0395-S7 found:

gasoline range petroleum hydrocarbons at a concentration of 326 parts per million (ppm),
no detectable (less than 0.1 ppm) benzene,
no detectable (less than 0.1 ppm) toluene,
no detectable (less than 0.3 ppm) ethylbenzene,
no detectable (less than 0.1 ppm) xylenes and
no detectable (less than 25 ppm) total lead.

Comparison of the analytical results (Appendix E) with the Cleanup Levels (Appendix F) indicates that remedial action is required at this location to reduce gasoline range petroleum hydrocarbon concentrations to acceptable levels.

Analysis of groundwater sample REP-0395-W8 found:

gasoline range petroleum hydrocarbons at a concentration of 53.1 ppm,
benzene at a concentration of 0.16 ppm,
toluene at a concentration of 0.83 ppm,
ethylbenzene at a concentration of 1.25 ppm,
xylenes at a concentration of 5.8 ppm and
total lead at a concentration of 0.047 ppm.

Comparison of the analytical results (Appendix E) with the Cleanup Levels (Appendix F) indicates that remedial action is required at this location to reduce gasoline, benzene, toluene, ethylbenzene, xylene and total lead concentrations to acceptable levels.

Soil Boring #5 (SB#5) was established at the eastern property border as shown by Figure 3. Stained soils were encountered at a depth of nine and one-half (9.5) feet BGS. Sage collected two (2) soil samples (REP-0395-S9 and S10) at depths of five (5) and ten (10) feet BGS. In addition, Sage collected one (1) groundwater sample (REP-0395-W11) from the boring.

Analysis of soil sample REP-0395-S10 found:

gasoline range petroleum hydrocarbons at a concentration of 117 ppm,
no detectable (less than 0.1 ppm) benzene,
no detectable (less than 0.1 ppm) toluene,
no detectable (less than 0.3 ppm) ethylbenzene and
no detectable (less than 0.1 ppm) xylenes.

Analysis of groundwater sample REP-0395-W11 found:

gasoline range petroleum hydrocarbons at a concentration of 55.6 ppm,
no detectable (less than 0.05 ppm) benzene,
toluene at a concentration of 0.34 ppm,
ethylbenzene at a concentration of 1.42 ppm,
xylenes at a concentration of 4.87 ppm and
total lead at a concentration of 0.145 ppm.

Comparison of the analytical results (Appendix E) with the Cleanup Levels (Appendix F) indicates that remedial action is required at this location to reduce gasoline, toluene, ethylbenzene, xylene and total lead concentrations to acceptable levels.

Soil Boring #6 (SB#6) was established at the northwestern property corner as shown by Figure 3. Stained soils were encountered at a depth of twelve (12) feet BGS. Sage collected two (2) soil samples (REP-0395-S12 and S13) at depths of five (5) and ten (10) feet BGS. In addition, Sage collected one (1) groundwater sample (REP-0395-W14) from the boring.

Analysis of soil sample REP-0395-S13 found:

no detectable (less than 20 ppm) gasoline range petroleum hydrocarbons,
no detectable (less than 0.1 ppm) benzene,
no detectable (less than 0.1 ppm) toluene,
no detectable (less than 0.3 ppm) ethylbenzene and
no detectable (less than 0.1 ppm) xylenes.

Comparison of the analytical results (Appendix E) with the Cleanup Levels (Appendix F) indicates that no remedial action is required at this sampling location.

Analysis of groundwater sample REP-0395-W14 found:

gasoline range petroleum hydrocarbons at a concentration of 185 ppm,
benzene at a concentration of 3.48 ppm,
toluene at a concentration of 1.89 ppm,
ethylbenzene at a concentration of 2.44 ppm,
xylenes at a concentration of 5.73 ppm and
total lead at a concentration of 0.096 ppm.

Soil Boring #7 (SB#7) was established near the southeastern corner of the service station building as shown by Figure 3. Stained soils were encountered at a depth of twelve (12) feet BGS. Sage collected three (3) soil samples (REP-0395-S15, S16 and S17) at depths of five (5), ten (10) and twelve (12) feet BGS. In addition, Sage collected one (1) groundwater sample (REP-0395-W17) from the boring.

Analysis of soil sample REP-0395-S17 found:

gasoline range petroleum hydrocarbons at a concentration of 426 ppm,
no detectable (less than 0.1 ppm) benzene,
no detectable (less than 0.1 ppm) toluene,
no detectable (less than 0.3 ppm) ethylbenzene,
no detectable (less than 0.1 ppm) xylenes and
no detectable (less than 25 ppm) total lead.

Comparison of the analytical results (Appendix E) with the Cleanup Levels (Appendix F) indicates that soil remediation is required at this sampling depth to reduce gasoline range petroleum hydrocarbon concentrations to acceptable levels.

Analysis of groundwater sample REP-0395-W18 found:

gasoline range petroleum hydrocarbons at a concentration of 111 ppm,
benzene at a concentration of 0.14 ppm,
toluene at a concentration of 2.08 ppm,
ethylbenzene at a concentration of 1.53 ppm,
xylenes at a concentration of 6.93 ppm and
total lead at a concentration of 0.037 ppm.

Soil Boring #8 (SB#8) was attempted along the northern property border at the location shown by Figure 3. Sage encountered an object which prevented further boring at a depth of eight and one-half (8.5) feet BGS. No stained soils were encountered at this soil boring location. Since adequate depths were not attained at this location the boring was abandoned and no samples were collected.

Soil Boring #9 (SB#9) was established along the eastern property border at the location shown by Figure 3. This boring was established to a depth of approximately nine (9) feet BGS. Stained soil and petroleum odors were encountered at this depth but additional depths were not attained due to the presence of an object which prevented further boring. Since adequate depths were not attained at this location the boring was abandoned and no samples were collected.

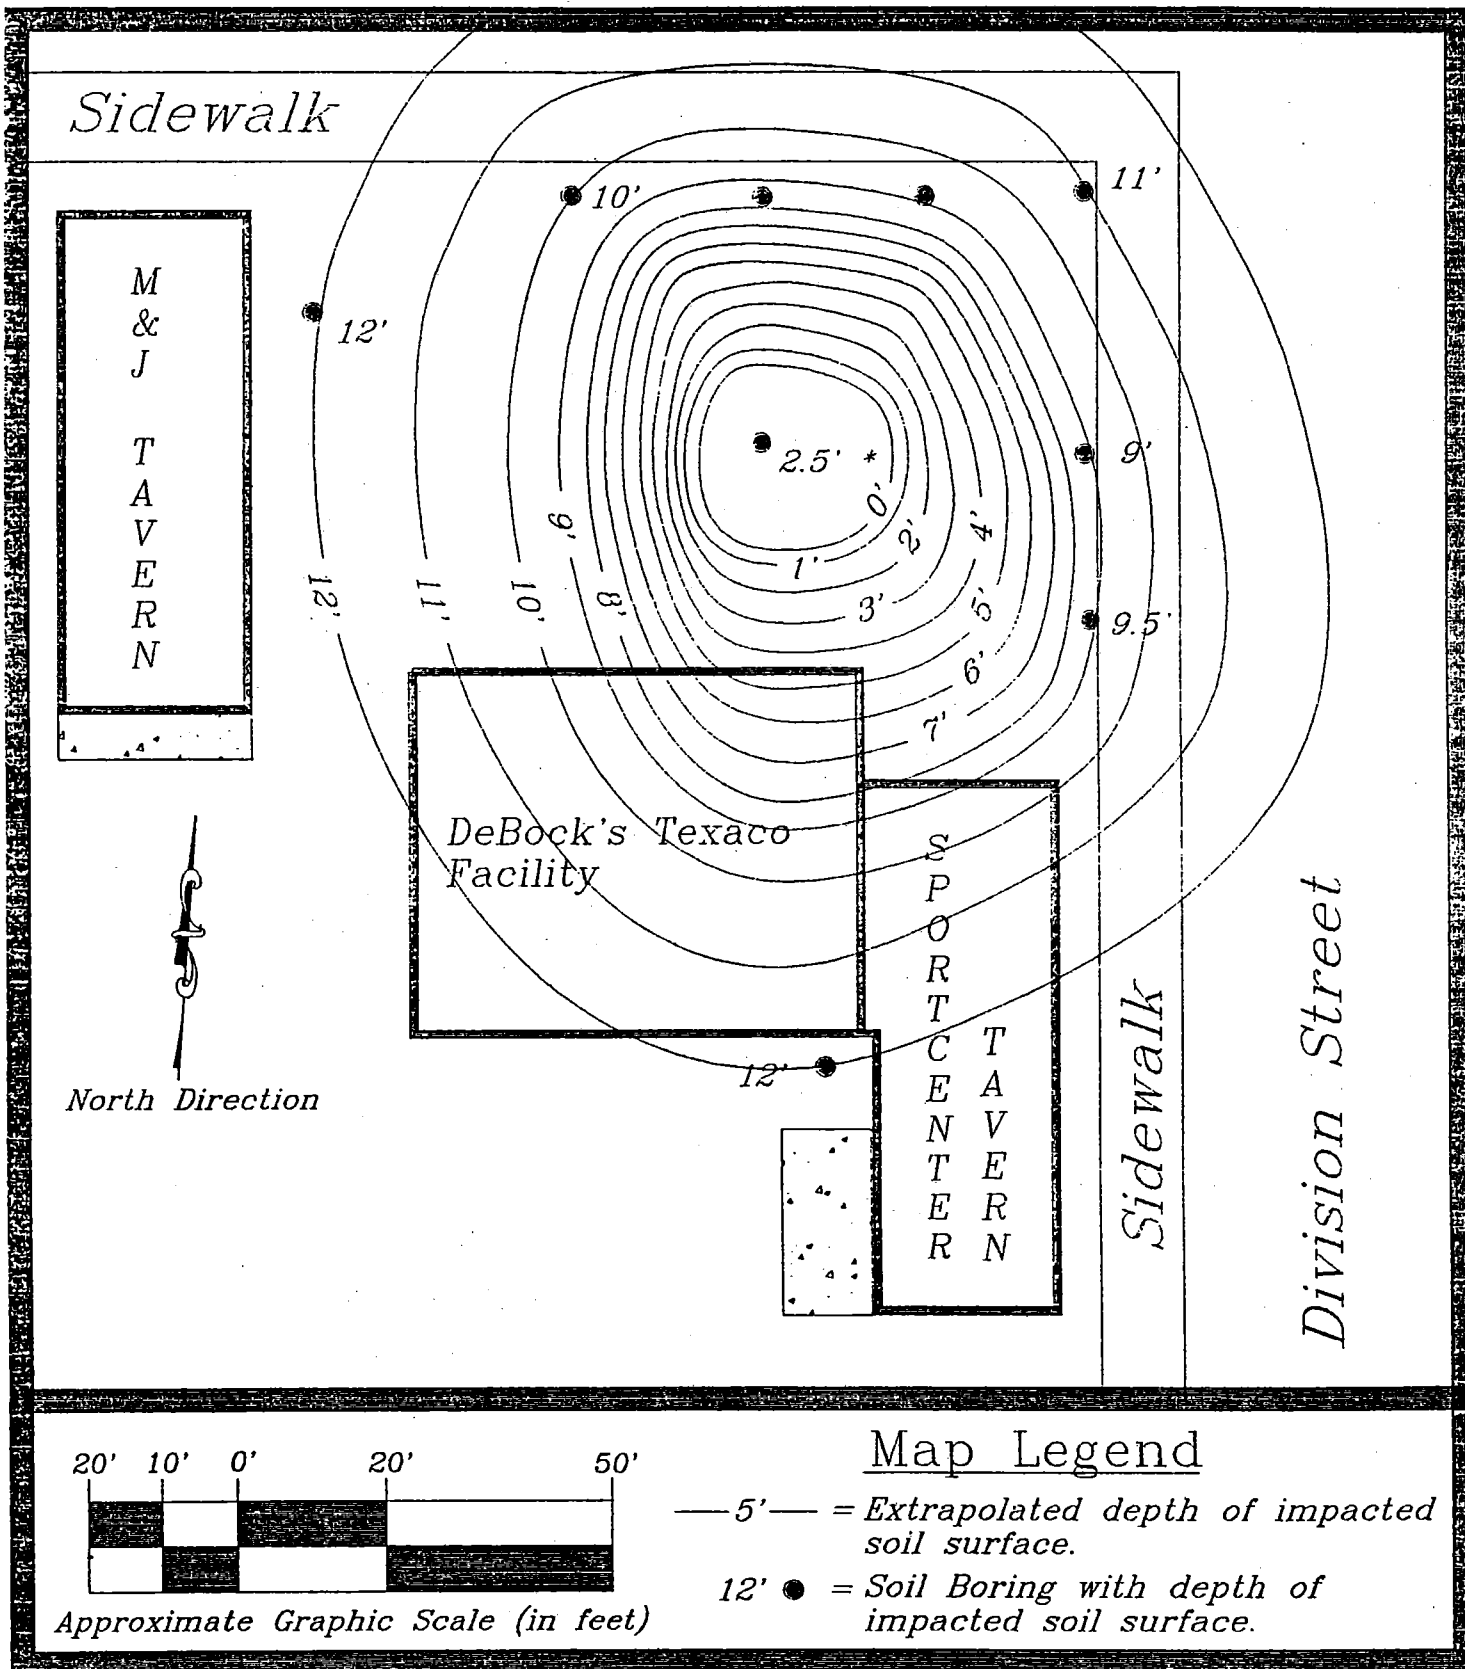
Figure 4. Extrapolated Depth of Impacted Soil Surface

Using data obtained from on-site soil borings, Sage constructed a map showing the extrapolated depth of the impacted soil surface. This map is shown by Figure 4. Depths to the top of the impacted soil plume were not extrapolated for depths beyond twelve (12) feet BGS. Additional soil borings must be established if this information is desired. The data indicates that petroleum impacted soil underlies the majority of the service station building and the northern portion of the Sport Center tavern.

Excavation and treatment of accessible petroleum impacted soil is likely to be the most effective method to reduce hydrocarbon concentrations in site soils. Based on the extrapolated data, it appears that soils readily accessible for excavation is limited to the northern portion of the subject property. Removal of this soil will require removal of the existing service station canopy. Sage recommends transport of the impacted soil to a permitted facility or to a site approved by the local Health District. The soil could then be treated using landfarming and/or bioremediation techniques. The lowermost portion of the remedial excavation should be backfilled with permeable material such as gravel. This will facilitate extraction of petroleum impacted groundwater, via an extraction well(s), for treatment and subsequent permitted discharge.
