Department of Ecology

Injection Pilot Test Results and Effects

June 2, 2021

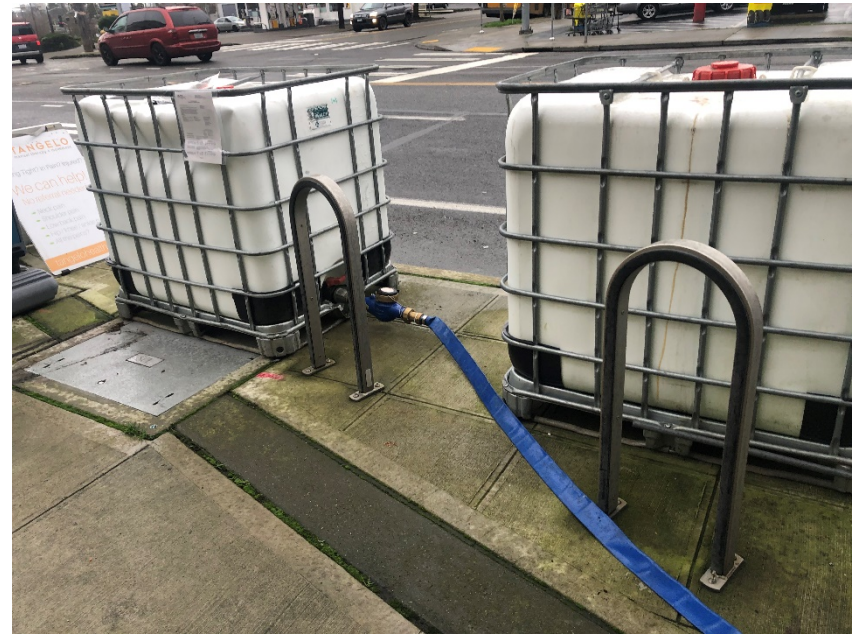
- Tracer dye from RW05 detected in the sump approx. 48 hours after completing the injection
- Tracer dye from RW05 still present in the sump 28 days after completing the injection

Conclusion: Short circuiting pathway exists between the well network and the Whittaker storm drainage system, which could introduce oxidant to the stormwater system during an ISCO injection program.

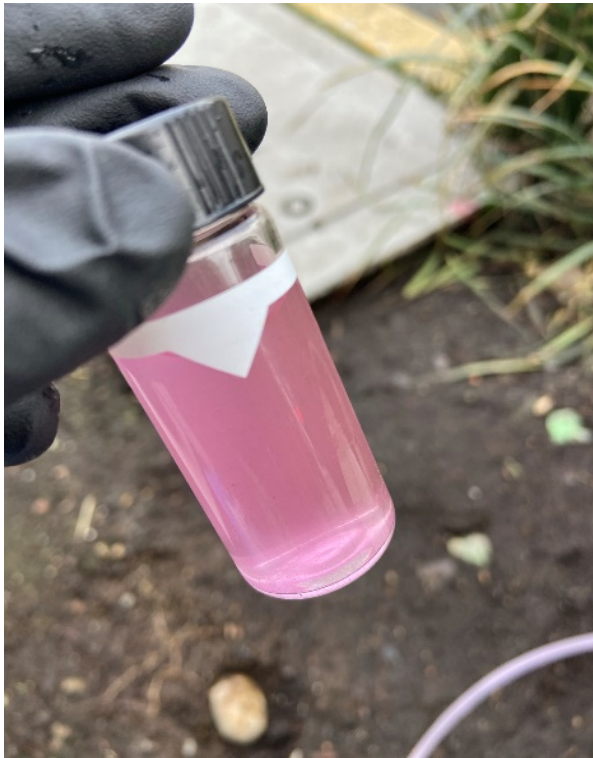
RW03

Tracer Dye in Wells After ~2 months of equilibrium
(January 12, 2021 to March 8, 2021)

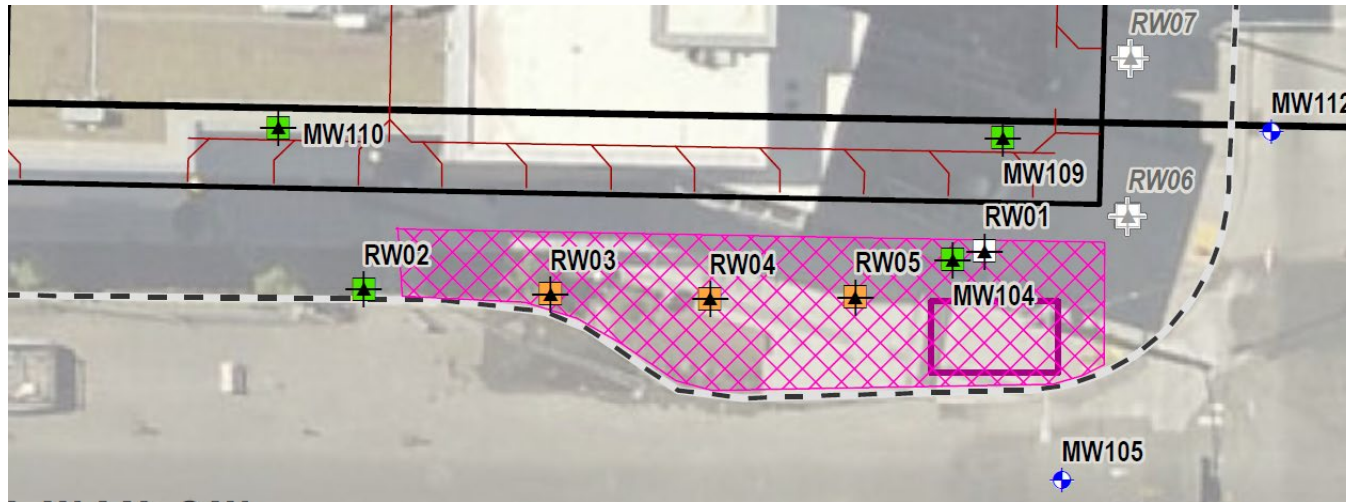
- Abnormally high detections diesel-range hydrocarbons detected in RW wells; some concentrations are higher than ever detected before remediation – WHY? Was it the Pilot Test?
 - The laboratory reports that the TPH did not match the diesel standard, that there is significant interference, and silica gel indicates polar compounds (or not representative of a hydrocarbon which is non-polar).
 - The abnormal result is NOT the dye. A tracer-dye-only standard did not produce a similar chromatographic pattern.
 - Field equipment, injected water, dye, and water storage tanks were proven NOT to be sources of contamination.

- Highest concentration was detected in RW05, which has never exceeded MTCA Method A CULs during compliance gw monitoring - and nearby well MW104 (9 feet from RW05), contained expected concentration of diesel-range TPH.
