Lower Duwamish Waterway South Park Marina

Summary of Existing Information and Identification of Data Gaps

June 2007

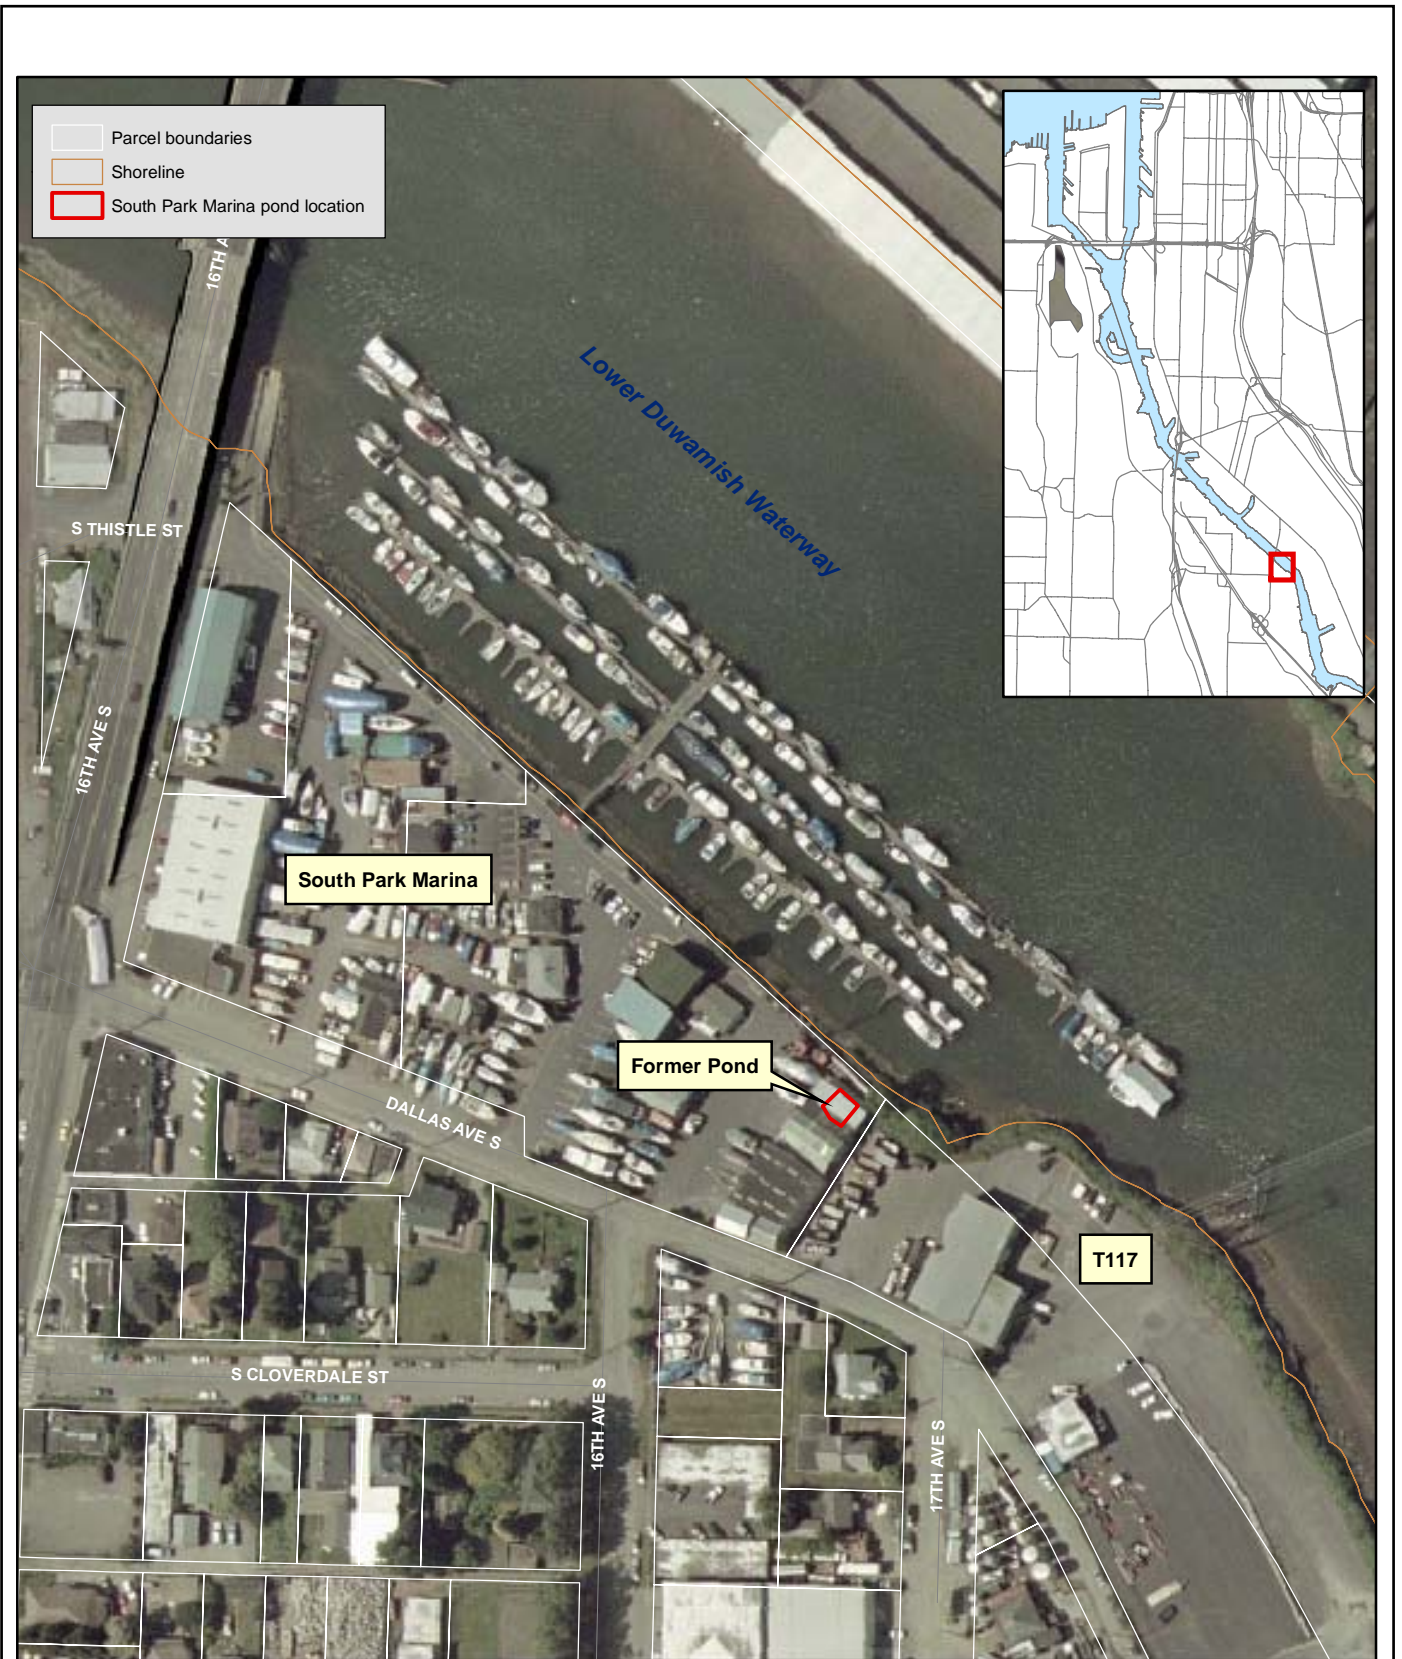
Figure 3. Current Site Photo Showing Location of Former Pond

An analysis of the waste in the pond indicated a concentration of 940 ppm sodium hydroxide (WSPCC 1955). Aerial photographs of the site in the 1950s show the location of the company building and pond near the southern property boundary. The location of the pond has been geo-referenced and superimposed on a current aerial photograph (Figures 3 and 6).

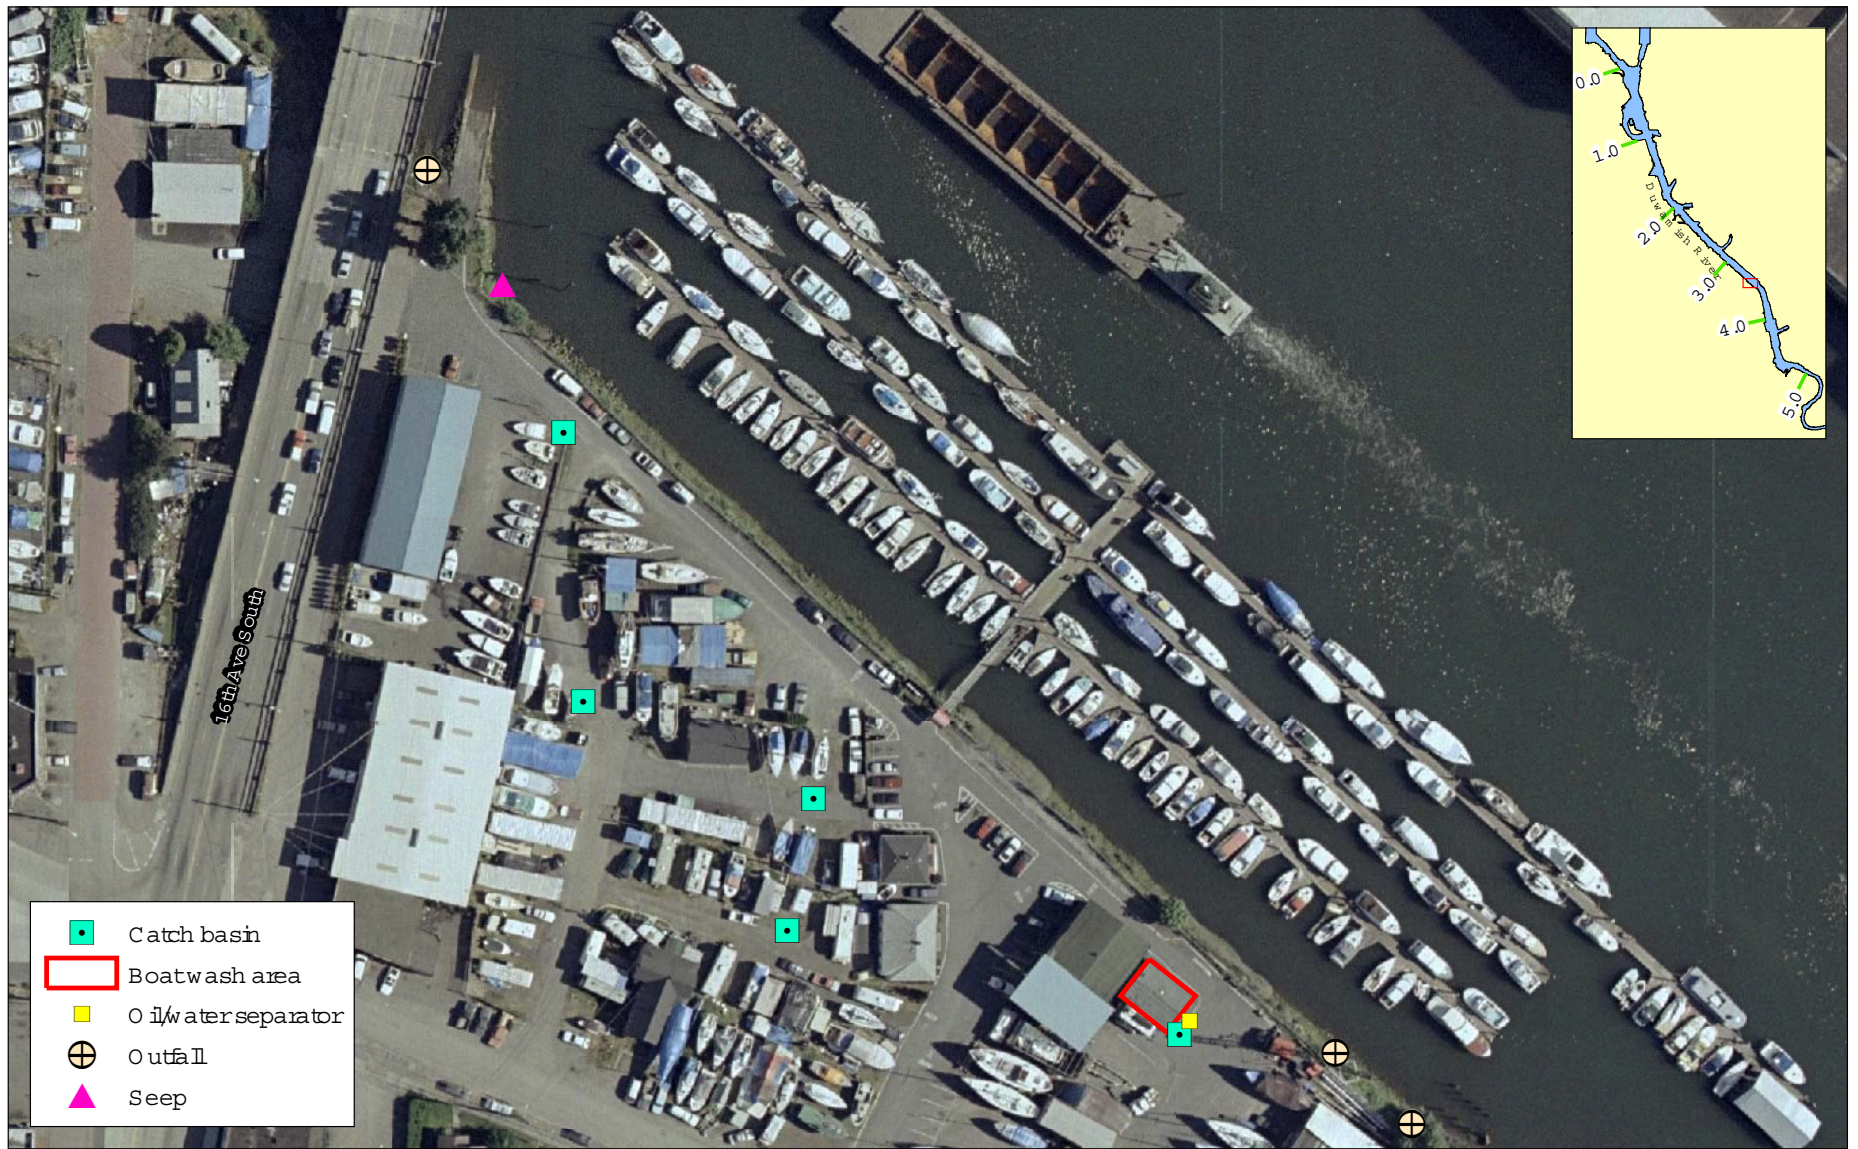
Figure 4. South Park Marina Catch Basins and Outfalls
Source: Windward 2003

The wash system is located in the vicinity of a catch basin that flows to a 3,000-gallon oil/water separator (Figure 4). The catch basin is covered with a metal plate when boat washing is conducted. Stormwater is collected in two catch basins, passed through the oil/water separator, then is discharged to the Lower Duwamish Waterway through an outfall near the boat haul-out crane. The marina is required to and has been sampling and analyzing the discharge for oil & grease, total recoverable copper, and TSS as required under its NPDES permit.

A catch basin and oil/water separator are located near the boat wash area (Figure 4); these drain to an outfall near the southeastern portion of the property which discharges to the LDW. Four additional catch basins are located on the site; it is not known where these ultimately discharge to.
