**PHASE I ENVIRONMENTAL SITE ASSESSMENT
HARDEL MUTUAL PLYWOOD WATERFRONT PROPERTY
1210 N.W. WEST BAY DRIVE
OLYMPIA, WASHINGTON**

Gibbs and Olson, Inc.
2604 12th Court, Suite A
Olympia, WA 98502

July 1999

Tetra Tech EM Inc.
600 University Street, Suite 800
Seattle, WA 98101

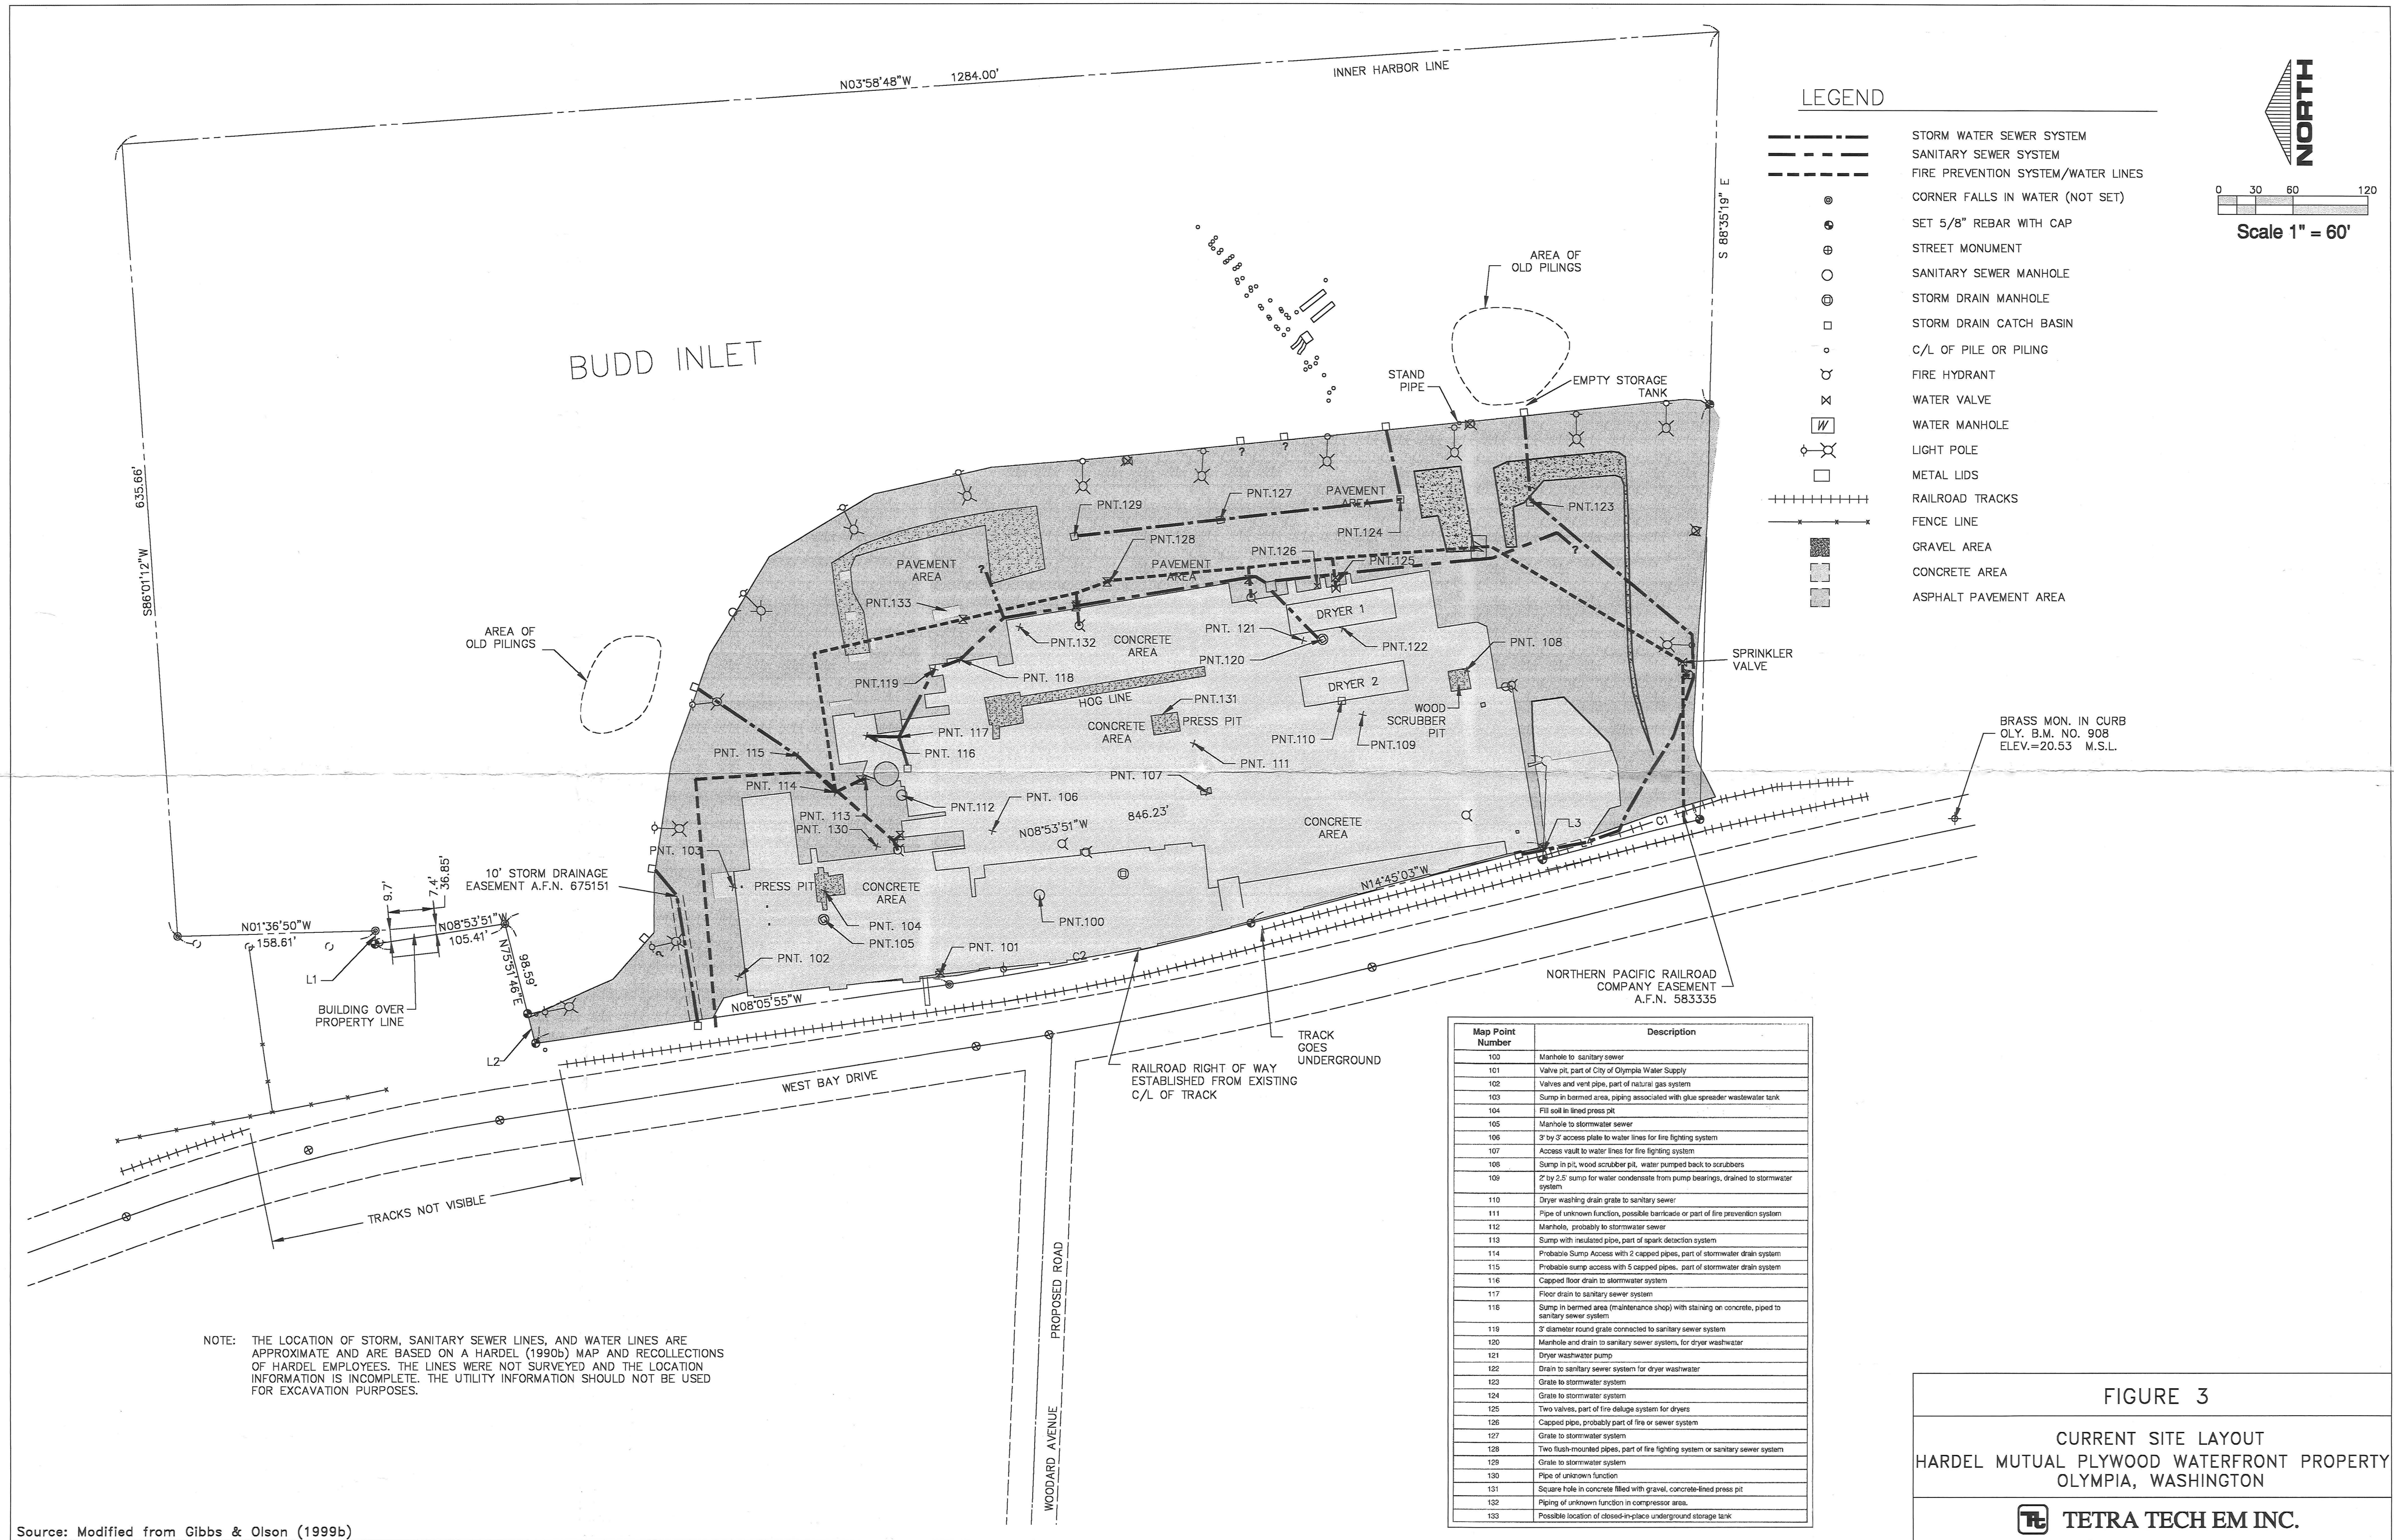
FIGURE 3
CURRENT SITE LAYOUT
HARDEL MUTUAL PLYWOOD WATERFRONT PROPERTY
OLYMPIA, WASHINGTON
TETRA TECH EM INC.

The land portion of the subject property currently consists primarily of a series of concrete building foundations and adjoining asphalt areas (Figure 3). About two-thirds of the 17.8 acre subject property consists of intertidal and subtidal areas east of the former plywood facility. An old abandoned pier and pilings is located in Budd Inlet in the eastern part of the site.

The site presently consists of concrete building foundations and adjoining asphalt parking and veneer storage areas. The field team noted the presence of several pipes, drains, and structures of unknown origin during the inspection. Most of these features were later identified through interviews with plant personnel and use of facility maps (refer to Figure 3). The field team was also able to walk the intertidal zone along the western side of the subject property as the May 1999 site inspection was conducted during a low-tide period.

- Limited soil and groundwater sampling is recommended to characterize the subsurface concentrations of petroleum and other substances used routinely in plant operations. Areas of potential concern include: the maintenance and welding shop drains, the petroleum products and used oil storage area, the glue and caustic storage area, the hog line and press pits, the glue wash water tank north of the main plant, and the suspected location of the gasoline UST east of the former welding shop. This work should be performed before starting excavation and construction projects related to site redevelopment or selling the property.

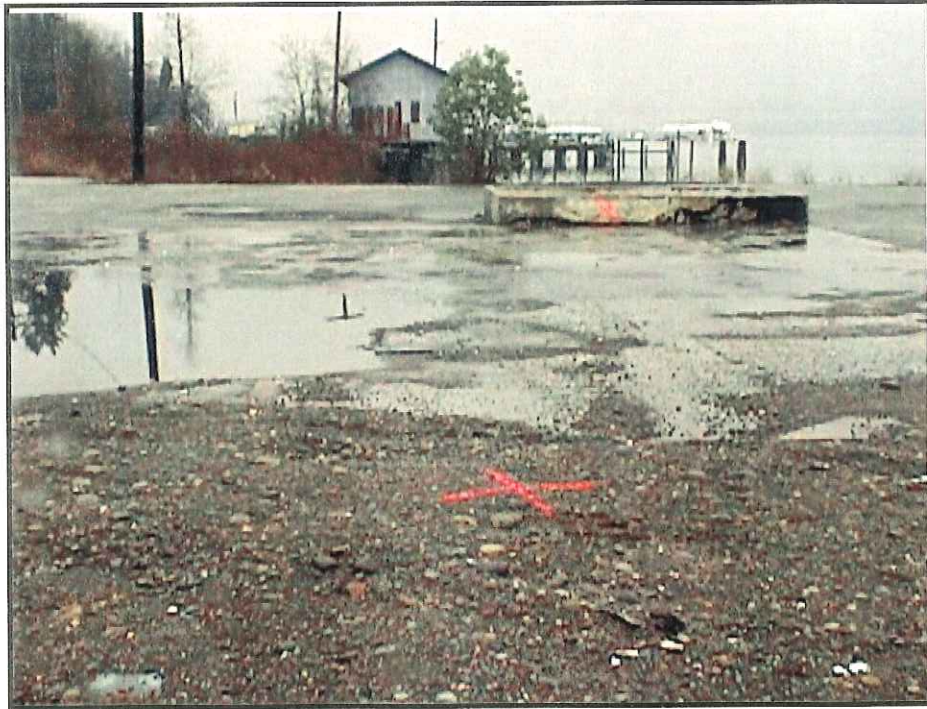
- The storage shed that lies across the northern property boundary may contain lead-based paint or asbestos-containing materials. Tetra Tech did not assess the storage shed because Tetra Tech believed that the shed was not on the subject property at the time of the inspection. Also, the pilings beneath the shack have been eroded, posing a potential safety hazard. The amount of lead-based paint or asbestos-containing materials in the shed, if present, is probably small based on the size of the shed.

Glue speaker wastewater tank foundation and storage shed lying across northern property boundary..

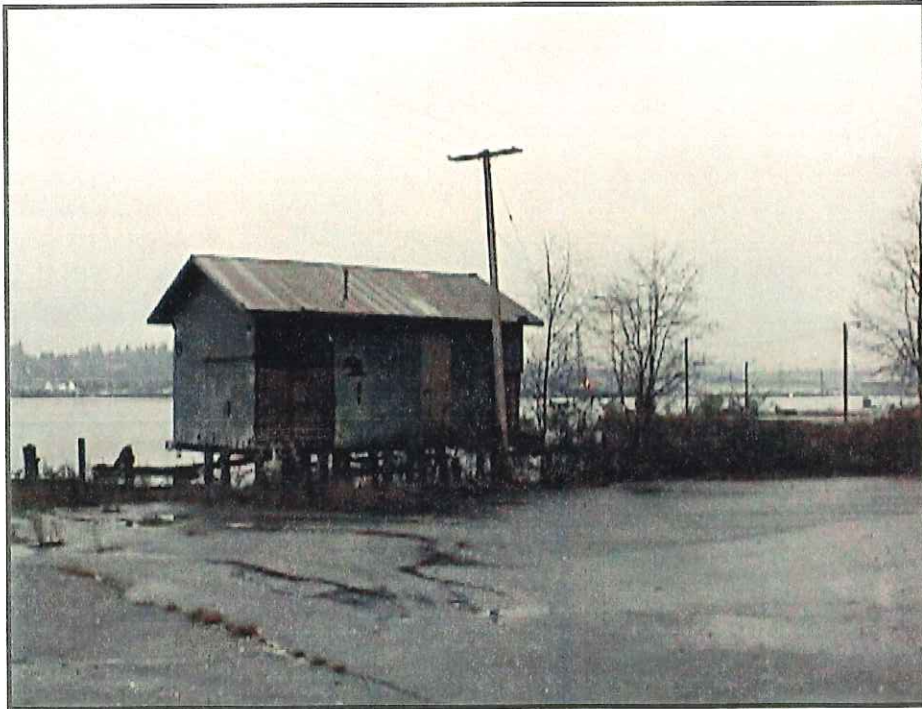
View of storage shed straddling northwestern property boundary, facing southeast.

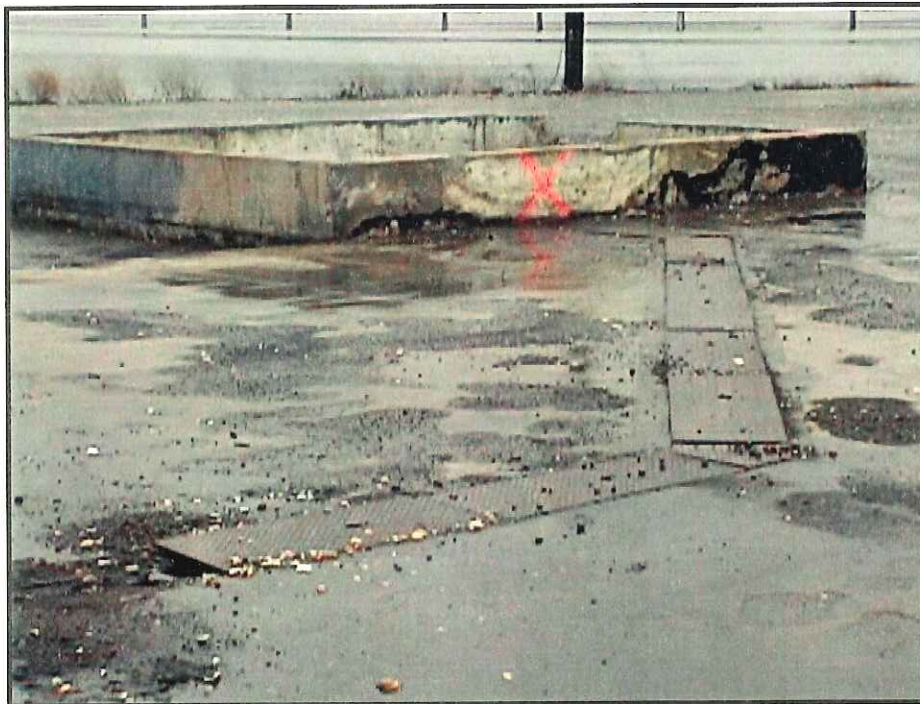
Glue spreader wastewater tank foundation (point 103).

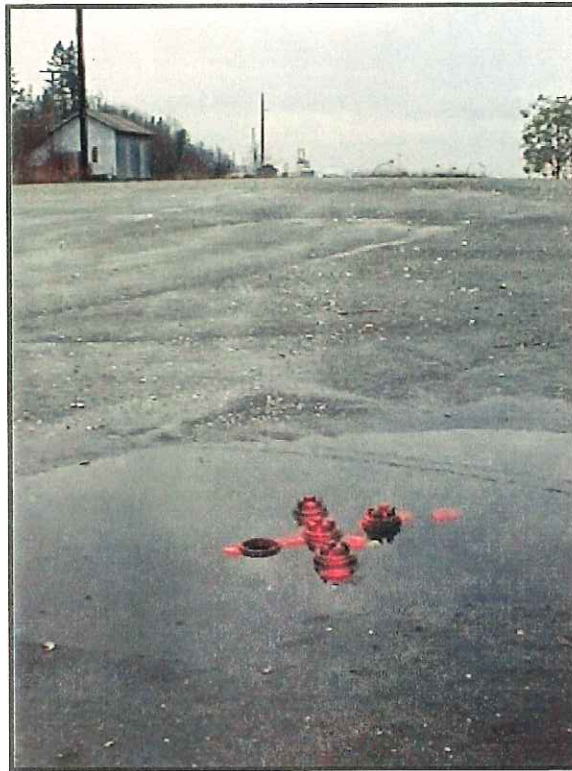
View of five capped pipes (pt 115), probable part of stormwater drain system.

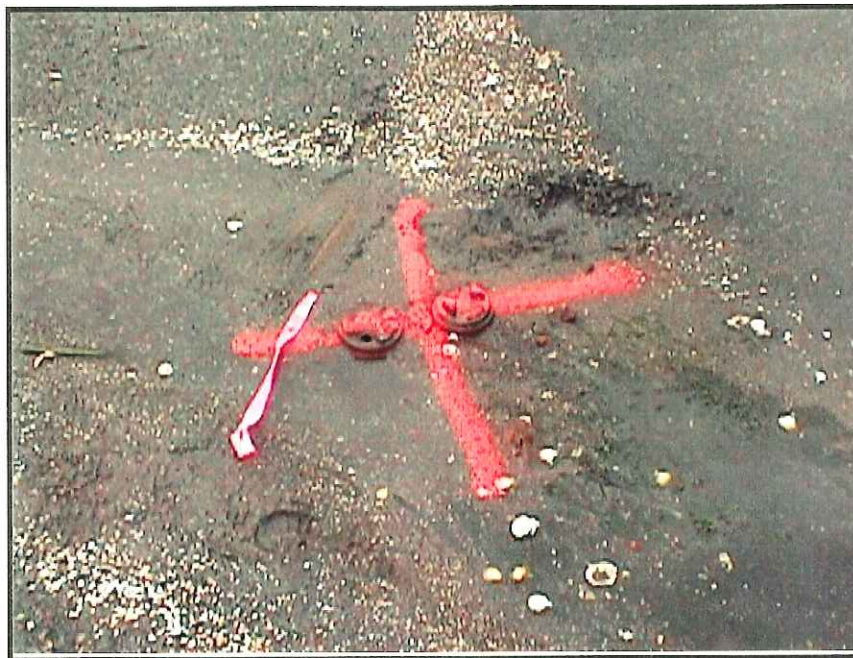
Close-up of two capped pipes (pt 114), probable part of stormwater drainage system.

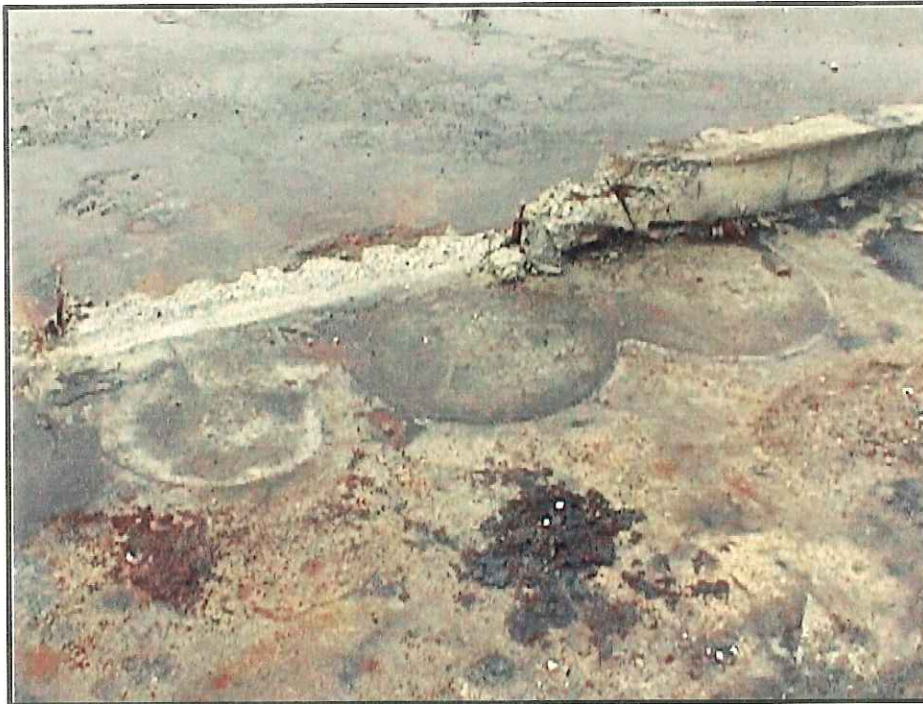
Close-up view of bermed area near resin
and caustic storage area.

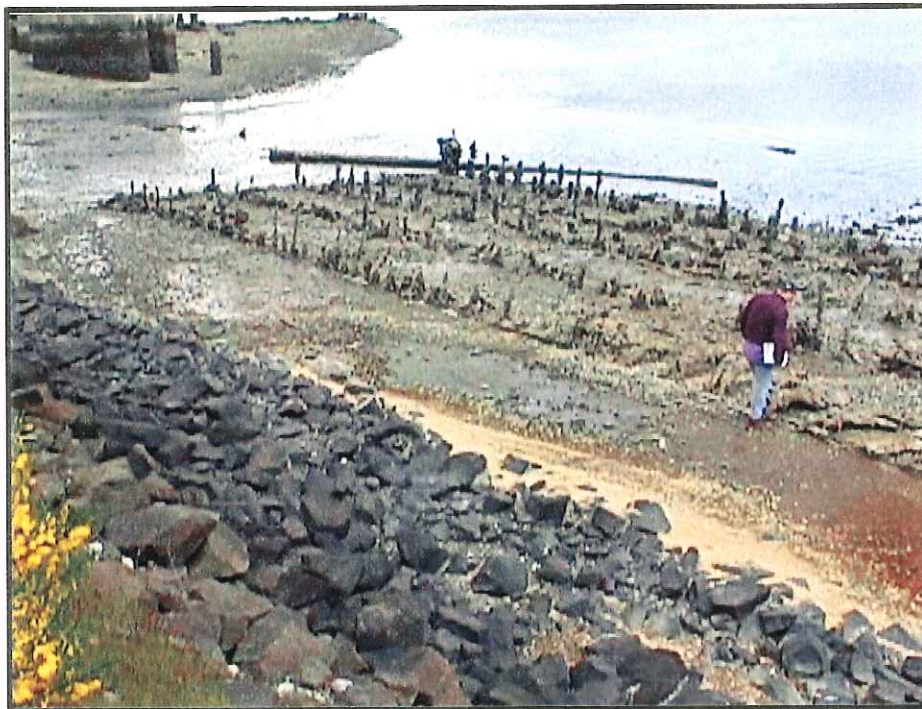
- Iron-stained sediments were noted in the intertidal zone at the southern end of the property (see photographic log). An empty 100 to 200 gallon tank was also found in the intertidal zone at this location. A sheen was noted on surface water draining from a seep in the iron-stained area. However, no petroleum odors were detected in the vicinity of the seep, and the sheen could be related to algae, bacteria, or other biogenic sources. The iron-stained sediments are located west of a former welding shop based on the 1946, 1947, and 1968 Sanborn fire insurance maps.

View of old pilings in southeast portion of property
and iron stained sediments..

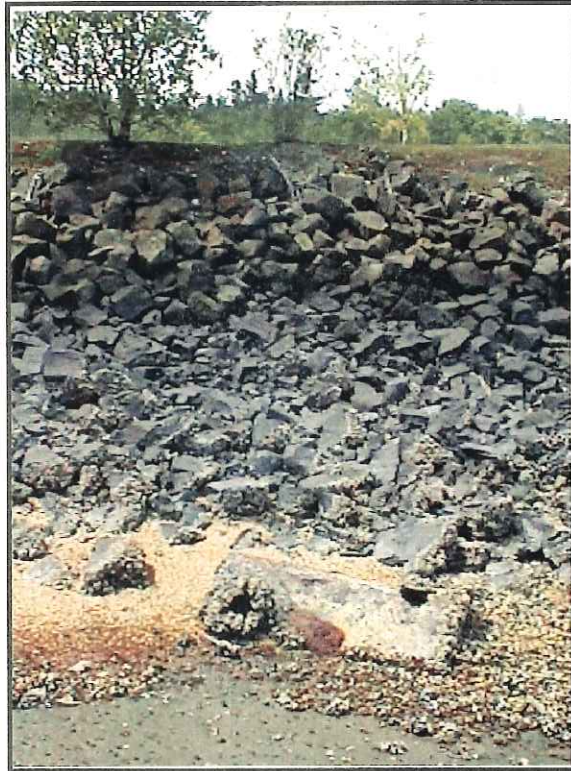
View of empty storage tank and iron stained sediments in intertidal zone.

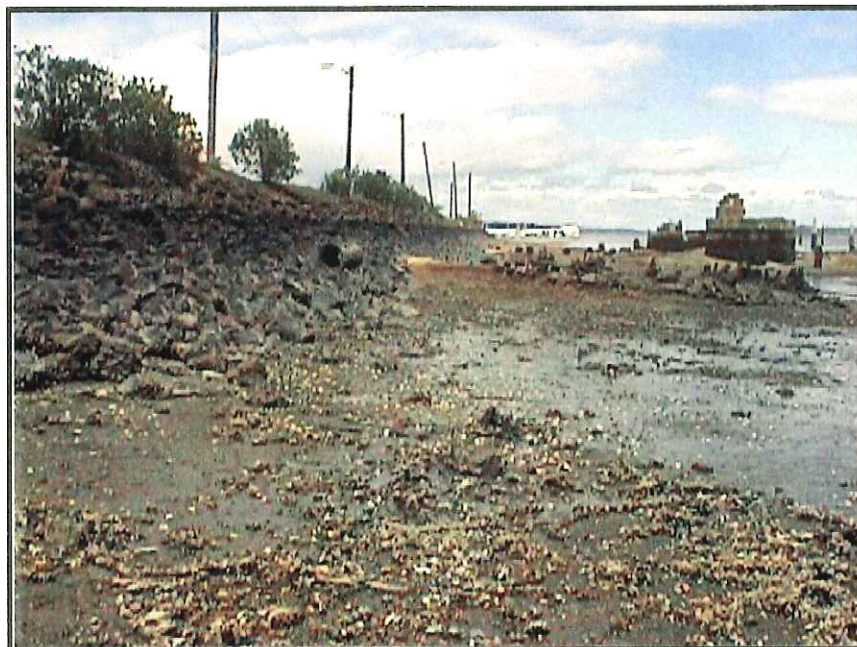
View of shoreline of subject property facing north from near the southern property boundary. An empty 55-gallon drum is visible on the rip-rap.

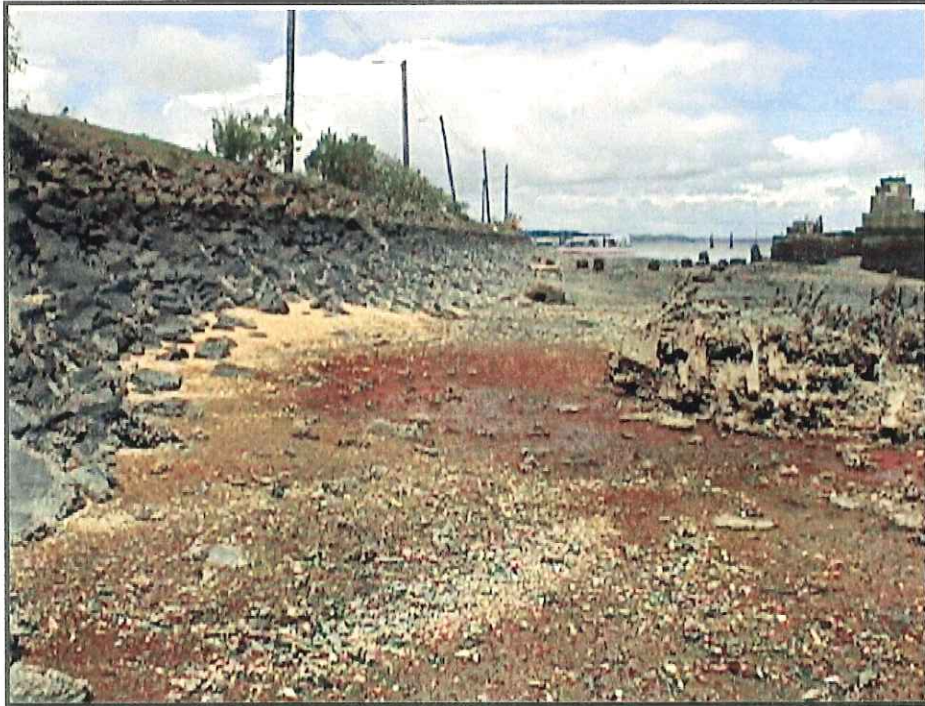
View of iron-stained sediments and former dock facing north from southern property boundary.

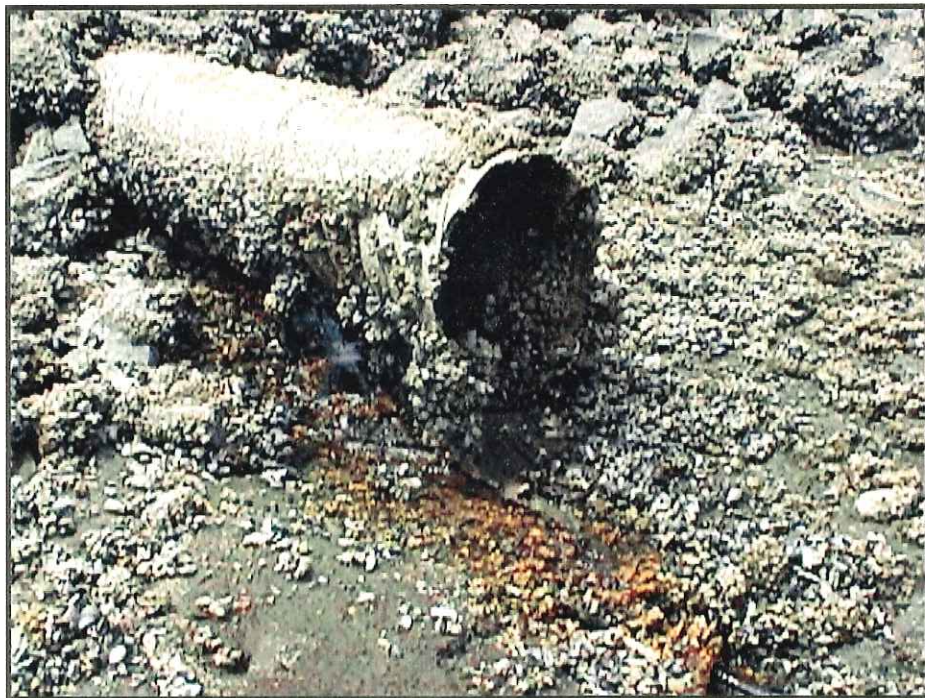
Close-up of southernmost storm sewer outfall.

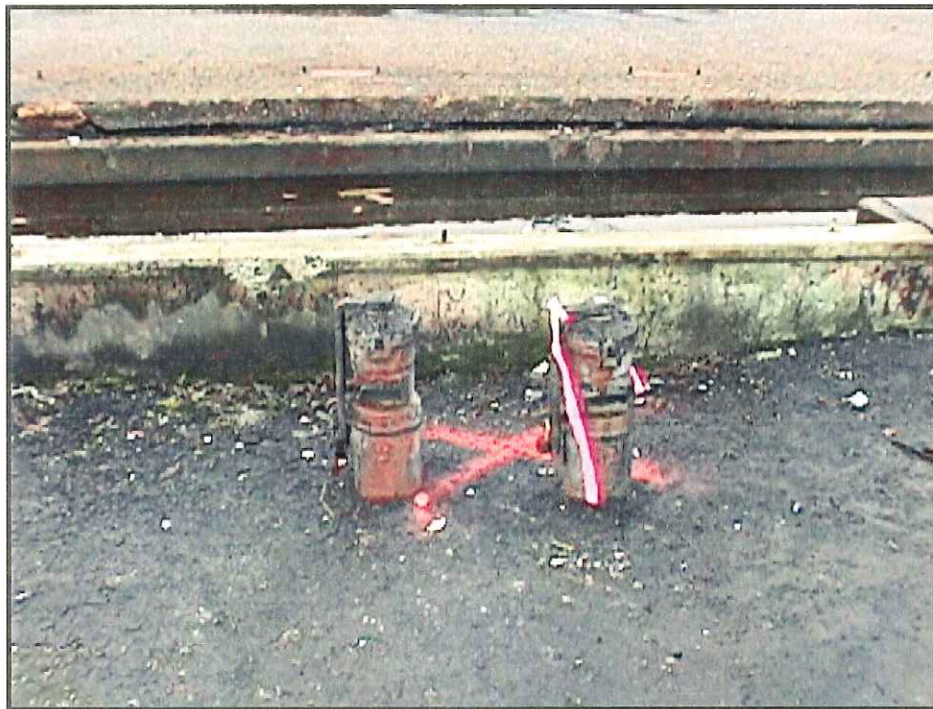
Close-up of 2 pipes, part of dryer fire deluge system (point 125) .

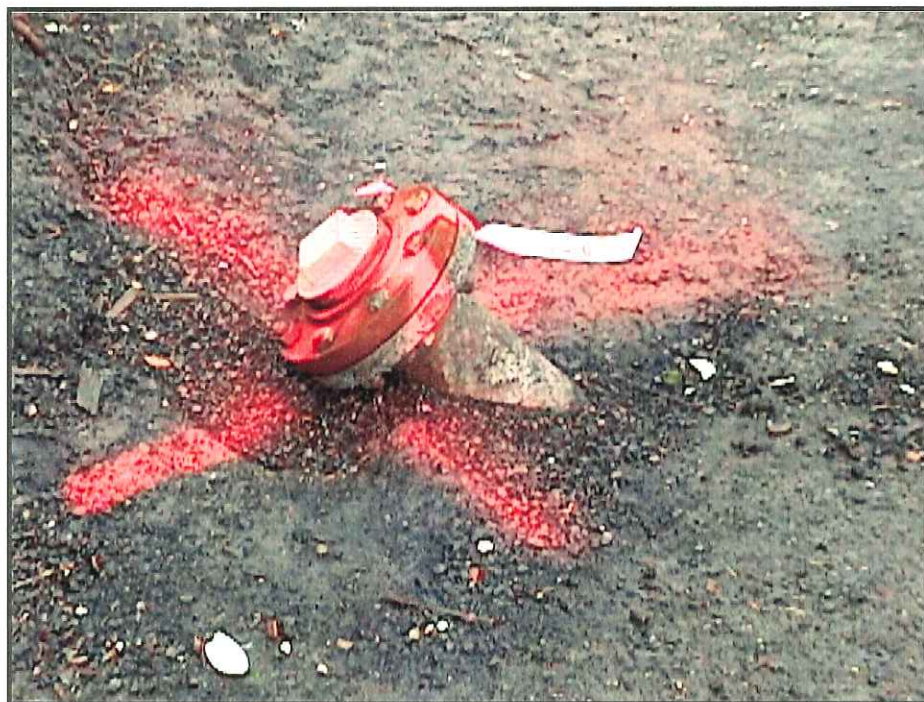
Close-up of pipe angled into ground,
probable part of sanitary sewer or
fire prevention system (point 126).

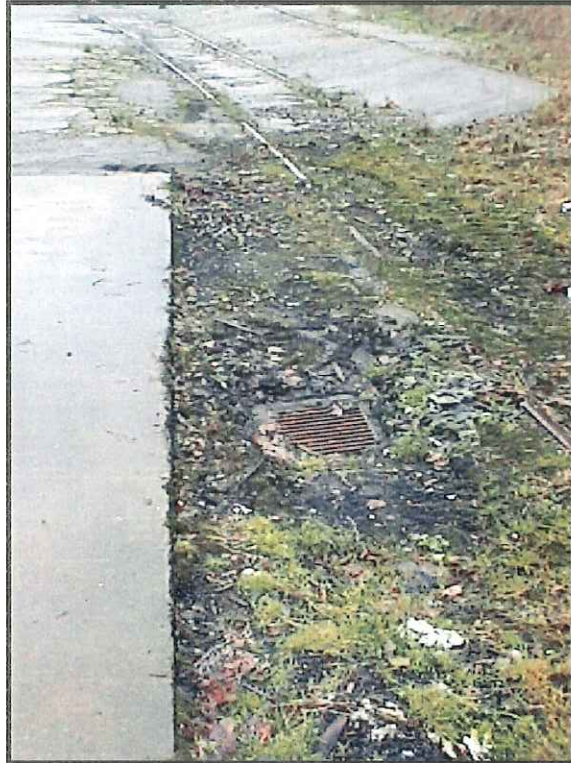
Close-up of storm sewer grate by railroad tracks, southwest corner of site.

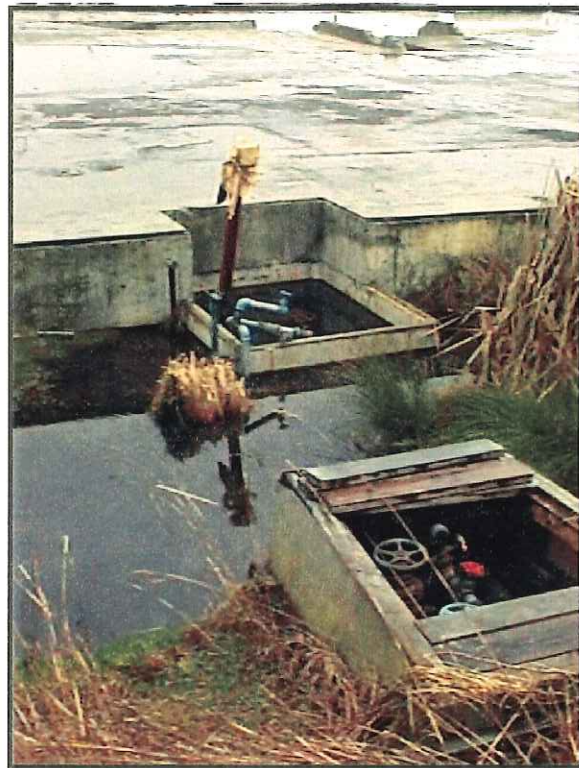
Close-up of valves set in recess in concrete with standing water, western site boundary.
