STATE OF WASHINGTON
DEPARTMENT OF ECOLOGY

Re: Opinion pursuant to WAC 173-340-515(5) on Remedial Action for a Property associated with a Site:

- **Property Address:** 23418 Pacific Highway South, Kent, Washington 98032
- **Site Name:** Southgate Oil – Muscatel Midway
- **Facility/Site No.:** 84946863
- **Cleanup Site ID:** 6762
- **VCP Project No.:** NW3309

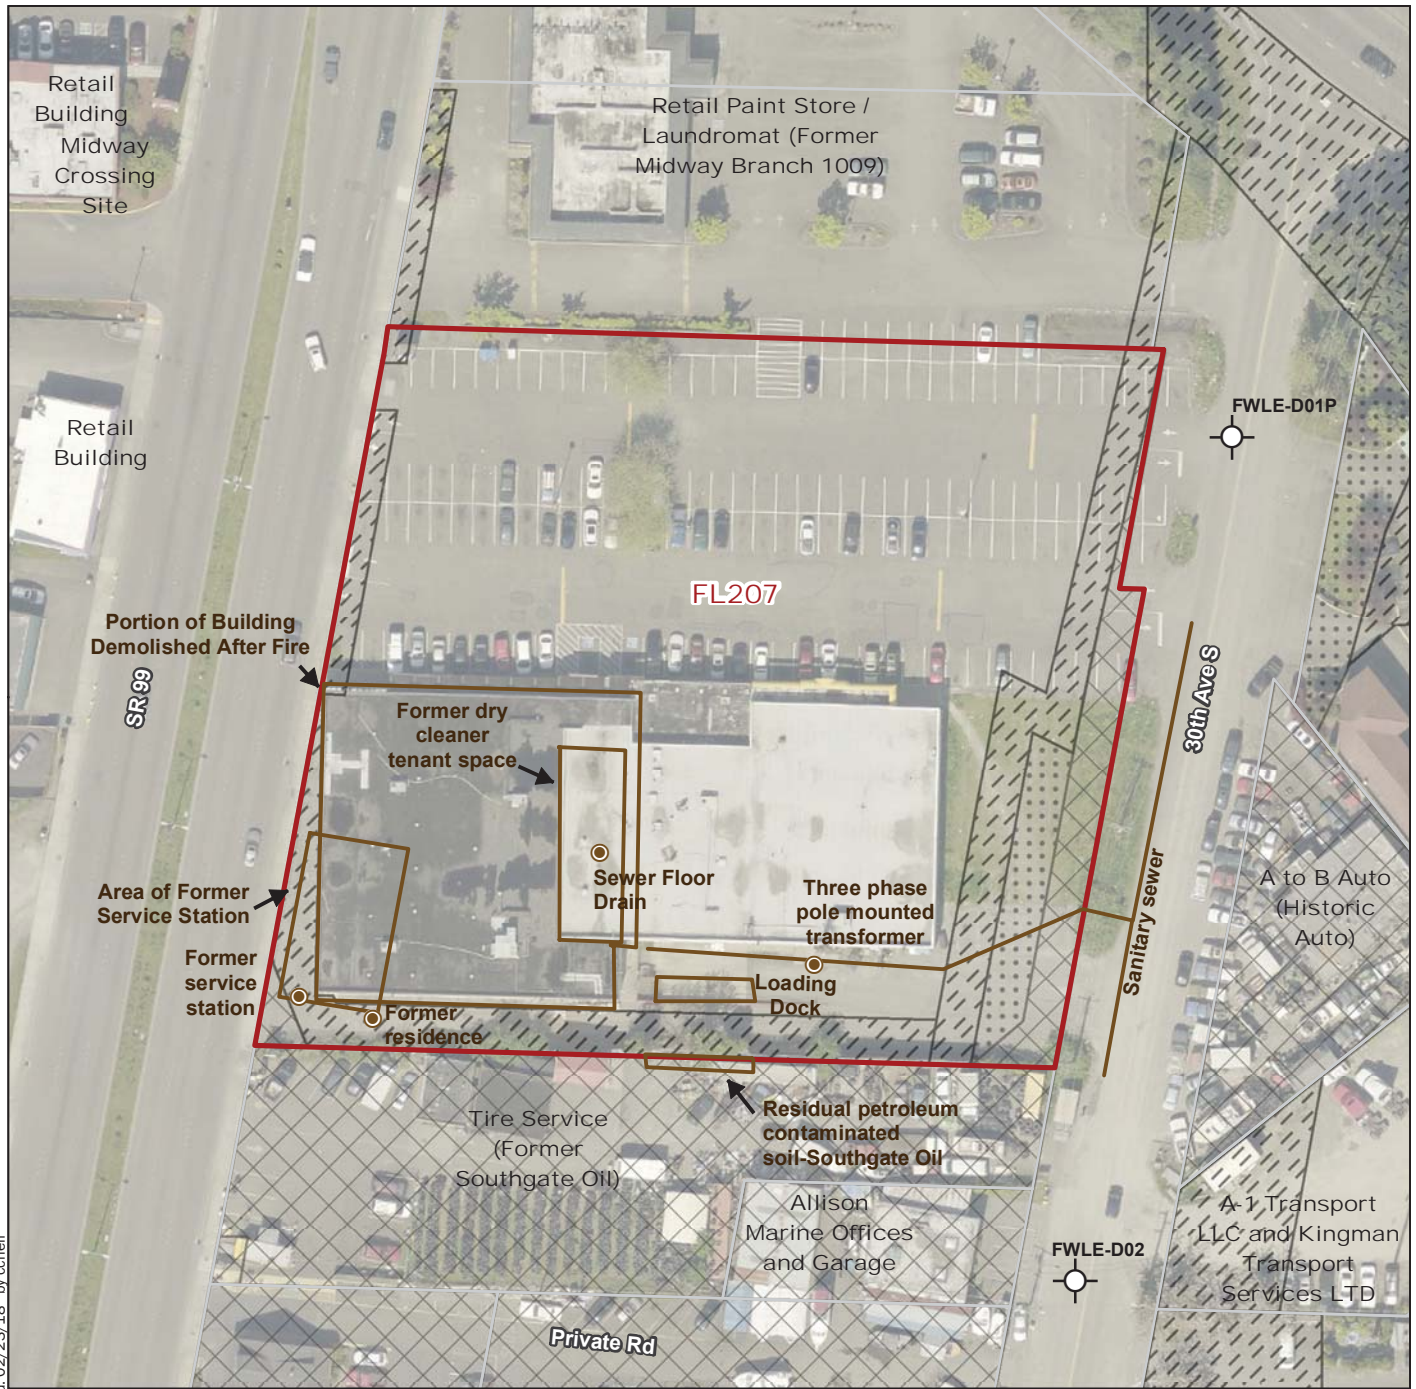
Enclosure B: Figure 2

The current layout of the Property, as well as the locations of the former service station and dry cleaner, are depicted on **Figure 2**.

Two geotechnical borings (FWLE-D01P and FWLE-D02) were advanced approximately 60 feet east and 100 feet south east of the Property (**Figure 2**). The depth to groundwater was approximately 58 feet bgs in March 2016 in a monitoring well installed in boring FWLE-D01P. Groundwater was observed at approximately 78 feet bgs in FWLE-D02 during drilling in December 2016¹. No groundwater sample was collected.

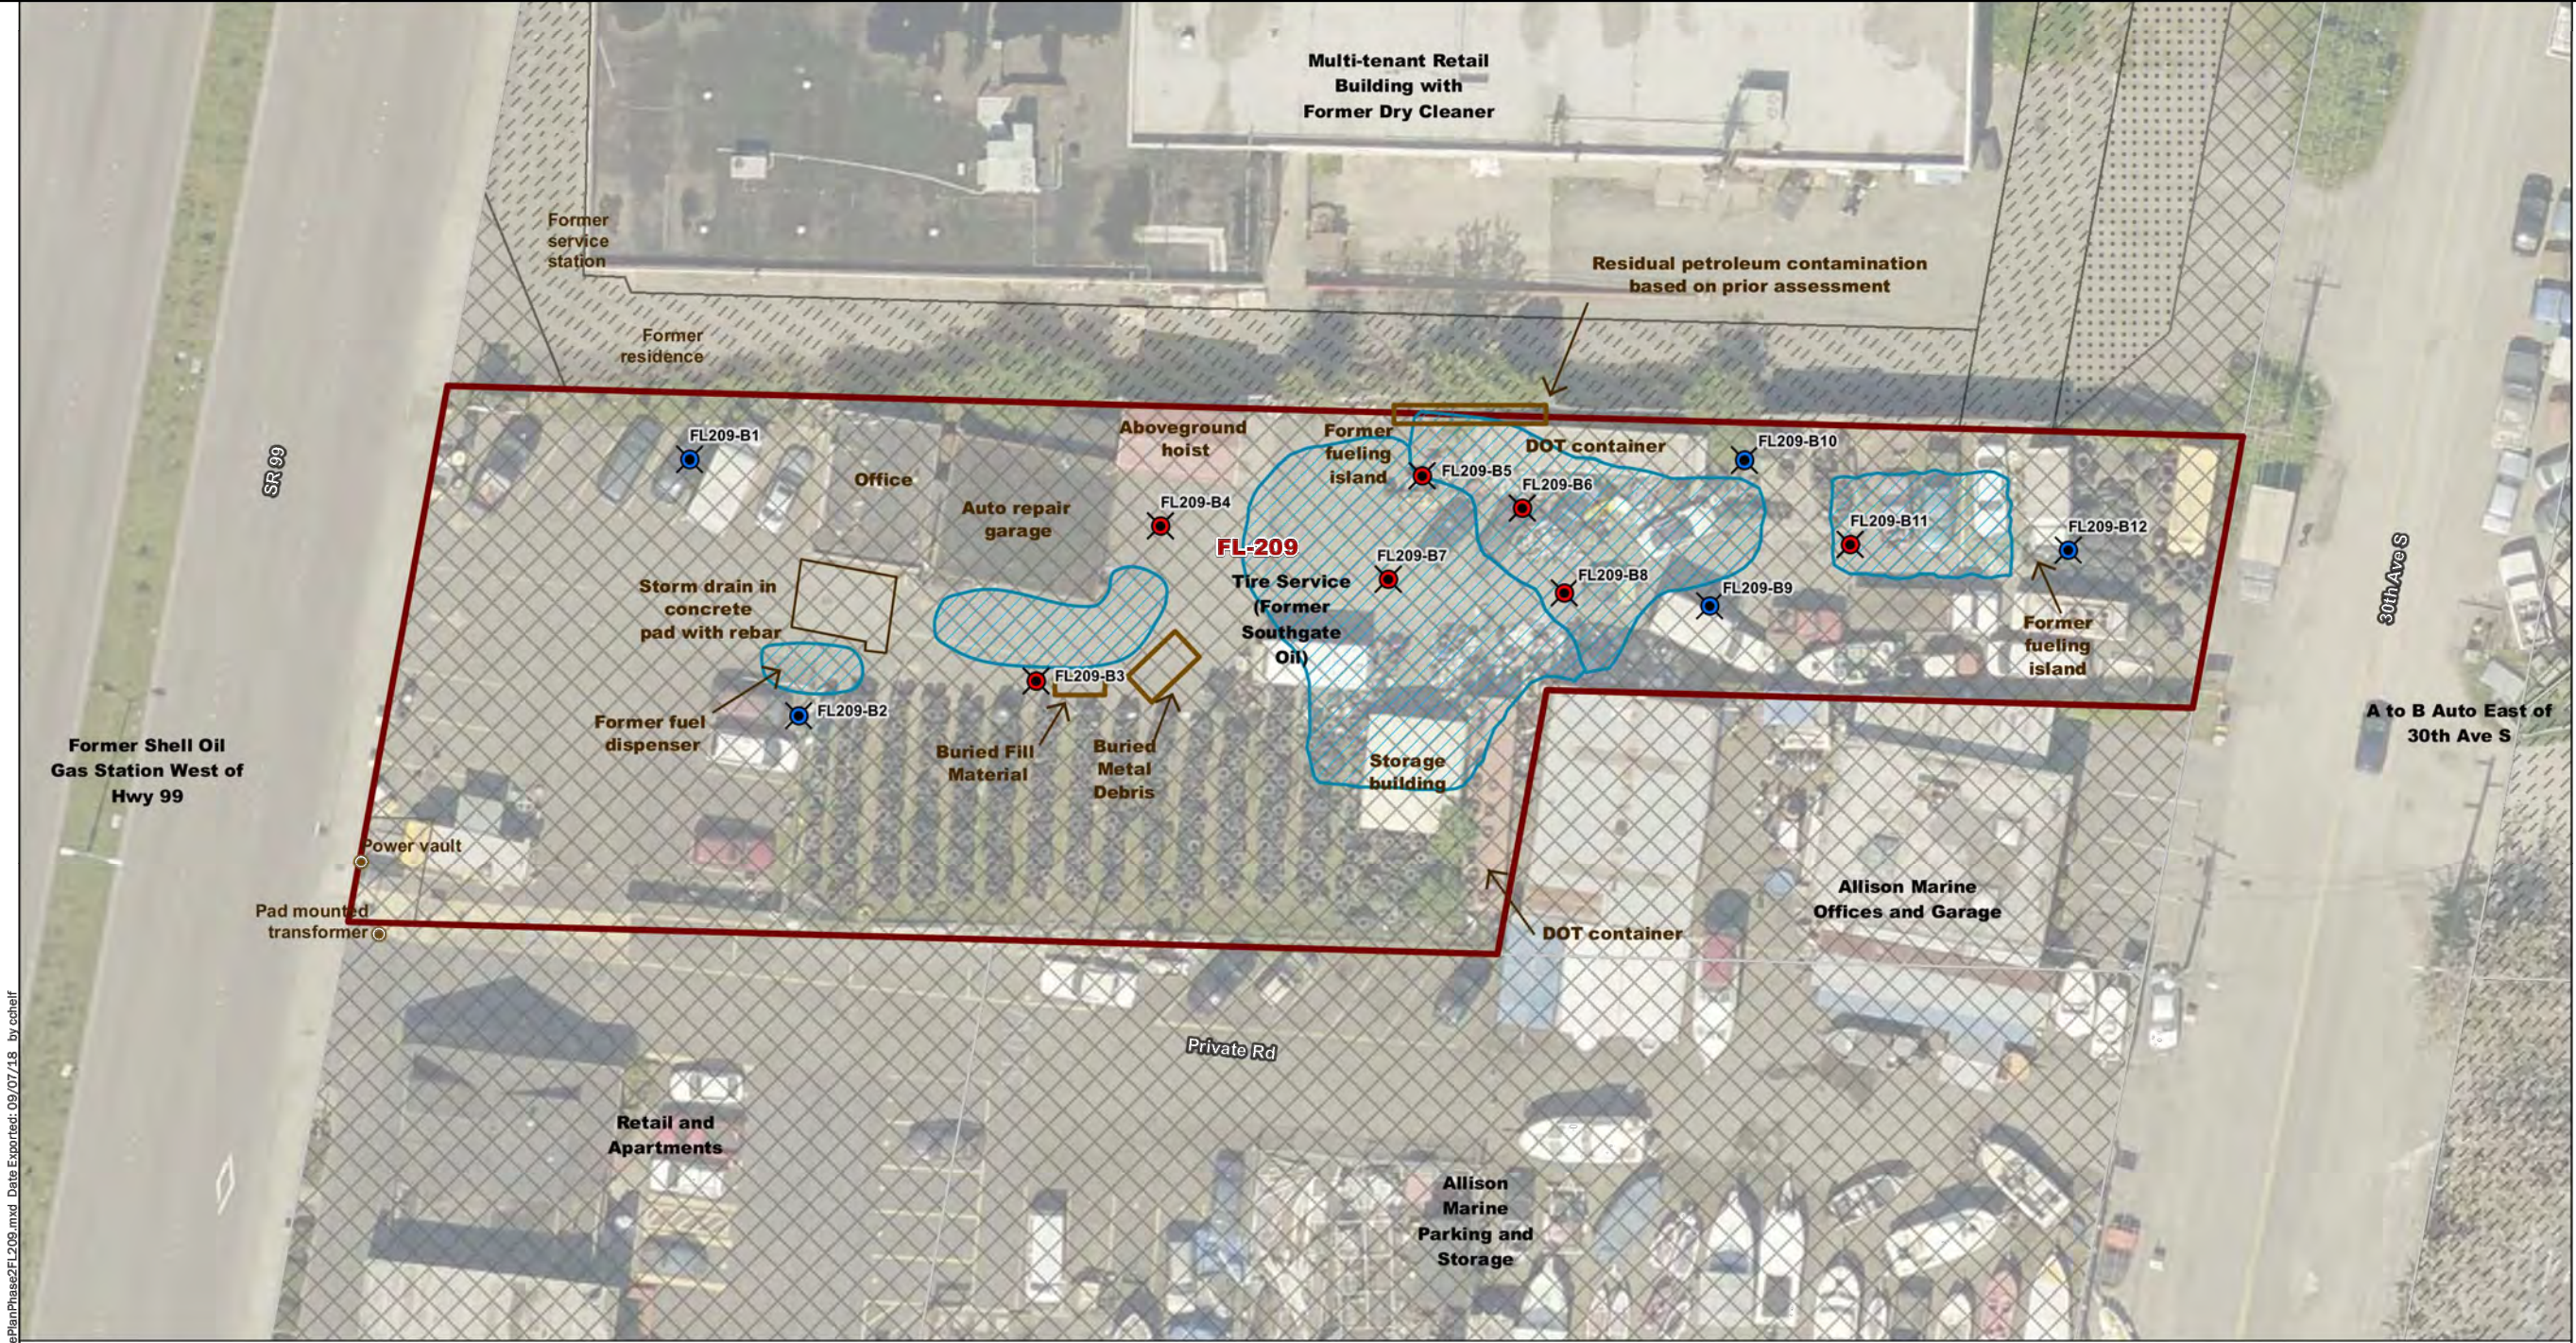
Enclosure B: Figure 3

The south property formerly operated as a bulk fuel distribution facility for approximately 75 years, most recently under the business name of Southgate Oil. The facility stopped distributing fuel in or around 1999. The facility included at least 11 USTs, multiple fuel dispensers, and an auto repair garage. These USTs were reportedly used to store gasoline, diesel, and heating oil, with storage capacities from 275 gallons to 25,000 gallons. The USTs were installed between the 1950s and 1990s. Nine USTs were removed in 2000; two USTs were removed in 2002. The historical facilities on the south property are depicted on **Figure 3**.

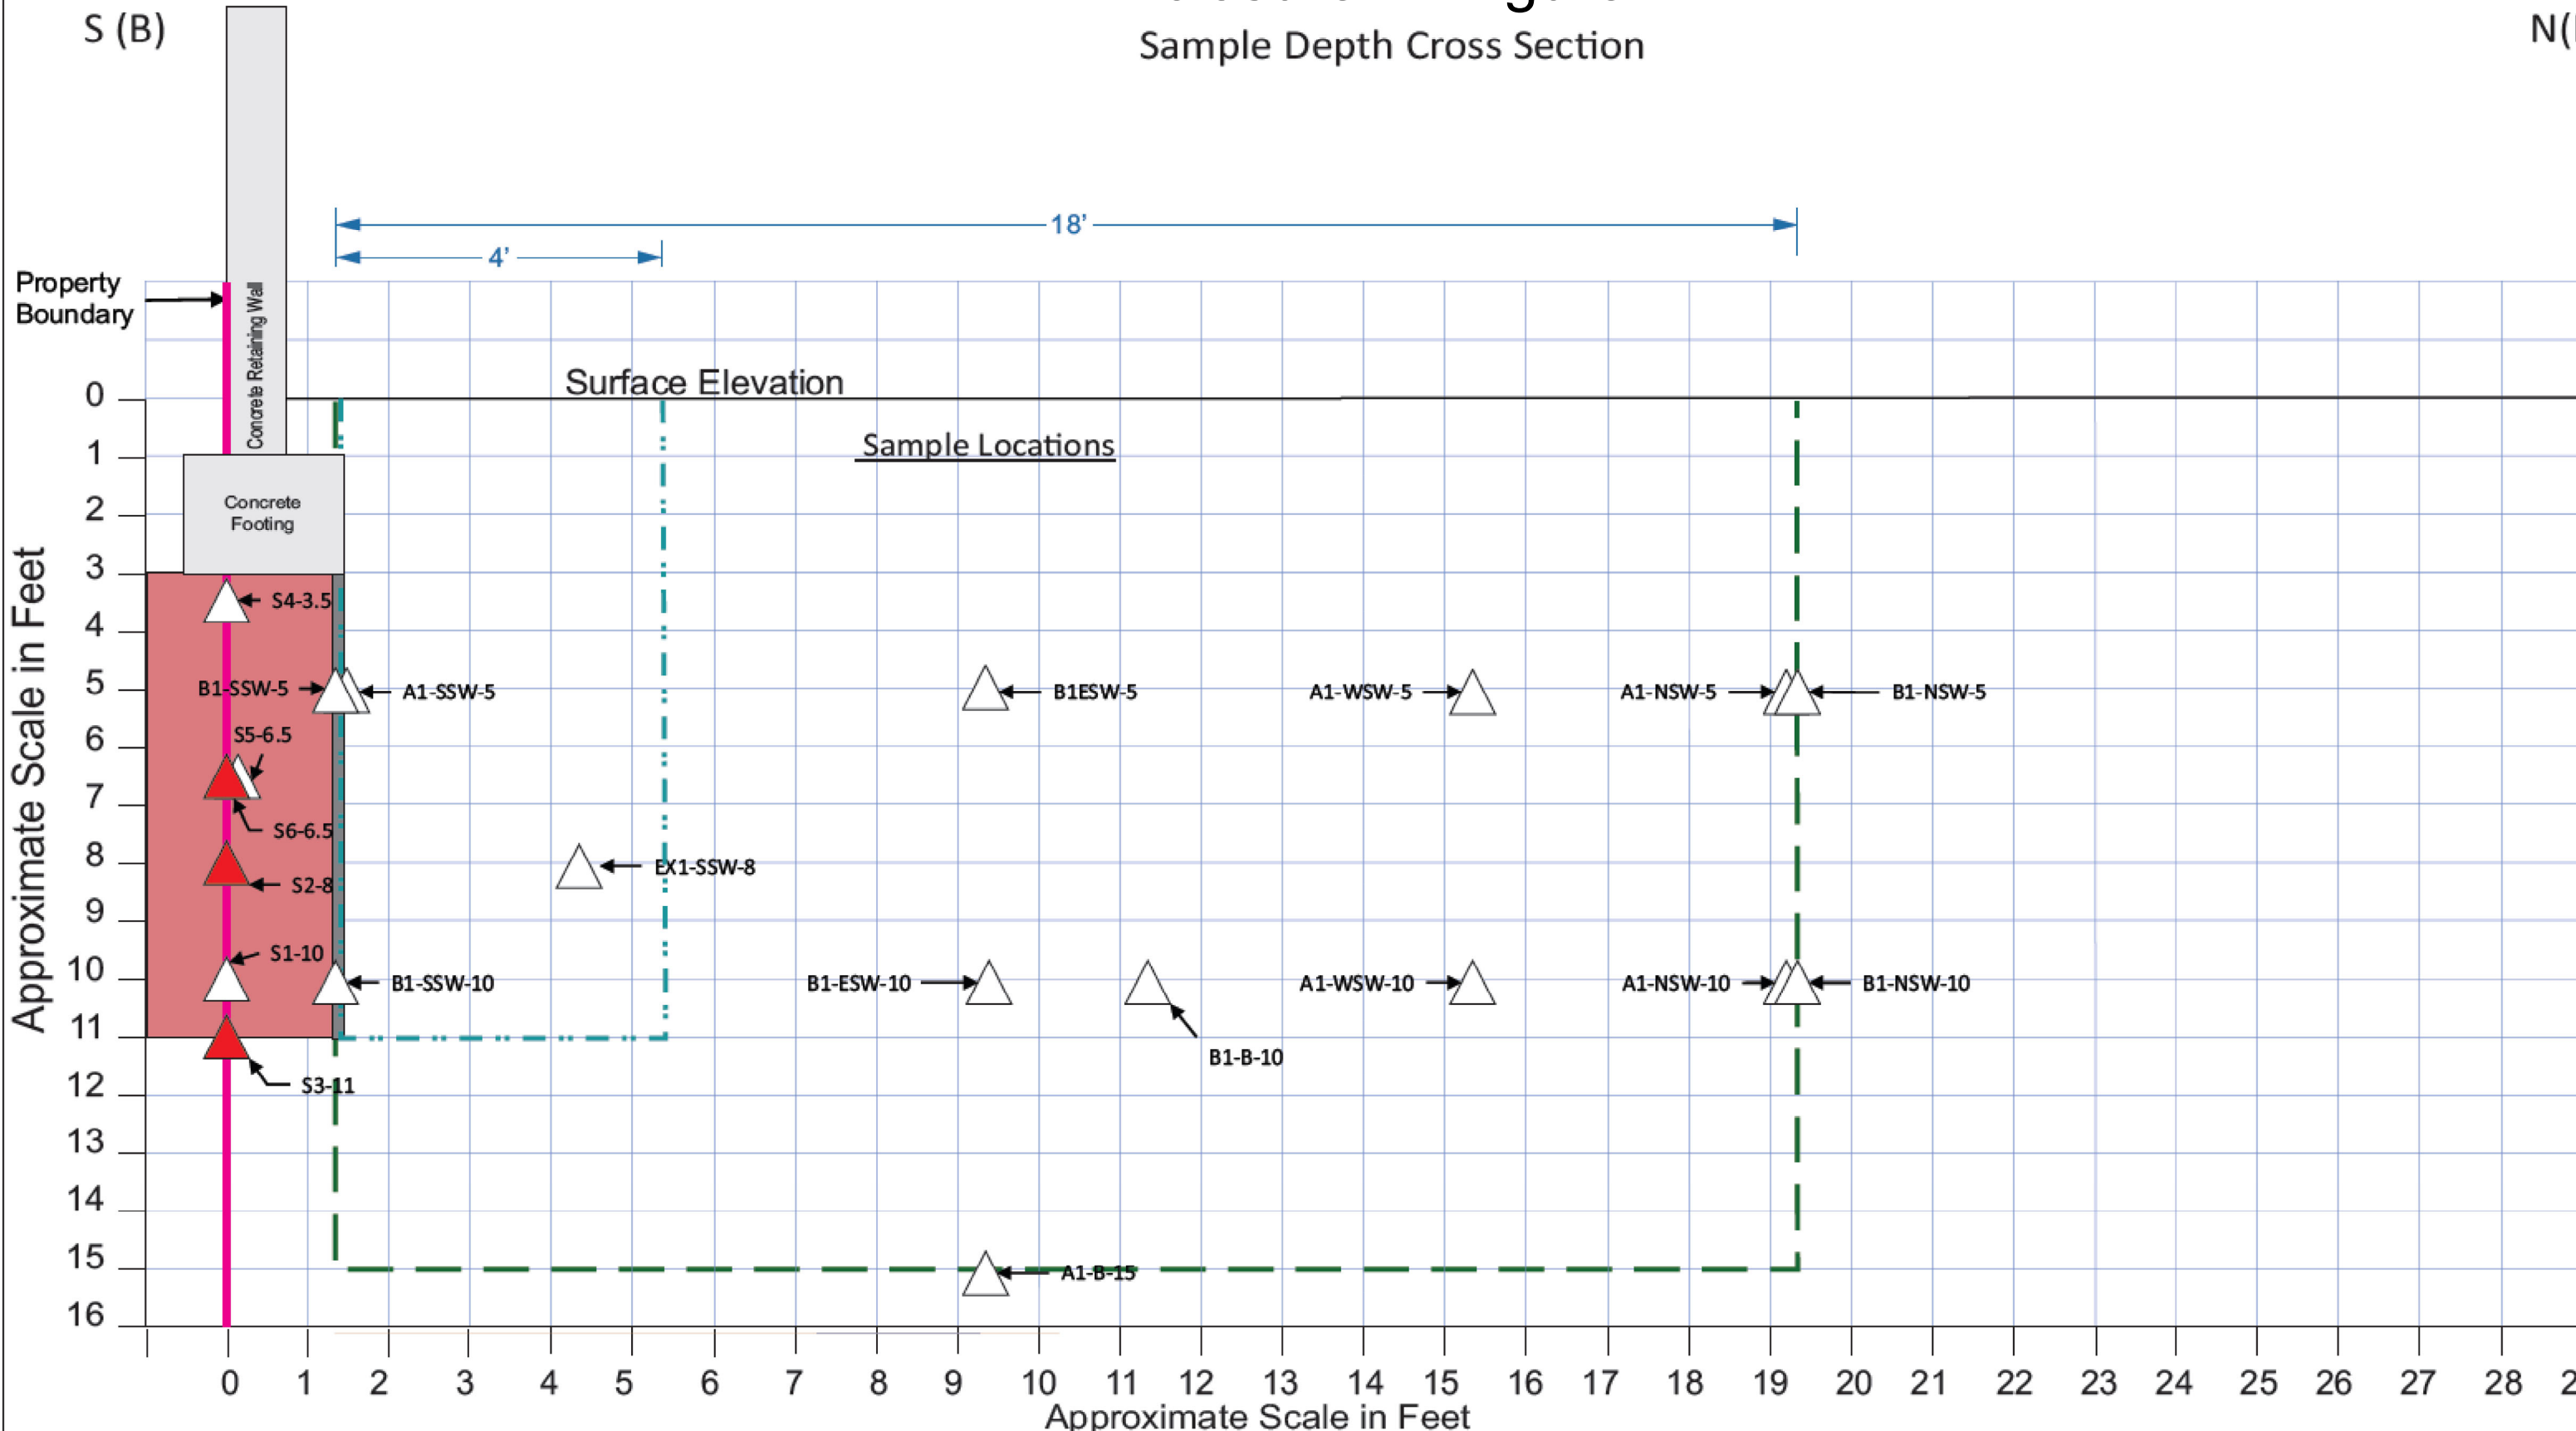
Enclosure B: Figure 7

Cross-Section of Remedial Action
Cleanup Action Report
23418 Pacific Hwy S
Kent, WA 98032
