## Outfall Verification Report

**Location:** East, West, and Upper Duwamish Waterway  
**Report Date:** 9/12/2007  
**Inspection Date:** 6/13/2007 & 6/14/2007  
**Present:** Matt Eyer, Phoinix Corporation  
Edwin Wong, Phoinix Corporation  
Tim Fitzgerald, Port of Seattle Contractor

**Purpose:** To locate and verify outfall locations from the Port of Seattle properties into the Duwamish, focusing on the East, West, and Upper Duwamish waterway. Also to confirm and obtain outfall pipe sizes, material, photos, and location.

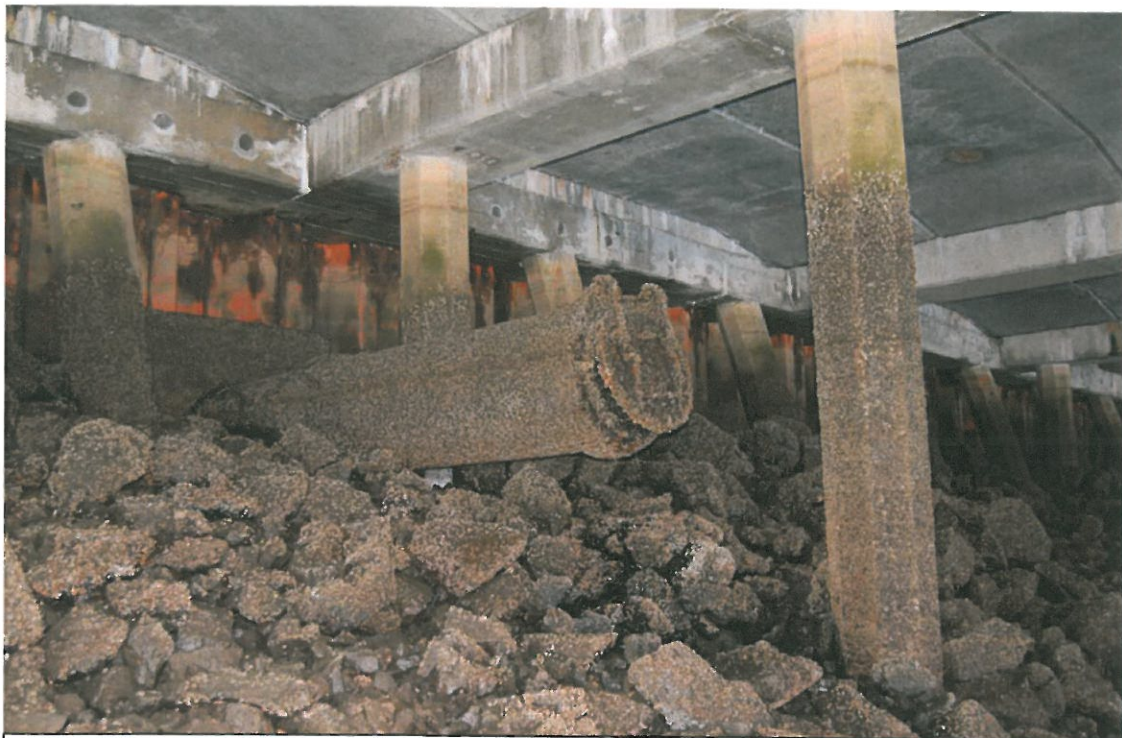
June 13, 2007 - Photo DSC-0021  
 Looking southeast at outfall # T25\_Outfall\_01.

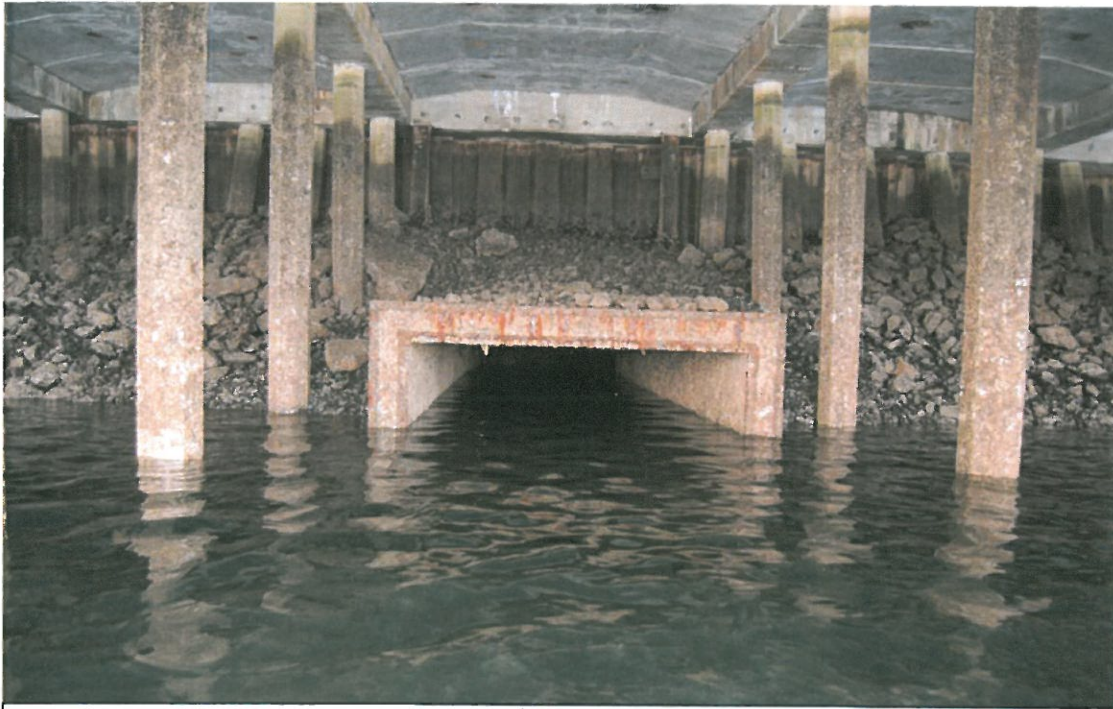
June 13, 2007 - Photo DSC-0023  
Looking east at the Metro sewer outfall# T25\_Outfall\_02.

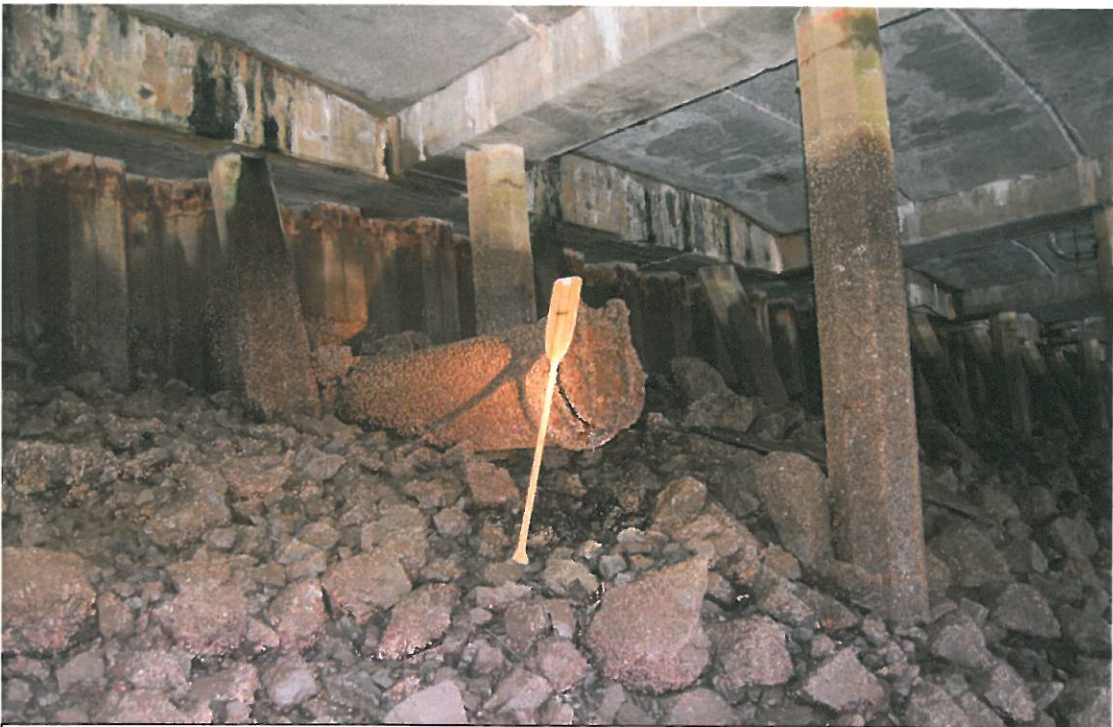
June 13, 2007 - Photo DSC-0017  
Looking southeast at outfall # T25\_Outfall\_03.

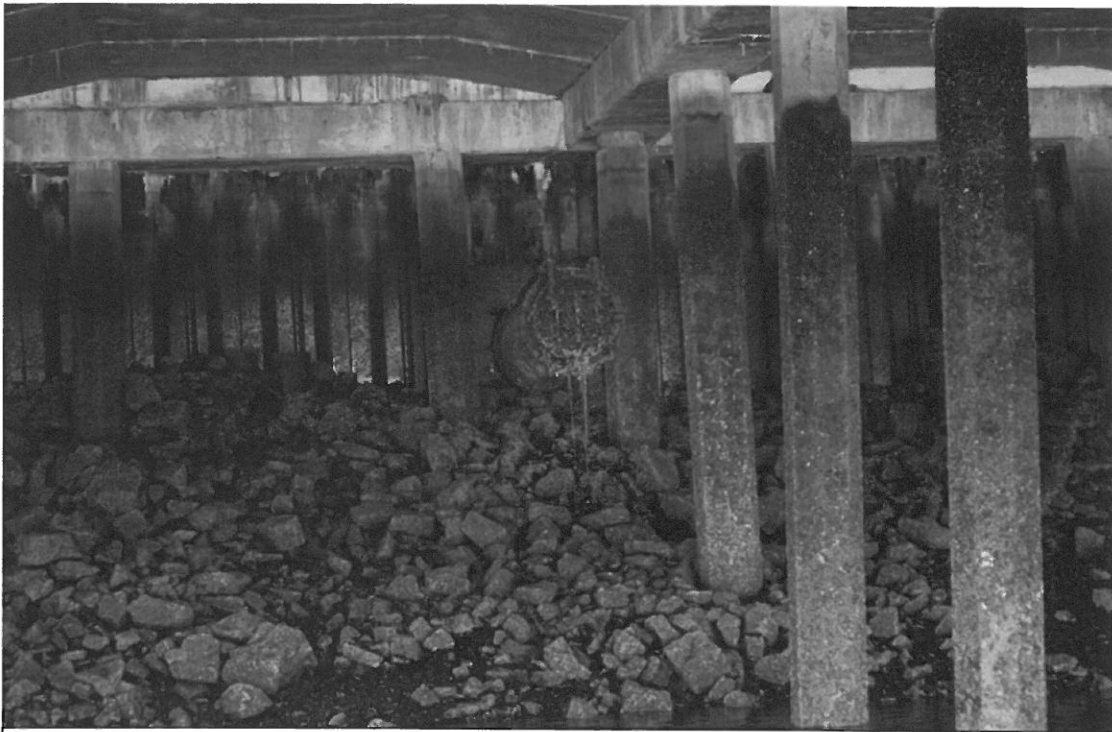
June 13, 2007 - Photo DSC-0013  
Looking east at outfall I# T25\_Outfall\_04.

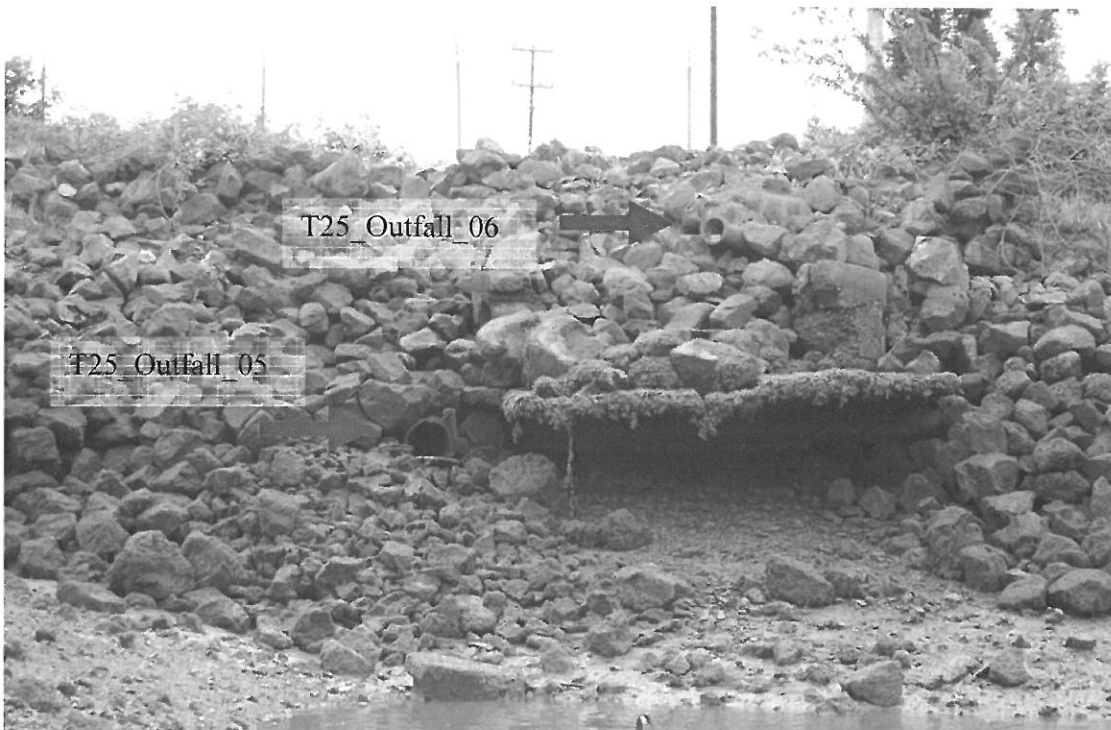
June 13, 2007 - Photo DSC-0013  
Looking east at outfalls # T25\_Outfall\_05 and T25\_Outfall\_06.

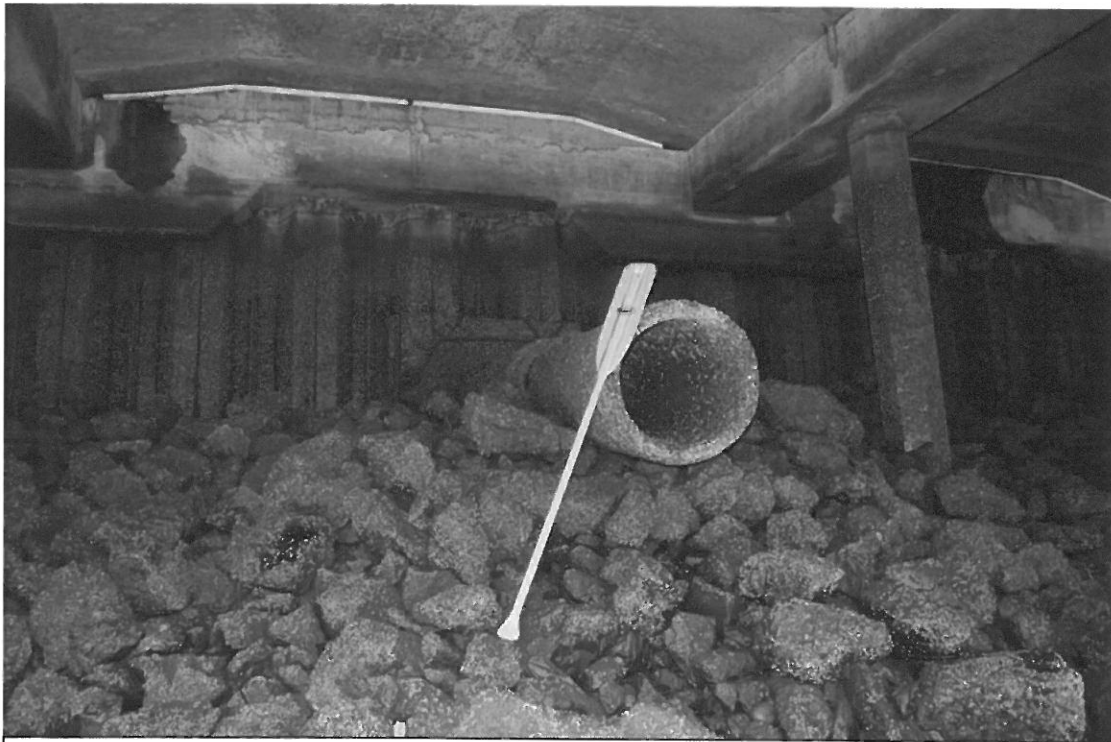
June 13, 2007 - Photo DSC-0032  
 Looking east at outfall # T30\_Outfall\_04.

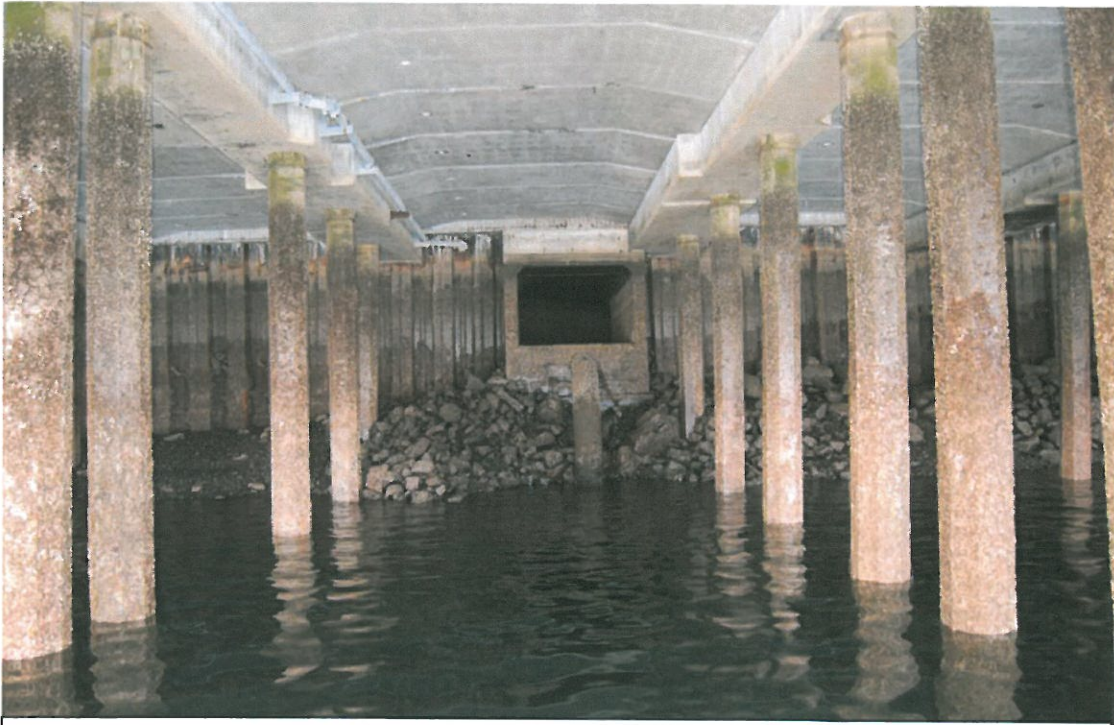
June 13, 2007 - Photo DSC-0028  
Looking east at outfall # T30\_Outfall\_05.

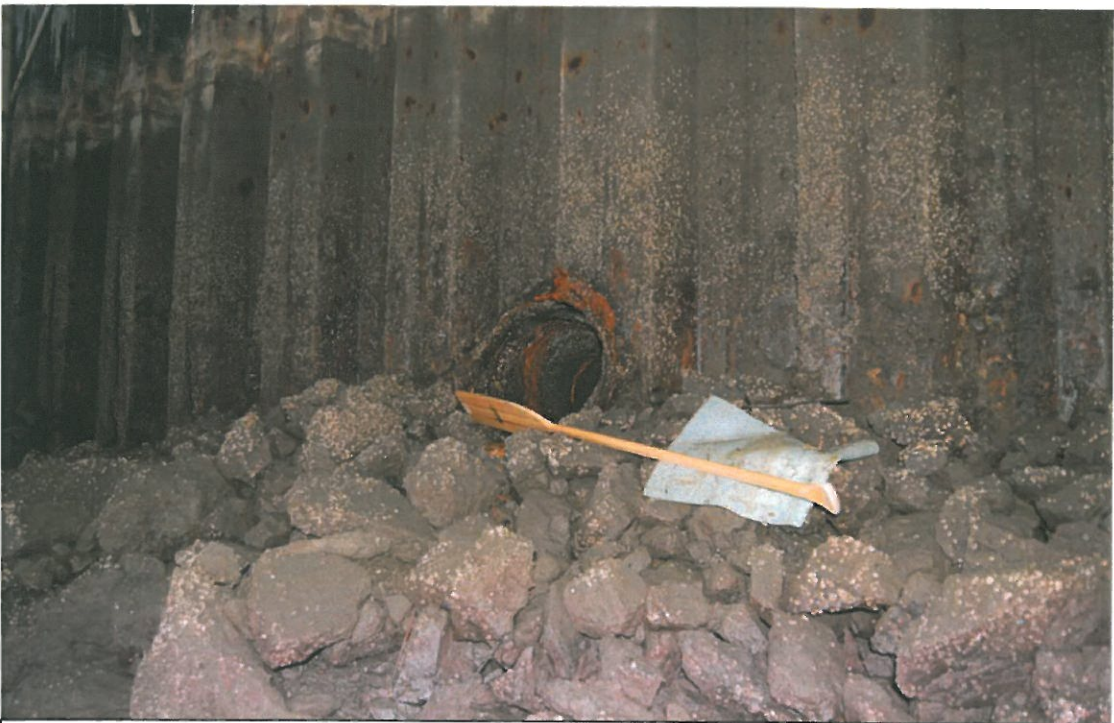
June 13, 2007 - Photo DSC-0026  
Looking northeast at outfall # T30\_Outfall\_06.

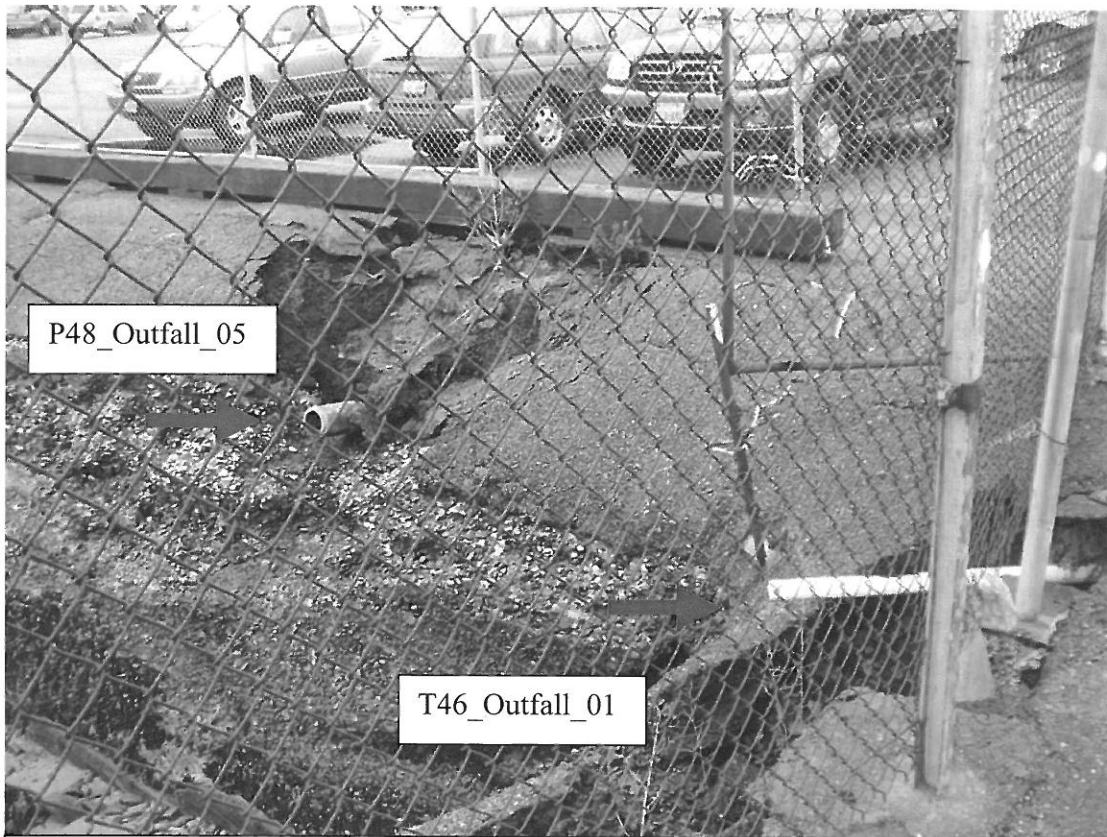
June 13, 2007 - Photo DSCF-0466  
 Looking east at outfalls # T46\_Outfall\_01 and P48\_Outfall\_05.

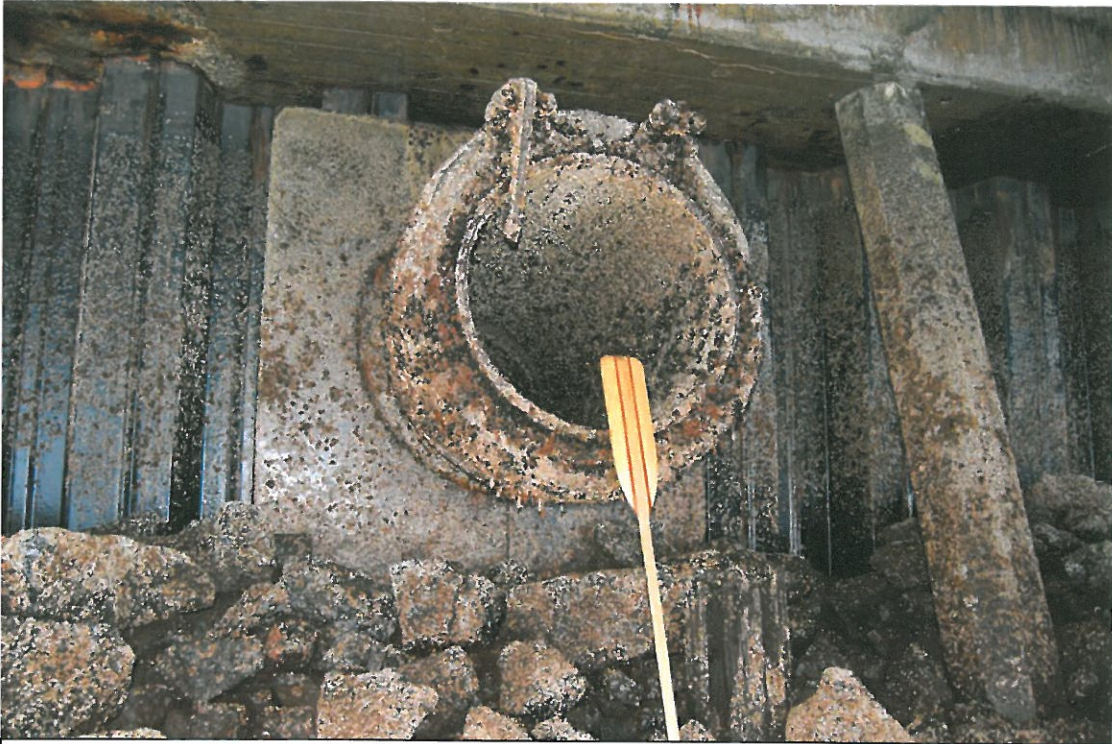
June 13, 2007 - Photo DSC-0049  
Looking east at outfall # T46\_Outfall\_02.

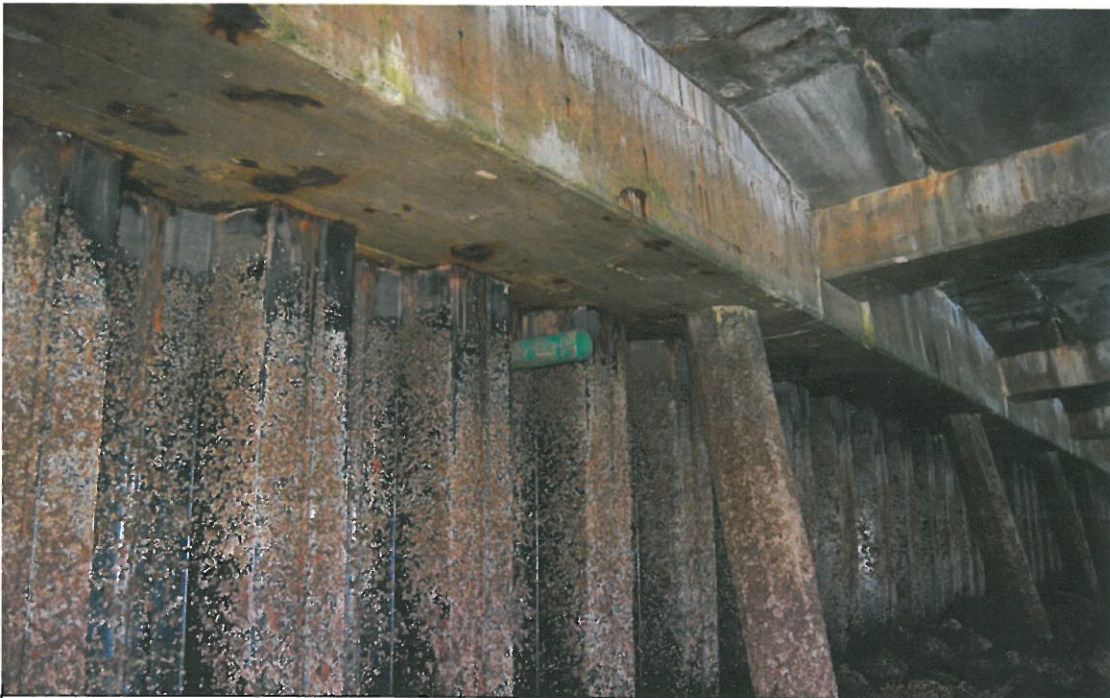
June 13, 2007 - Photo DSC-0052  
Looking southeast at outfall # T46\_Outfall\_03.

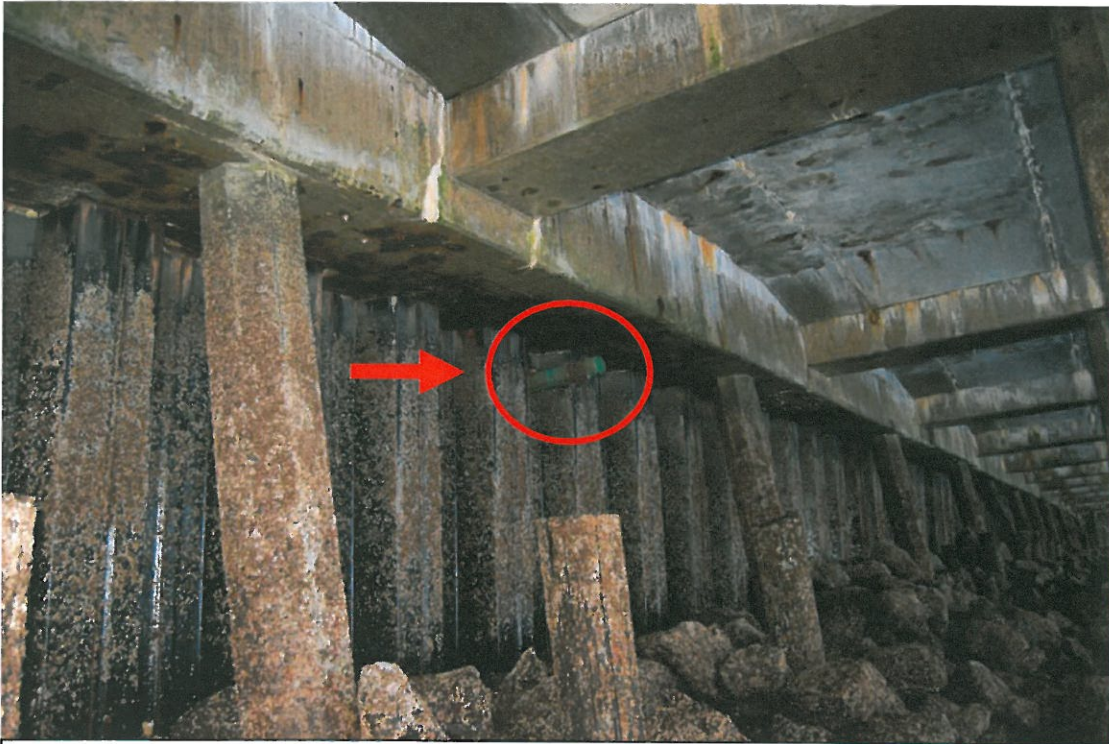
June 13, 2007 - Photo DSC-0054  
Looking southeast at outfall # T46\_Outfall\_04.

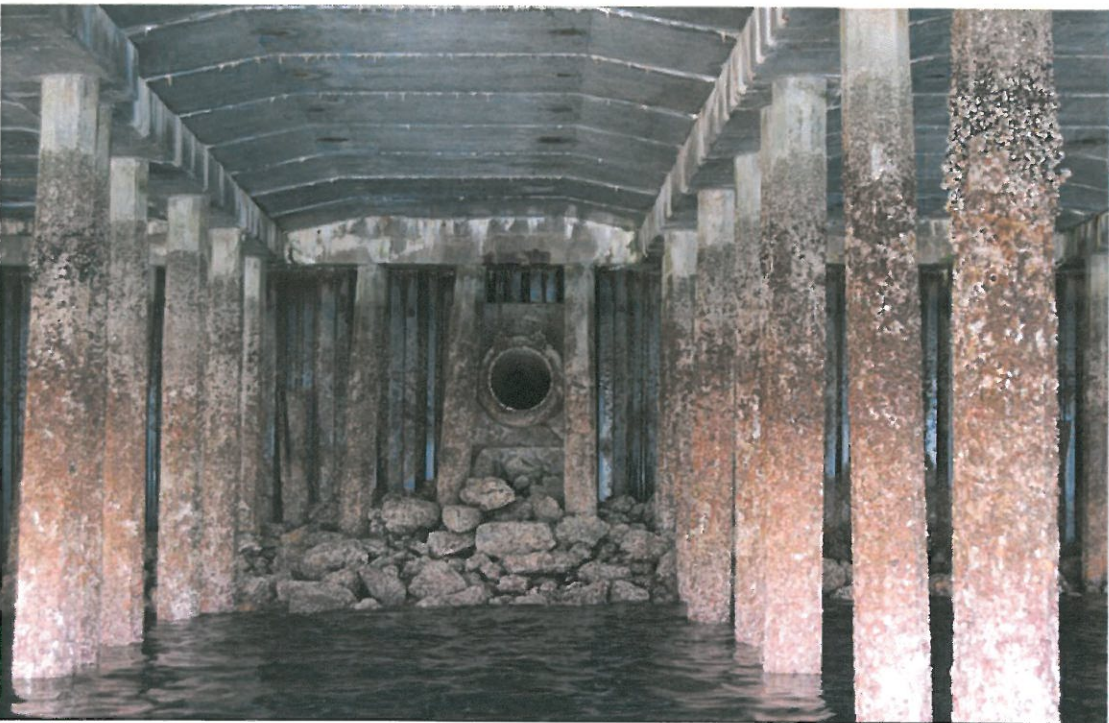
June 13, 2007 - Photo DSC-0045  
Looking east at outfall # T46\_Outfall\_05.

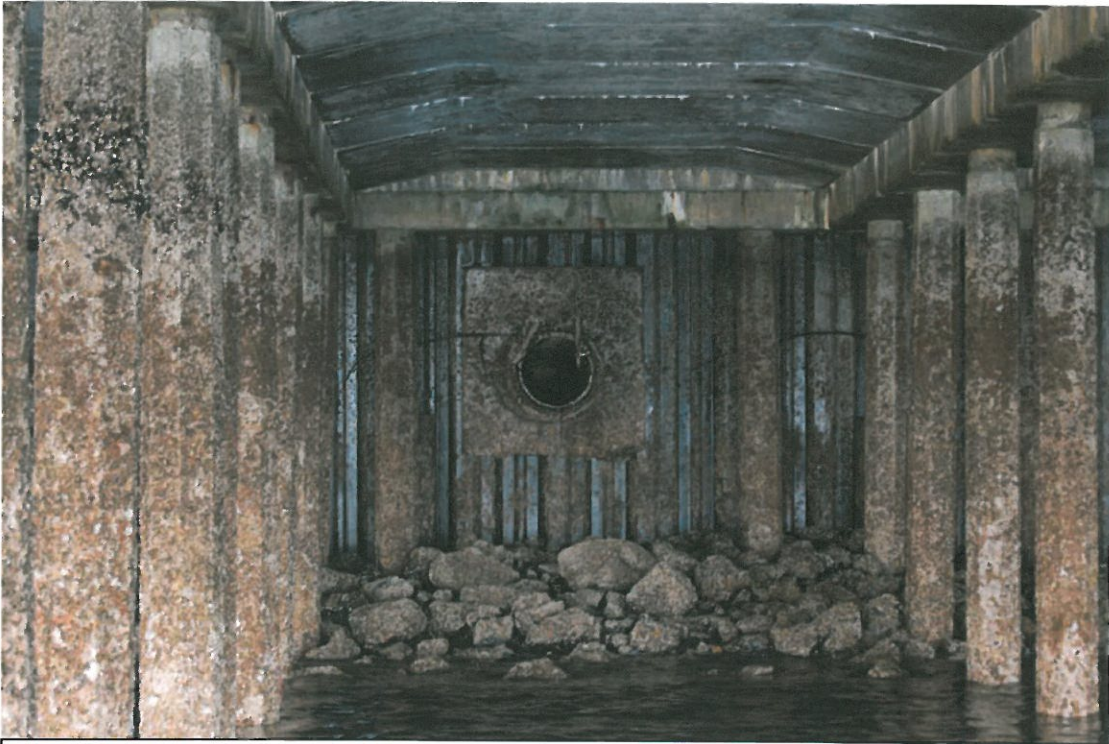
June 13, 2007 - Photo DSC-0043  
Looking east at outfall # T46\_Outfall\_06.

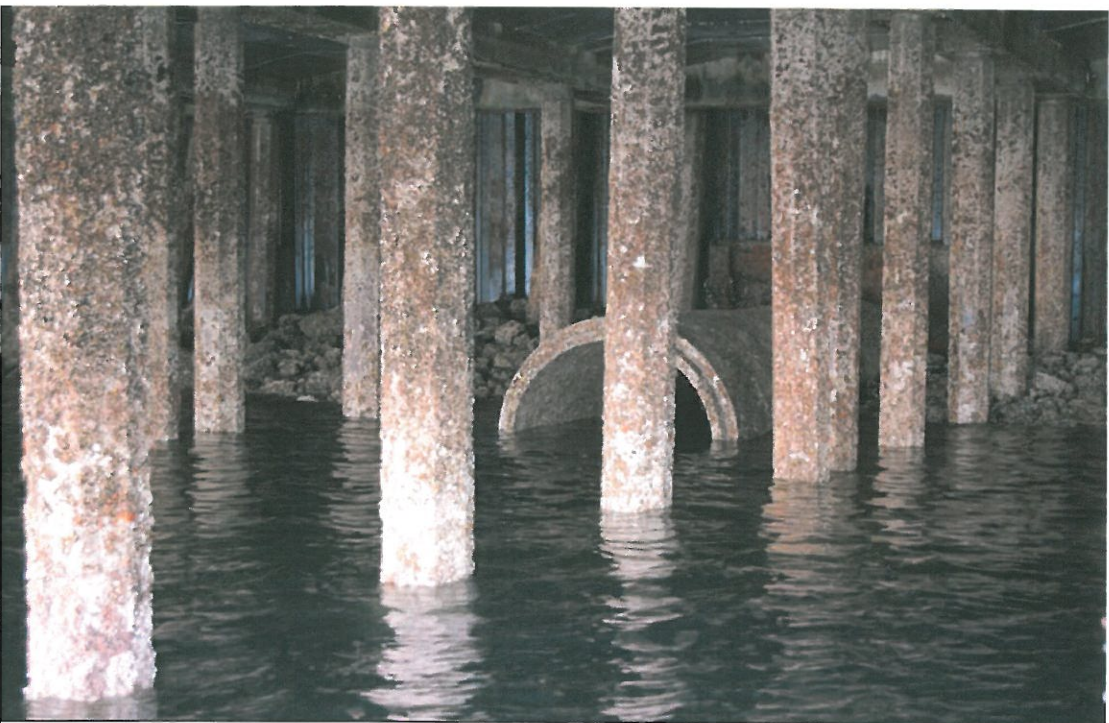
June 13, 2007 - Photo DSC-0043  
Looking east at the Metro sewer outfall # T46\_Outfall\_07.

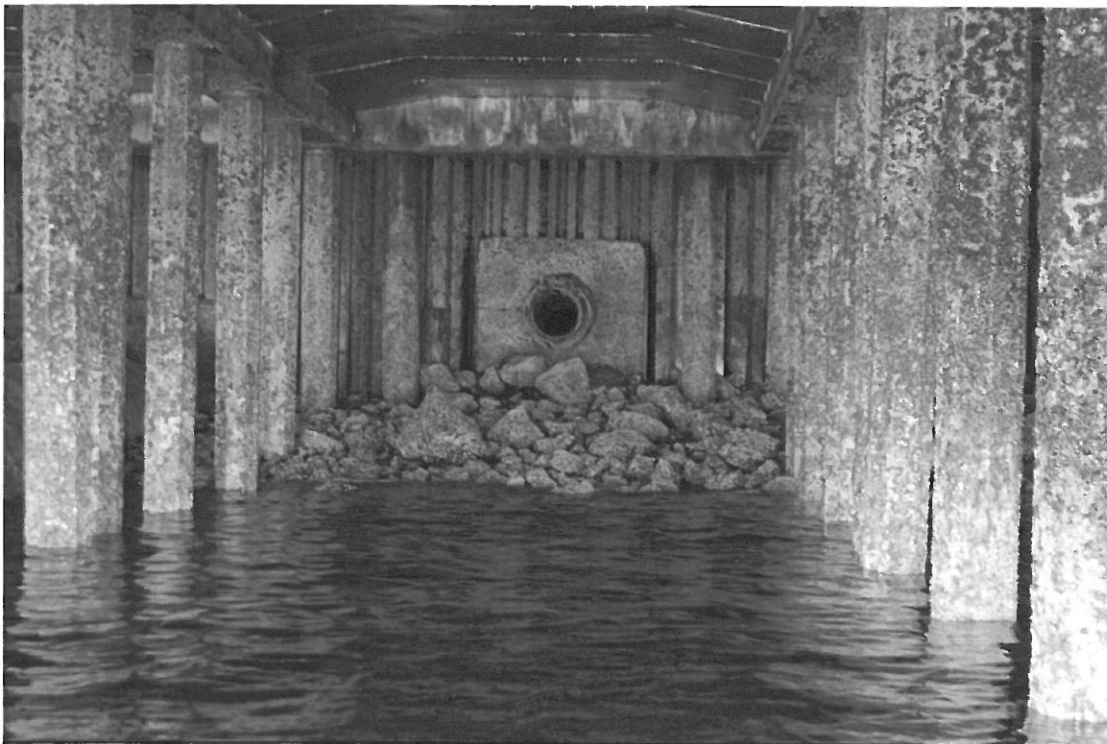
June 13, 2007 - Photo DSC-0040  
Looking east at outfall # T46\_Outfall\_08.

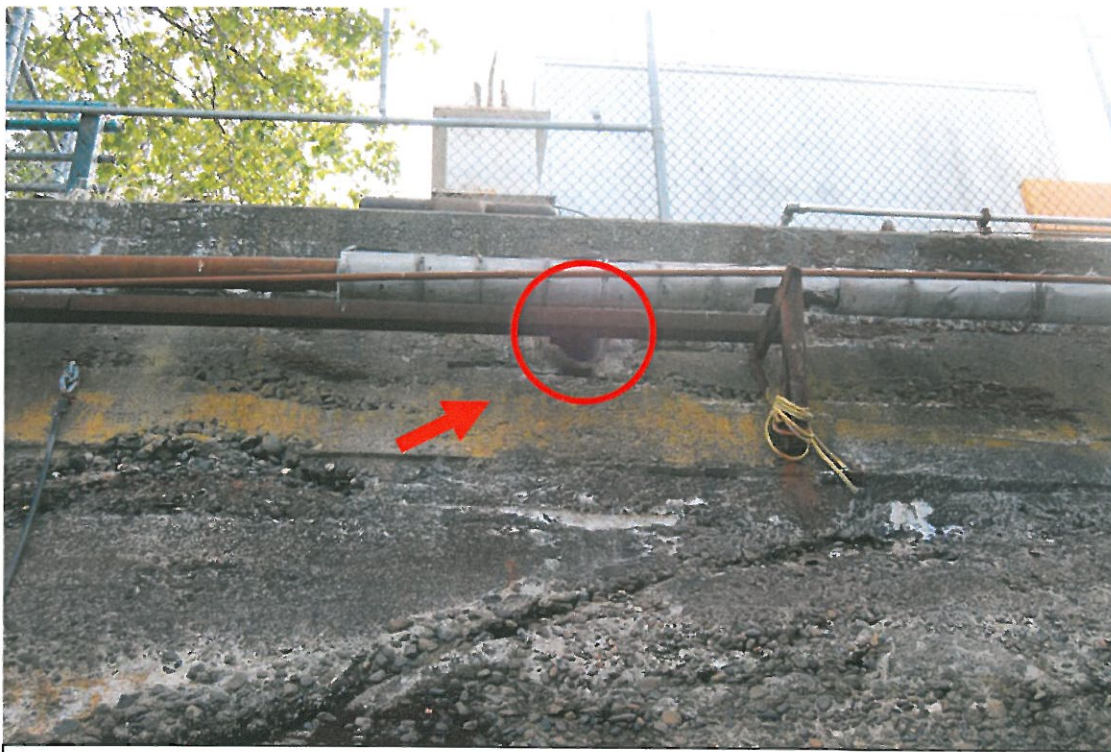
June 13, 2007 - Photo DSC-0063  
Looking east at outfall # P48\_Outfall\_01.

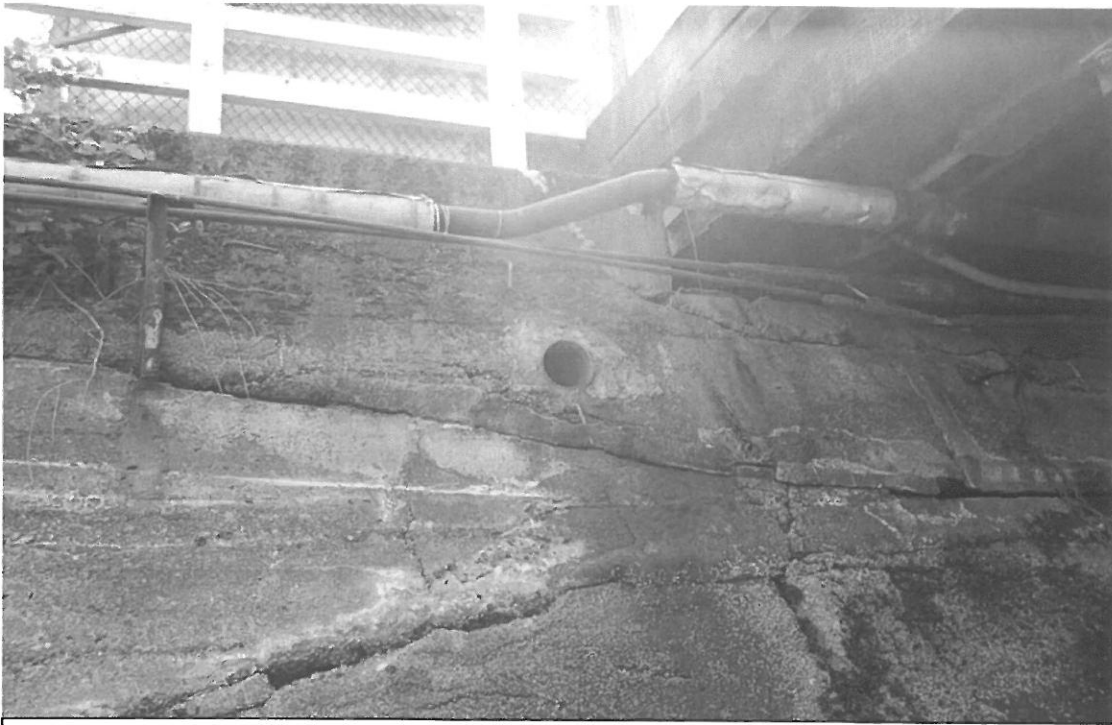
June 13, 2007 - Photo DSC-0061  
Looking east at outfall # P48\_Outfall\_02.

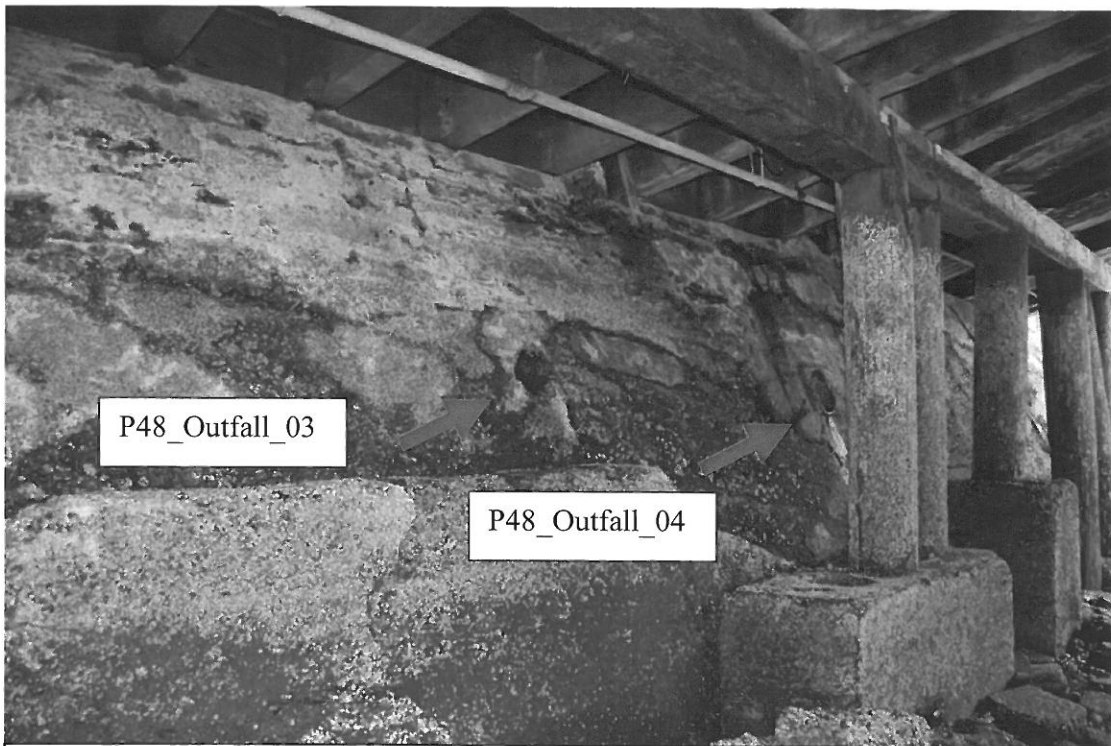
June 13, 2007 - Photo DSC-0057  
Looking southeast at outfalls # P48\_Outfall\_03 and P48\_Outfall\_04.

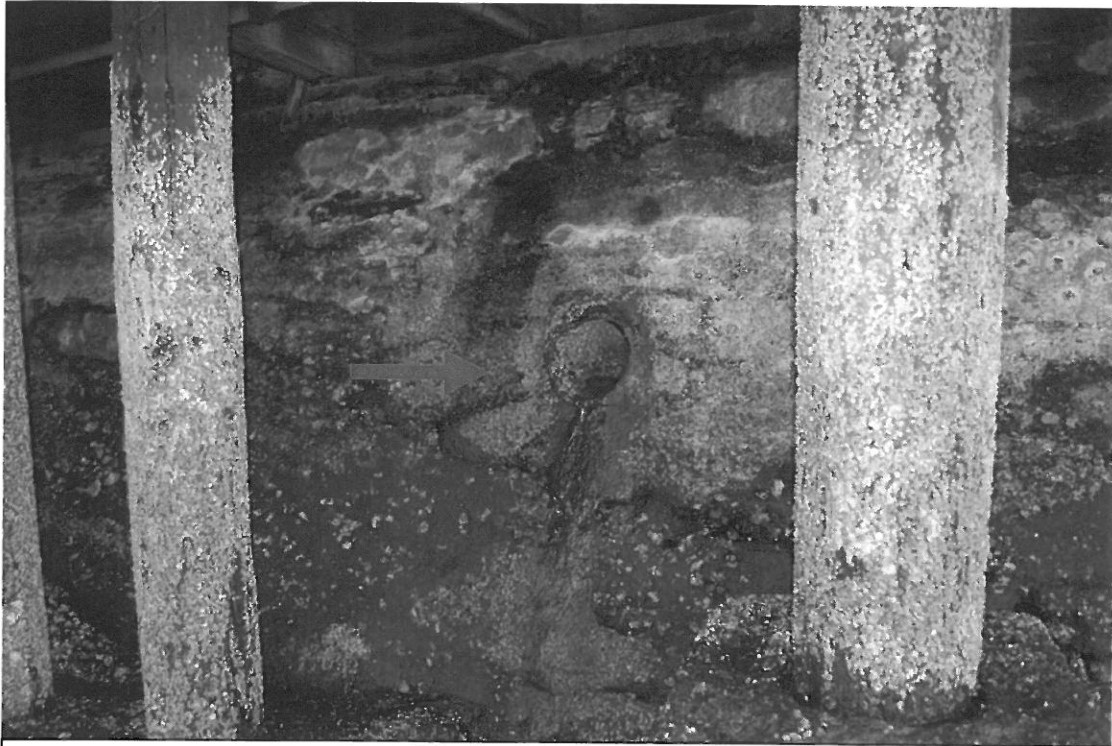
June 13, 2007 - Photo DSC-0055  
Looking east at outfall # P48\_Outfall\_04.

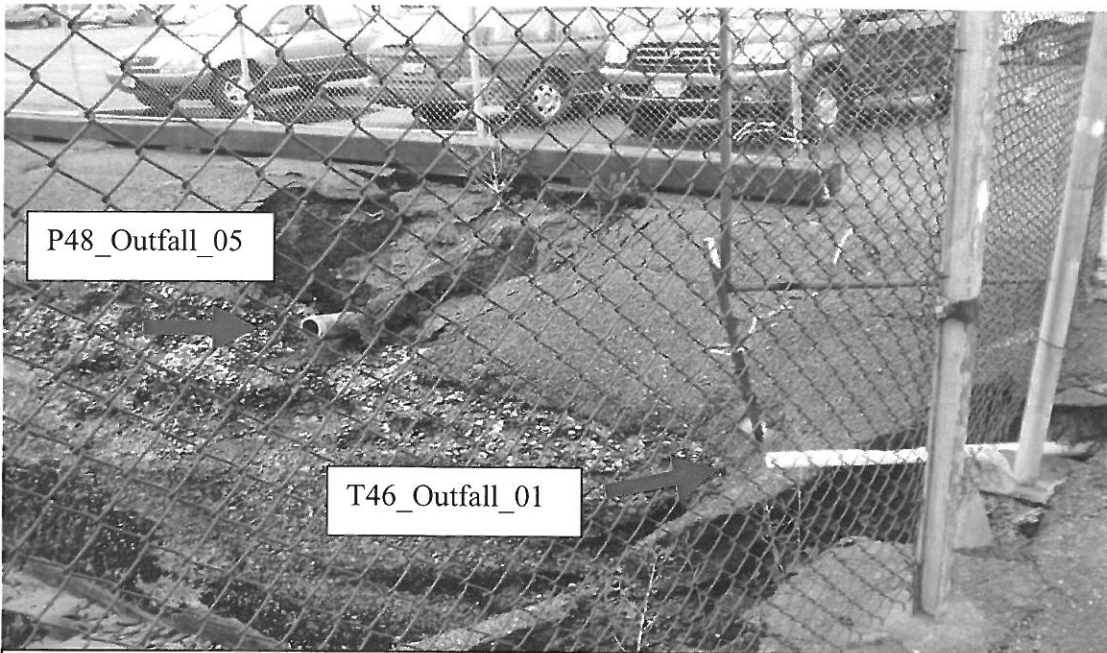
June 13, 2007 - Photo DSCF-0466  
Looking east at outfalls # P48\_Outfall\_05 and T46\_Outfall\_01.

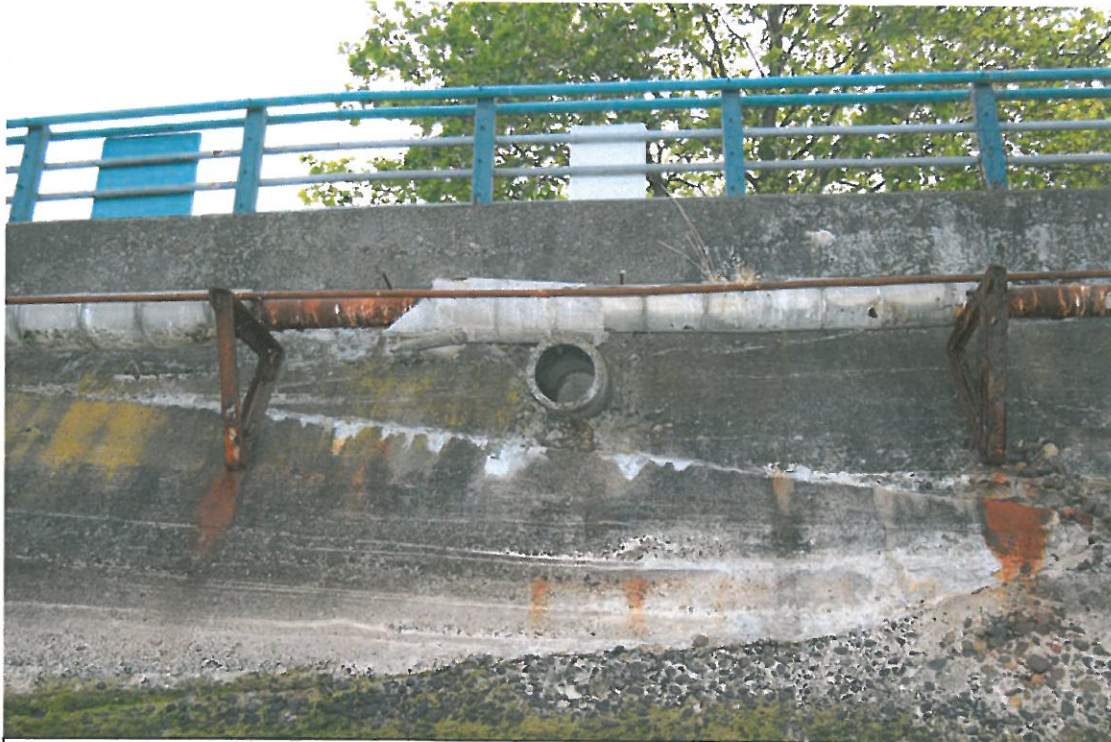
June 13, 2007 - Photo DSC-0065  
 Looking east at outfall # Alaska Square Park\_Outfall\_01.

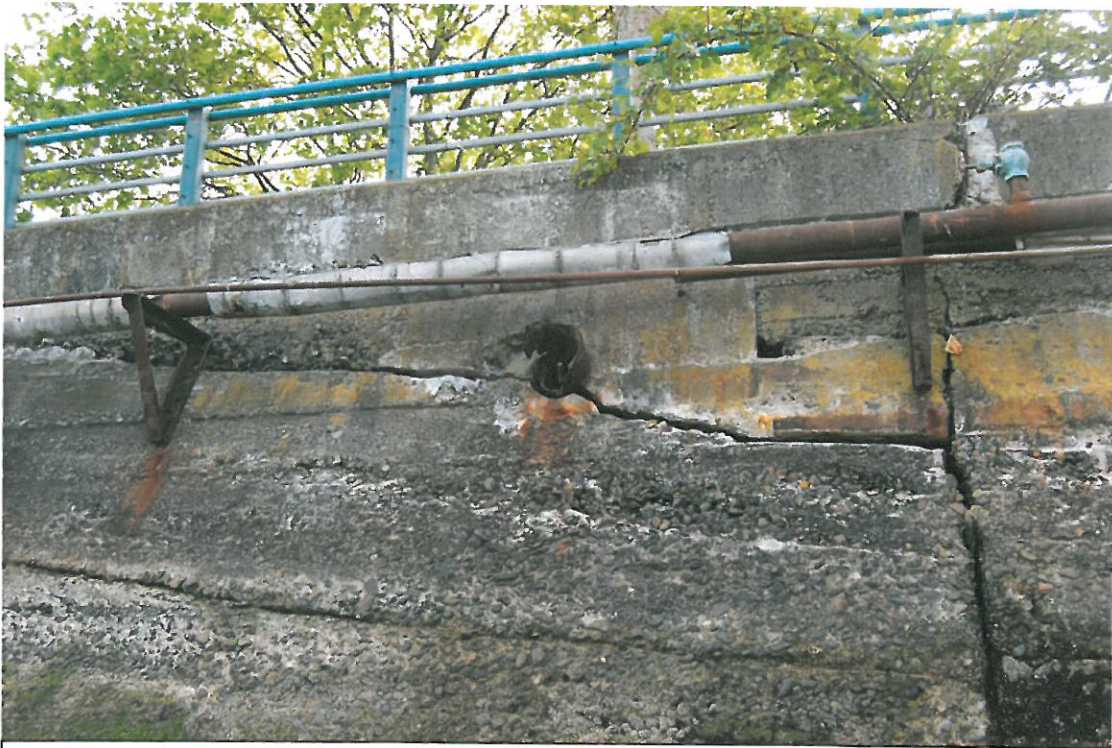
June 13, 2007 - Photo DSC-0064  
Looking east at outfall # Alaska Square Park\_Outfall\_02.

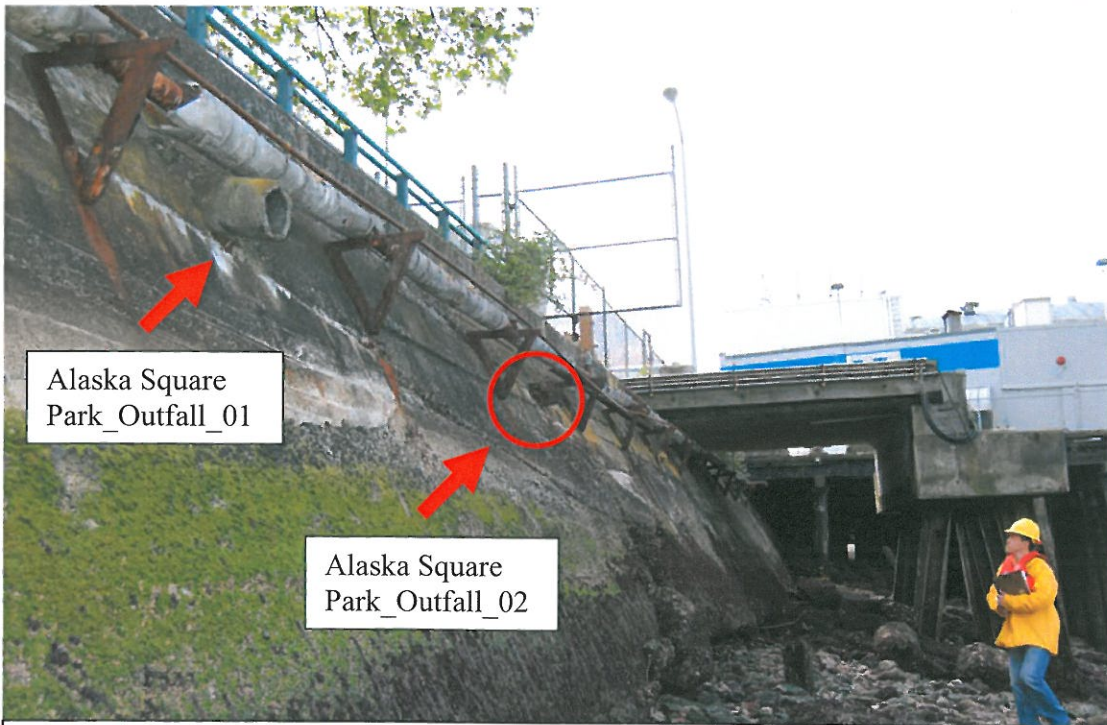
June 13, 2007 - Photo DSC-0066  
Looking southeast at outfalls # Alaska Square Park\_Outfall\_01 and Outfall\_02.

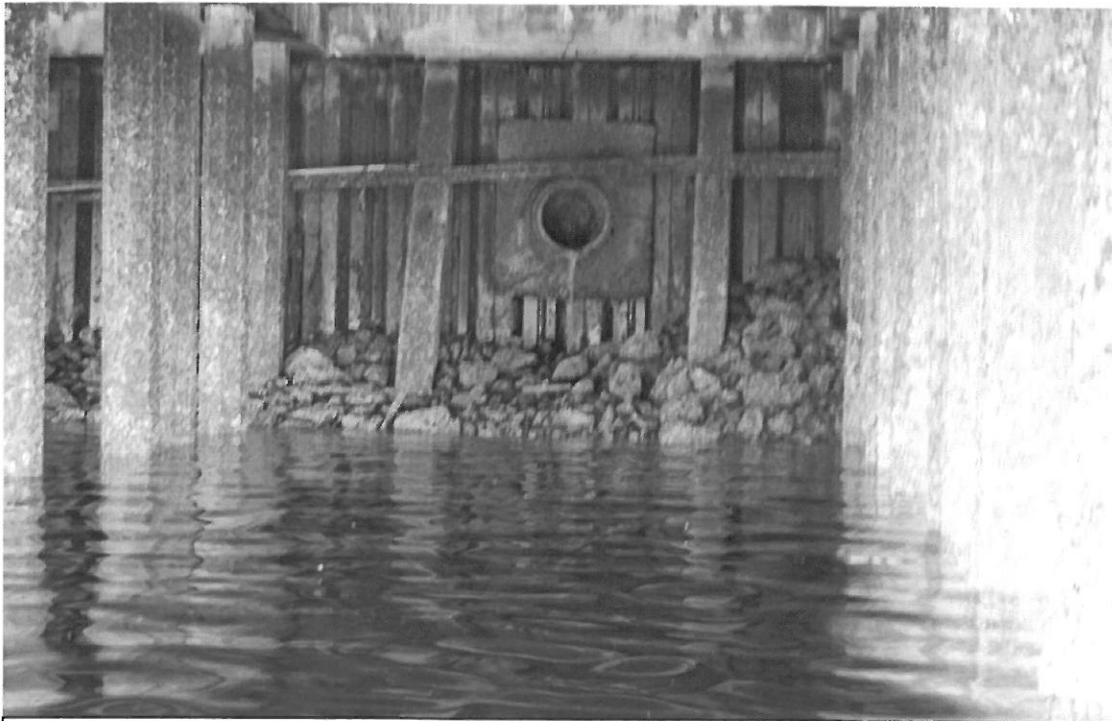
June 13, 2007 - Photo DSC-0075  
Looking west at outfall # T18\_Outfall\_02.

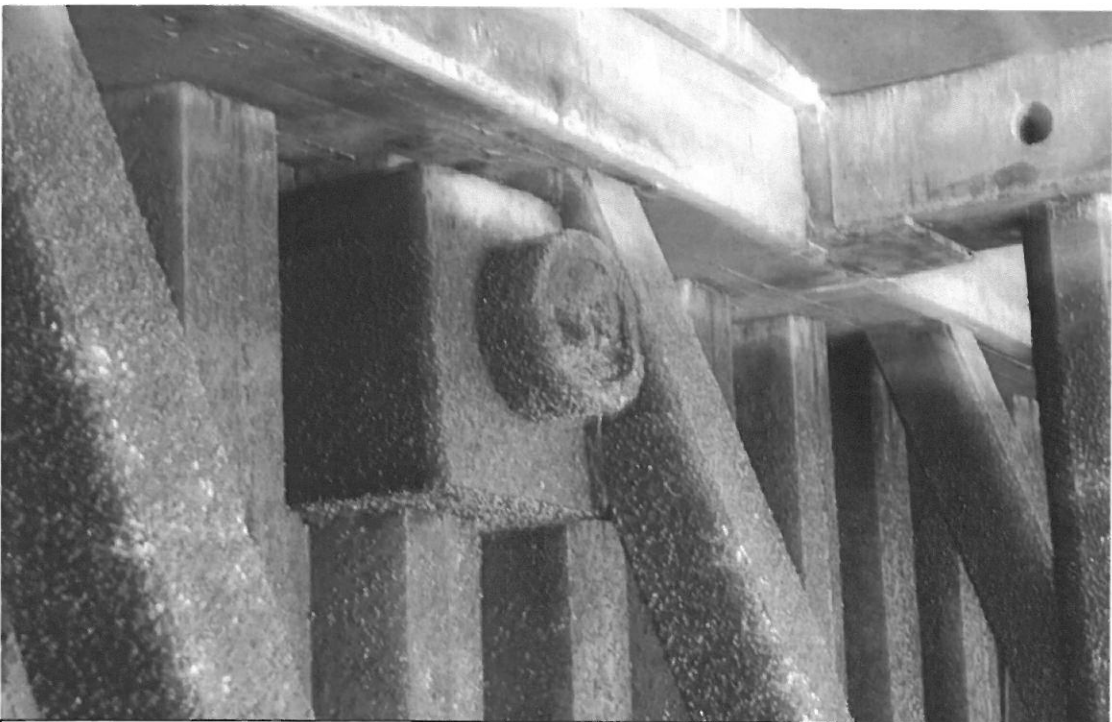
June 13, 2007 - Photo DSC-0076  
Looking northwest at outfall # T18\_Outfall\_03, 1st of 4 sealed outfalls.

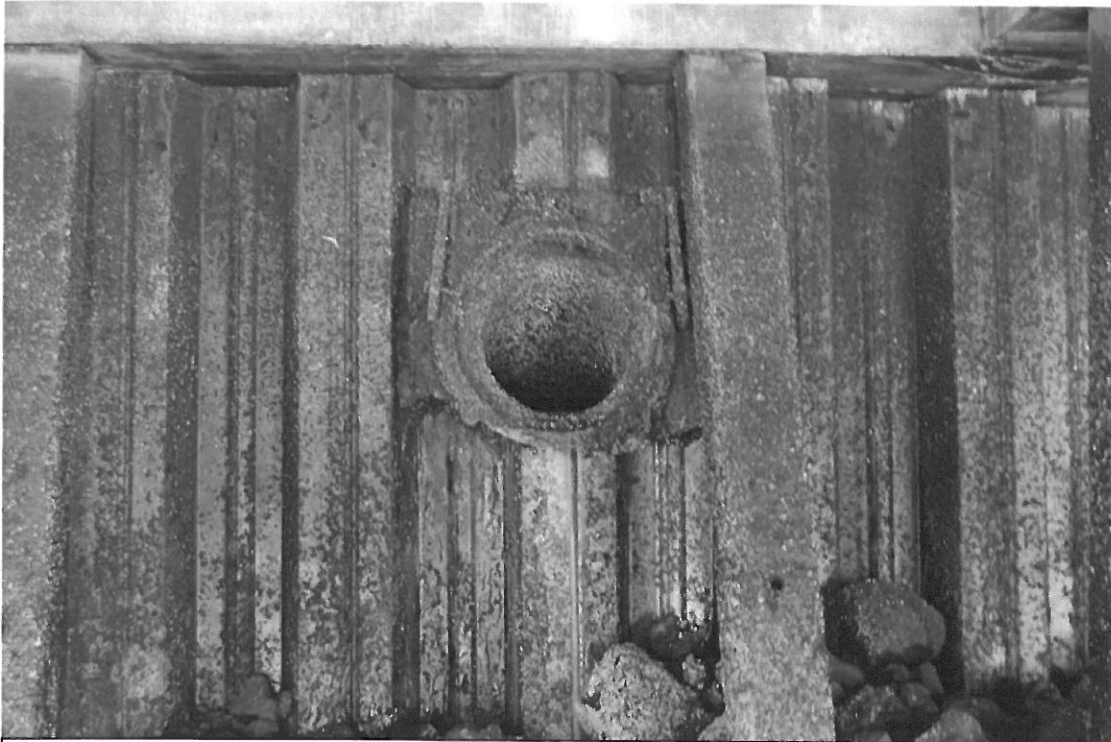
June 13, 2007 - Photo DSC-0077  
Looking west at outfall # T18\_Outfall\_04.
