## Outfall Verification Report

**Location:** East, West, and Upper Duwamish Waterway  
**Report Date:** 9/12/2007  
**Inspection Date:** 6/13/2007 & 6/14/2007  
**Present:** Matt Eyer, Phoinix Corporation  
Edwin Wong, Phoinix Corporation  
Tim Fitzgerald, Port of Seattle Contractor

**Purpose:** To locate and verify outfall locations from the Port of Seattle properties into the Duwamish, focusing on the East, West, and Upper Duwamish waterway. Also to confirm and obtain outfall pipe sizes, material, photos, and location.

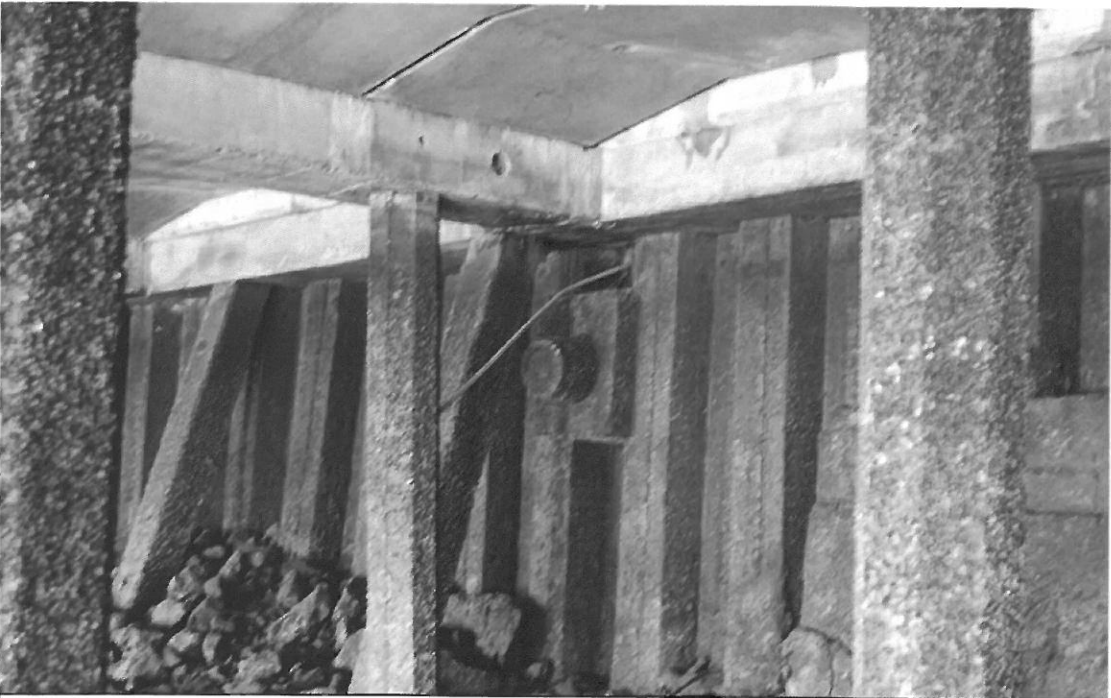
June 13, 2007 - Photo DSC-0080  
Looking southwest at outfall # T18\_Outfall\_05, 2<sup>nd</sup> of 4 sealed outfalls.

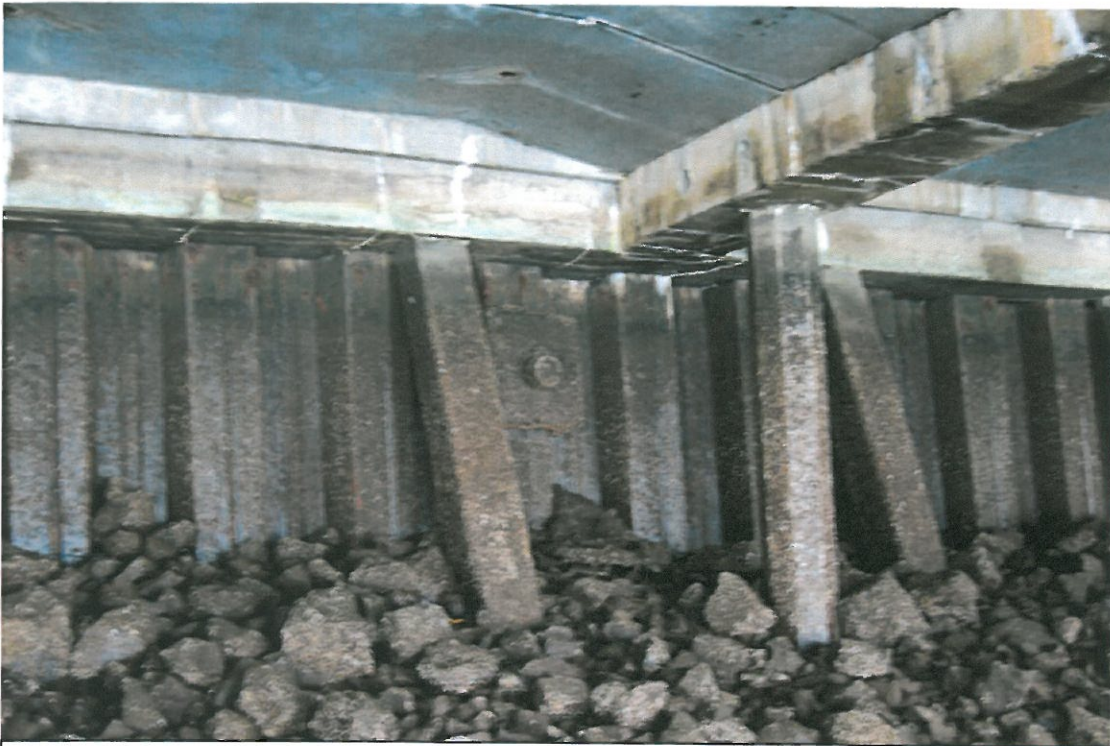
June 13, 2007 - Photo DSC-0081  
Looking west at outfall # T18\_Outfall\_06, 3<sup>rd</sup> of 4 sealed outfalls.

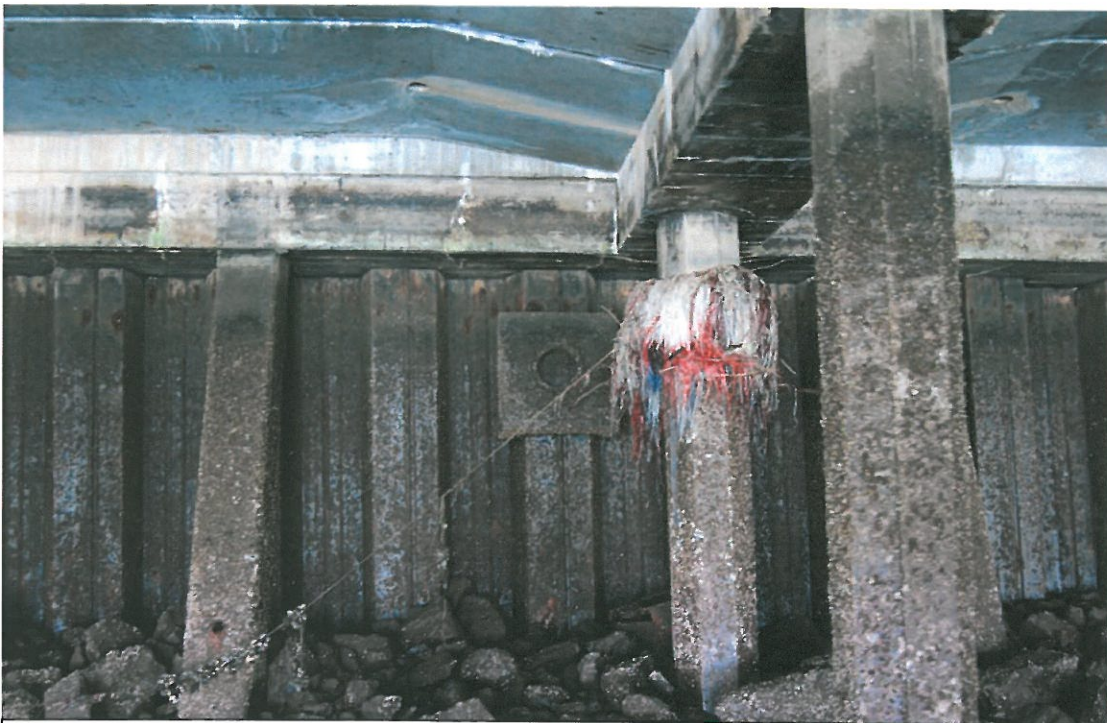
June 13, 2007 - Photo DSC-0082  
Looking west at outfall # T18\_Outfall\_07, 4<sup>th</sup> of 4 sealed outfalls.

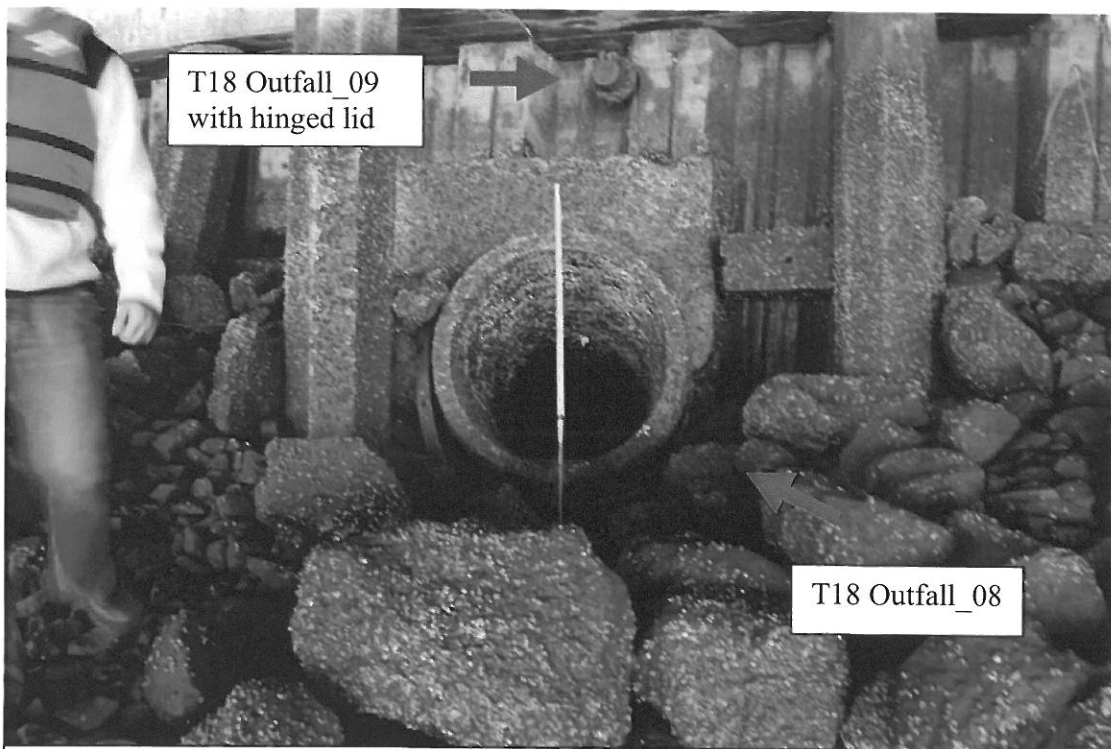
June 13, 2007 - Photo DSC-0083  
Looking west at outfalls # T18\_Outfall\_08 and Outfall\_09.

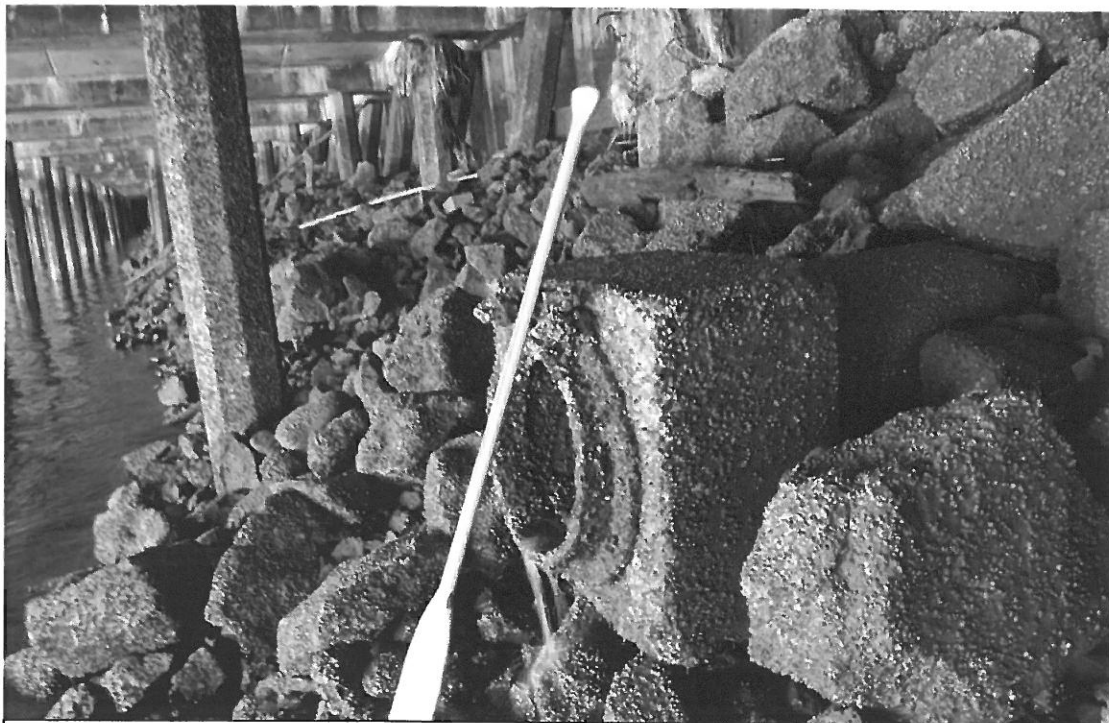
June 13, 2007 - Photo DSC-0087  
Looking southwest at outfall # T18\_Outfall\_10.

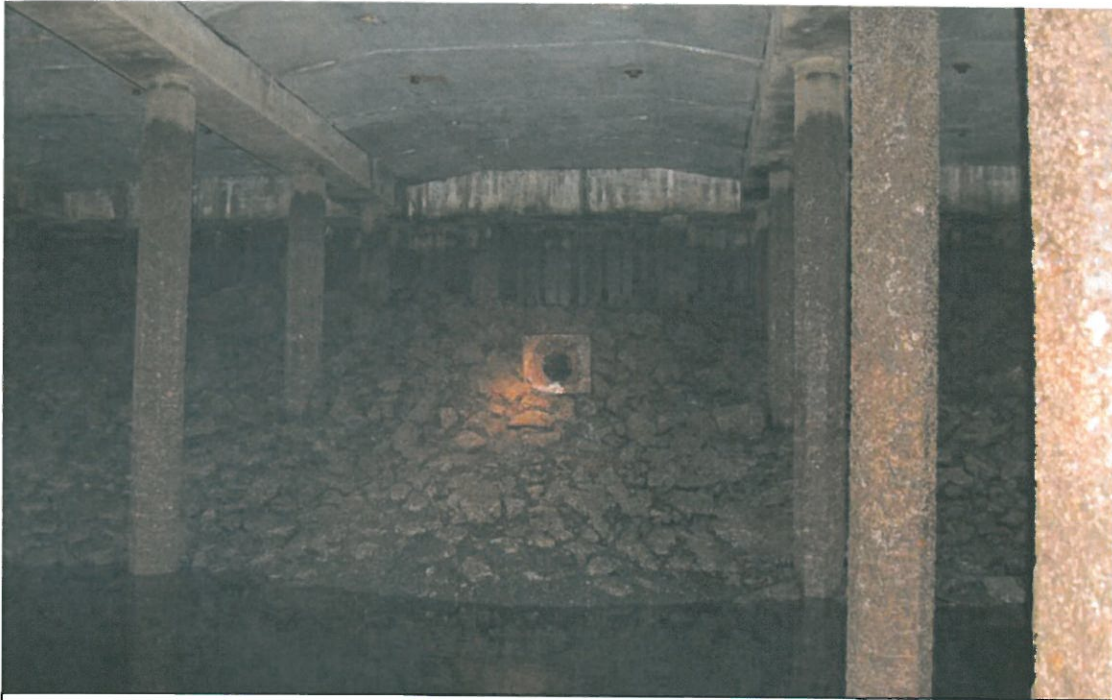
June 14, 2007 - Photo DSC-0002  
Looking west at outfall # T18\_Outfall\_11.

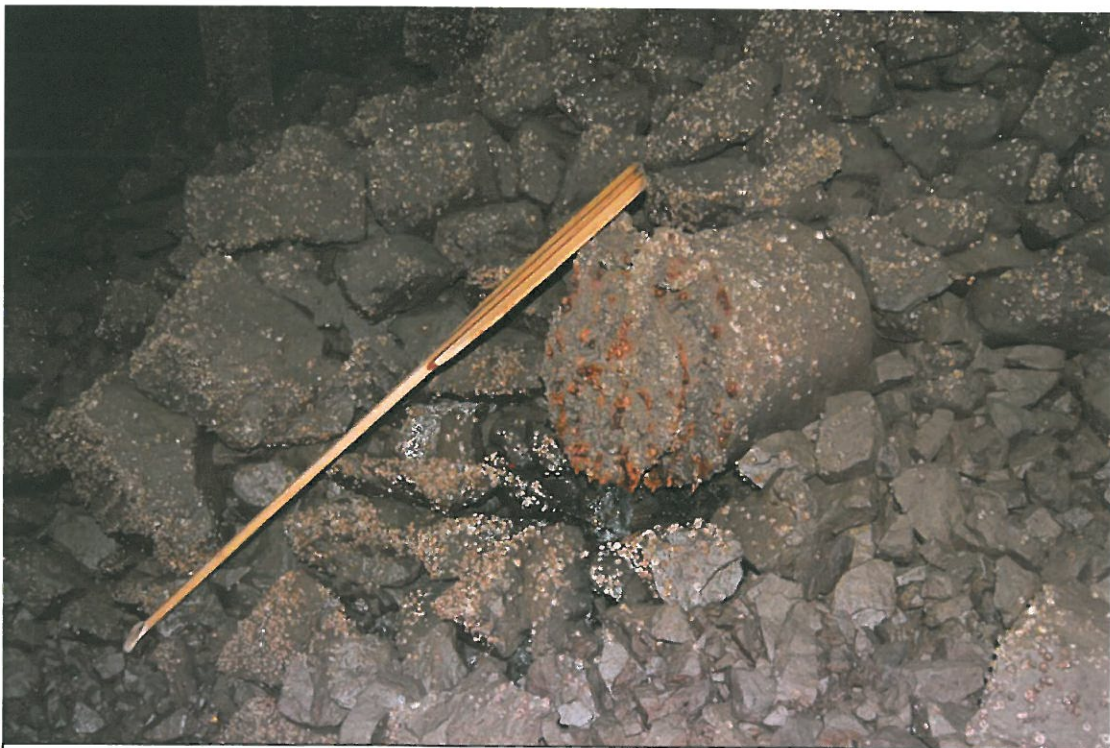
June 14, 2007 - Photo DSC-0020  
Looking west at outfall # T18\_Outfall\_12.

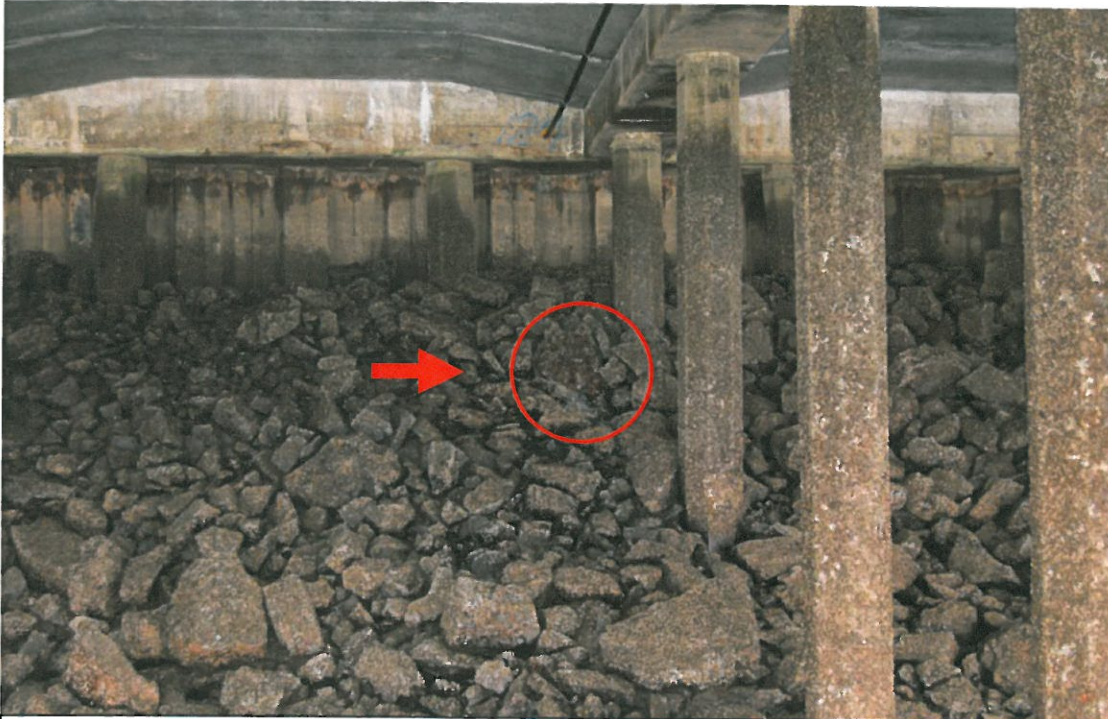
June 14, 2007 - Photo DSC-0020  
Looking west at outfall # T18\_Outfall\_13.

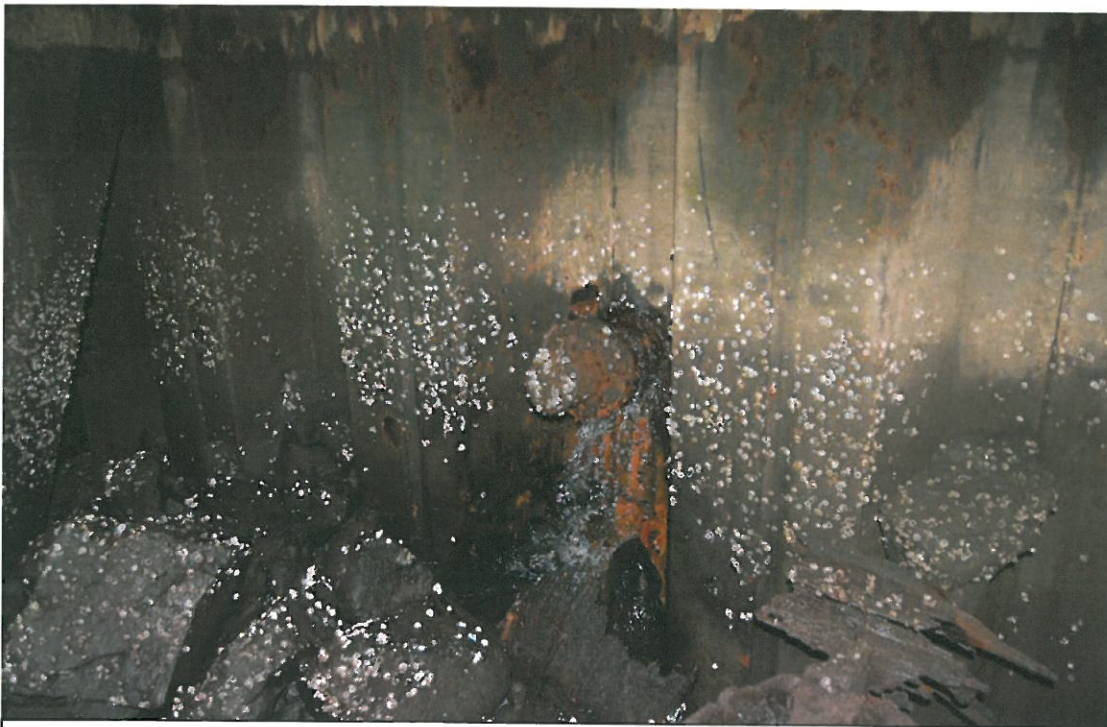
June 14, 2007 - Photo DSC-0014  
Looking west at outfall # T18\_Outfall\_14.

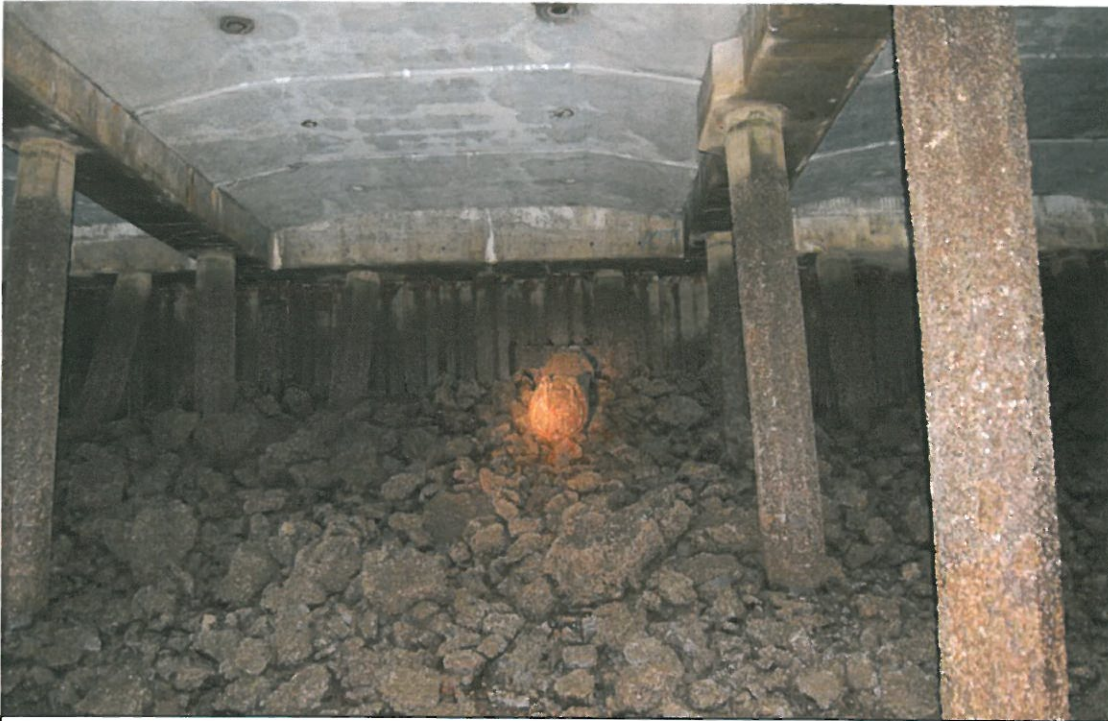
June 14, 2007 - Photo DSC-0012  
Looking west at outfall # T18\_Outfall\_15.

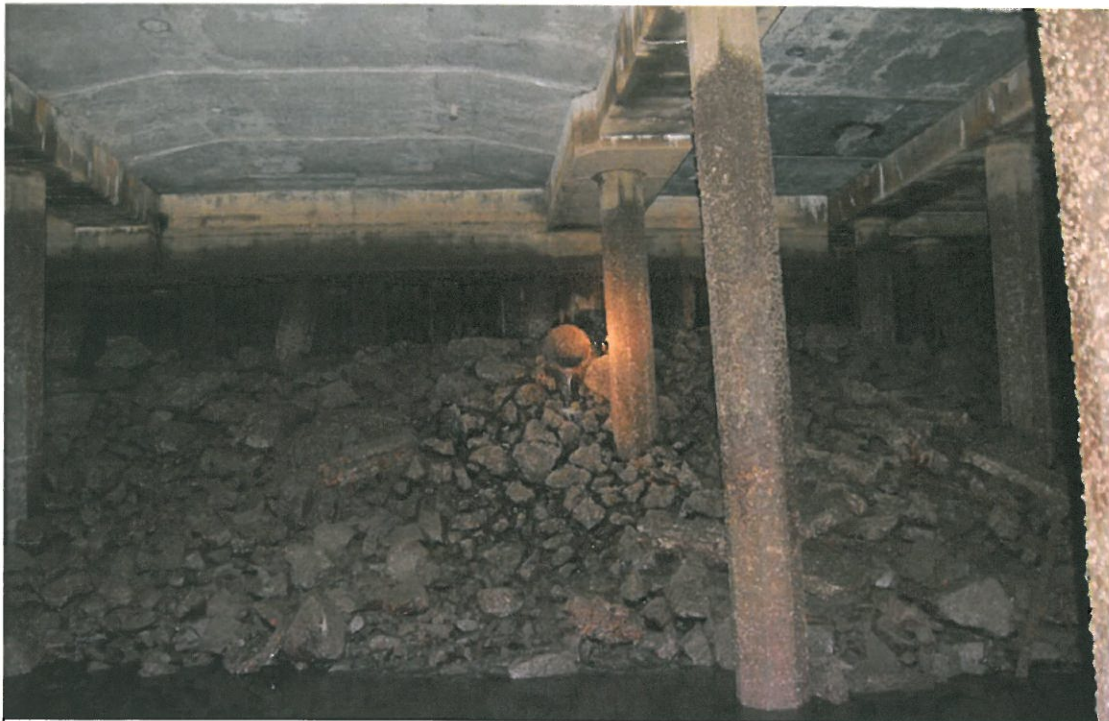
June 14, 2007 - Photo DSC-0010  
Looking west at outfall # T18\_Outfall\_16.

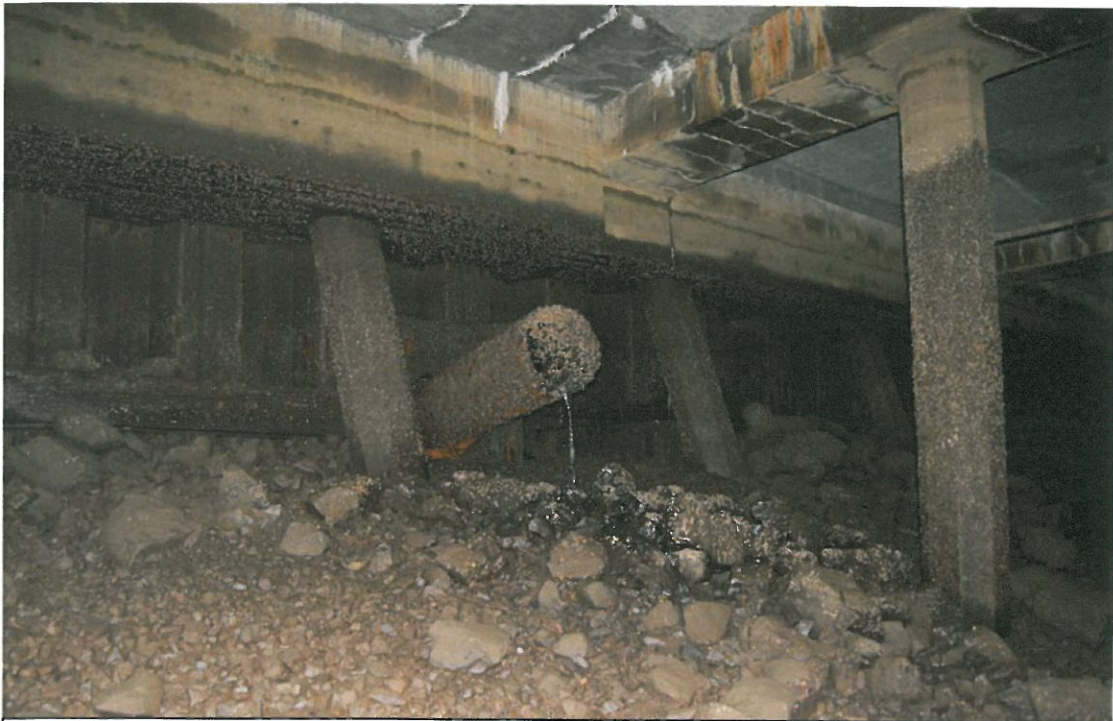
June 14, 2007 - Photo DSC-0007  
Looking west at outfall # T18\_Outfall\_17.

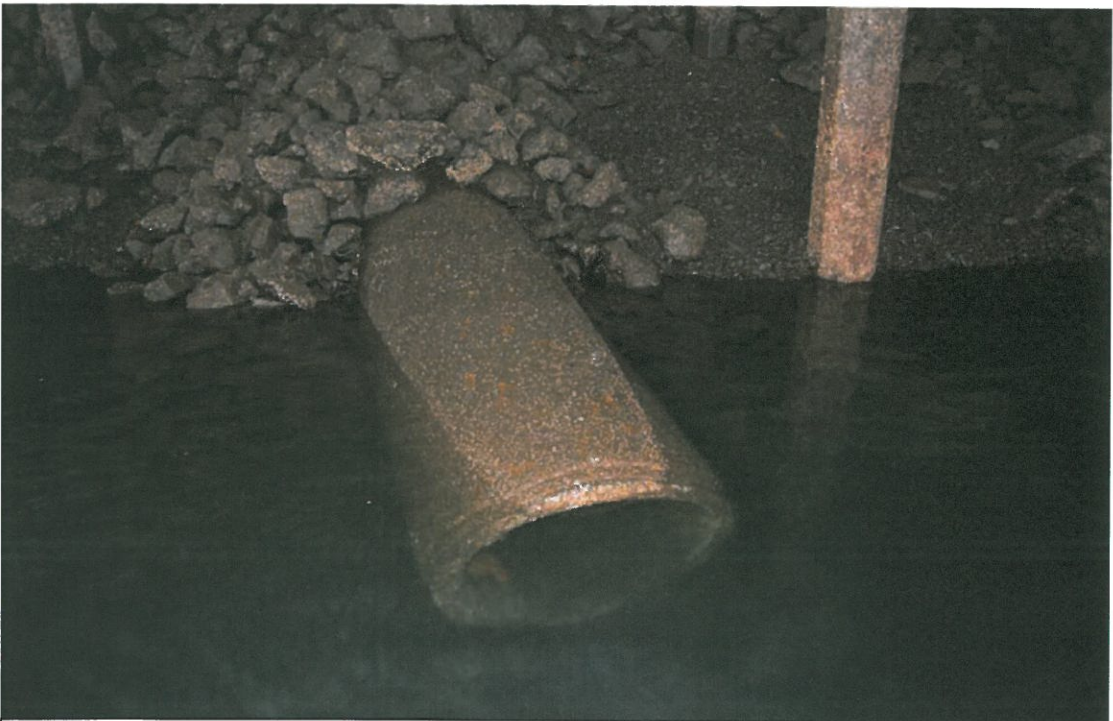
June 14, 2007 - Photo DSC-0004  
Looking west at outfall # T18\_Outfall\_18.

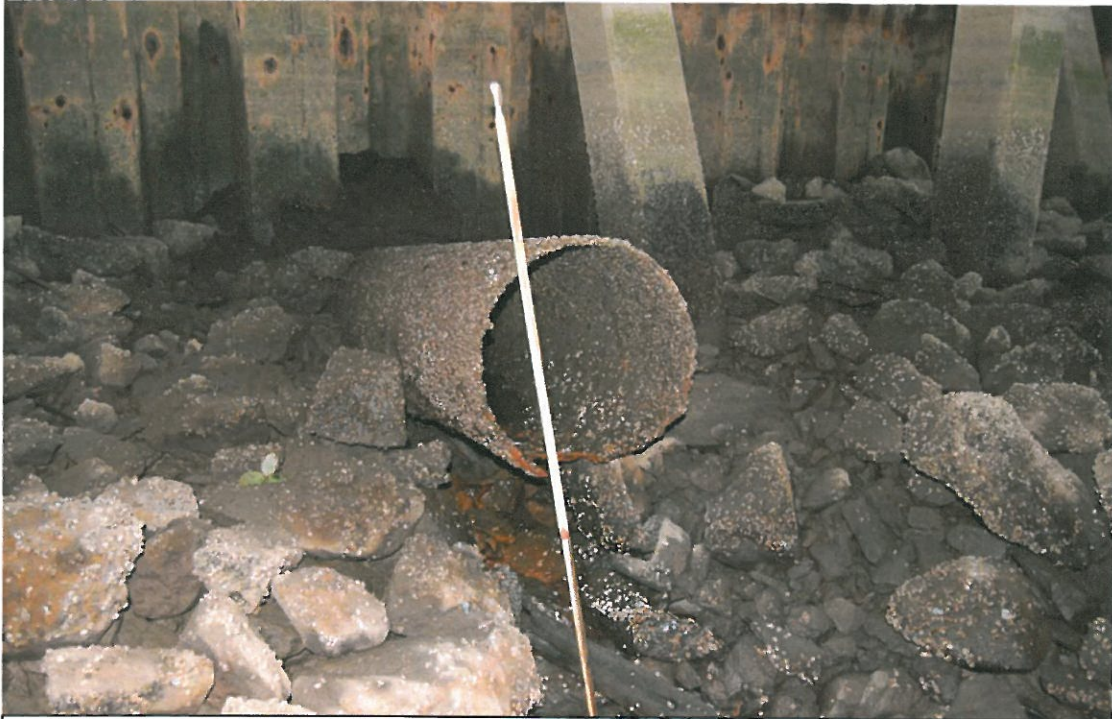
June 14, 2007 - Photo DSC-0103  
Looking west at outfall # T18\_Outfall\_19.

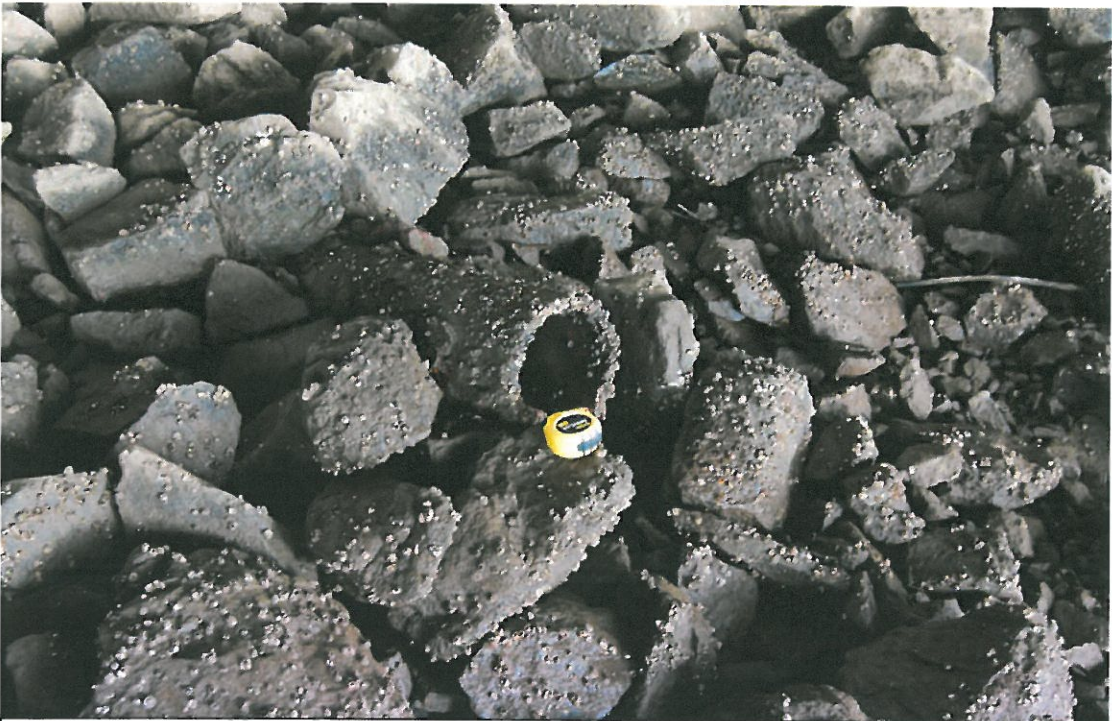
June 14, 2007 - Photo DSC-0101  
Looking west at outfall # T18\_Outfall\_20.

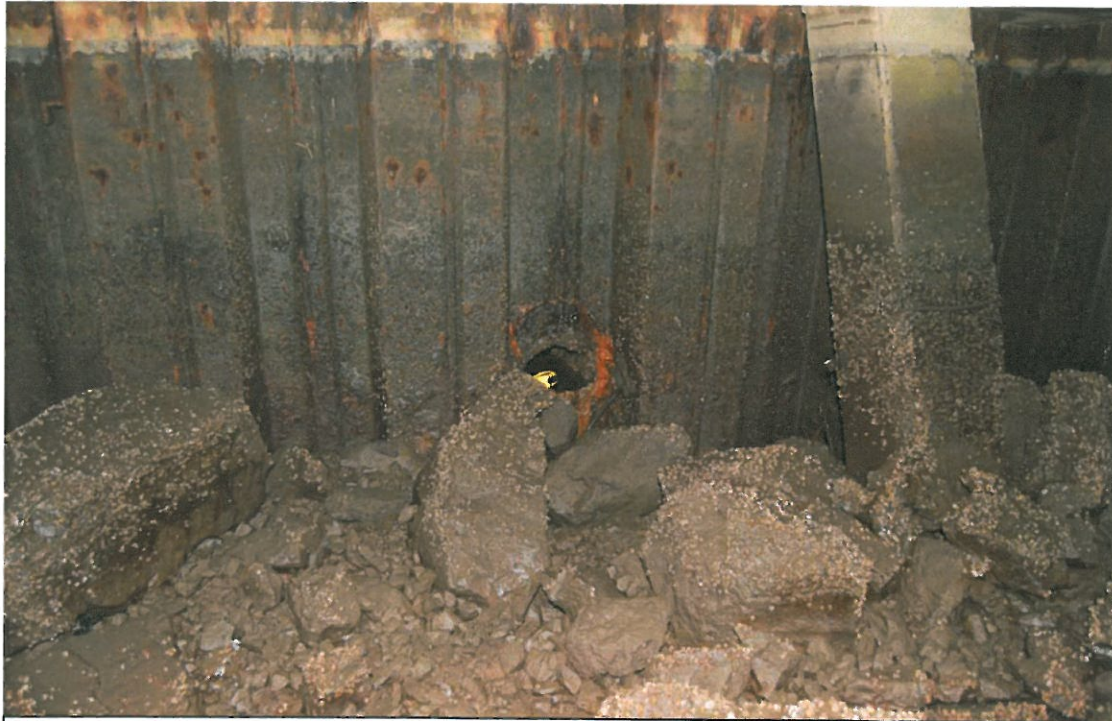
June 14, 2007 - Photo DSC-0001  
Looking west at outfall # T18\_Outfall\_21.

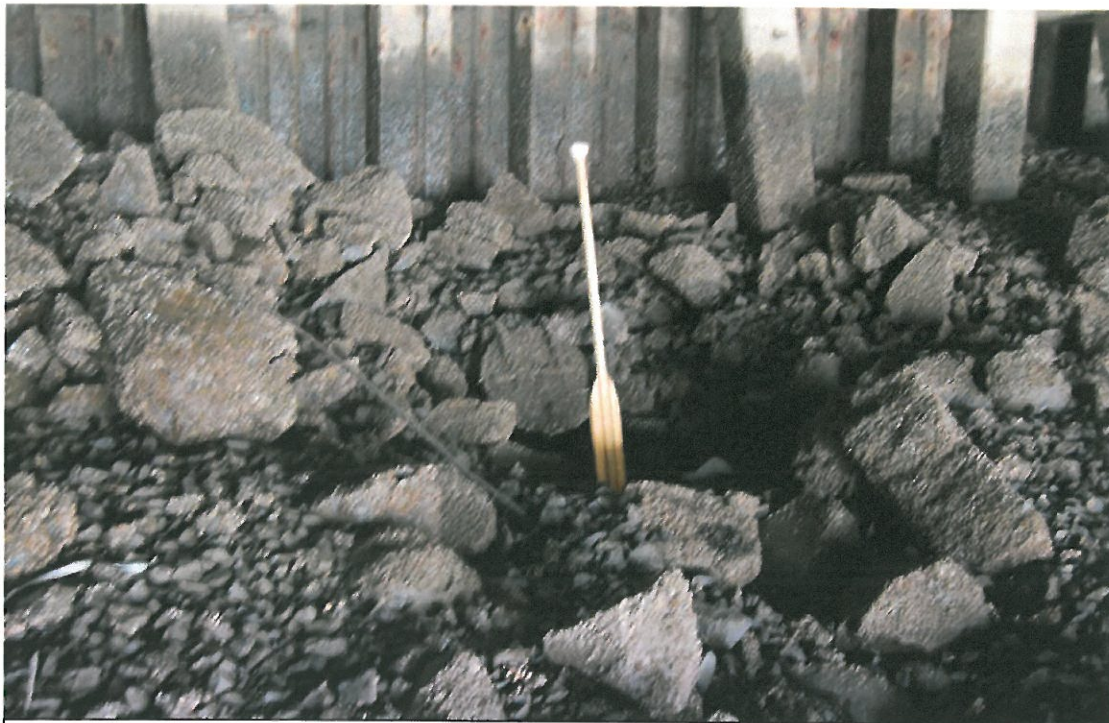
June 14, 2007 - Photo DSC-0099  
Looking west at outfall # T18\_Outfall\_22.

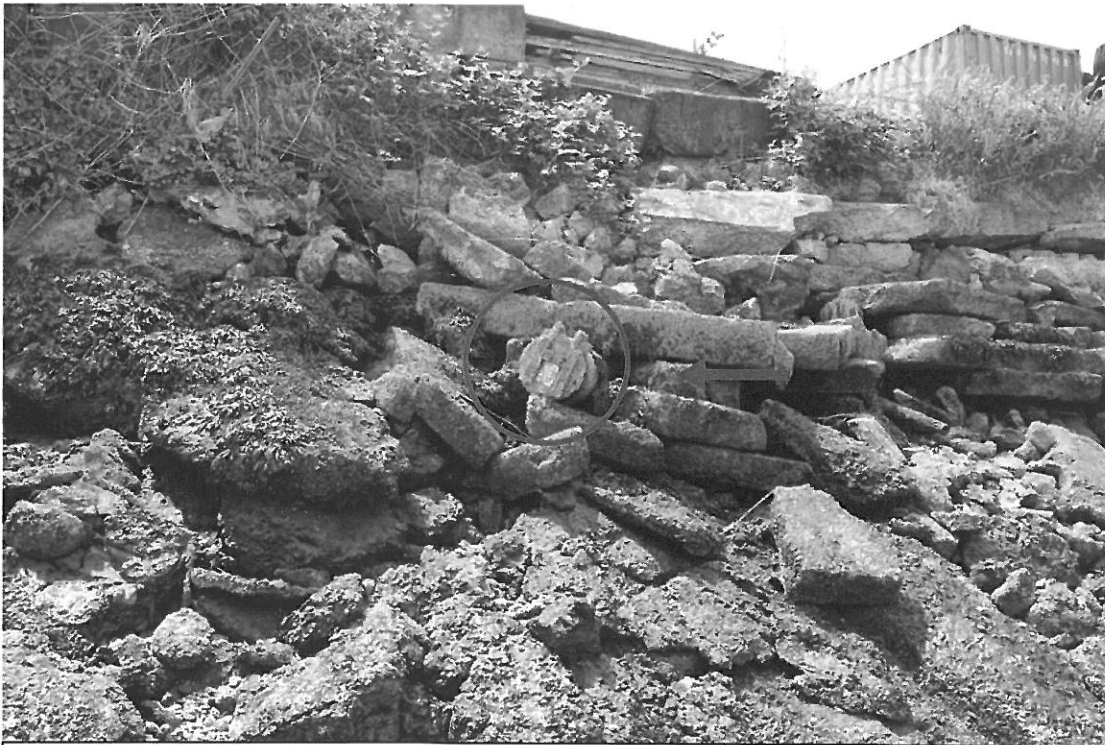
June 14, 2007 - Photo DSC-0100

Looking south at outfall # Harbor Island Outfall\_01 located SE of Terminal 18.

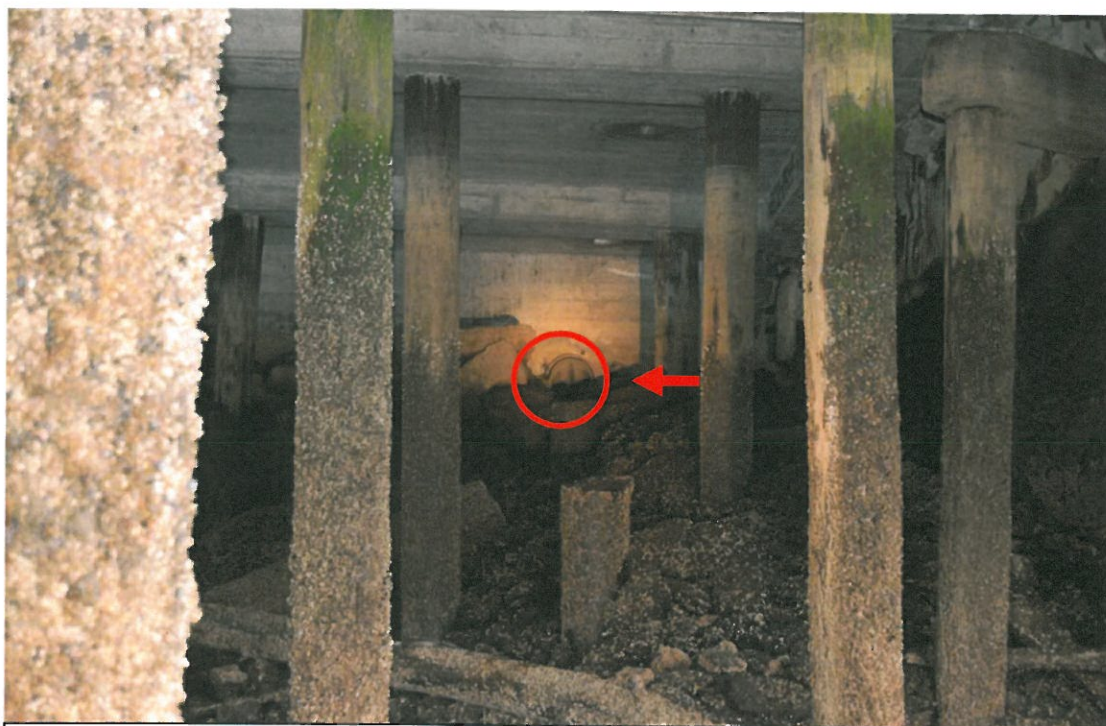
June 14, 2007 - Photo DSC-0007  
Looking West at Harbor Island Outfall\_02 located SE of Terminal 18.

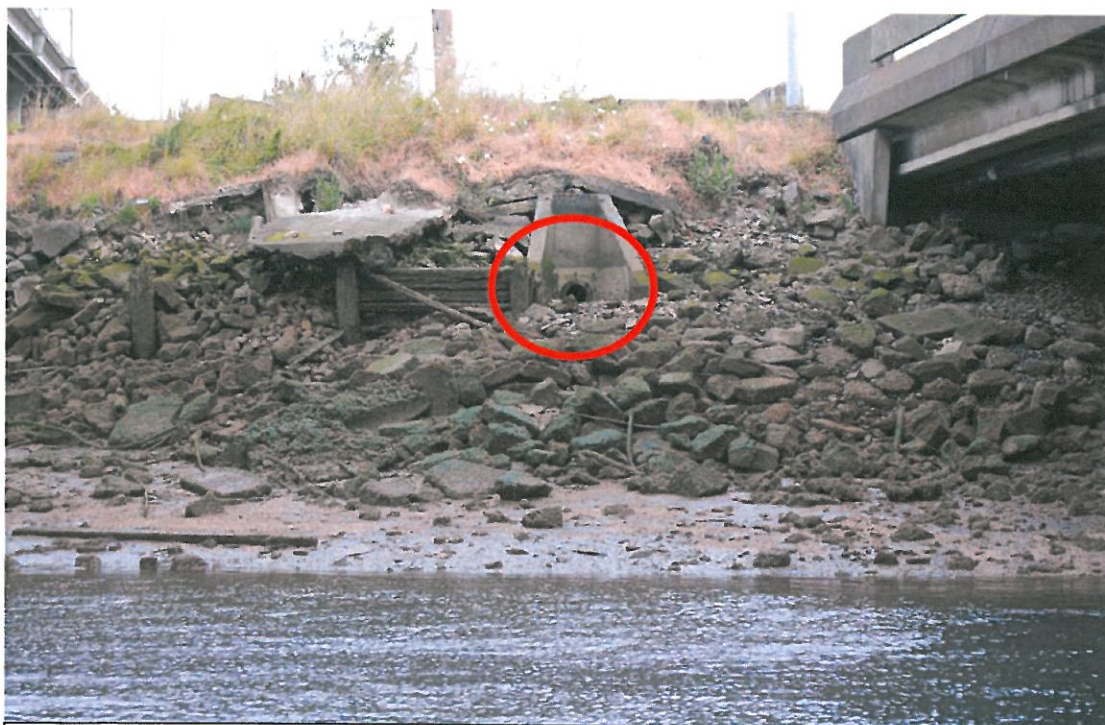
June 14, 2007 - Photo DSC-0004  
Looking West at Harbor Island Outfall\_03 located SE of Terminal 18.

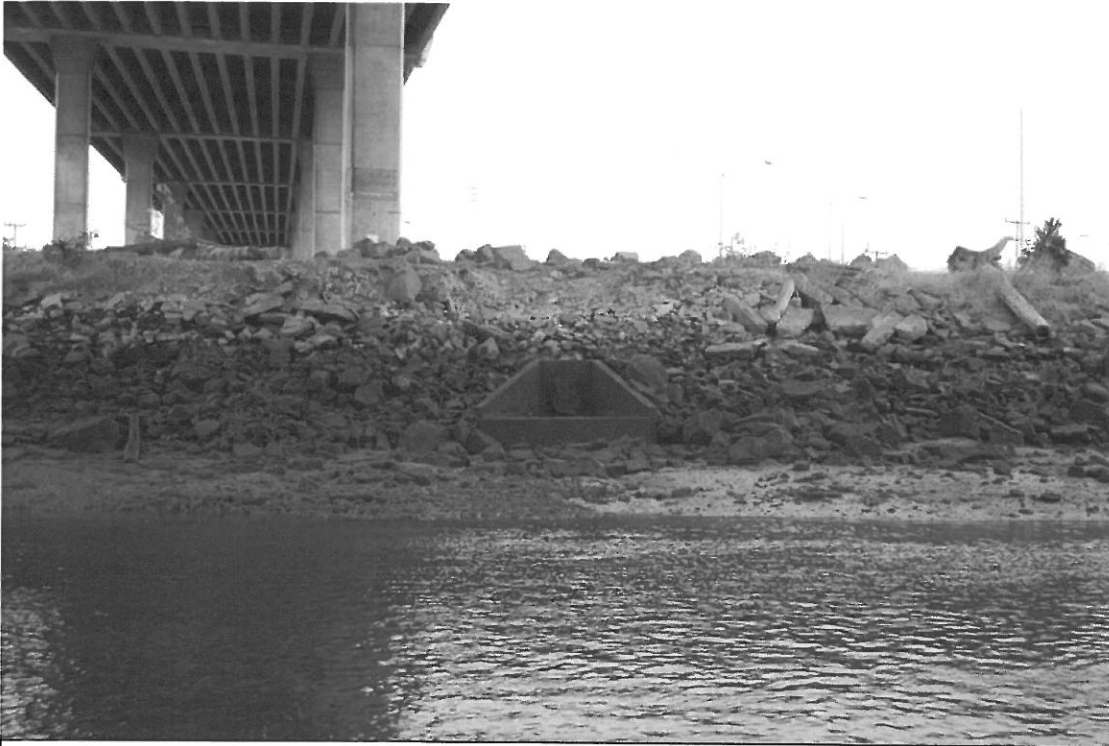
June 14, 2007 - Photo DSC-0001  
Looking West at Harbor Island Outfall\_04 located SE of Terminal 18.

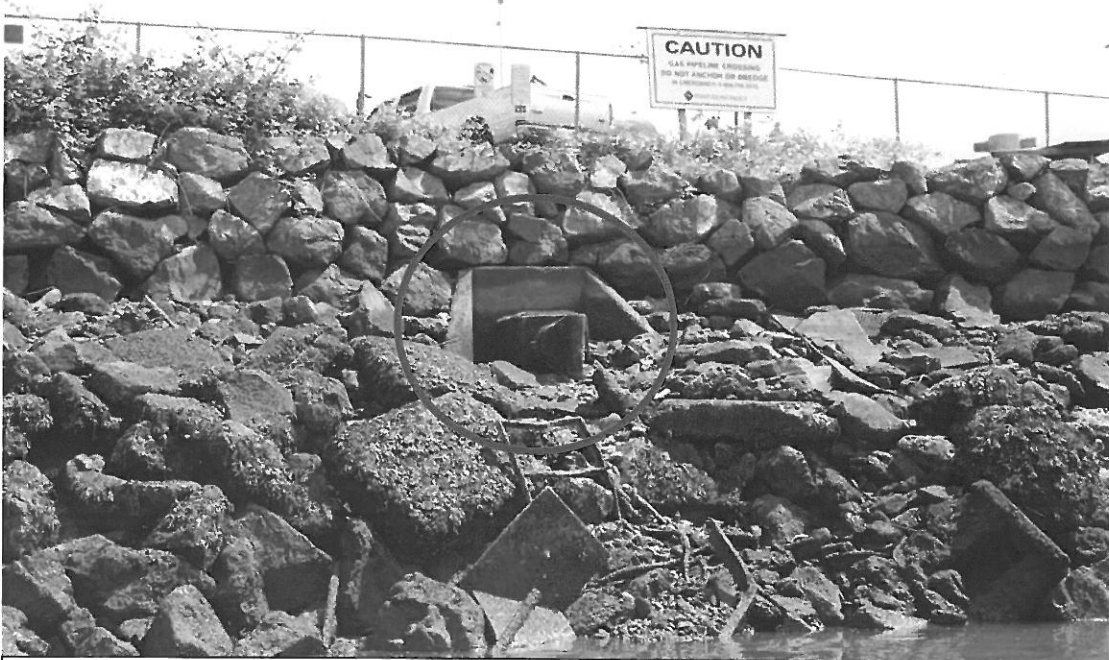
June 14, 2007 - Photo DCS-0040  
Looking east at outfall # Harbor Island\_Outfall\_05.

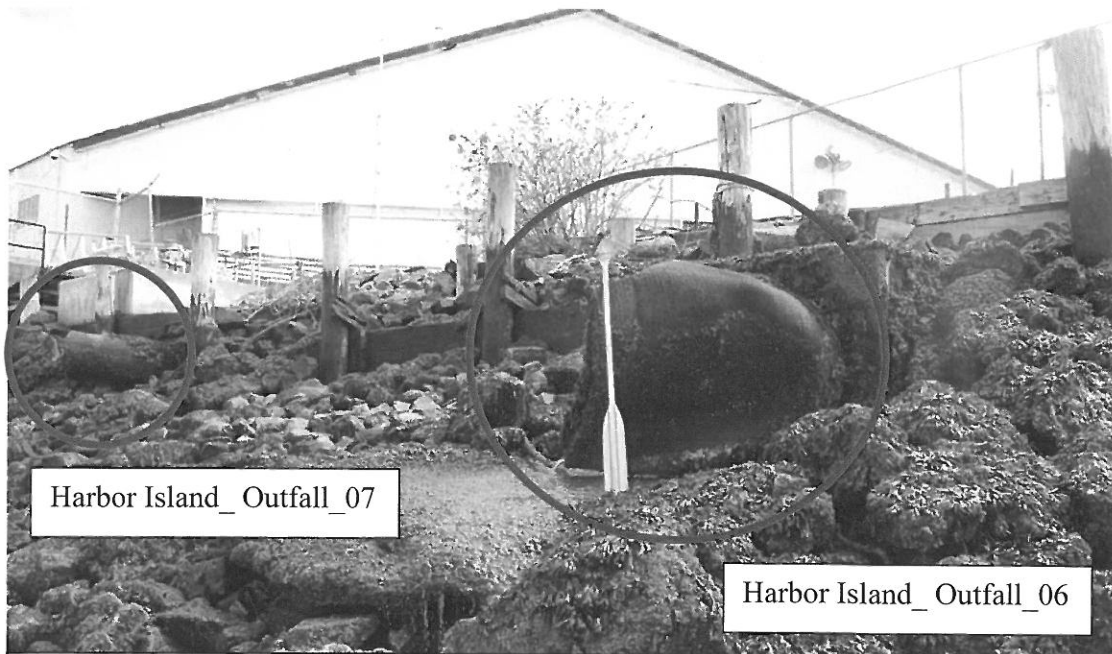
June 14, 2007 - Photo DCS-0037

Looking northeast at outfalls # Harbor Island\_Outfall\_06 and Outfall\_07.

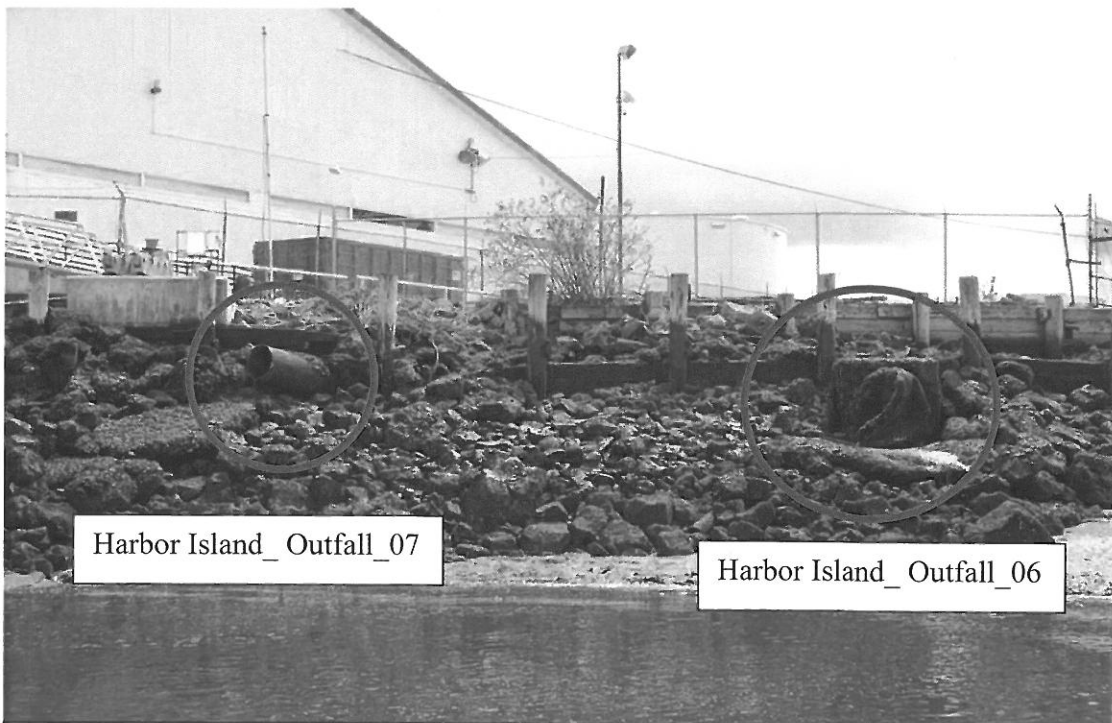
June 14, 2007 - Photo DCS-0036

Looking northeast at outfalls # Harbor Island\_Outfall\_06 and Outfall\_07.

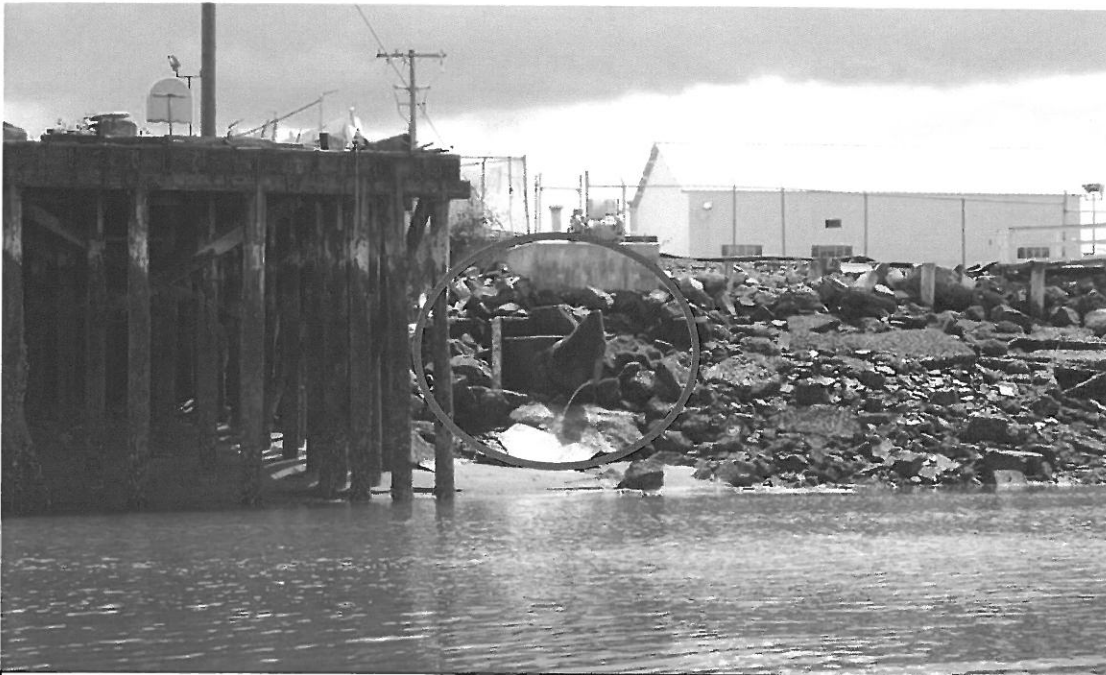
June 14, 2007 - Photo DCS-0030  
Looking east at outfall # Harbor Island\_Outfall\_08.

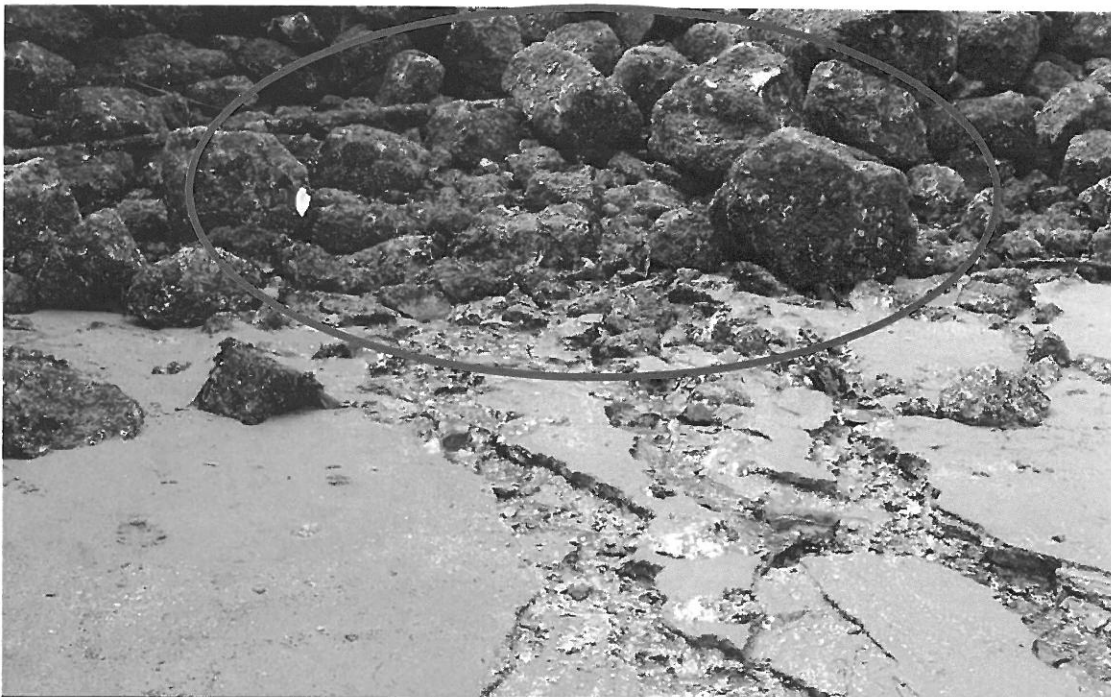
June 14, 2007 - Photo DCS-0025  
Looking south at the general area of outfall # Harbor Island\_Outfall\_09. This outfall was evident by the water flowing from the bank and the associated structures on the surface. The size of this outfall could not be determined.

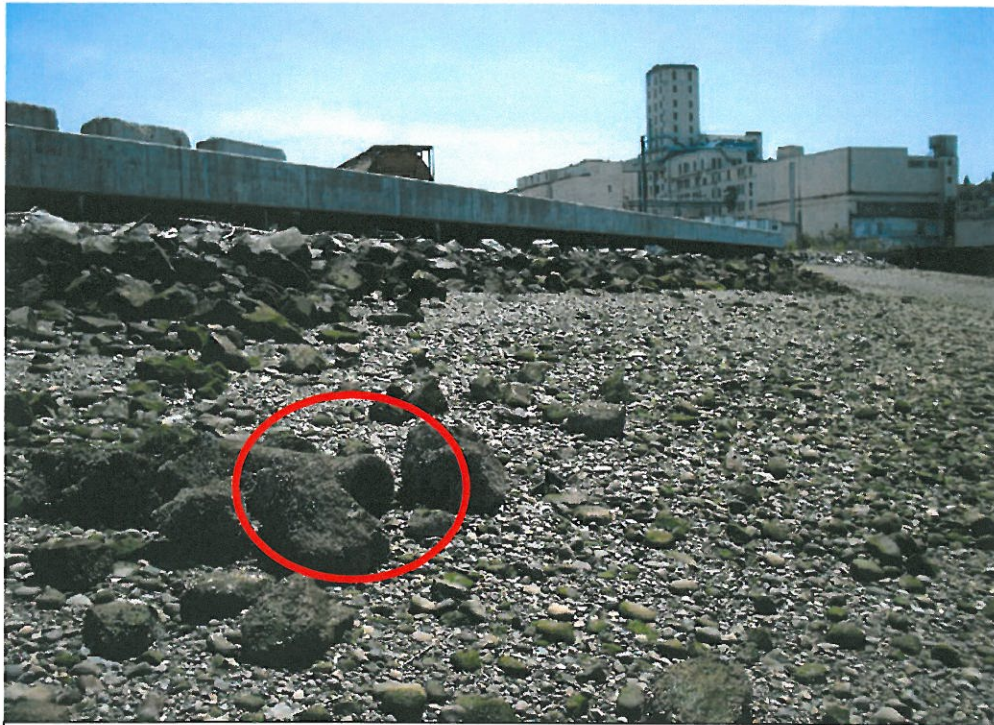
June 14, 2007 – Photo DCS –0038  
 Looking south at outfall # T10\_Outfall\_01.

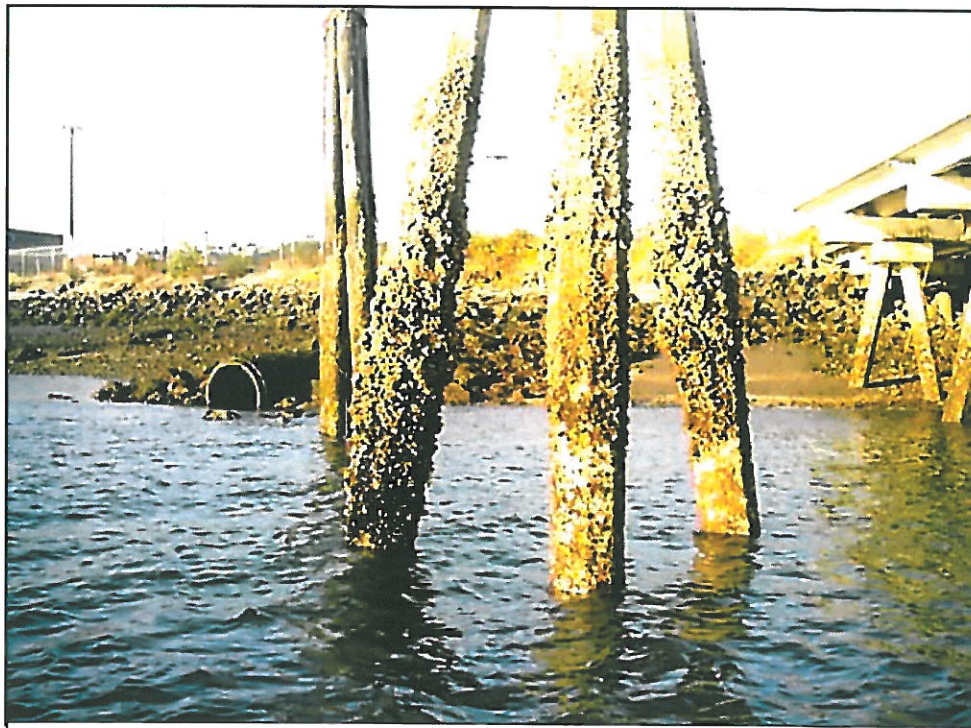
October 4, 2006 – Photo 100-0029  
Looking west at outfall # T5\_Outfall\_06.
