## Outfall Verification Report

**Location:** East, West, and Upper Duwamish Waterway  
**Report Date:** 9/12/2007  
**Inspection Date:** 6/13/2007 & 6/14/2007  
**Present:** Matt Eyer, Phoinix Corporation  
Edwin Wong, Phoinix Corporation  
Tim Fitzgerald, Port of Seattle Contractor

**Purpose:** To locate and verify outfall locations from the Port of Seattle properties into the Duwamish, focusing on the East, West, and Upper Duwamish waterway. Also to confirm and obtain outfall pipe sizes, material, photos, and location.

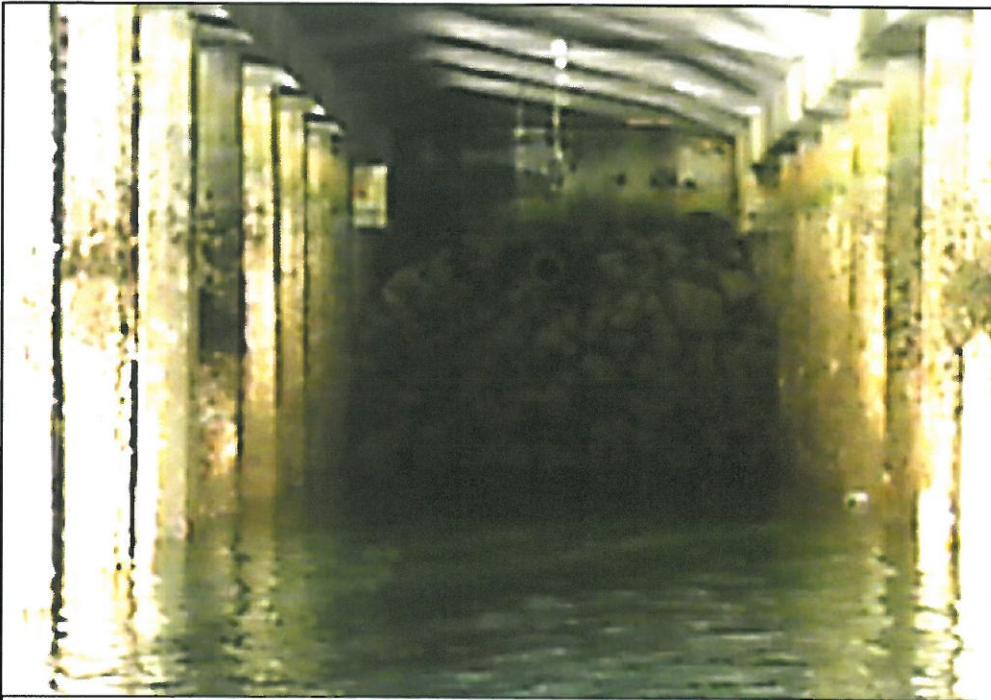
October 4, 2006 – Photo 100-0032  
Looking west at outfall # T5\_Outfall\_07.

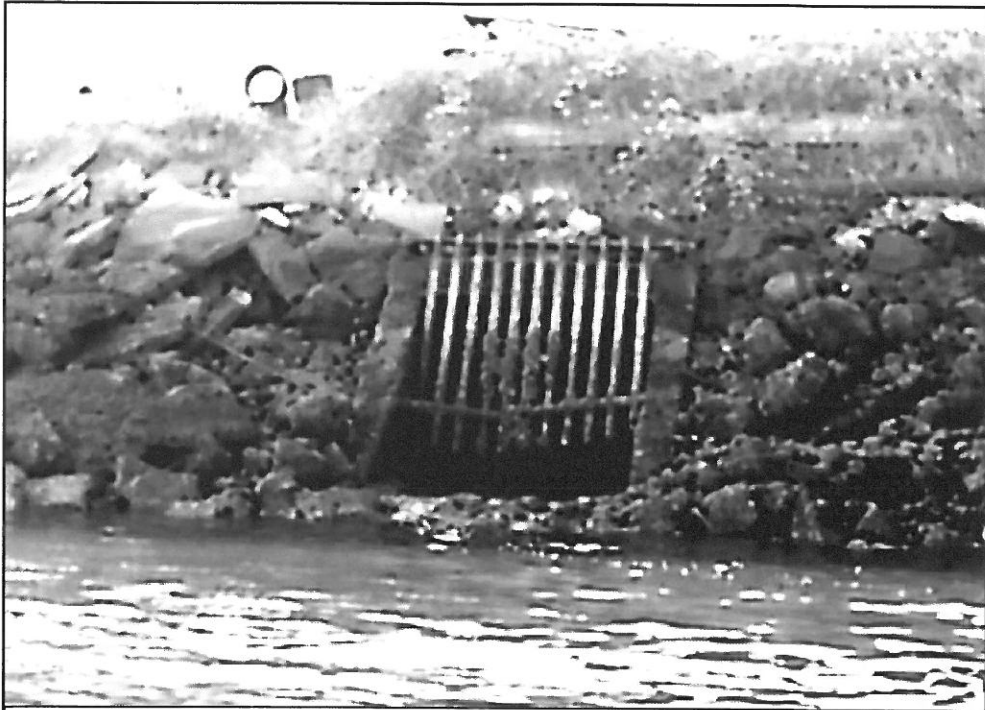
October 4, 2006 – Photo 100-0045  
Looking southwest at outfall # T5\_Outfall\_14.

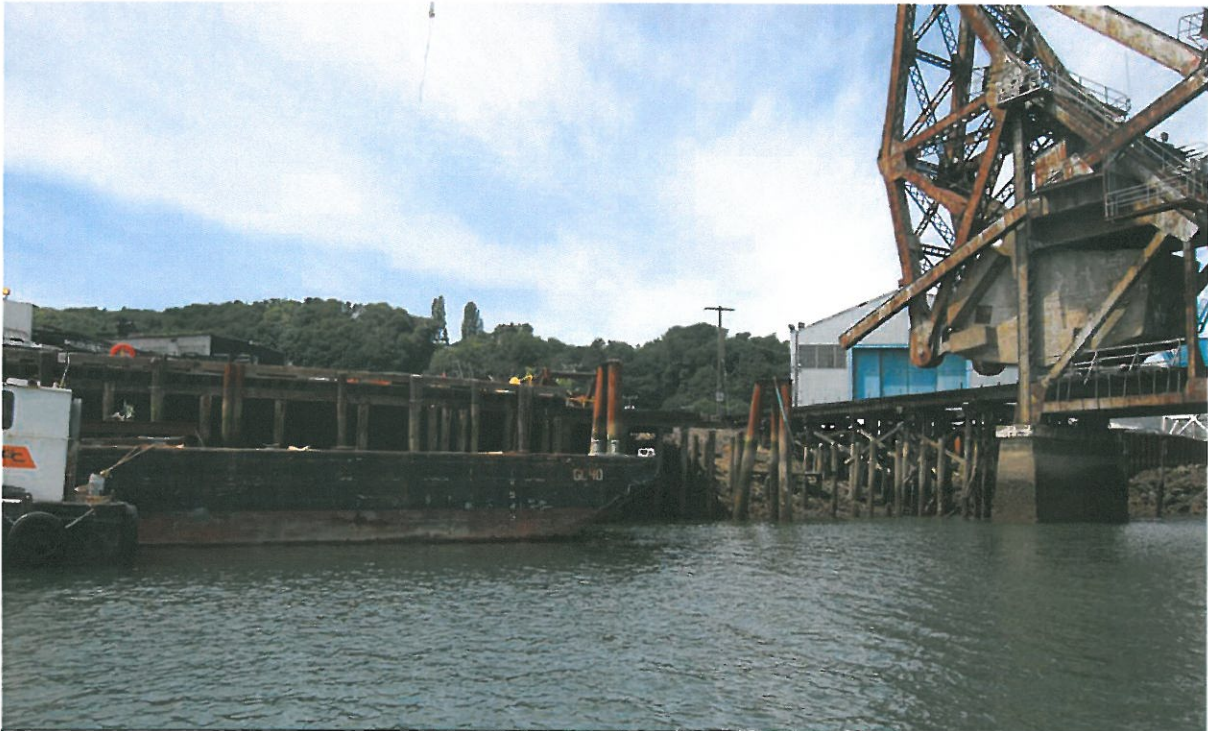
June 14, 2007 – Photo DCS-0046

Looking northwest at the area of the shoreline where outfall T103\_Outfall\_01 was reported to be by the facility manager. As the photo shows access to this outfall will likely be limited.

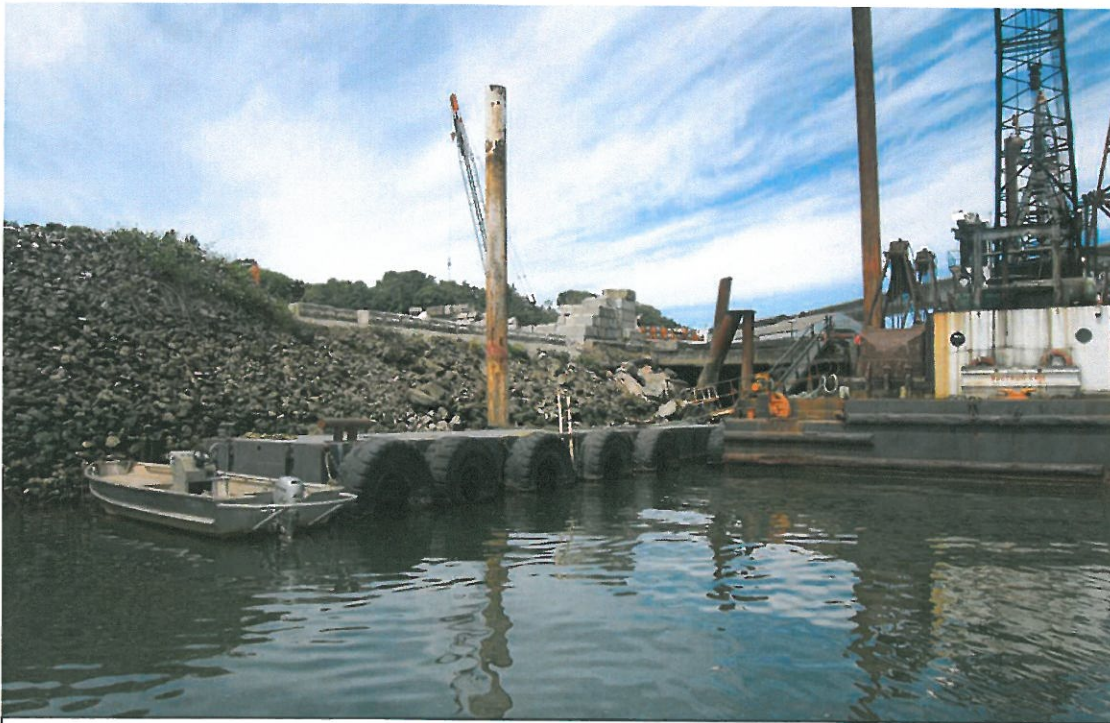
June 14, 2007 – Photo DCS-0045

Looking northwest at the general area of the shoreline of outfall T103\_Outfall\_02.

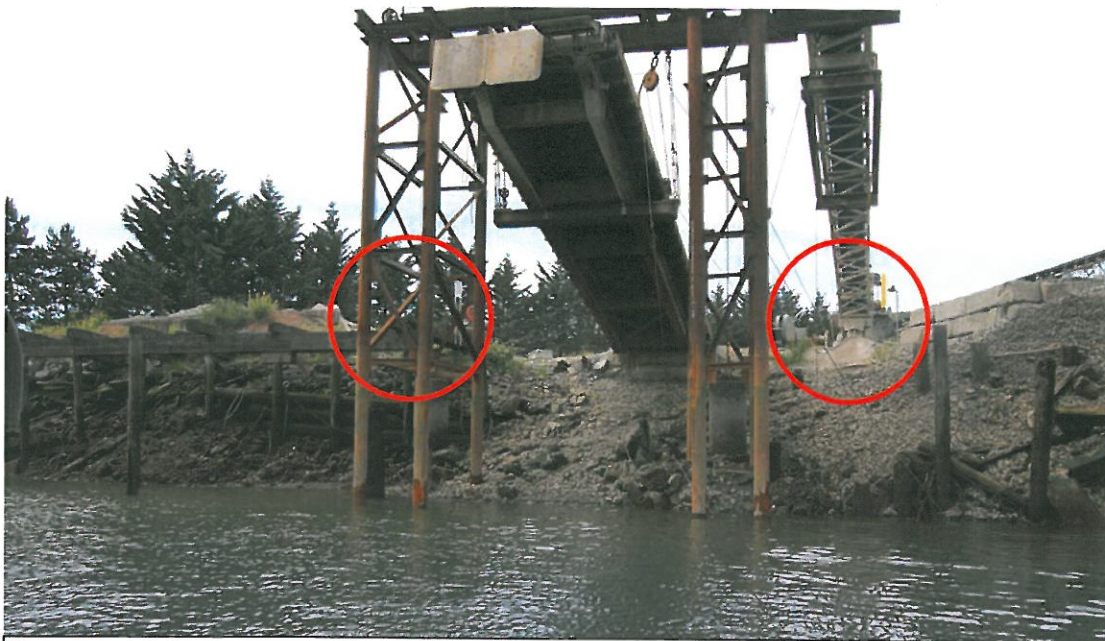
June 14, 2007 – Photo DCS-0043

Looking west at the location of the discharge areas T103\_outfall\_03 (on left side of photo) and T103\_Outfall\_04 (on right side of photo).
