***Preliminary Environmental Site Evaluation and
Focused Pentachlorophenol Explorations
Merrill and Ring, Inc.
Port Angeles, Washington***

***Prepared for
Merrill and Ring, Inc.
and
Davis Wright & Jones***

June 28, 1988

J-2159-03

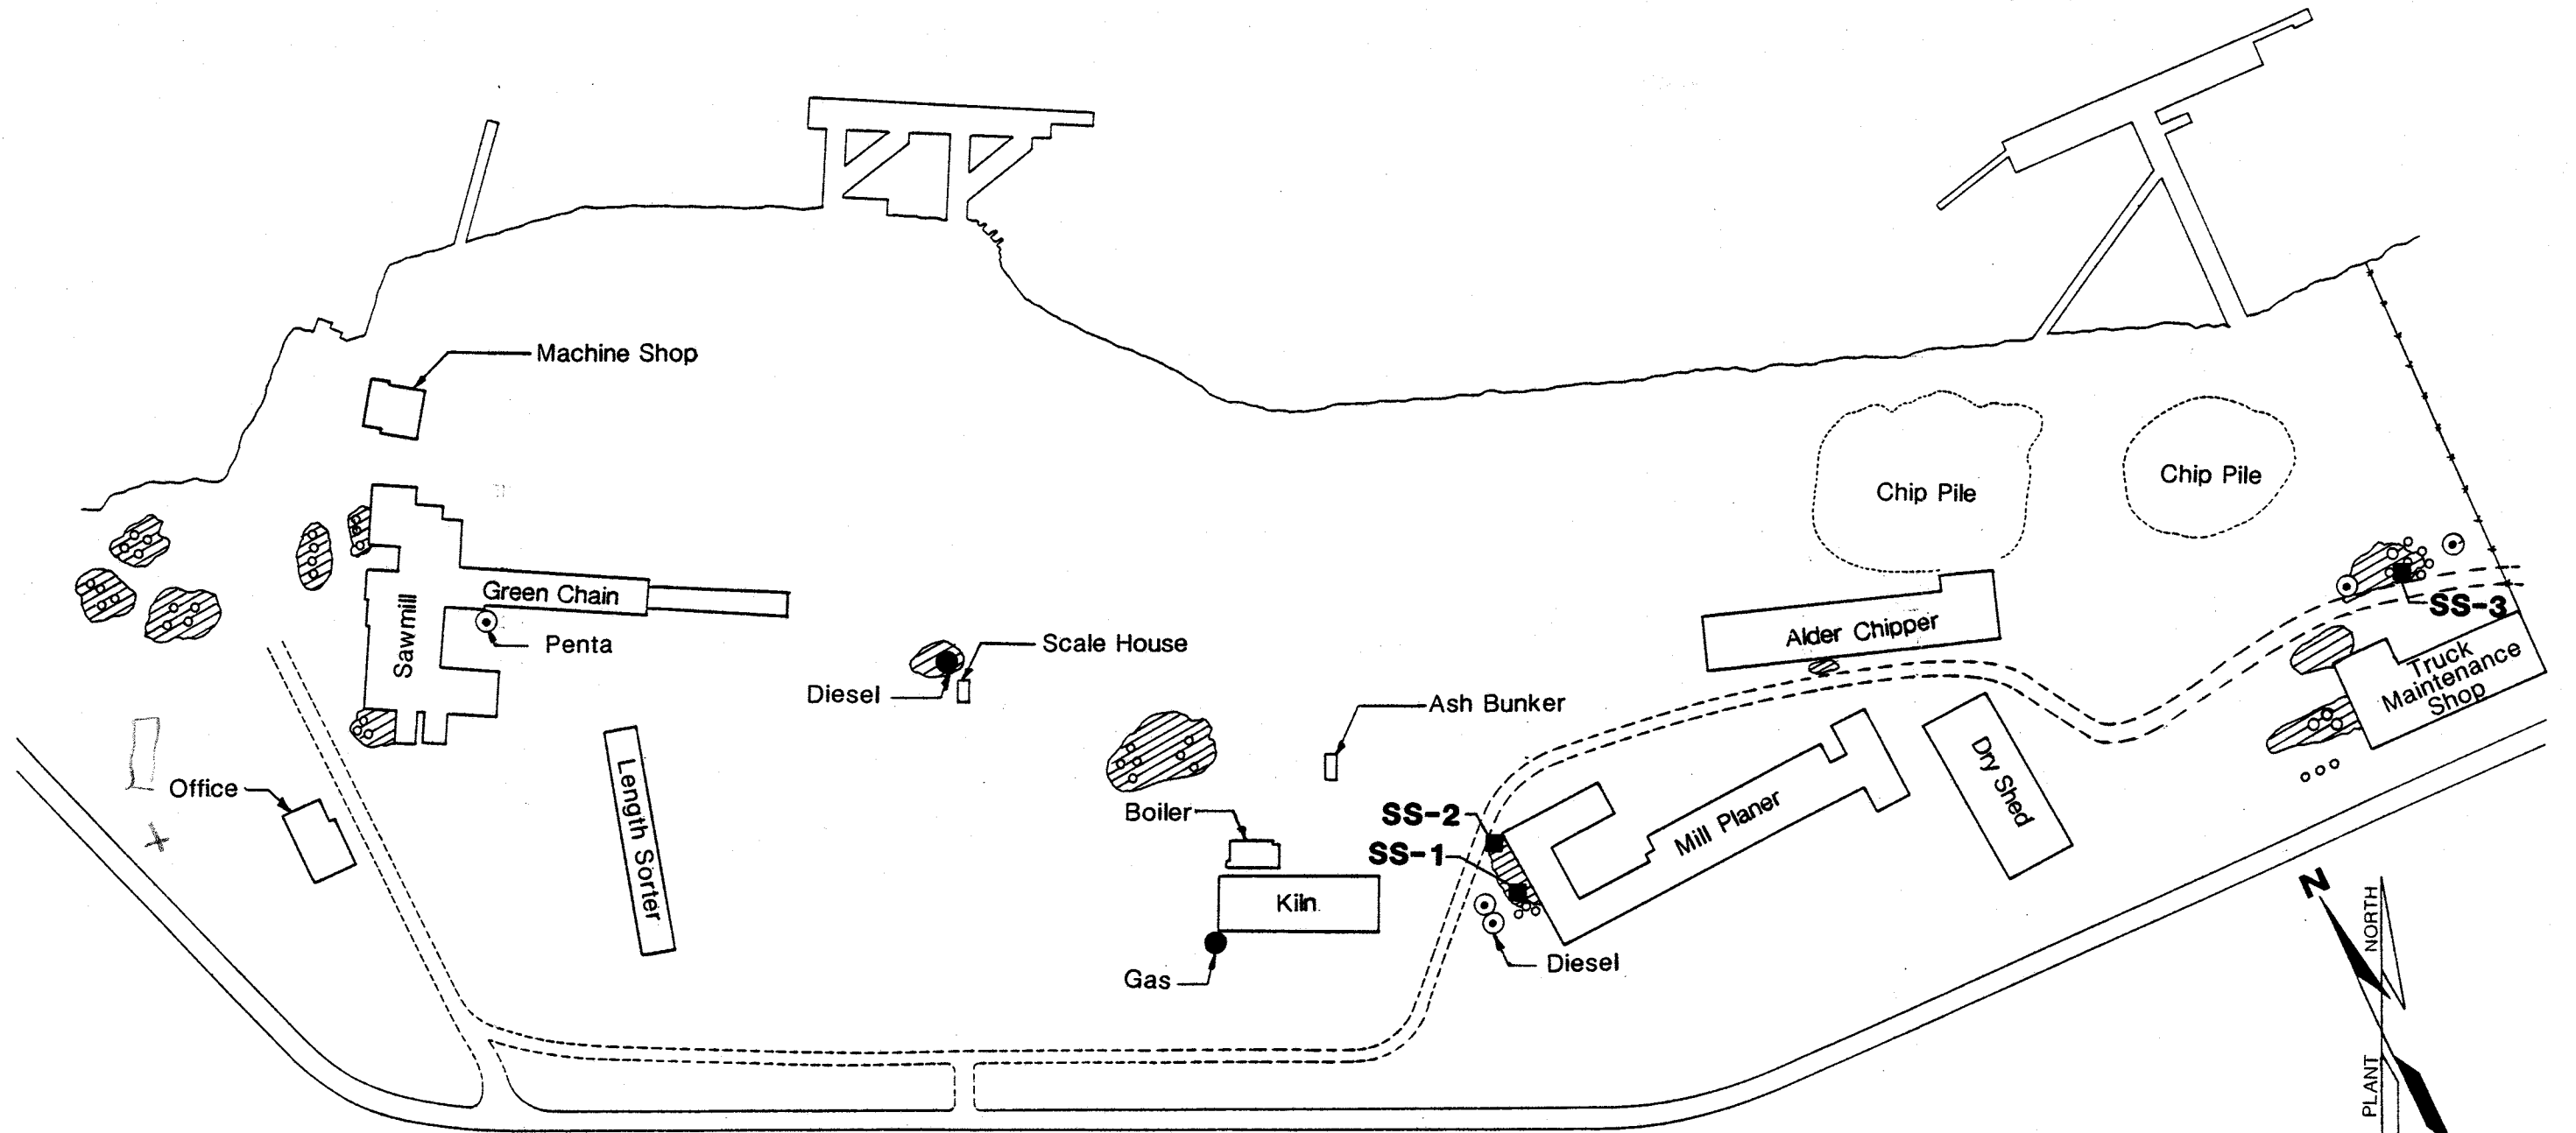
Soil Staining Storage Tanks and Surface Soil Sampling Locations Plan

The areas of noticeable surface stains observed during the site reconnaissance are shown on Figure 8 and are discussed below. Appendix B contains photographic documentation of the reconnaissance including stained soils. Appendix C contains sampling procedures and exploration logs.

Visual observations revealed stained soils at a number of locations shown on Figure 8. The surface soil sample (SS-2) collected near the new planer mill was found to contain phenols. Pentachlorophenol (270,000 ug/kg) and tetrachlorophenol (40,000 ug/kg) were measured at relatively high concentrations as were sodium tetrachlorophenate (4,000 ug/kg) and sodium pentachlorophenate (17,000 ug/kg). Data evaluation of sample SS-2 is discussed in subsection 2.5.3.2. The other surface soil sample (SS-3), obtained at the east end of the property, was analyzed using the GC/FID screen. A concentration of 2,400,000 ug/kg, was detected indicating that significant levels of solvent extractable compounds exist in the surface soil at this location.

surface. In order to reduce potential sources of subsurface contamination we recommend that all surface stains be removed down to a depth where visual evidence and odors no longer exist.

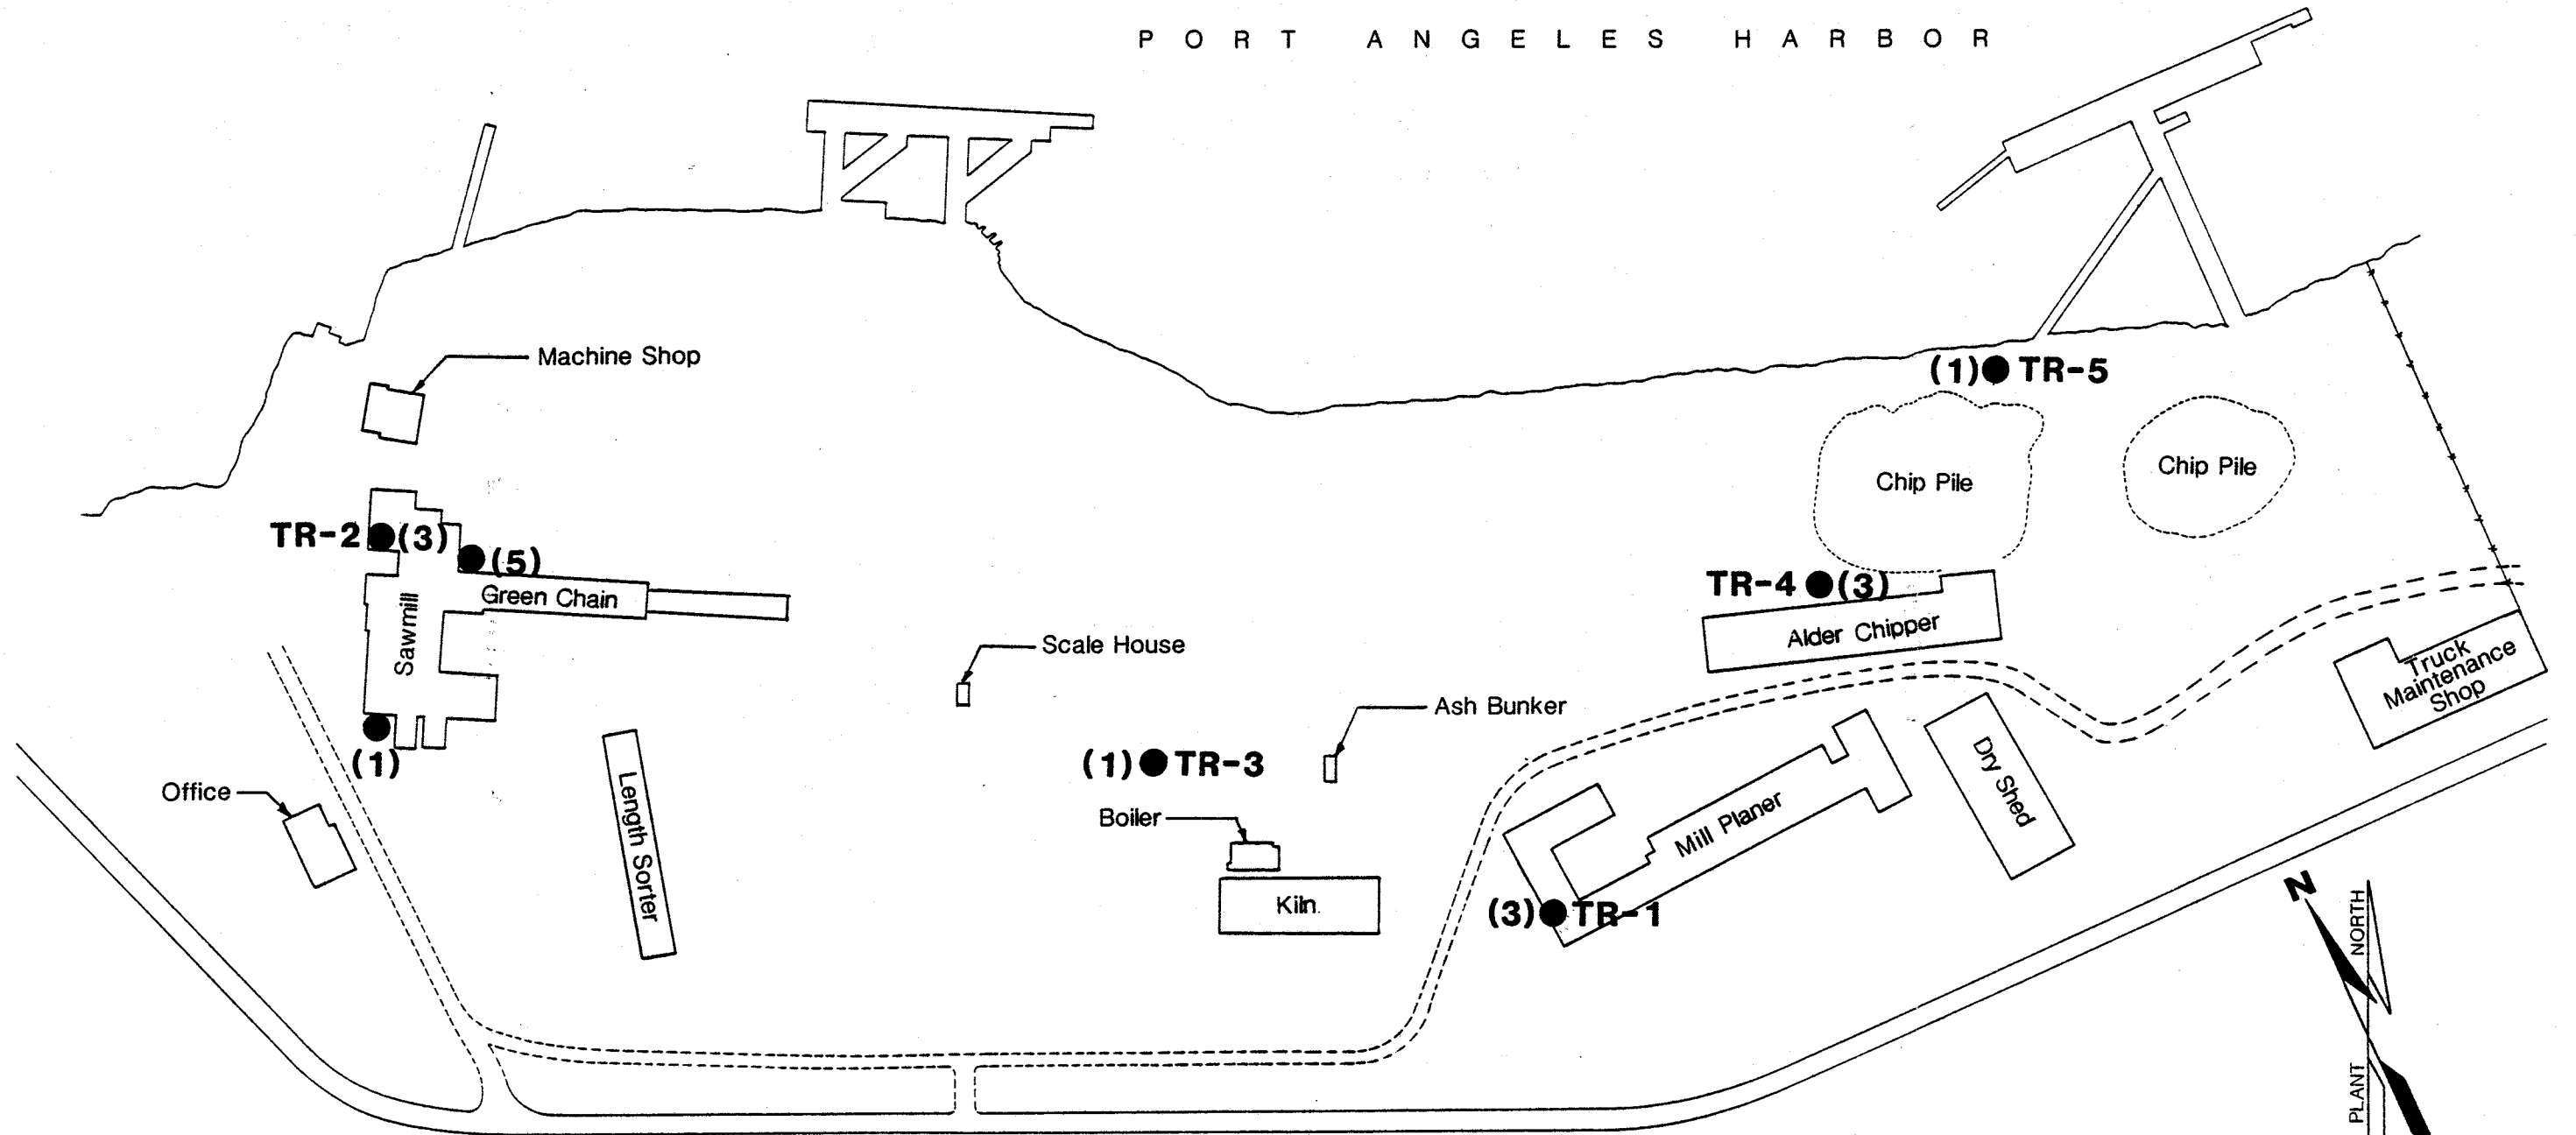
Transformer Sampling Location Plan

During the preliminary assessment, Hart Crowser observed all transformers known to be on site. Samples for PCB analysis were obtained, if possible, adjacent to transformers that appeared to be leaking. Figure 9 shows transformer locations and sampling points. Documentation of transformer identification label information and close observation of the transformers were not possible due to electrical hazard.

The transformer reconnaissance results are shown on Figure 9 and are discussed below. Appendix B contains photographic documentation of the walk through and any leaking transformers. We do not know whether all transformers on-site have been analyzed for PCBs. Appendix C contains sampling procedures.
