**Assessment of
PCB Contamination**

**Snoqualmie Falls
Plywood Plant
Fire Site**

**Weyerhaeuser
Cascade
Division**

MARCH 1989

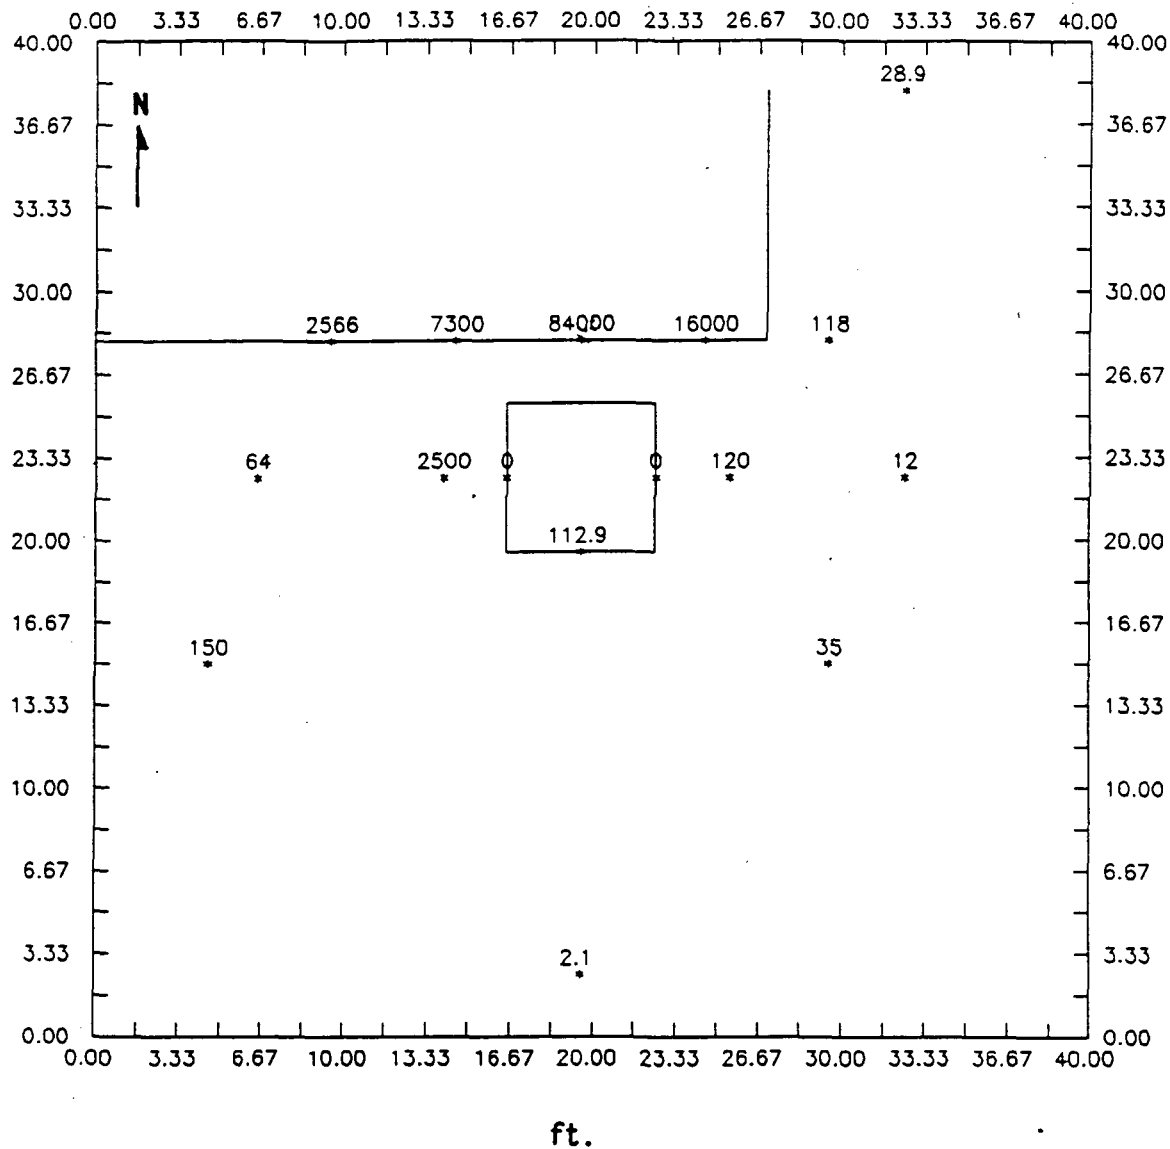
Figure 3.1 Transformer Pad T-12: PCB Concentrations at Sampling Stations (ppm)

At Transformer pad T-12, the soil and the bottom of the excavated trench (2-ft deep - sample 12-09-SL-SS-02) contained 84,000 ppm PCB. This level decreased somewhat to adjacent (5-ft distant) stations 09A and 09B, where the bottom-of-trench PCB concentrations were 7,300 and 16,000 ppm, respectively. However, these levels of PCBs in soils still indicate direct contact concentrated released fluids. Elevated levels of PCB were also noted further to the west at station 08, which had concentrations of 2,200 and 350 ppm at the 1 and 2-ft levels. Station 5A also had a surface soil PCB concentration of 2,500. The remaining stations all exhibited PCB levels below 150 ppm, typical of secondary contamination in the immediate vicinity of a concentrated spill.

Stations having a PCB concentration between 25 and 150 ppm were 01, 02, 03 04, 5A and 6A. Samples obtained at depth at station 03 indicated PCB concentrations of 9.0 and 4.9 at the 1 and 2-ft levels.

Ash from the fire debris was sampled by HDR Engineering and submitted for PCB analysis. At transformer pad T-12, The ash from station 11 (located on the plant foundation ten feet north of soil sampling station 08 - Figure 3.1). contained less than 0.5 ppm PCB. Ash samples taken at pad T-17 from stations 11 and 12 and 14 (station 14 is a field split sample from station 12) also contained extremely low levels of PCBs: 0.8, 2.7 and 0.6 ppm, respectively.

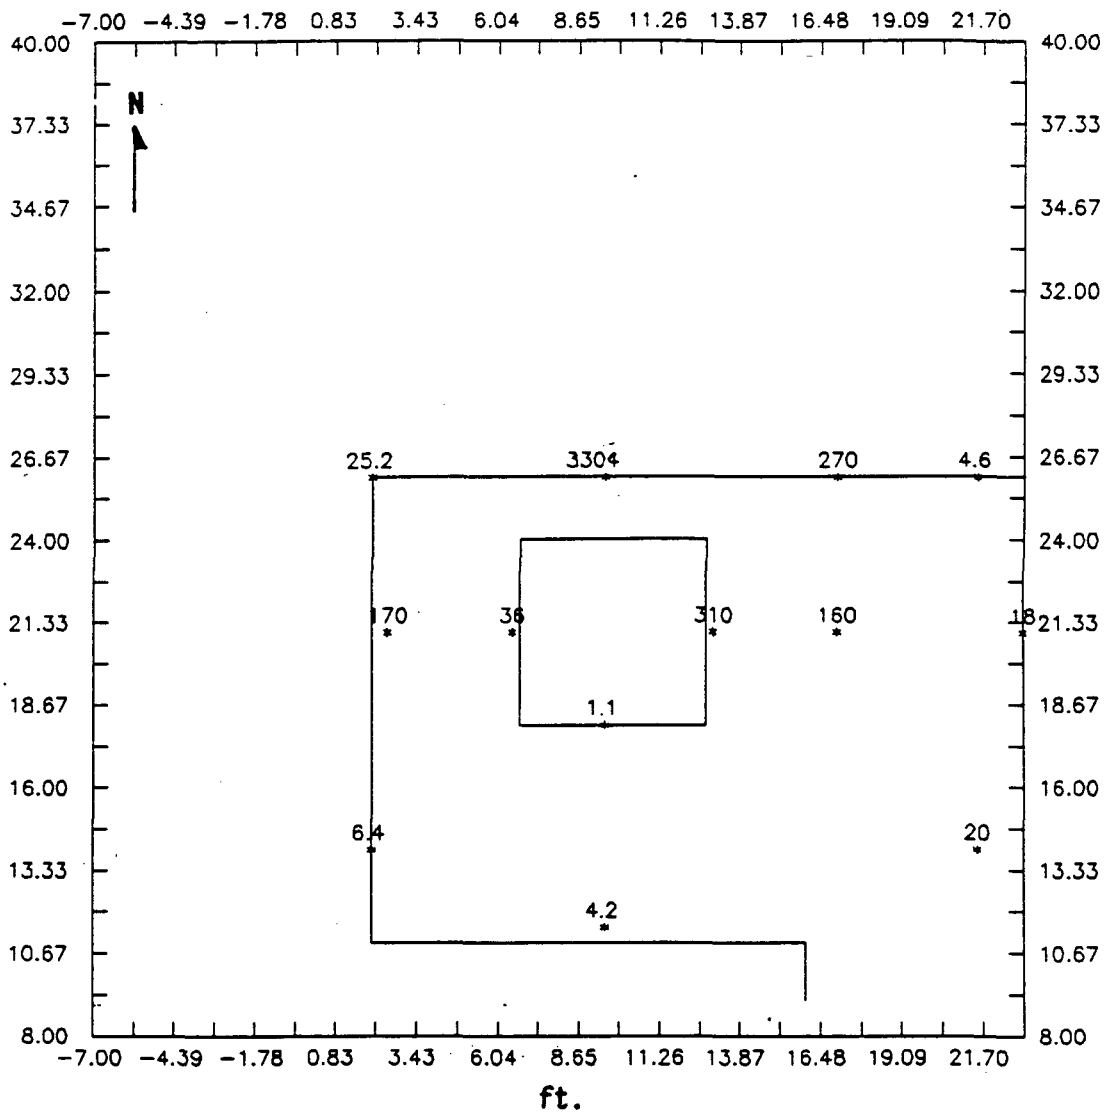
Figure 3.2 Transformer Pad T-17: PCB Concentrations at Sampling Stations (ppm)

The levels of PCB contamination detected at transformer pad T-17 were lower than those encountered at T-12, yet still indicate the presence of spilled concentrated PCB fluids. The highest PCB level (3,300 ppm) was encountered immediately below the transformer secondary bushings (on the north side of the pad) at a depth of 2.5 ft below the original ground surface. A sample obtained immediately above at the 2 ft level (at the bottom of the trench) contained only 4.7 ppm PCBs. This overlying soil may have been dropped back into the trench during the removal of the transformer curbing.

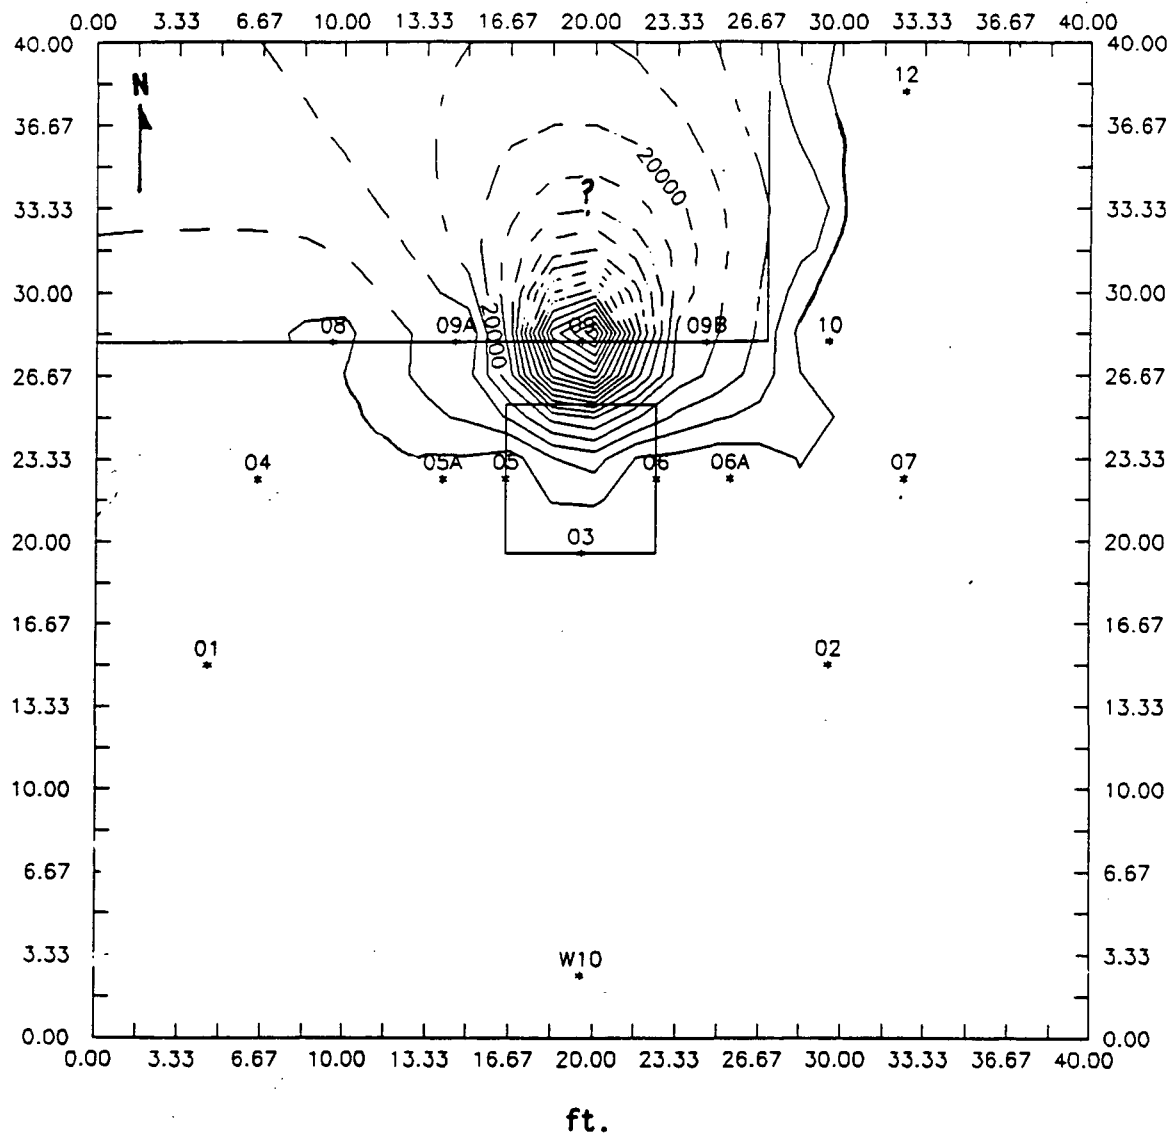
Figure 3.3 Transformer Pad T-12: Estimated PCB Concentration Gradients (summed over all sampling depths). Contour Interval: 4,000 ppm

The areal extent of both fluid releases onto adjacent soils shown in Figures 3.3 and 3.4 is estimated to be approximately 100 and 35 square ft. for transformers T-12 and T-17, respectively. The extent to which contamination extended northward, either onto or underneath the former plywood plant foundations is currently unknown. It is likely that PCB contamination extends at least 2 or 3 ft northward, to the location of the secondary switchgear. Much of this was cleaned up when ash and debris in this area was deposited into drums. The extent of contamination beneath the foundations is difficult to estimate and may only be determined during further cleanup (see "Recommendations" - Section 5.0).
