Date: August 10, 2021 RGI Project Number: 2012-107M

**Subject:** 2021 Annual Inspection Summary

Alamo Manhattan Main Street

10575 Main Street

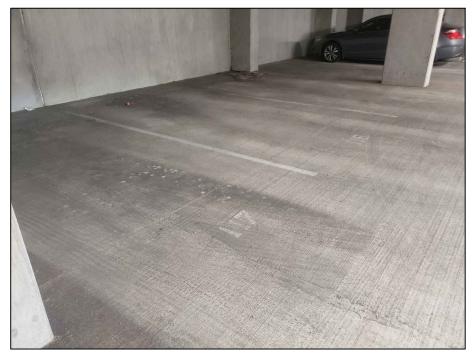
The portions of the concrete garage floor slab situated above Areas 1 and 2 were in good condition and no damage was observed (see Photos 1 through 4). Groundwater monitoring wells RW1, RW2, and MW6 were also in good condition with no damage observed (see Photos 5 through 10).

Photograph 1: View looking northwest at the garage floor slab overlying Area 1.

No further work is recommended at this time. The next annual inspection is scheduled for mid-2022.

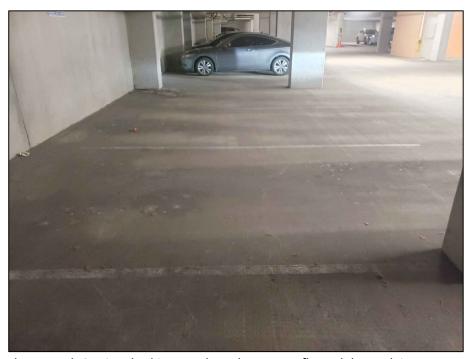
Photograph 2: View looking north at the garage floor slab overlying Area 1.

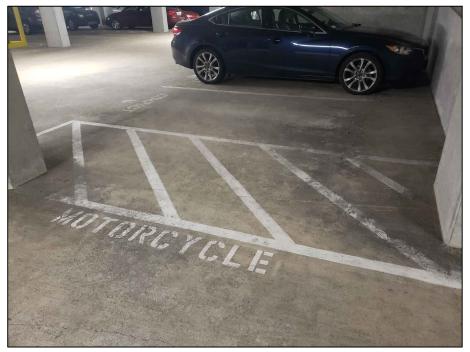
Photograph 3: View looking east at the garage floor slab overlying Area 2.

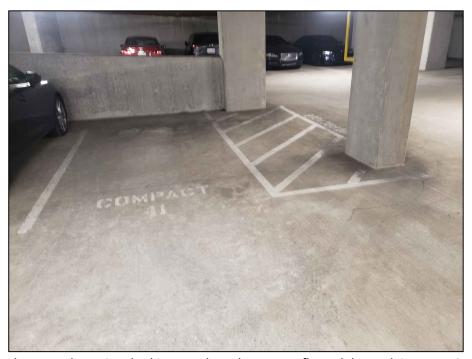
Photograph 4: View looking south at the garage floor slab overlying Area 2.

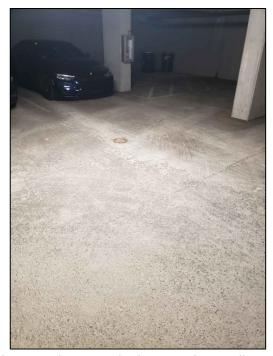
Photograph 5: View looking south at well RW1.

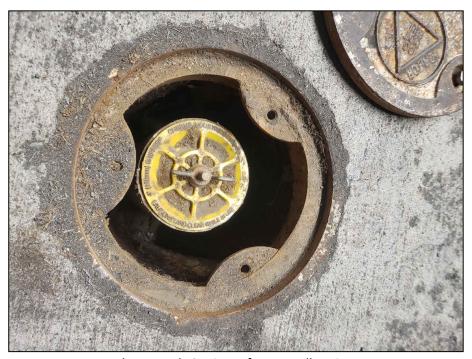
Photograph 6: View of RW1 well casing.

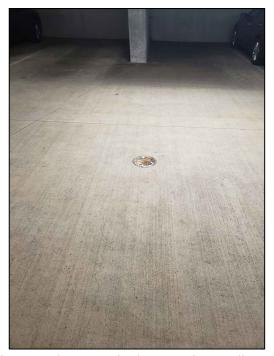
Photograph 7: View looking south at well RW2.

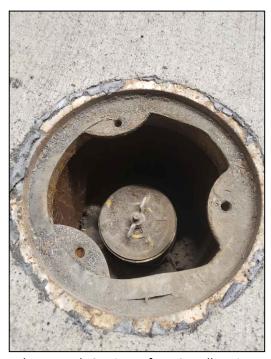
Photograph 8: View of RW2 well casing.

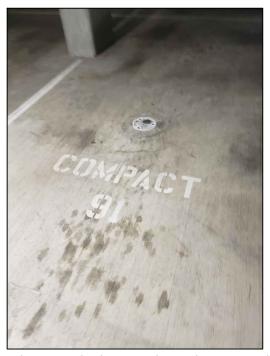
Photograph 9: View looking south-southeast at well MW6.

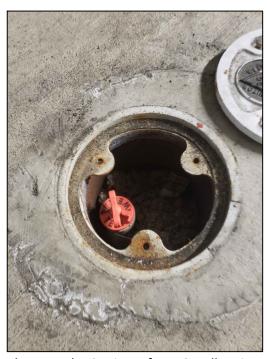
Photograph 10: View of MW6 well casing.
