TERRA ASSOCIATES, Inc.

May 1, 1987
Project No. T-291-1

Subject: Soil and Groundwater Sampling and Testing
Sternoff Metals Site
East Marginal Way South
Seattle, Washington

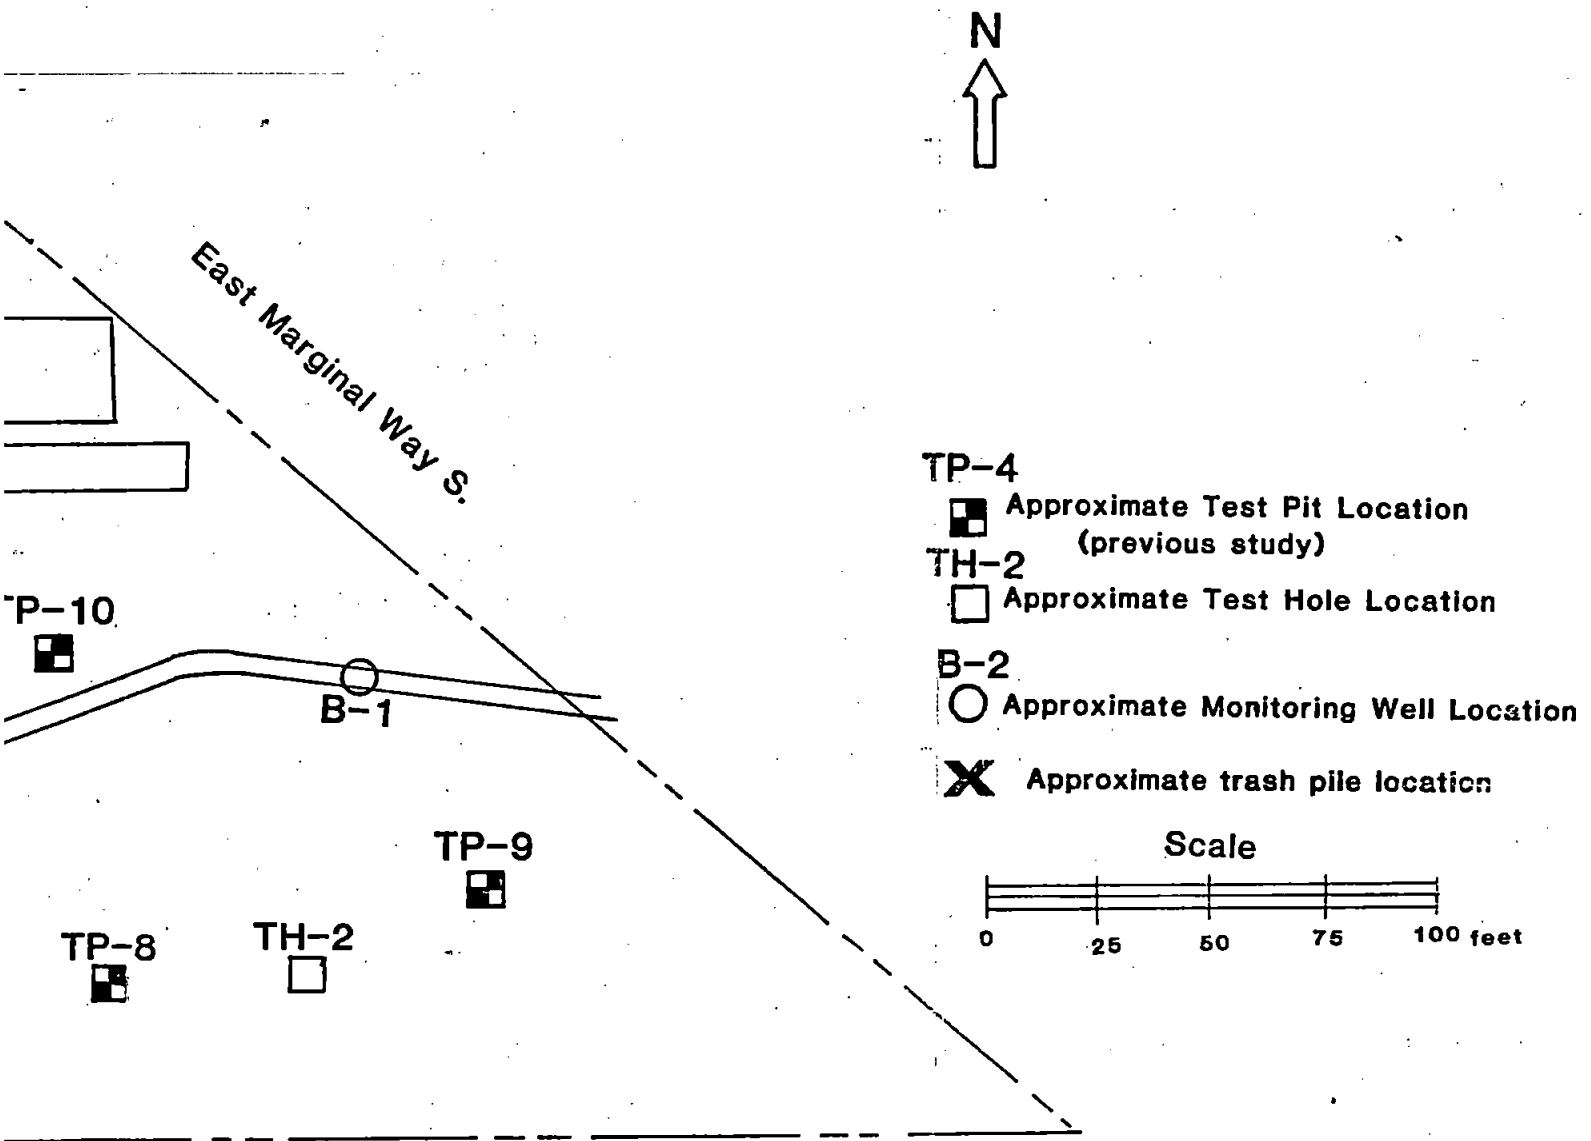
Proj. No291-1 Date Feb. 87 Figure 1

Our previous sampling at the site was conducted on April 17, 1986 when a back-hoe was used to excavate test pits for collection of soil samples. Sample collection locations are shown on the attached Site Plan, Figure 1.

PCB's were measured in the soil in an unpaved area near the southwest corner of the property (TP-5) at a level of 75 ug/g (ppm). Subsequent testing (TH-3, TH-4 and B-2) indicate that the area of soils with PCB's at a concentration greater than 50 ug/g is limited. Other tests showed lower levels of PCB's; 23 ug/g in TP-1, 12 ug/g in TP-2 and 3.3 ug/g in TP-10. We understand that the southwest corner of the site is underlain by a concrete slab at a depth of approximately 18 to 24 inches below the existing grade. This concrete slab, where present, should prevent downward migration of the higher levels of PCB's noted in this area.

We also collected a sample of material from the trash pile located in the southwest corner of the site for analysis. The trash pile is located above an asphalt surface. PCB levels in this sample were 540 ug/g. At this level, this pile should be treated as dangerous waste and should be disposed of accordingly.

It is our opinion that the migration of potentially contaminated materials off the site and the environmental hazard can be minimized by placing an impermeable fill cap over the existing grades to seal the site. The trash pile in the southwest corner should be cleaned up and treated as hazardous waste. In addition, the soils in the vicinity of our Test Pit TP-5 should also be cleaned up to levels below 50 ug/g. We estimate that this involves removal of soil to a depth of two feet in an area approximately 20 feet by 20 feet. Existing storm drains should be abandoned and plugged and a new storm drainage system installed after fills have been placed to seal the site. The sediment should be removed from the storm drains. The native silt layer across the site is presumed to be relatively impermeable and excavations for buildings, and utility trenches should not penetrate this layer in order to maintain this natural impermeable layer. It may be possible to seal spoils from site excavations under the clean fill cover. Excavations into the existing soils and through the existing pavement should be minimized.
