SECOND PERIODIC REVIEW REPORT FINAL

PACE INDUSTRIES PUGET DIV INC
Facility Site ID#: 86715242
Cleanup Site ID#: 6787

2011 & 2101 Mildred Street W
Tacoma, WA 98466

October 2021

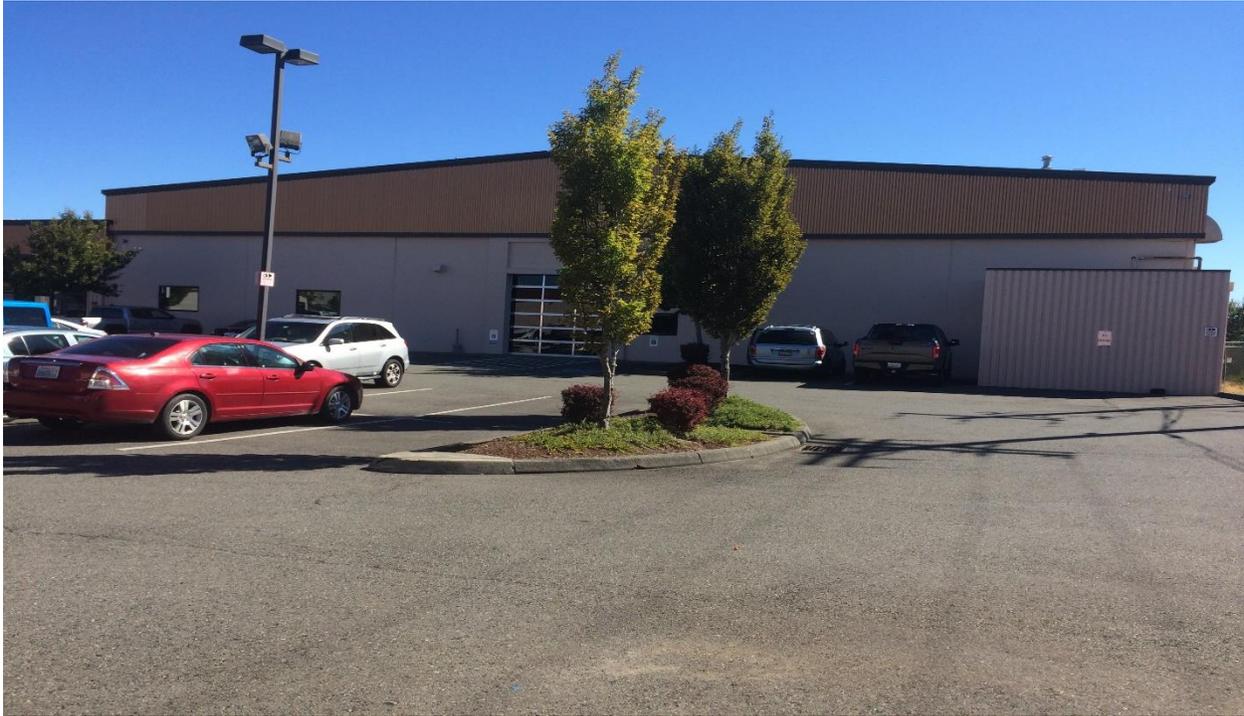
Photo 1. Building below which contaminated soil left in place – from the South.

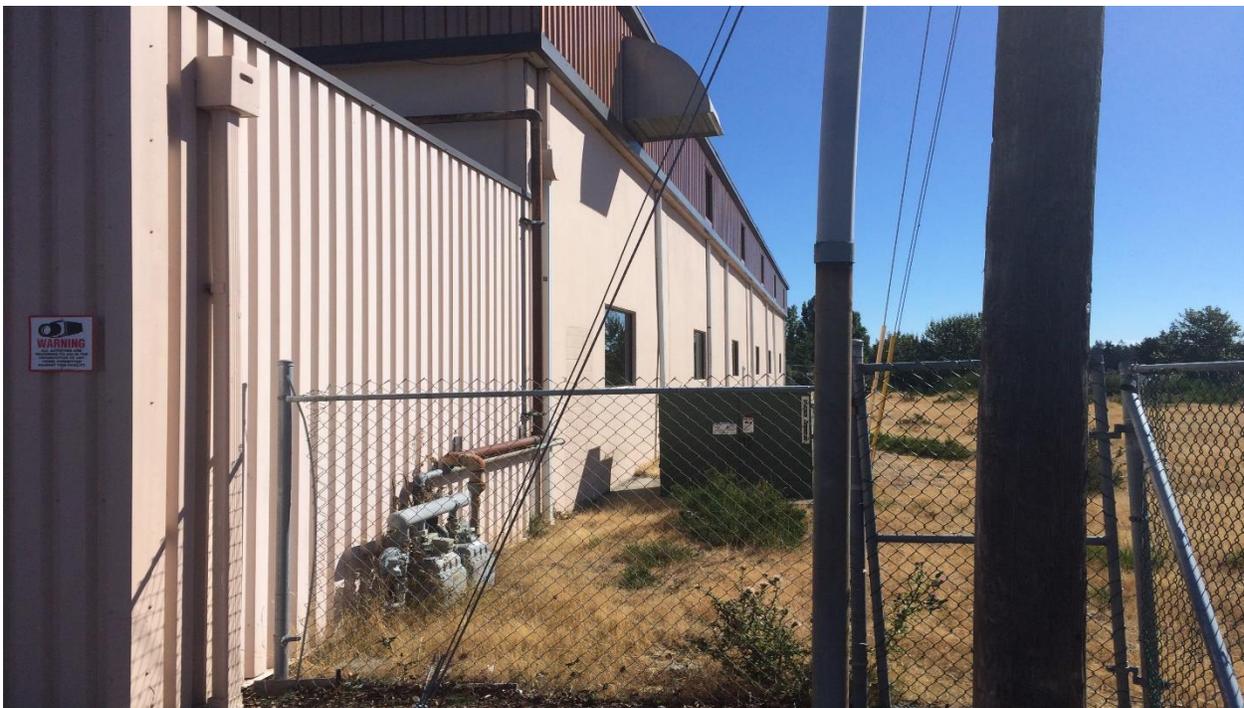
Photo 2. Building below which contaminated soils left in place (eastern side of the building) – from the Southwest.

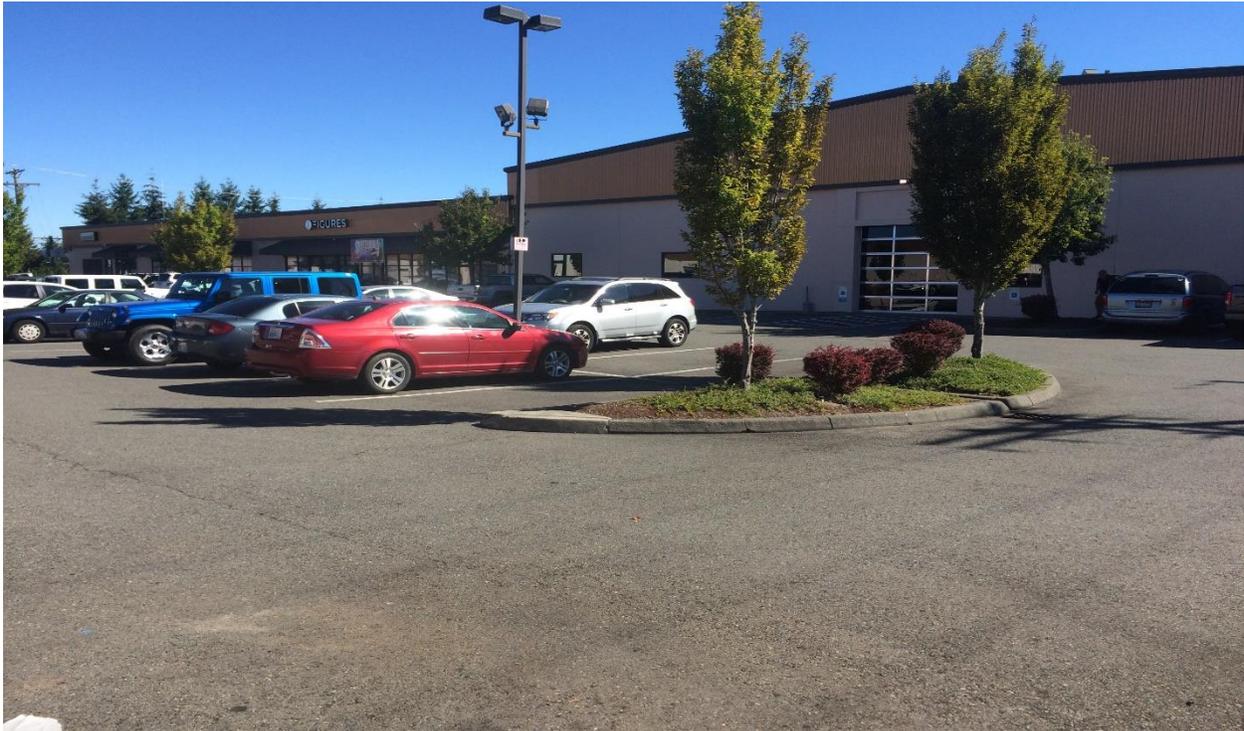
Photo 3. Previously excavated Area 2, current parking lot – from the Southwest.

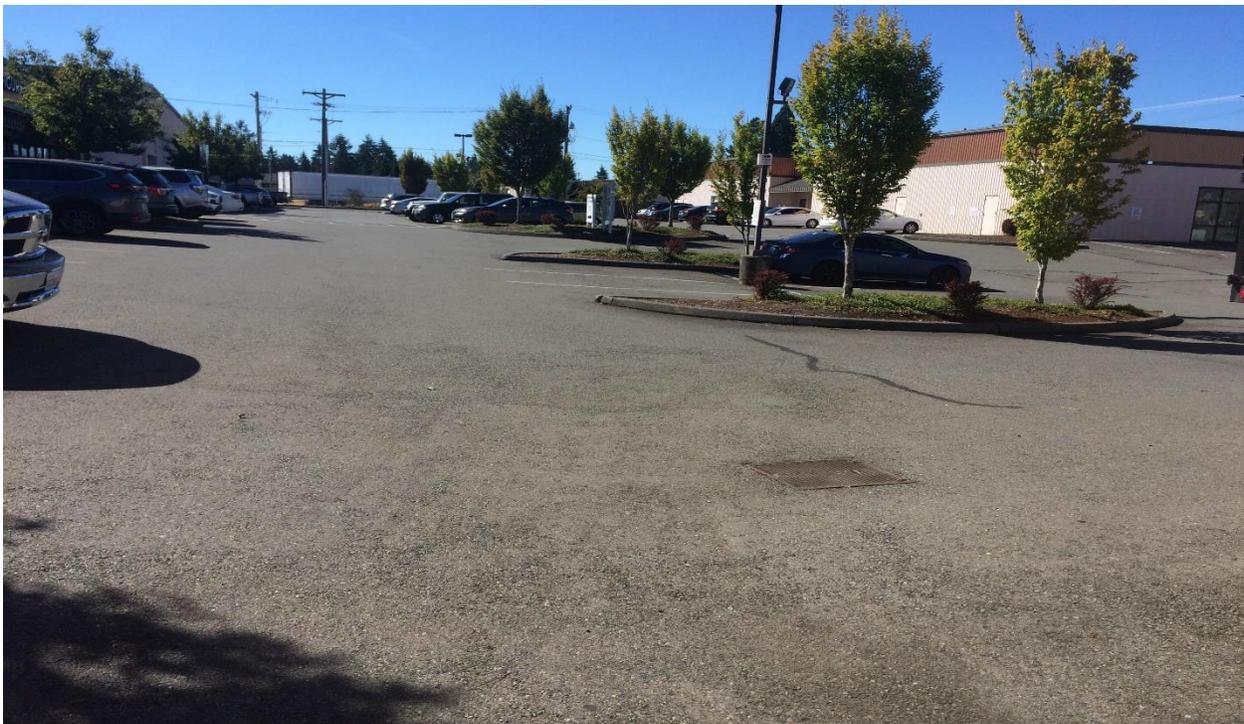
Photo 4. Previously excavated Area 4, current parking lot – from the North.

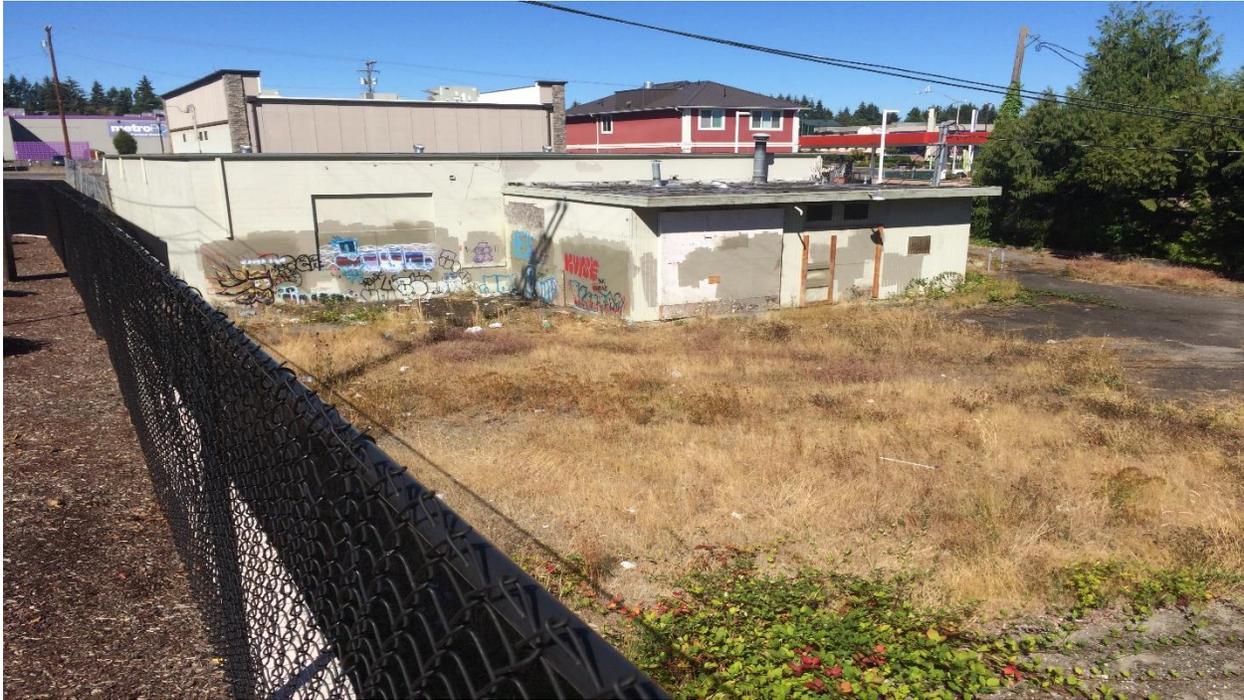
Photo 5. Former Towne Cleaners in Area 5 some contaminated soils left below the building foundation-Looking West.

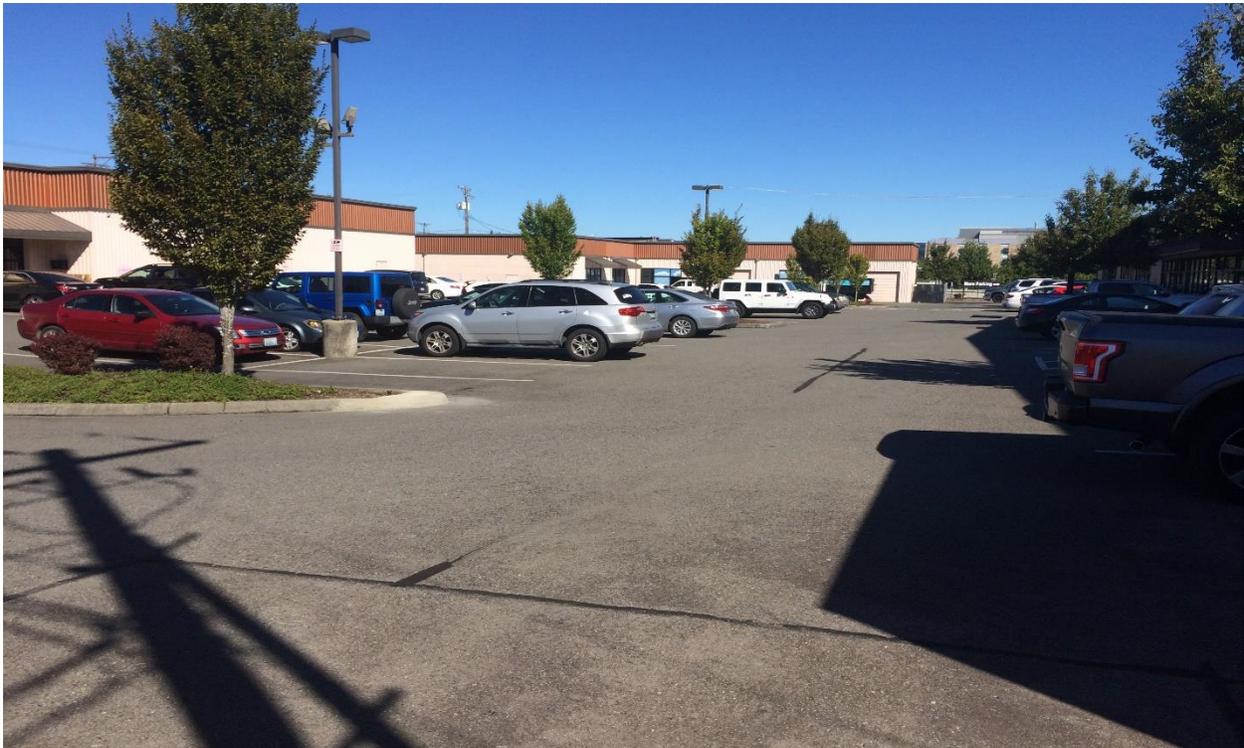
Photo 6. Previously excavated Area 4 and Area 8, current parking lot – from the North.

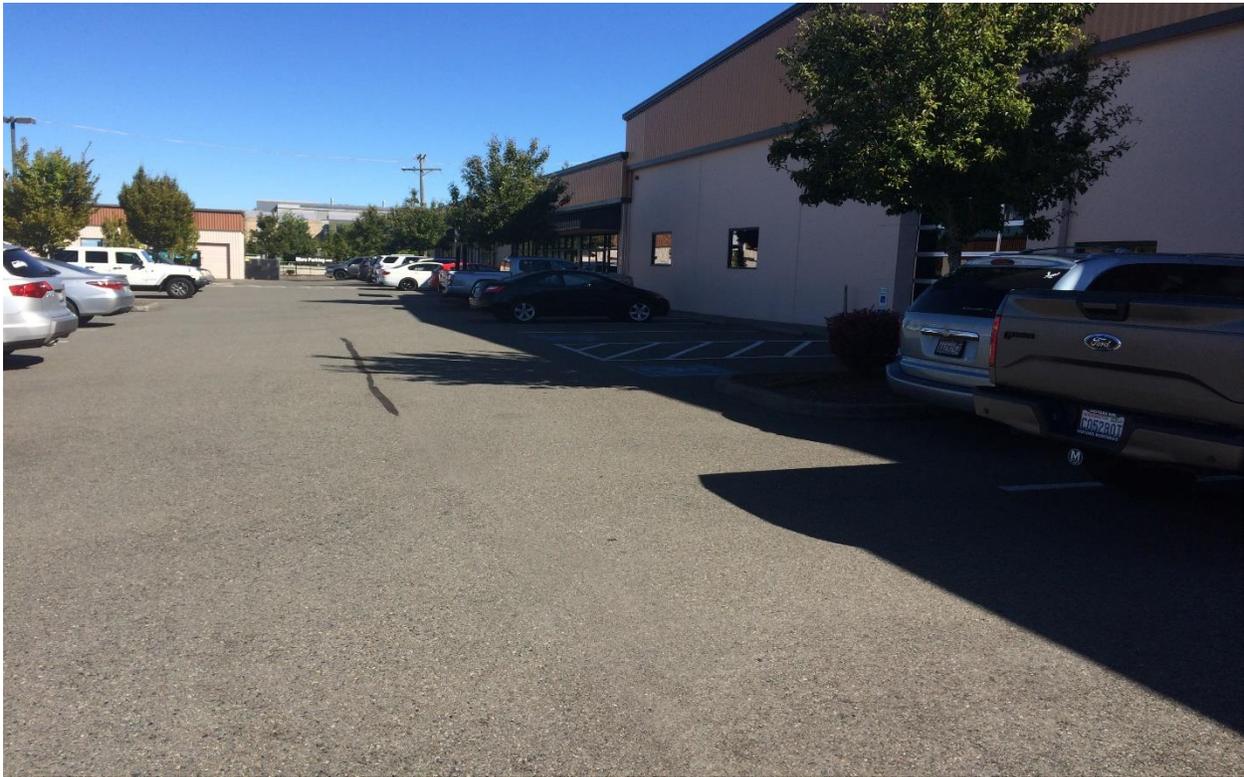
Photo 7. Previously investigated area, current parking lot – from the West.

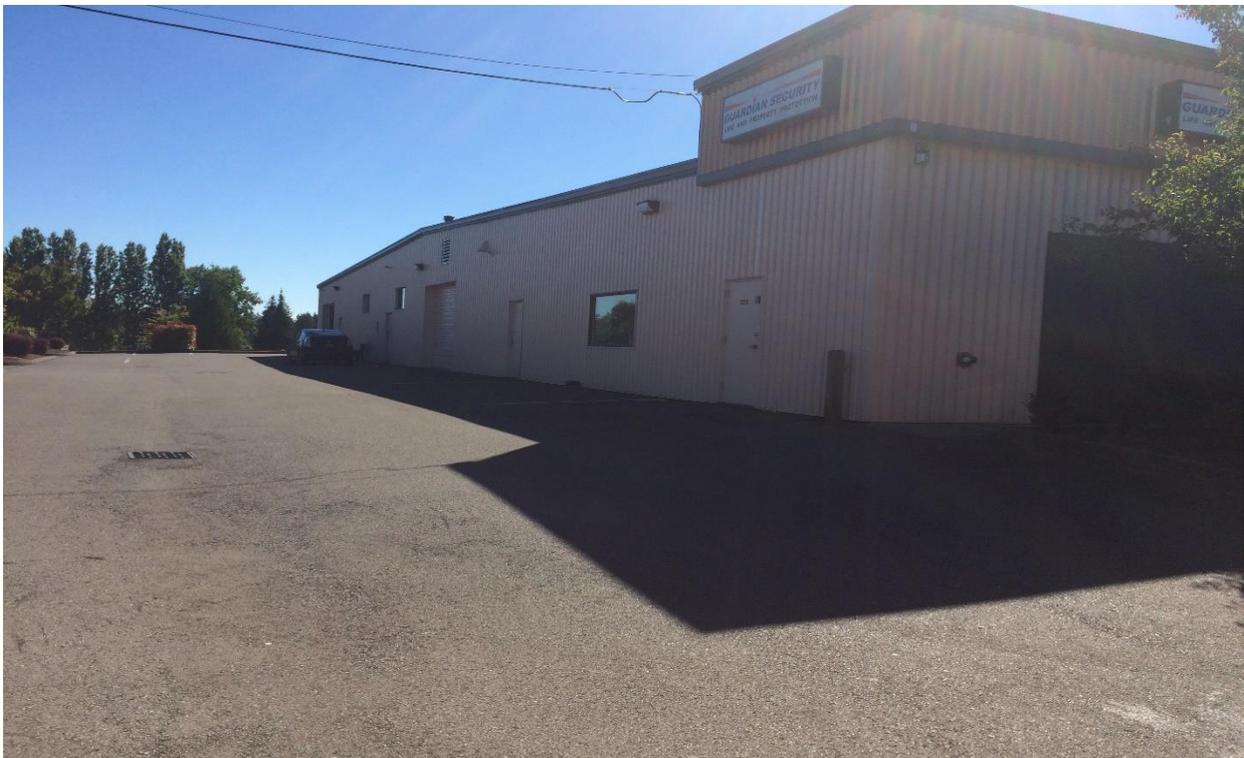
Photo 8. Previous Area 3, behind the Current Building, Looking South.
