## T E C H N I C A L M E M O R A N D U M

**RE:** **LANDFILL CAP ANNUAL INSPECTION PROGRESS REPORT—2018**  
**SPPD PROPERTY**  
**SOUTH PARK LANDFILL SITE, SEATTLE, WASHINGTON**  
**FARALLON PN: 408-002**

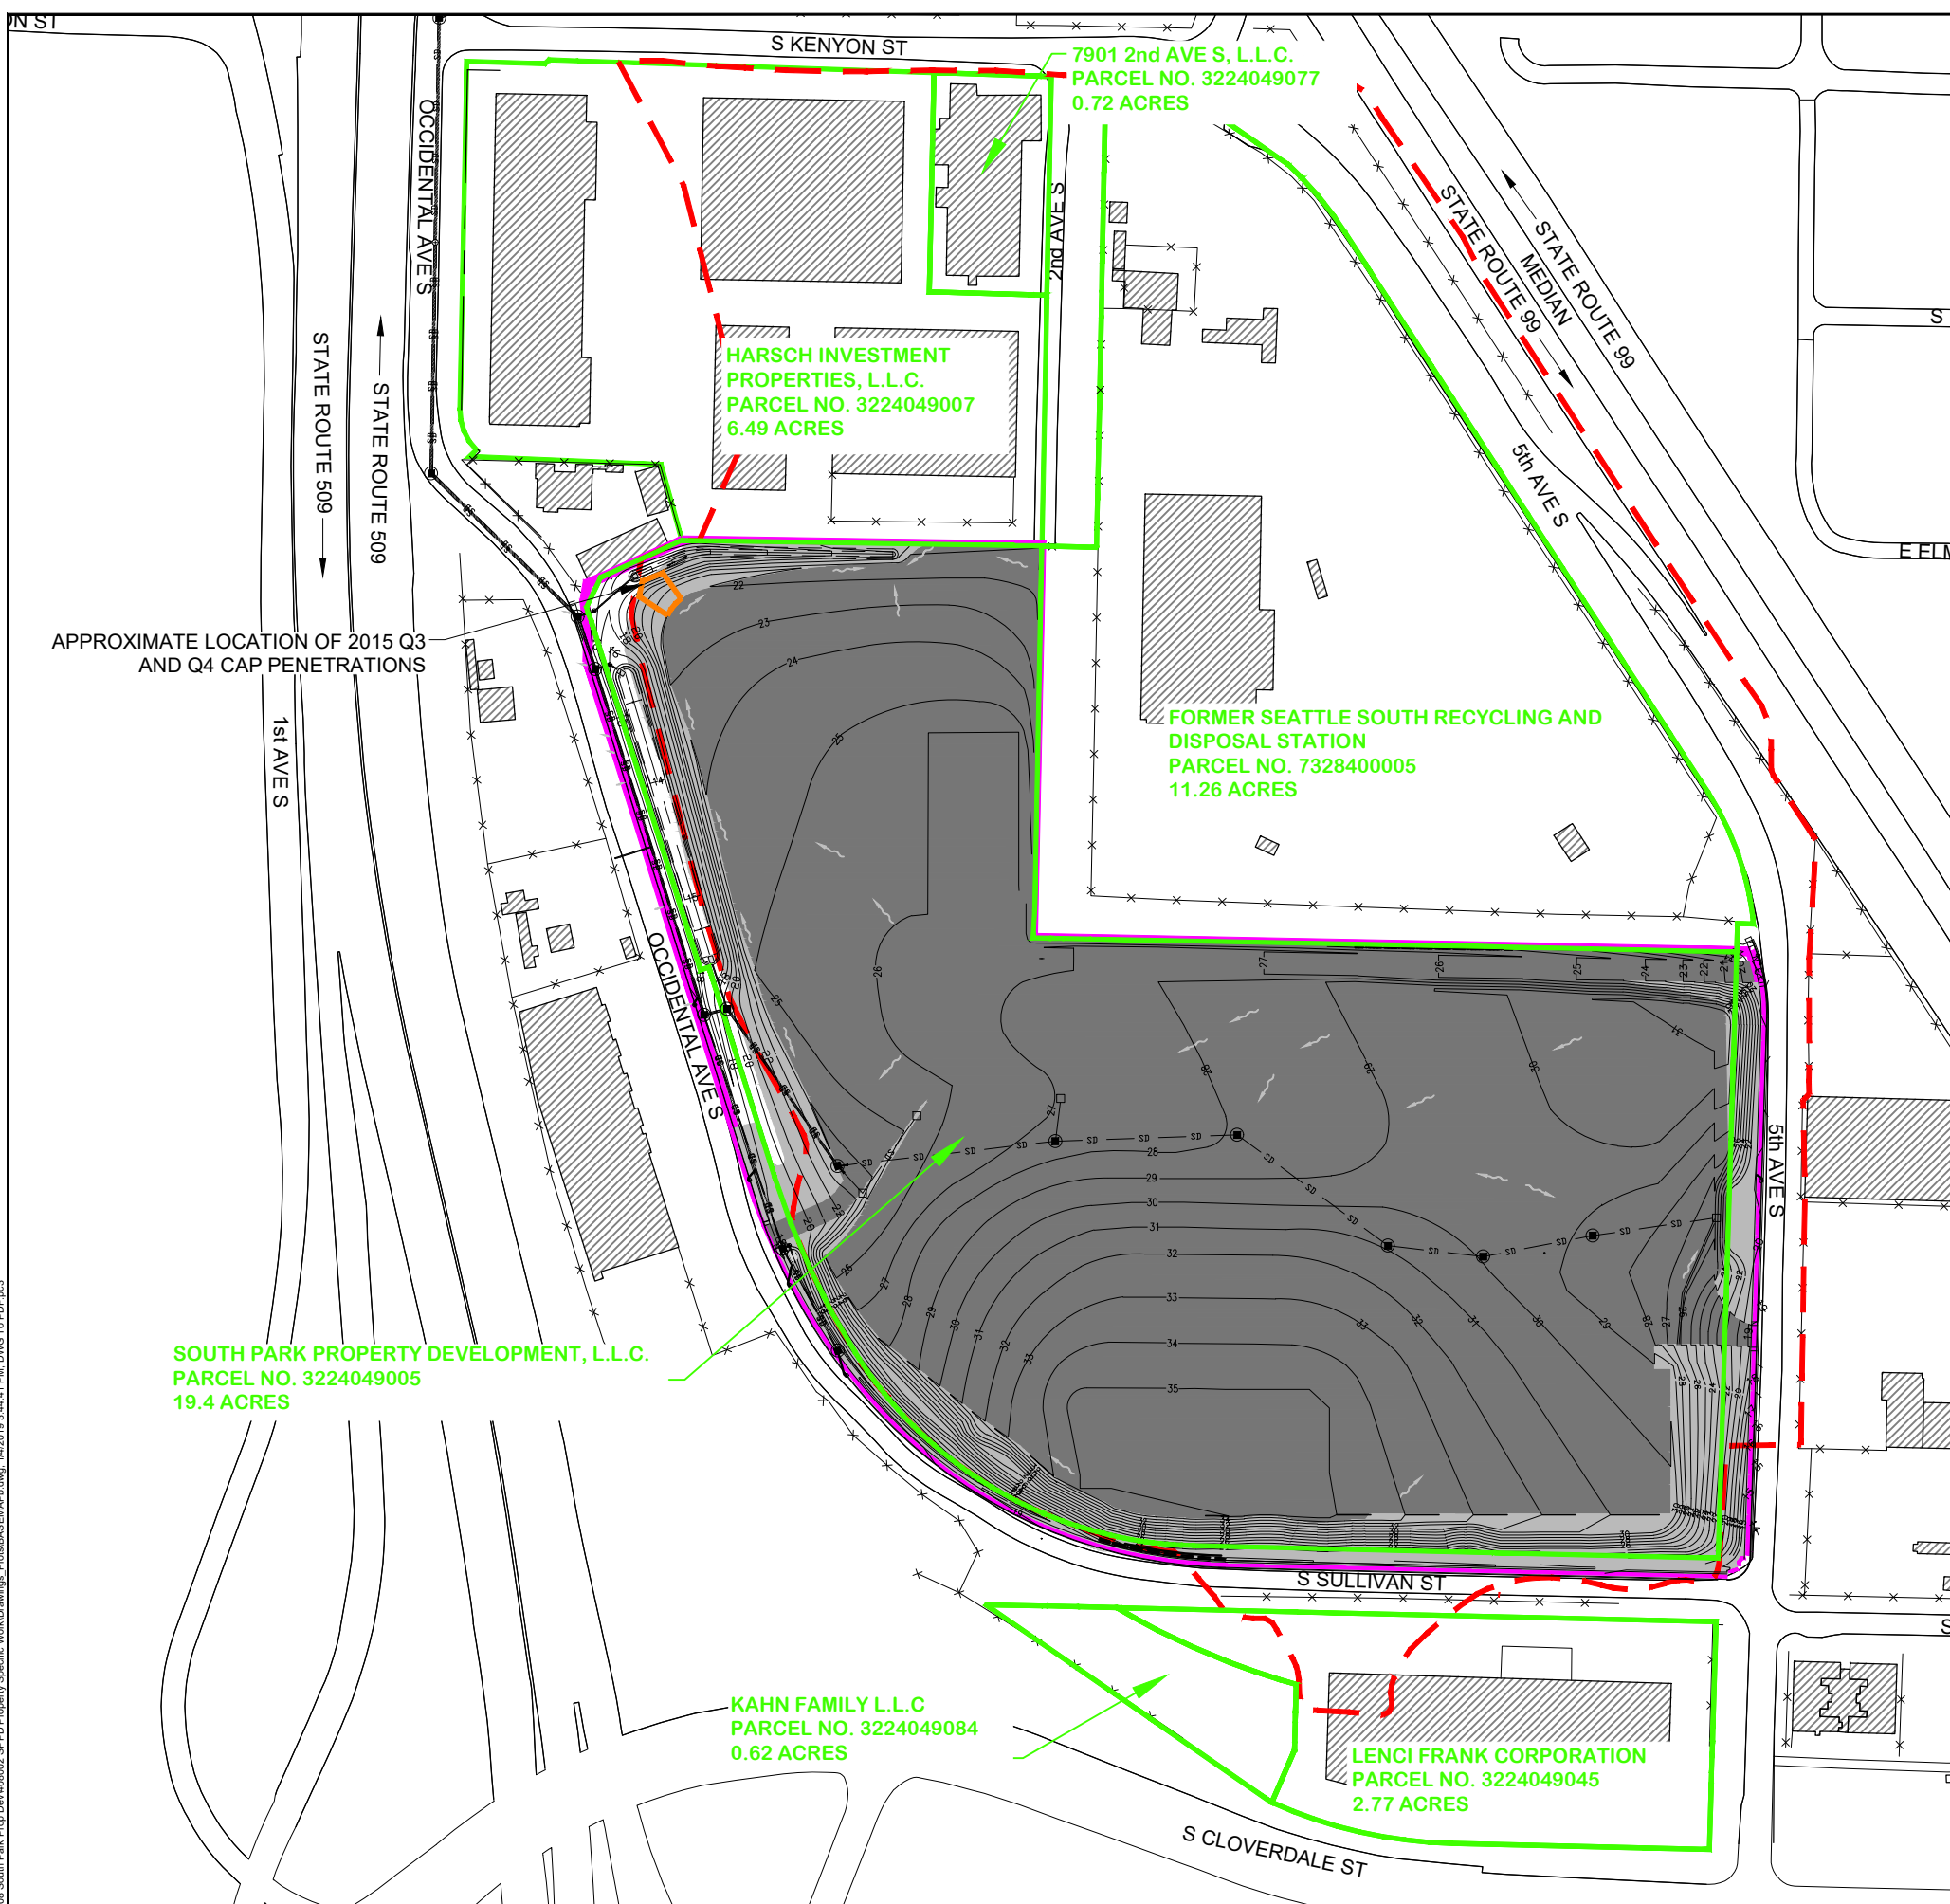
**FIGURE 2**  
 LANDFILL CAP  
 SPPD PROPERTY, SOUTH PARK LANDFILL SITE  
 SEATTLE, WASHINGTON

APPROXIMATE LOCATION OF 2015 Q3 AND Q4 CAP PENETRATIONS
