STATE OF WASHINGTON  
DEPARTMENT OF ECOLOGY

**Re: Further Action at the following Site:**

- **Site Name:** Shell Station 120531
- **Site Address:** 11700 NE 160<sup>th</sup> Bothell, WA
- **Facility/Site No.:** 63265631
- **VCP Project No.:** NW2053

## **Enclosure A**

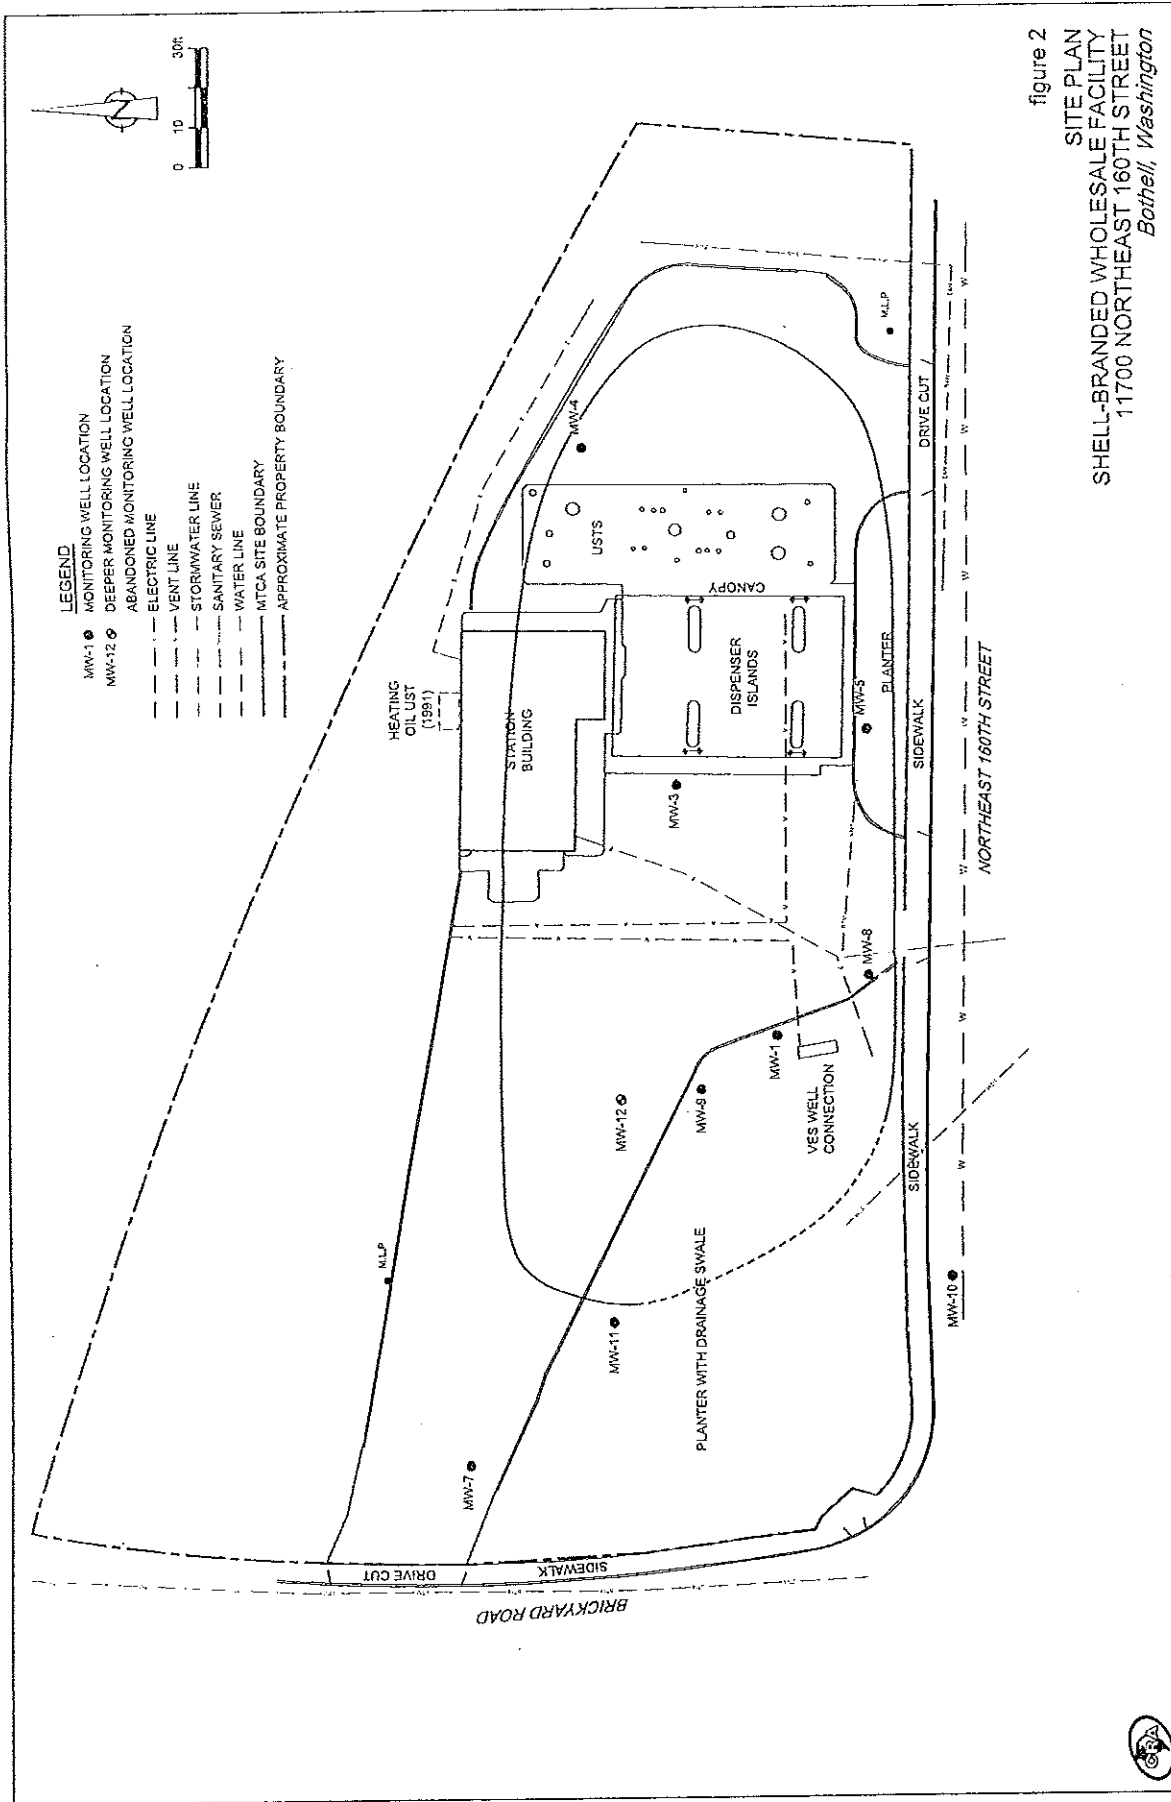
**Contaminant Sources and History of Releases:** The source of contamination is attributed to leaks and spills from the underground storage tanks (UST), dispenser islands and associated piping. No specific equipment failure has been identified at this site. The release was reported to Ecology in December 1991. The approximate boundary of the Site is presented in the attached figure.

**Release and Extent of Contamination - Soil:** Soil contamination was detected in soil adjacent to and below the original USTs, the former dispenser islands and along product supply lines when they were removed and replaced in 1991. Current sample results document hydrocarbon concentrations above Method A direct contact soil cleanup levels in the east portion of the drainage swale at soil boring SB-8-6.

**Extent of Contamination – Ground Water:** Ground water sampling confirmed gasoline-, and diesel-range TPH and BTEX that exceeded MTCA Method A groundwater cleanup levels. The lateral and possible vertical extent of contamination has not been completely determined. Ground water sample results document hydrocarbon concentrations above Method A cleanup levels at monitoring wells MW-1, and MW-9.
