STATE OF WASHINGTON
DEPARTMENT OF ECOLOGY
1250 W Alder St • Union Gap, WA 98903-0009 • (509) 575-2490

RE: No Further Action at the following Site:

- **Site Name:** Tonys Auto Repair
- **Site Address:** 1220 S. 6th Street, Yakima
- **Facility Site ID No.:** 548
- **Cleanup Site ID No.:** 1597

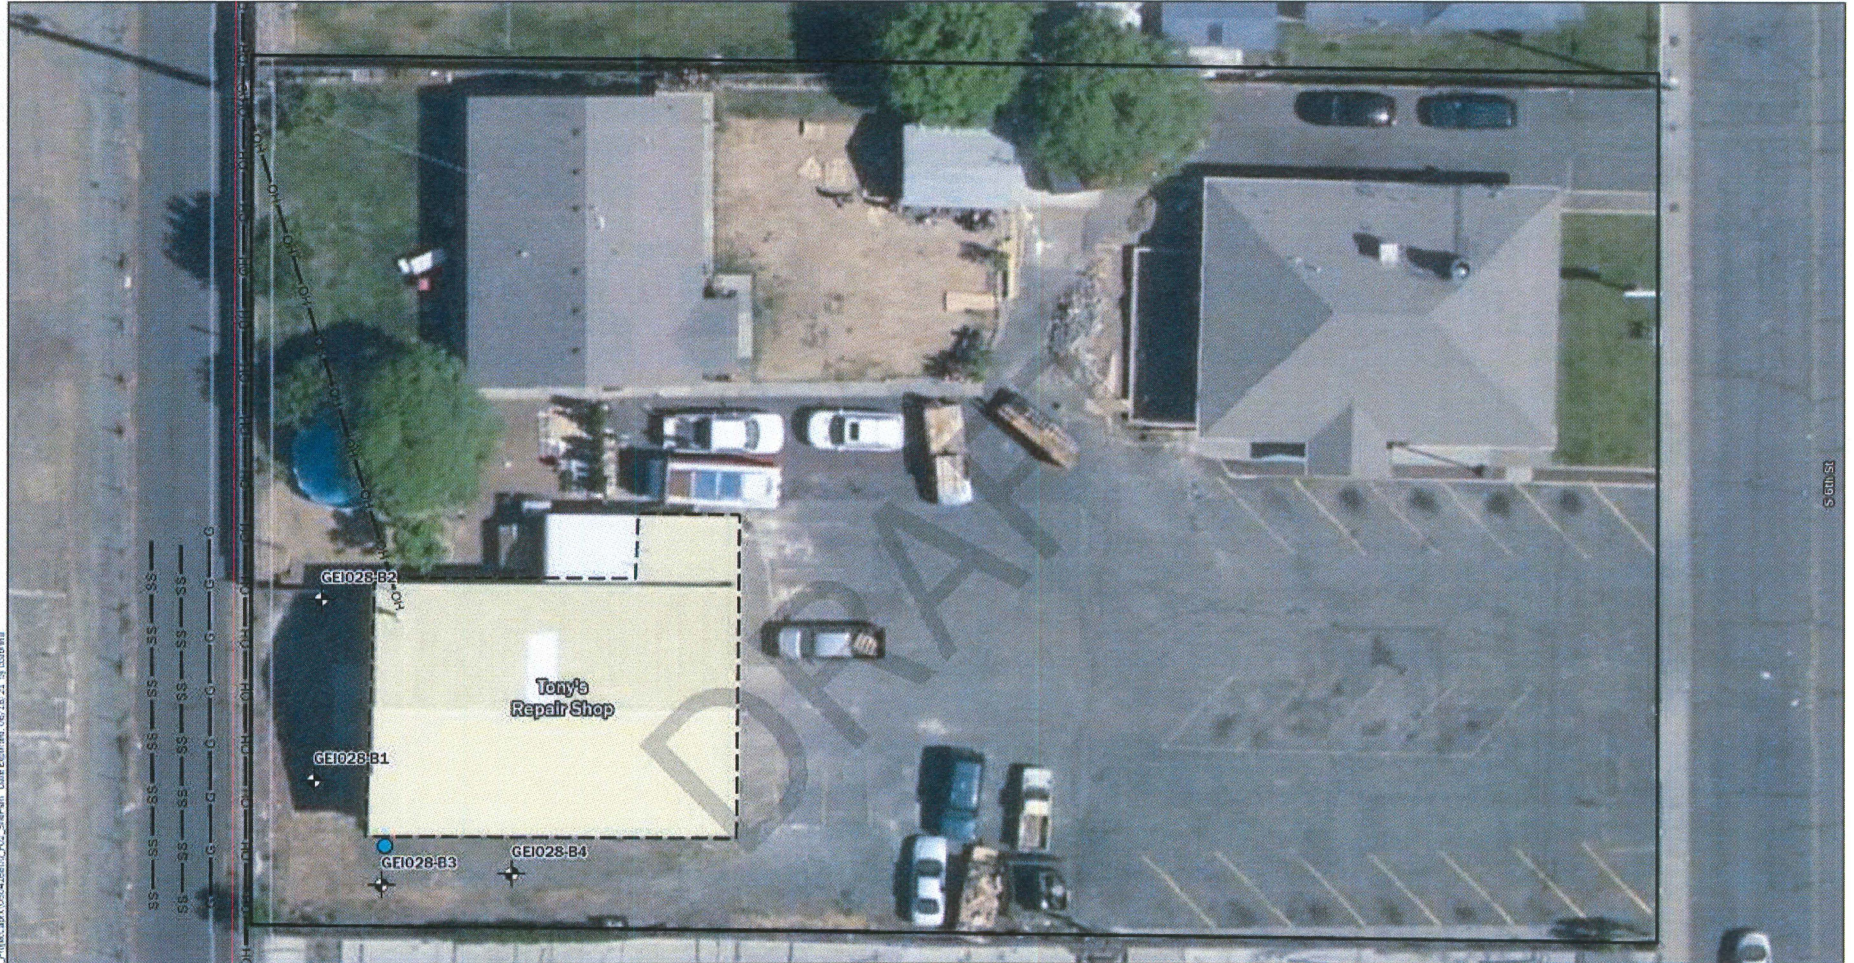
Site Diagram

An investigation was conducted on behalf the Department of Ecology Toxics Cleanup Program (TCP) by GeoEngineers in May 2021. This investigation included soil borings at four locations in open areas south and west of the auto repair shop structures. Direct push soil borings were placed at locations to provide lateral coverage within the adjacent yard areas. No soil staining was noted. The soil borings were advanced to 10 to 14 feet below ground surface (ft bgs) until refusal was reached. No groundwater was encountered and soils were observed to be dry to the depth of refusal.

One soil sample was collected at each of the four boring locations at depths ranging between 0.5 to 2.0 ft bgs. No indications of contamination were noted and photoionization detector (PID) readings were within background range. Soil samples were analyzed for gasoline-range, diesel-range, and heavy oil range organics by NWTPH-Gx and NWTPH-Dx, and for volatile organic compounds by EPA Method 8260.

No analytes were detected above any potential cleanup levels, except for one detection of 1,2,4-trimethylbenzene. This compound was detected at an estimated 0.075 mg/kg, above a calculated Method B soil protective of groundwater concentration of 0.072 mg/kg. This detection is not believed by Ecology to present a risk to groundwater based on the drilling observations reported at the Site.
