STATE OF WASHINGTON
DEPARTMENT OF ECOLOGY

Re: No Further Action at the following Site:

- **Site Name:** 6326 Brooklyn Property
- **Site Address:** 6326 Brooklyn Avenue NE, Seattle
- **Facility/Site No.:** 7942345
- **VCP Project No.:** NW2005

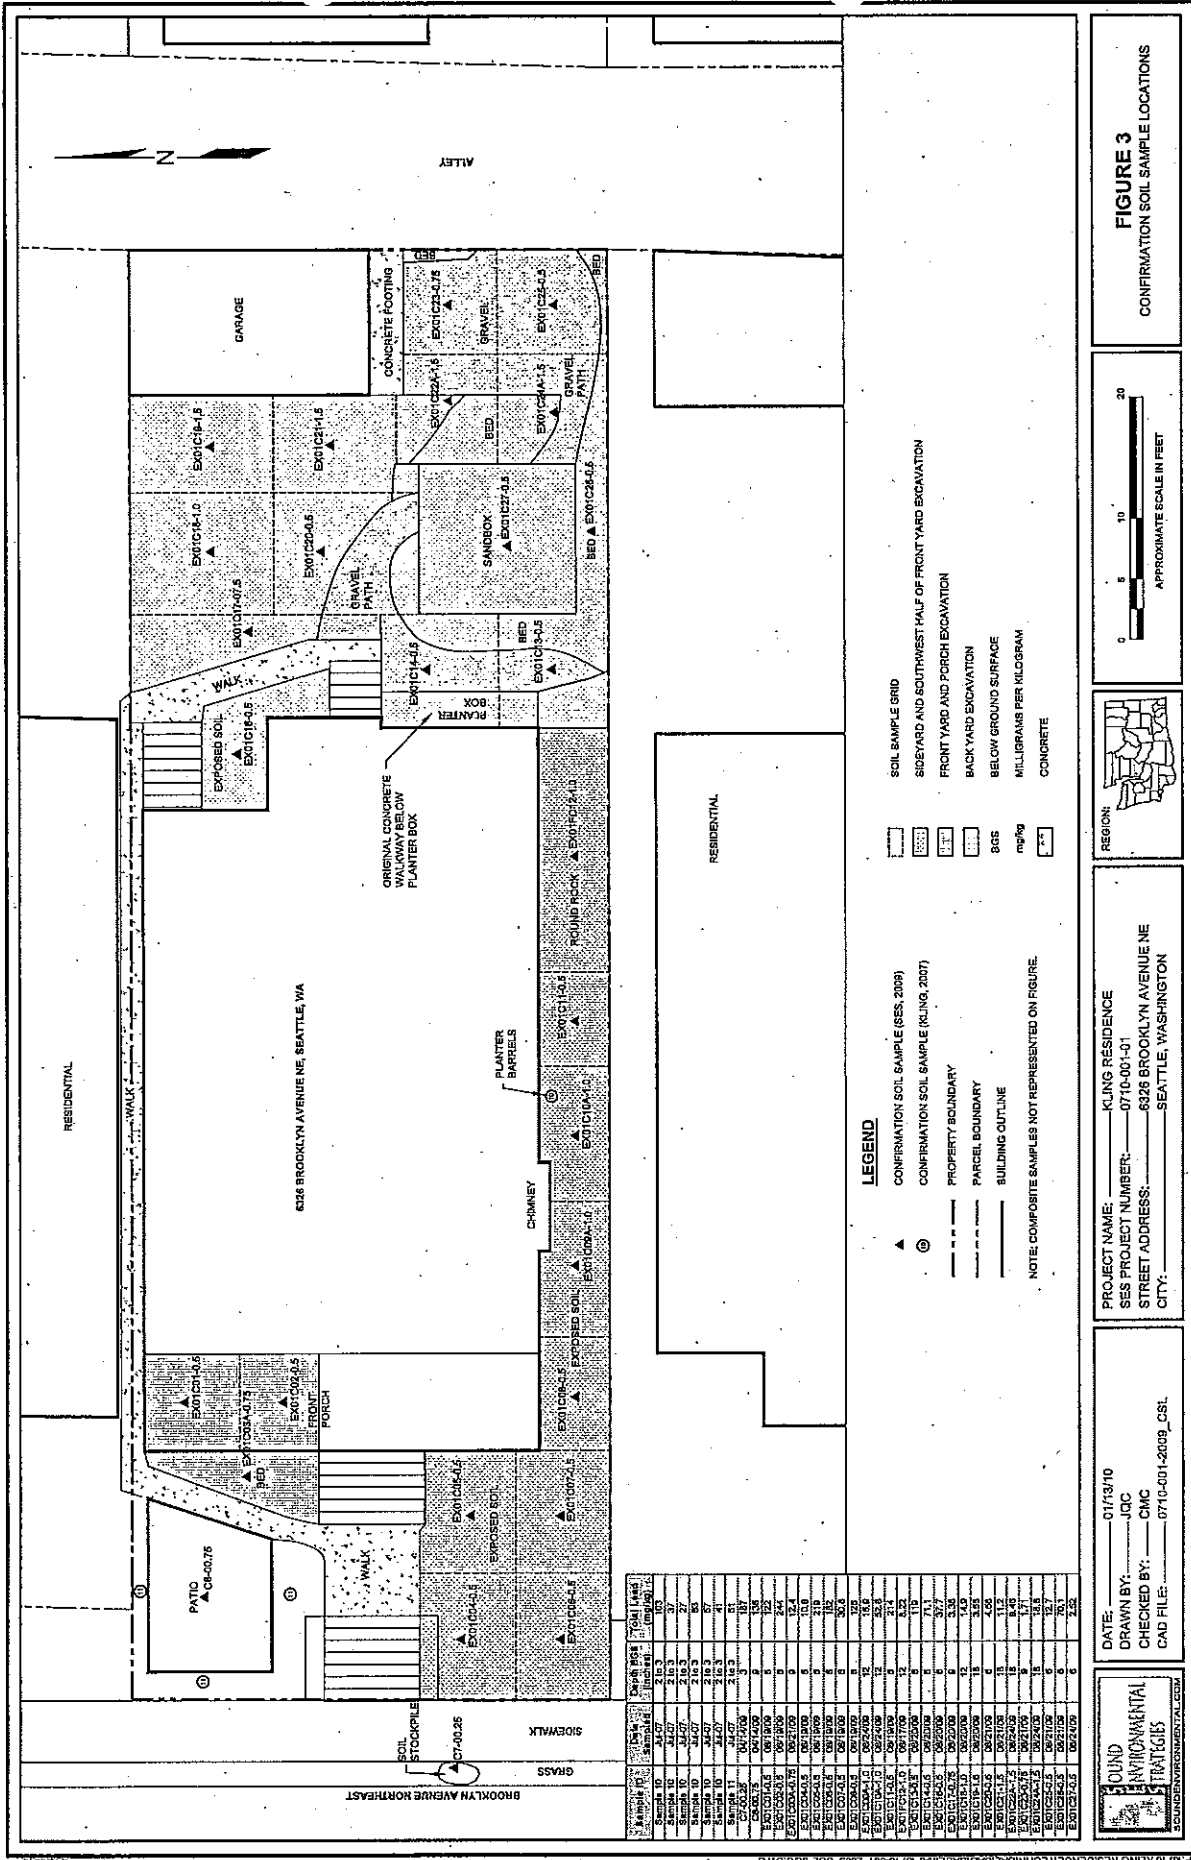
FIGURE 3
CONFIRMATION SOIL SAMPLE LOCATIONS

Areas of the excavation were subdivided into approximately 100 square foot sections, and soil samples were collected from the floor in the approximate center of each section at the extent of the excavation (Figure 3). If confirmation soil samples contained concentrations of lead greater than the cleanup level, the soil sample location was over excavated and the soil sample was reclassified as a performance sample. Upon completion of over excavation, additional soil sampling was conducted to document that concentrations of lead were less than the cleanup level.

Residual exterior lead-based paint from the property house and garage has been identified as the source for lead contamination on the property. Soil with lead concentrations exceeding Method A were limited to the surface soils surrounding the property structures, and the maximum vertical extent was approximately 18-inches below ground surface (bgs). The Site is therefore defined as the excavation areas shown on Figure 3
