Summary Report – Environmental Construction Activities

**Sam's Club Store No. 4835
Renton, King County, Washington**

J-1470-10

Subject: Summary Report – Environmental Construction Activities
Sam's Club Store No. 4835
901 South Grady Way
Renton, King County, Washington

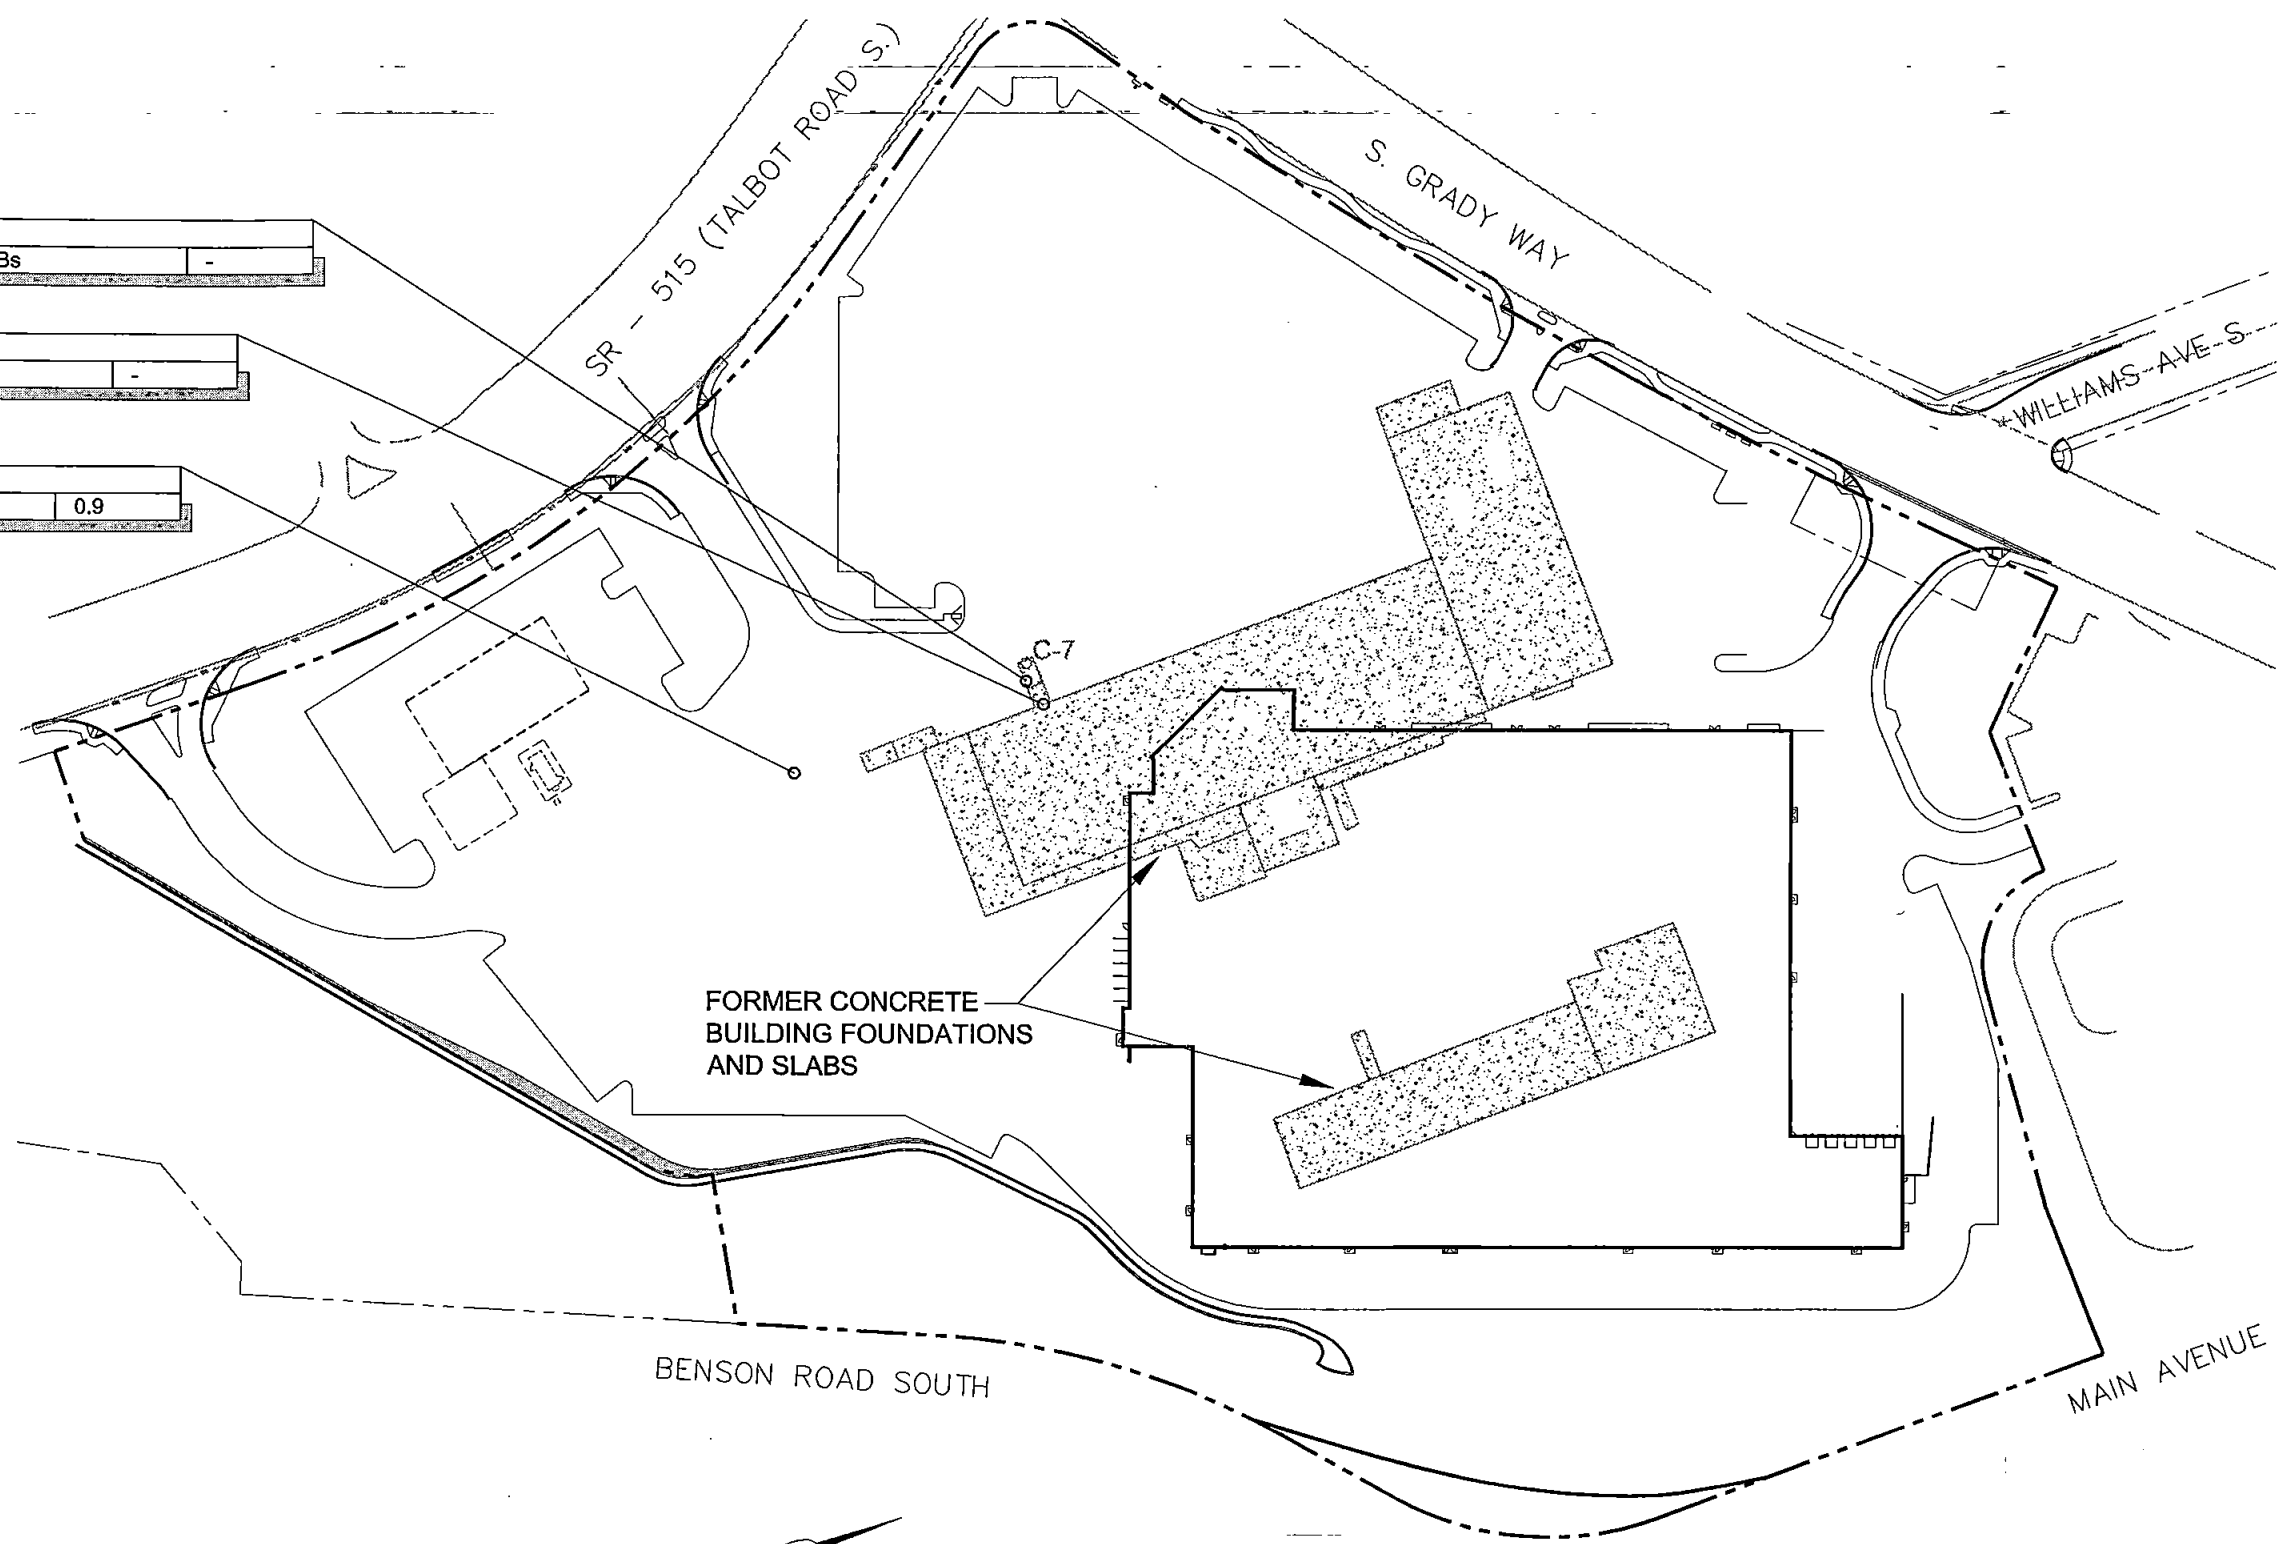
Summary Report - Environmental Construction Activities
 Sam's Club Store No. 4835
 Renton, King County, Washington
FIGURE 3 - CONCRETE SAMPLING
 Basemap DWG File Provided by PaLand and modified by ZZA

Prior to the demolition and on-site use of concrete slabs and foundation elements from the former buildings present on the subject site, ZZA collected two samples of concrete from the vicinity of a concrete chip sample identified as C-7, collected by GeoEngineers and documented in the 1998 report entitled *Environmental Site Assessment* as containing 1.05 ppm total PCBs, the highest concentration reported in the report. In order to ensure that suspected PCB-impacted concrete was not used as fill on the site, ZZA recommended the concrete in the vicinity of the 1.05 ppm concrete sample collected by GeoEngineers be sampled prior to use on-site. On 21 May 2003, after demolition of the two slabs interpreted to be the location of the concrete chip sample collected by GeoEngineers (C-7), ZZA obtained two samples from each of the slab sections identified as C-1 and C-2 and submitted them for PCB analysis. The locations of these samples are depicted graphically on Figure 3. The samples were reported with non-detectable concentrations of PCBs. The results are reported in tabular form on Table II of this report, with laboratory test certificates presented in Appendix A.

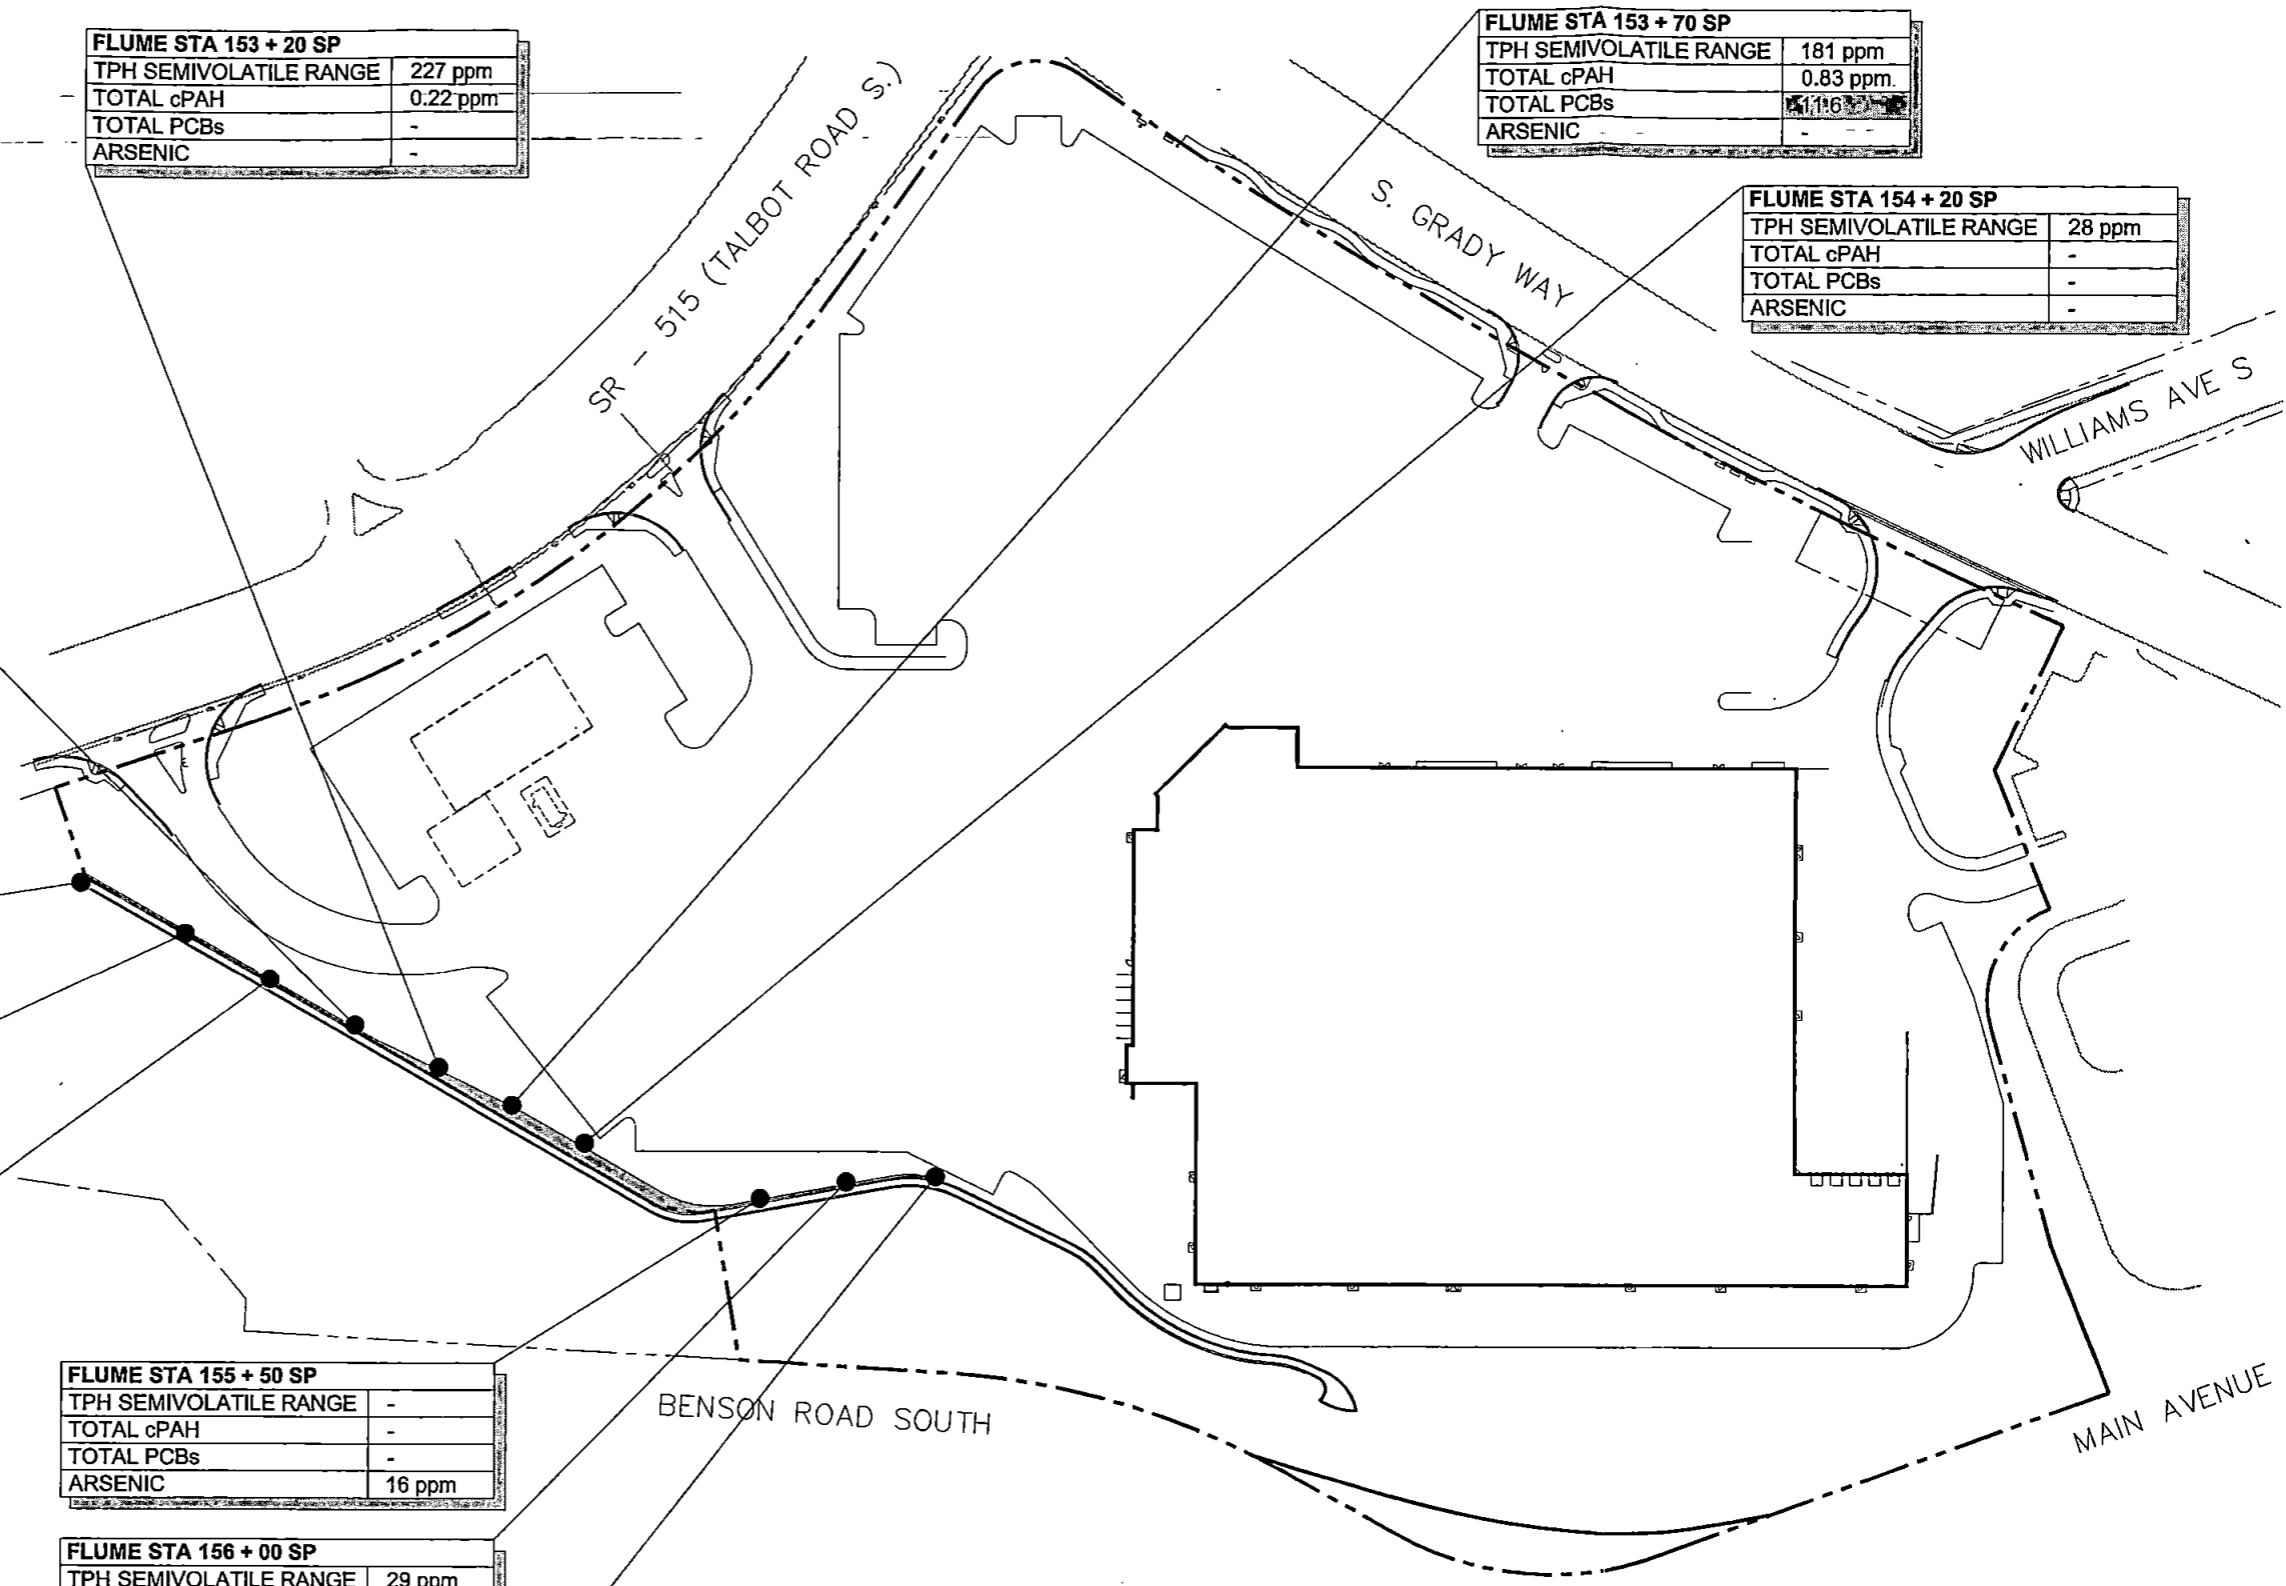
FIGURE 9 - FLUME STOCKPILE SOIL SAMPLING

Soil in this area of the Site consisted of very loose coal fill or sand or very soft to soft silt. ZZA recommended against removing soils below the invert of the existing concrete flume so as not to threaten the flume stability. Accordingly, no remedial excavation was advanced in this trench. Instead, soil from the stockpile on either side of *Flume STA 153+70 SP*, midway to the sample locations on either side, *Flume STA 153+20 SP* and *Flume STA 154+20 SP*, respectively, was removed and disposed off-site.

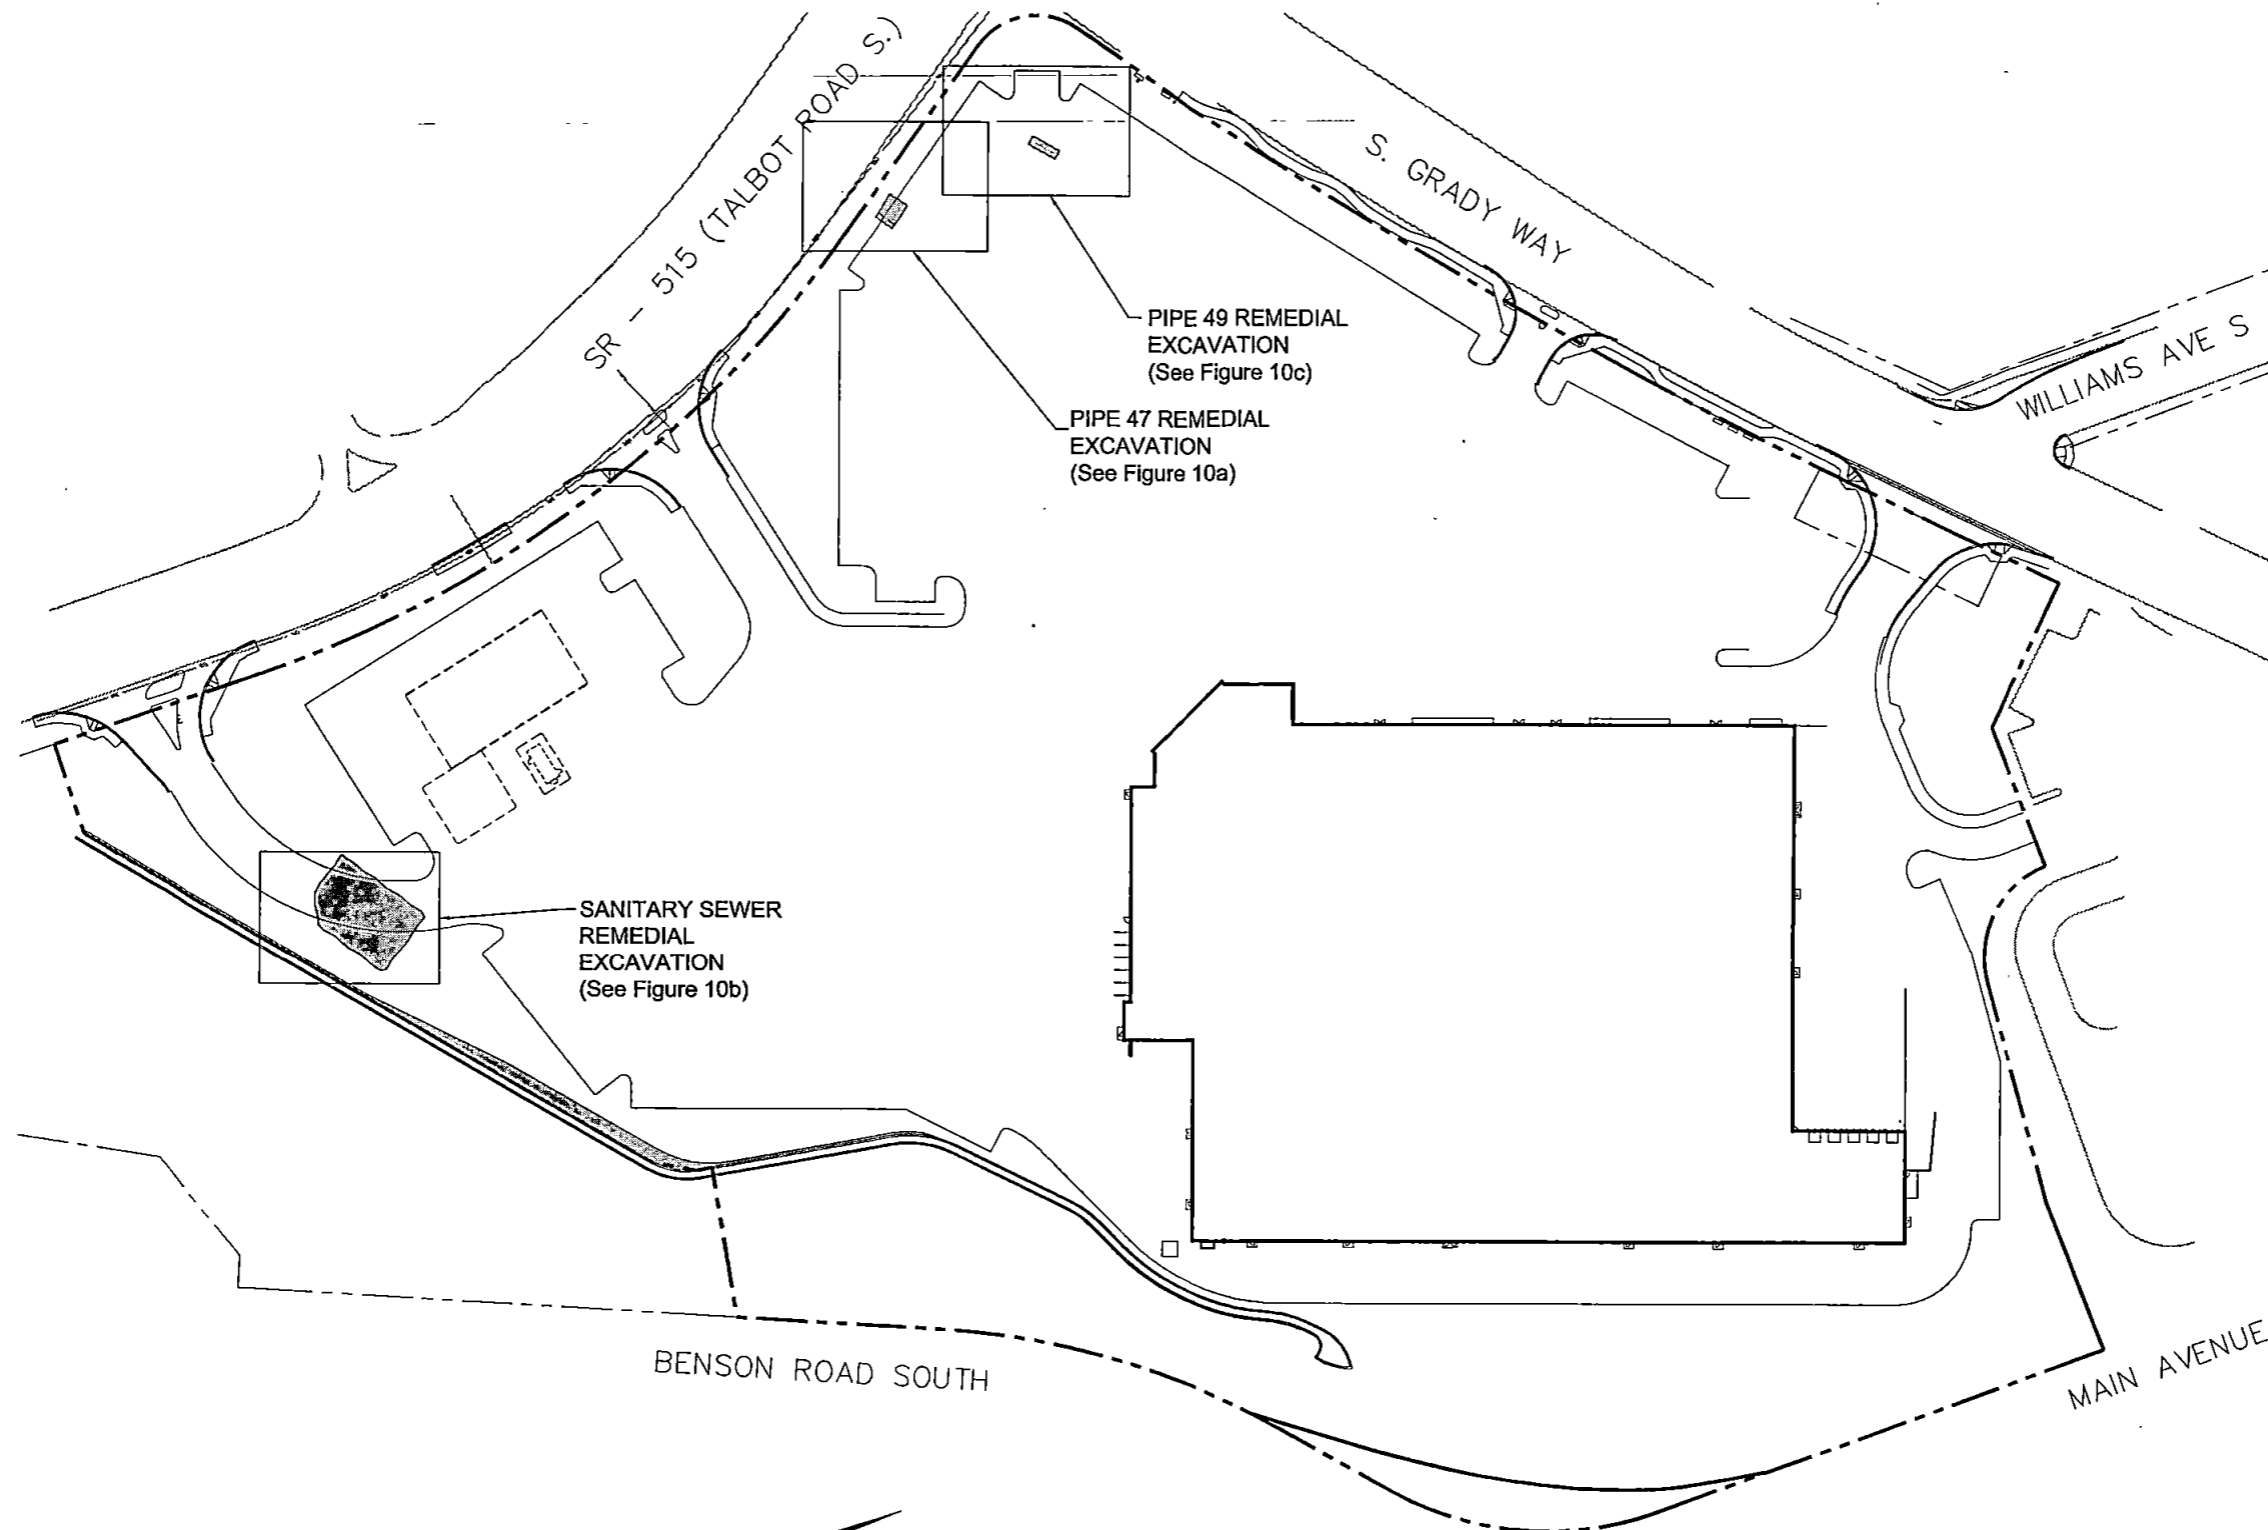
FIGURE 10 - REMEDIAL EXCAVATIONS

The material from which the sample was collected consisted of fine fragments of coal, coal cinders, ash, and occasional pockets of weathered sandstone. In response, ZZA recommended to the earthwork contractor to cover the excavation spoils from the trench between catchbasins CB #47 and CB#46 (area was still paved with asphalt) and indicated that a remedial excavation would need to be advanced.

On 14 July 2003, the remedial excavation was initiated with the removal of the pipe backfill (imported granular material), which was stockpiled separately. The excavation was advanced five feet west and east from the pipe backfill extents, five feet north and south of the 54 ppm sample location, and four feet deep. The initial remedial excavation limits were selected based upon minimizing the amount of material generated because no change in subsurface conditions was visible in the entire trench alignment that would provide a suggested limit. Samples were collected from each of the four sidewalls and one from the bottom of the excavation. The samples were identified as follows:

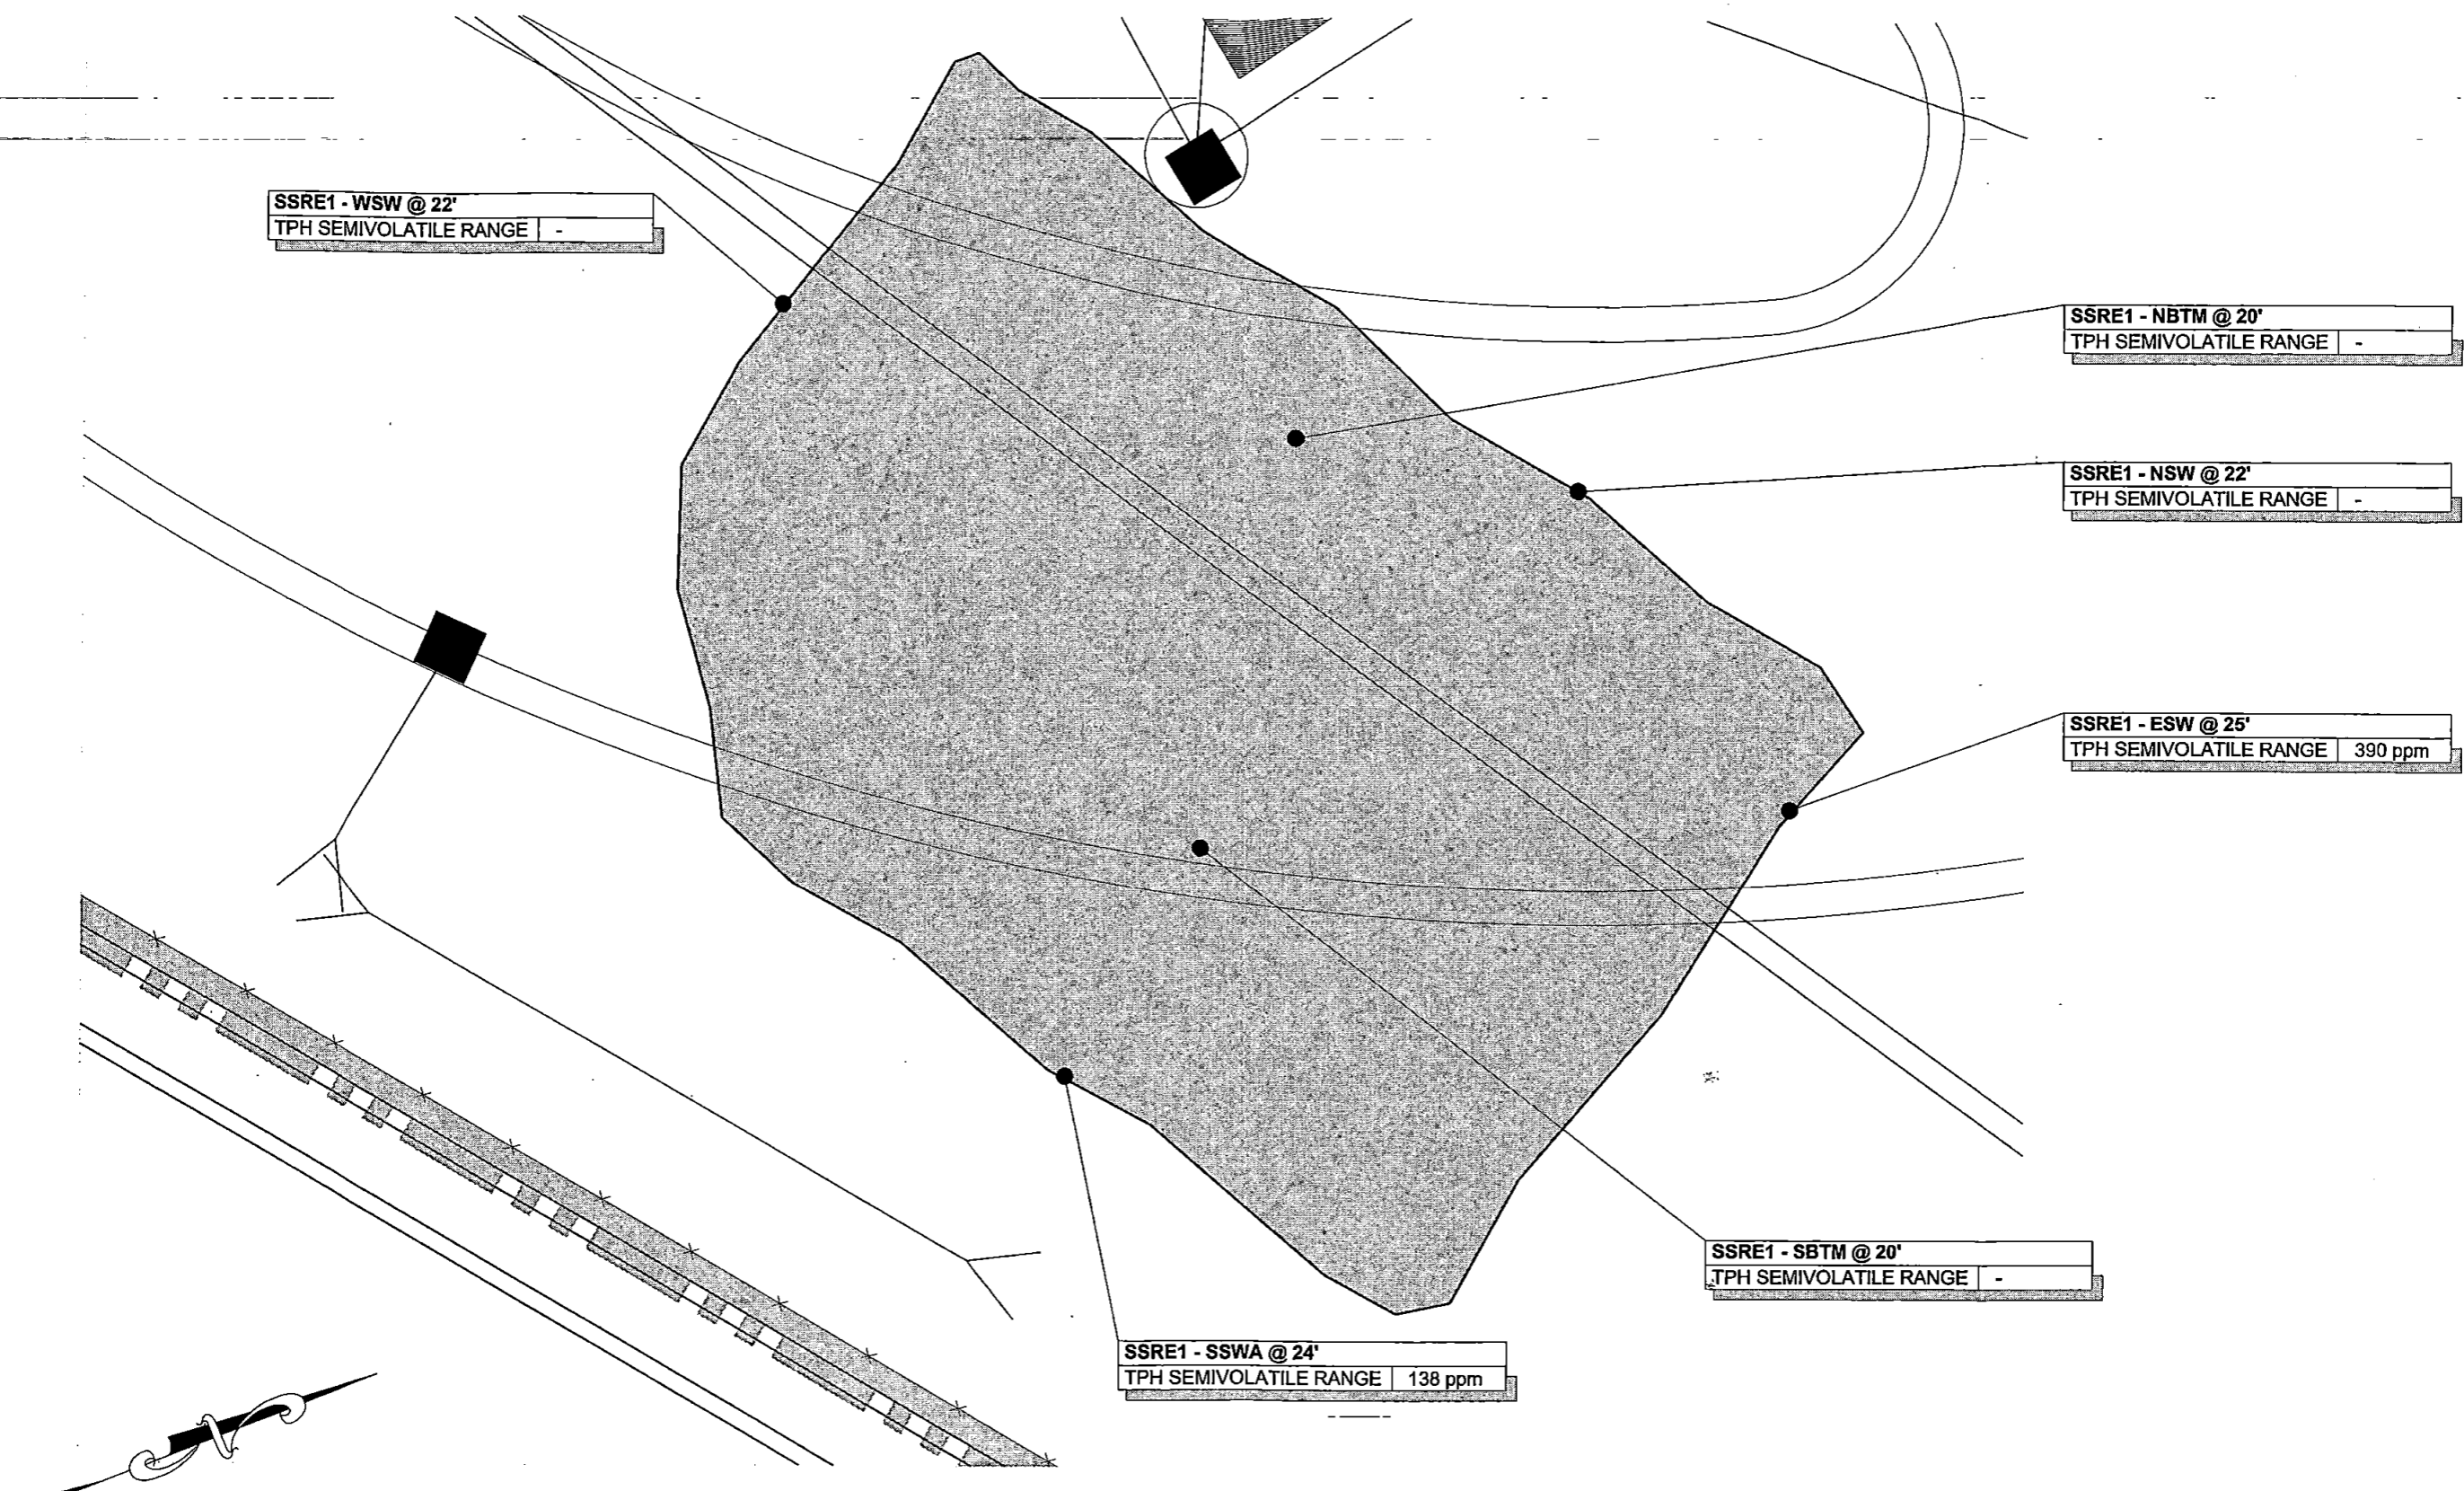
Summary Report - Environmental Construction Activities
Sam's Club Store No. 4835
Renton, King County, Washington
**FIGURE 10b - SANITARY SEWER
REMEDIAL EXCAVATION**
Basemap DWG File Provided by PacLand and modified by ZZA

On 5 September 2003, the remedial excavation was initiated with the removal of the backfill material, which was stockpiled separately. The excavation was advanced ten feet west and eight feet east from the pipe backfill extents, five feet north and five feet south from the sample location, and six feet deep. The initial remedial excavation limits were selected based upon minimizing the amount of material generated because no change in subsurface conditions was visible in the entire trench alignment that would provide a suggested limit. The following samples were collected from each of the four sidewalls and one from the bottom of the excavation and identified as follows:

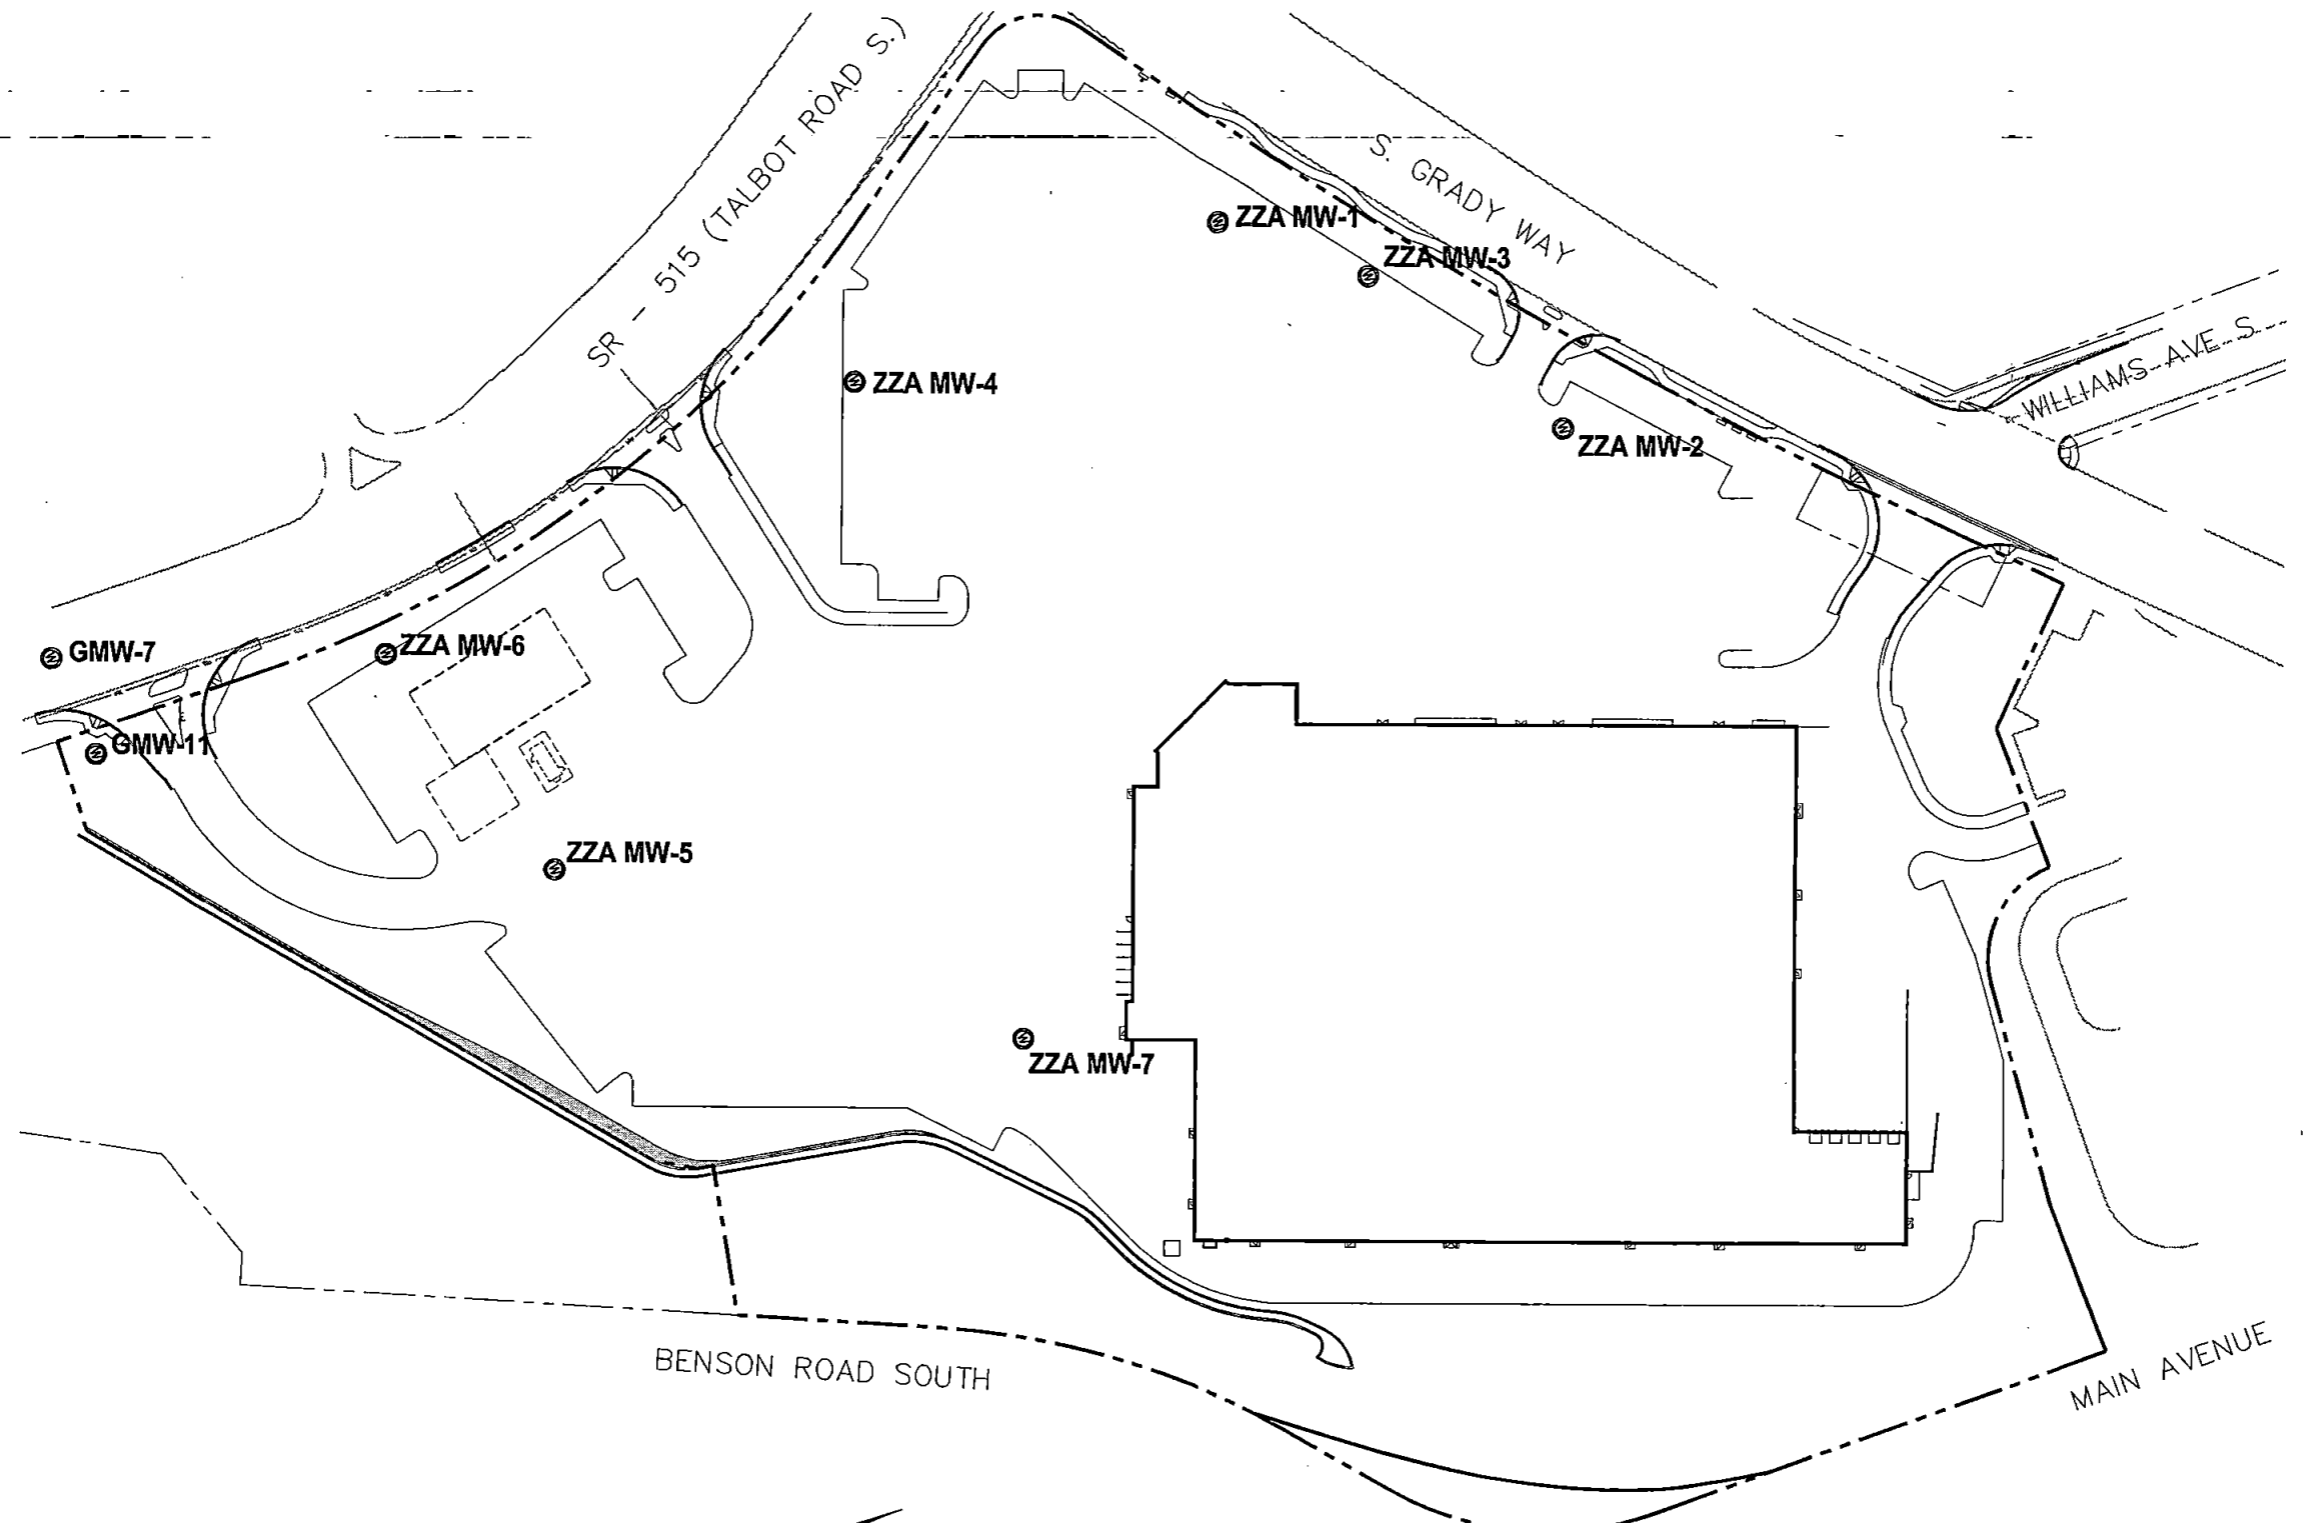
Summary Report - Environmental Construction Activities
 Sam's Club Store No. 4835
 Renton, King County, Washington
FIGURE 11 - GROUNDWATER MONITORING WELL INSTALLATIONS
 Basemap DWG File Provided by PacLand and modified by ZZA

Because a relatively large portion of the Site was to be covered by new structures, fewer than 18 replacement wells were installed. Five replacement, shallow-zone groundwater monitoring wells were installed prior to the opening of the store over two days, 26 and 27 January 2004. The locations of these replacement monitoring wells were identified in a letter entitled *Proposed Monitoring Well Installations – Renton Sam's Club Project* dated 17 January 2004, which was reviewed and approved by Ecology. See Figure 11 the location of the wells installed.

The replacement wells were identified as ZZA MW-3 through ZZA MW-7 and are used in conjunction with the two remaining wells installed as part of previous site characterization activities by GeoEngineers as well as the two deep zone groundwater wells installed by ZZA and discussed above in Section 5.2 to monitor groundwater quality on the site.
