**To:** Steve Teel, Department of Ecology

**Date:** September 16, 2021

**Subject: TWAFA Existing Groundwater Monitoring Network Evaluation and Recommendations Addendum**

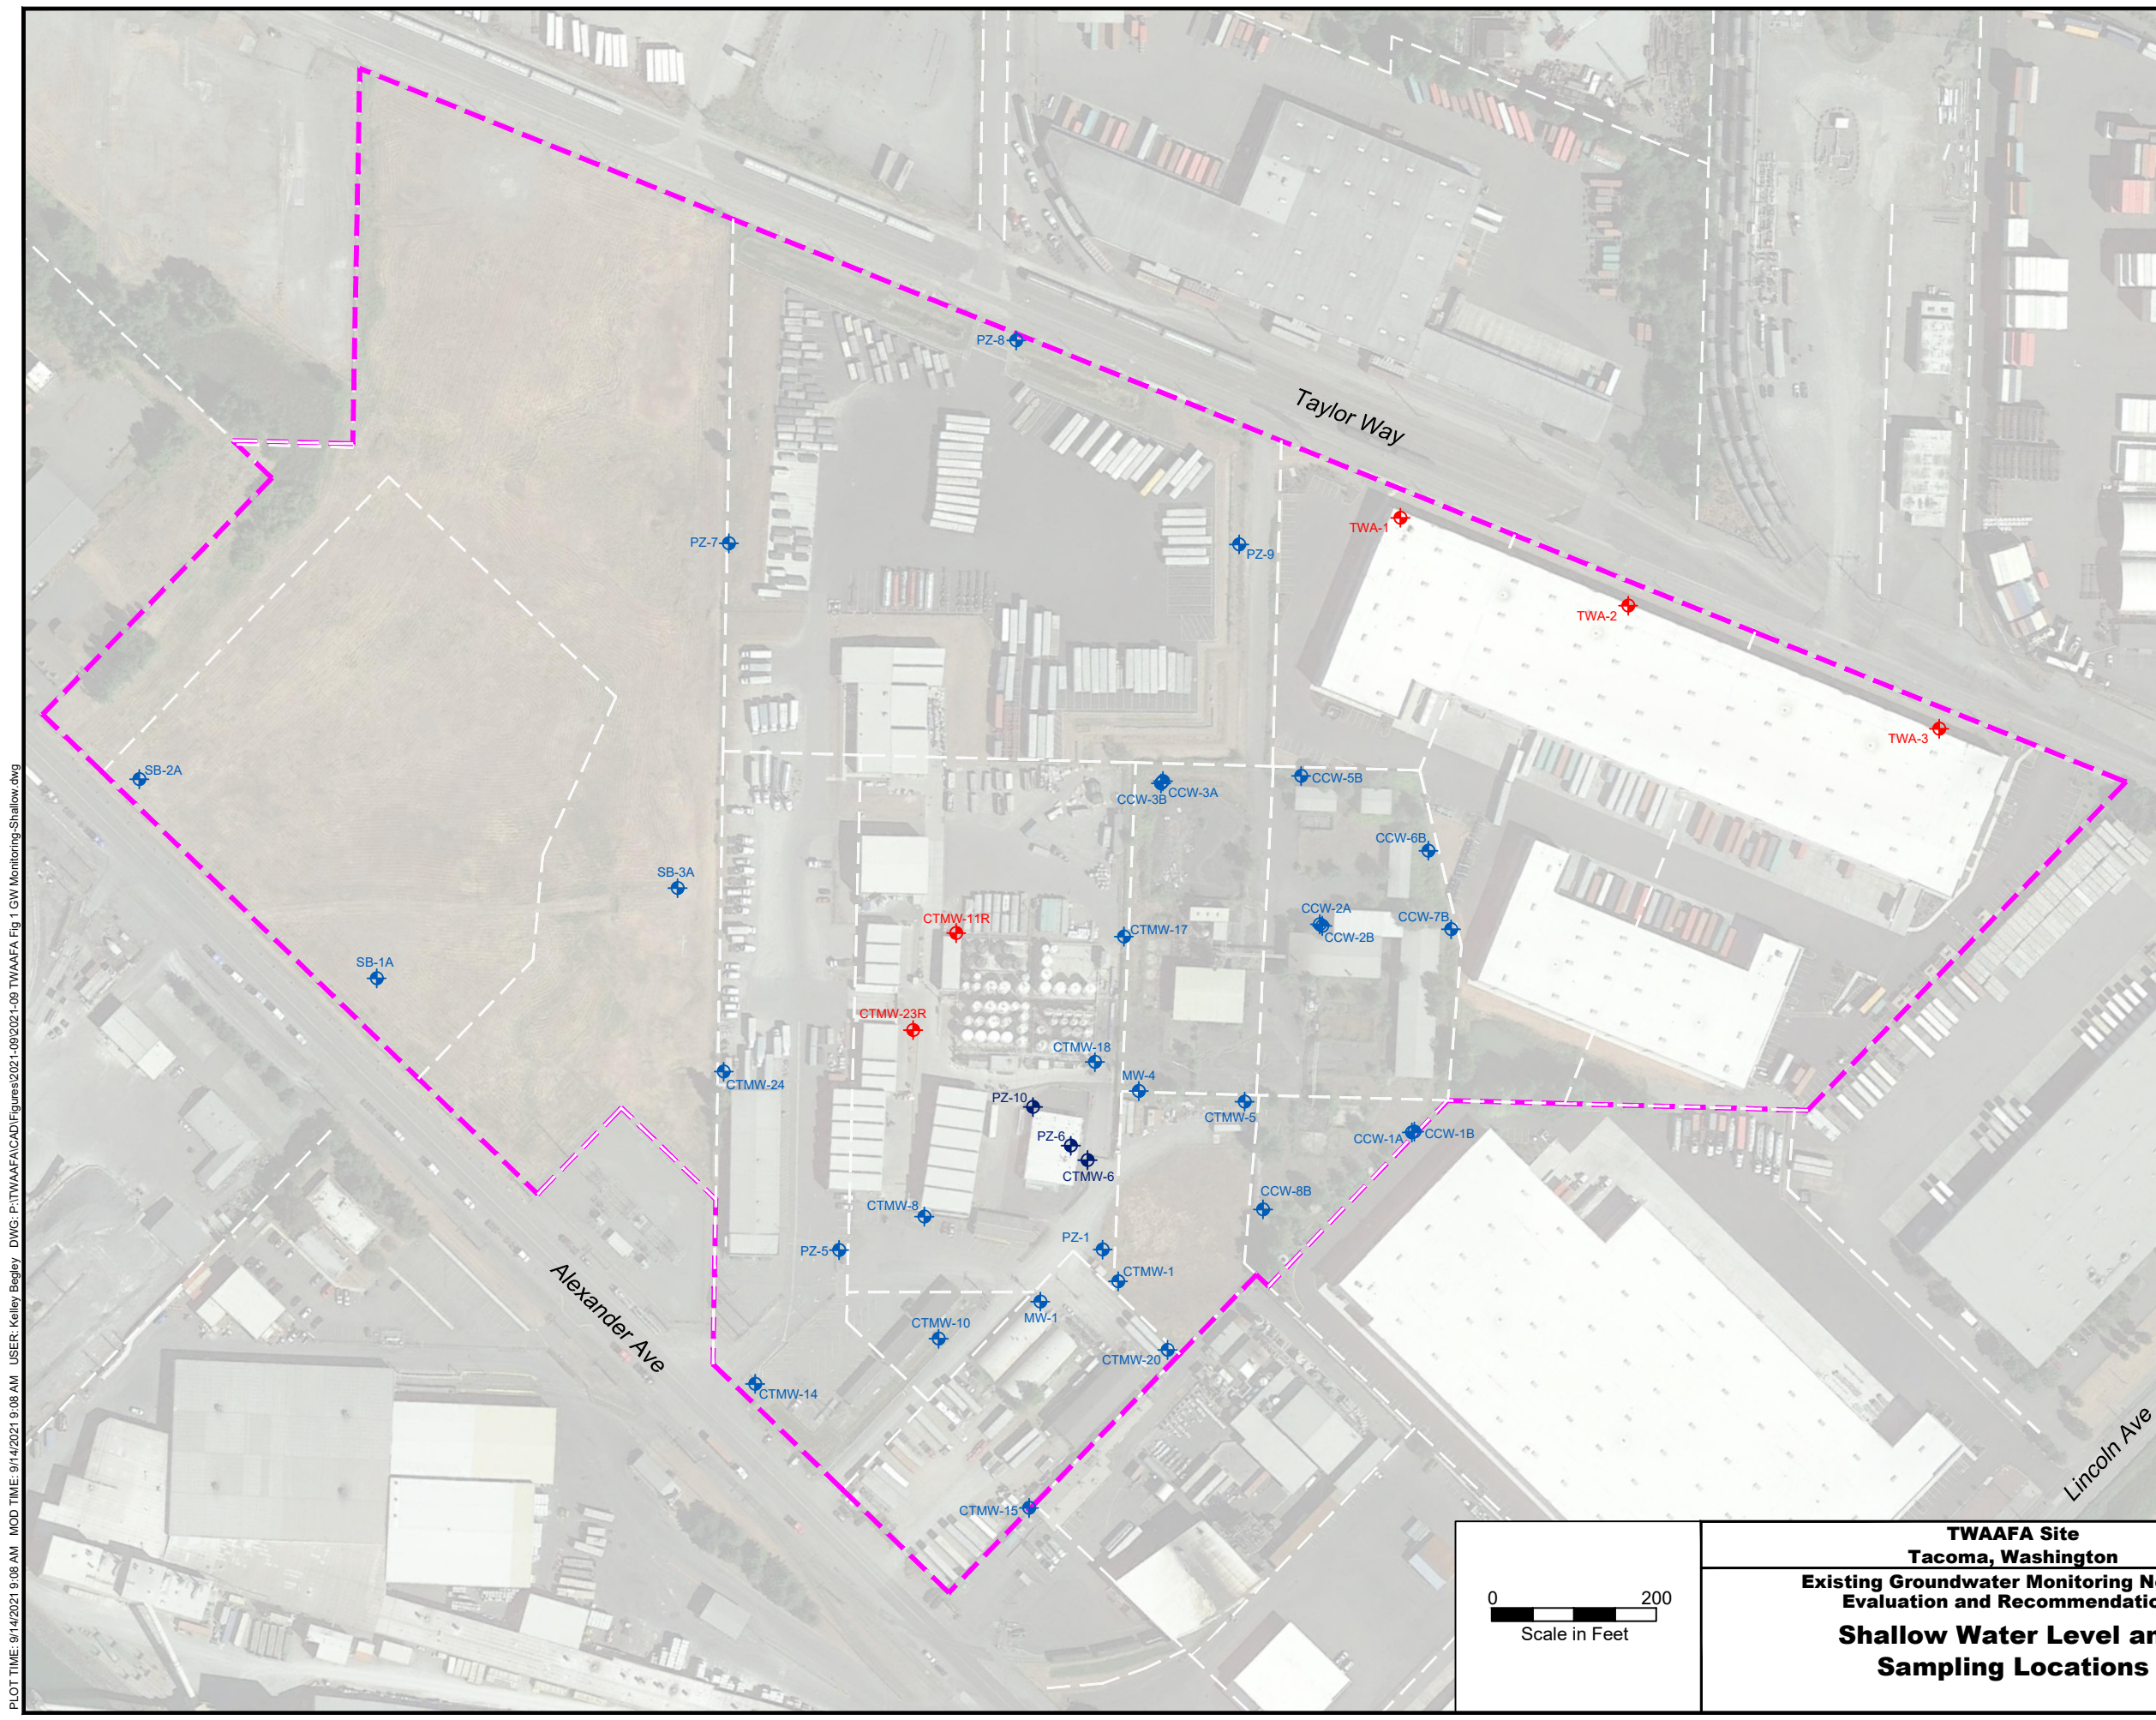
**FIGURE  
1**

Locations identified for installing replacement monitoring wells, CTMW-11R and CTMW-23R, on Burlington Environmental property are shown in Figure 1. The proposed locations are in the vicinity of the tank farm and limit the potential for damage due to facility operations.

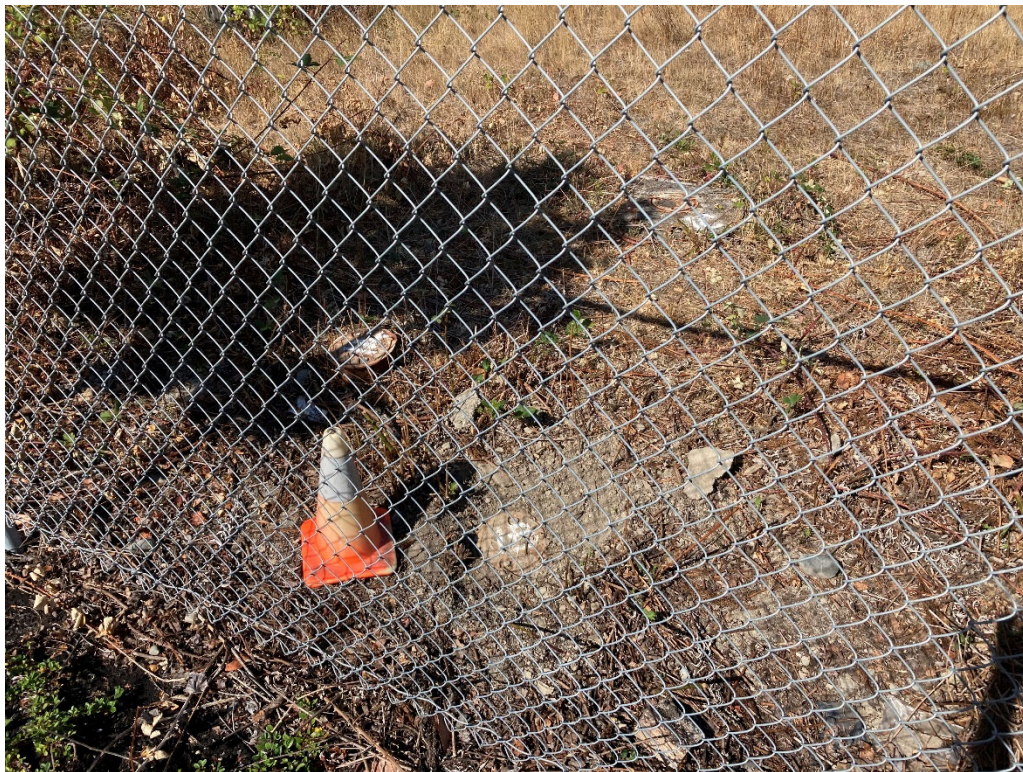
*Picture 4 Monitoring wells CCW-1B (foreground), CCW-1A (left), CCW-1C (background)*

- The concrete surrounding the flush mount monument of well CCW-1A was dislodged and the monument itself was loose, but still had its lid (Picture 4). The well casing inside was capped and appeared in good condition.
- The flush mount monument of well CCW-1B was buried below 6 inches of soil. The well casing inside was capped and appeared in good condition.
- The flush mount monument of well MW-4 was located in an area where DOF previously observed ponded water in February 2021.

- Routine maintenance - replace gaskets and bolts (or re-tap if bolts are stripped) on well monuments CCW-4C, CCW-6B, CCW-6C, CCW-7B, CCW-7C, and internal j-plug caps.
- Replace the monuments at wells CCW-1A, CCW-1B, and MW-4 and raise well casing to facilitate seasonal monitoring.
