STATE OF WASHINGTON
DEPARTMENT OF ECOLOGY

Re: No Further Action at the following Site:

- **Site Name:** Amy's Cleaners
- **Site Address:** 3377 Bethel Road SE, Port Orchard, WA
- **Facility/Site No.:** 28514228
- **VCP Project No.:** NW3125

Issue Presented and Opinion

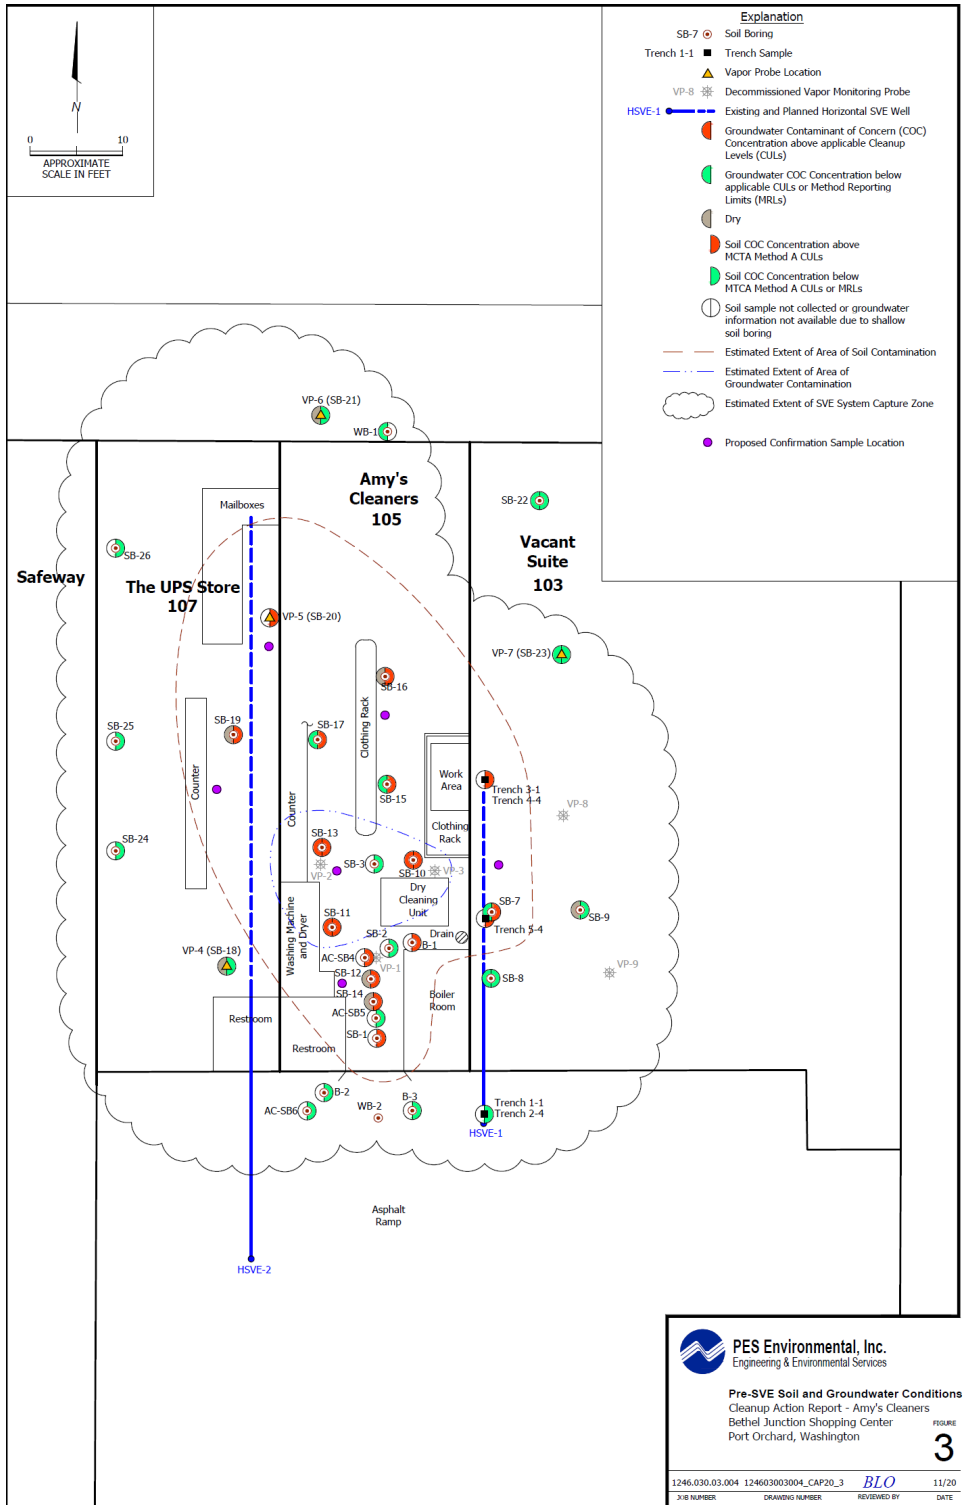
FIGURE
3

Pre-SVE Soil and Groundwater Conditions
Cleanup Action Report - Amy's Cleaners
Bethel Junction Shopping Center
Port Orchard, Washington

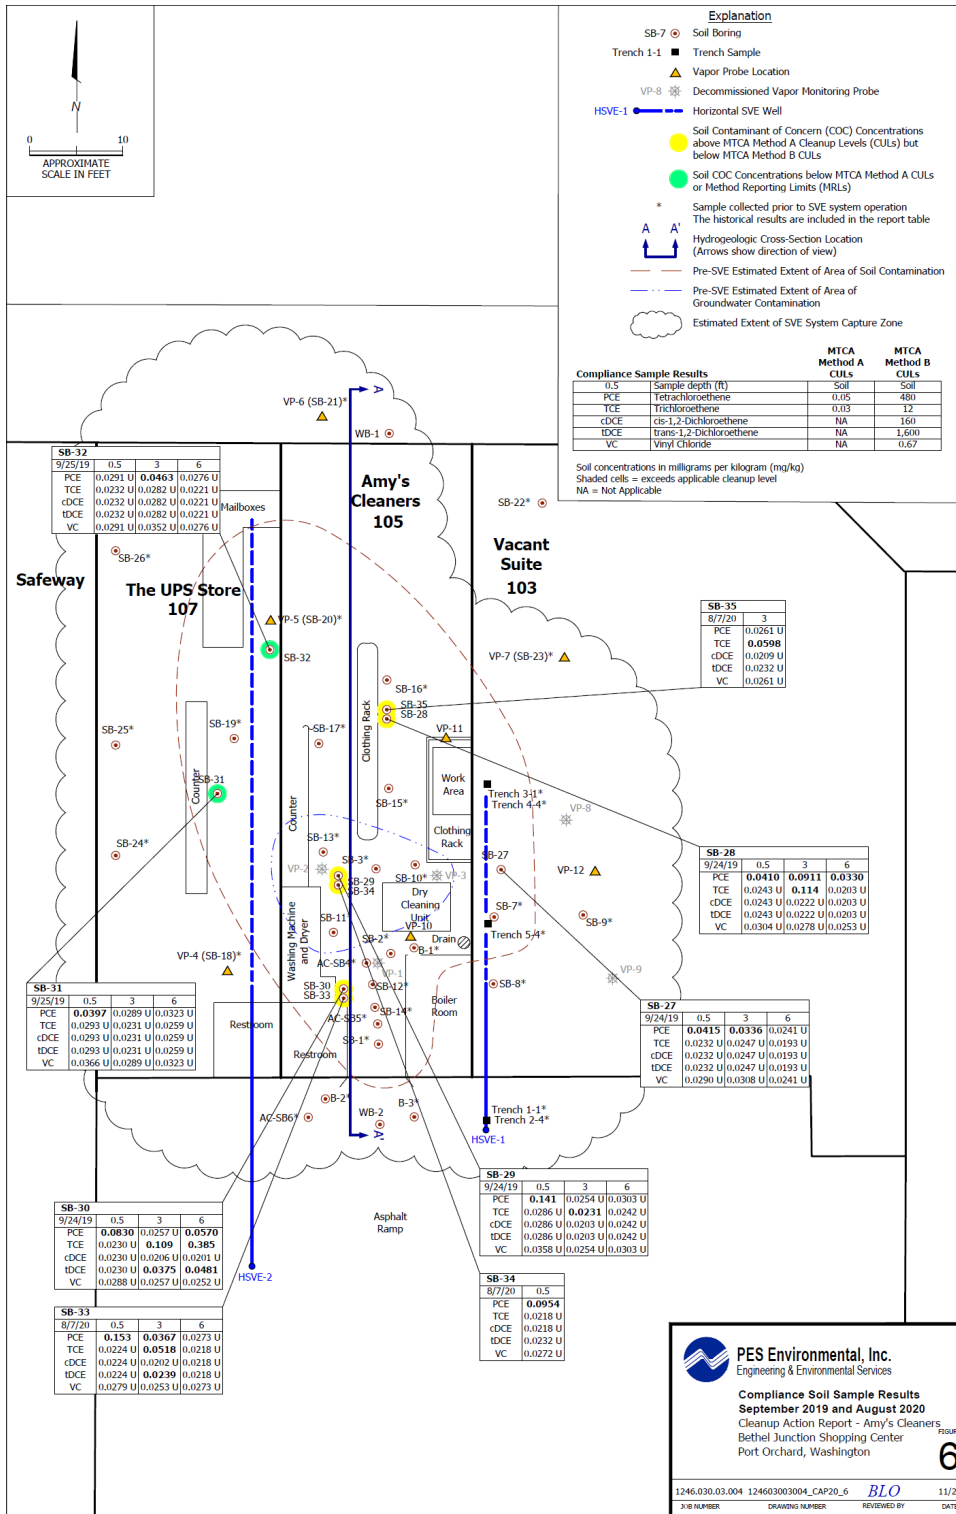
FIGURE
6

Compliance Soil Sample Results
September 2019 and August 2020
Cleanup Action Report - Amy's Cleaners
Bethel Junction Shopping Center
Port Orchard, Washington

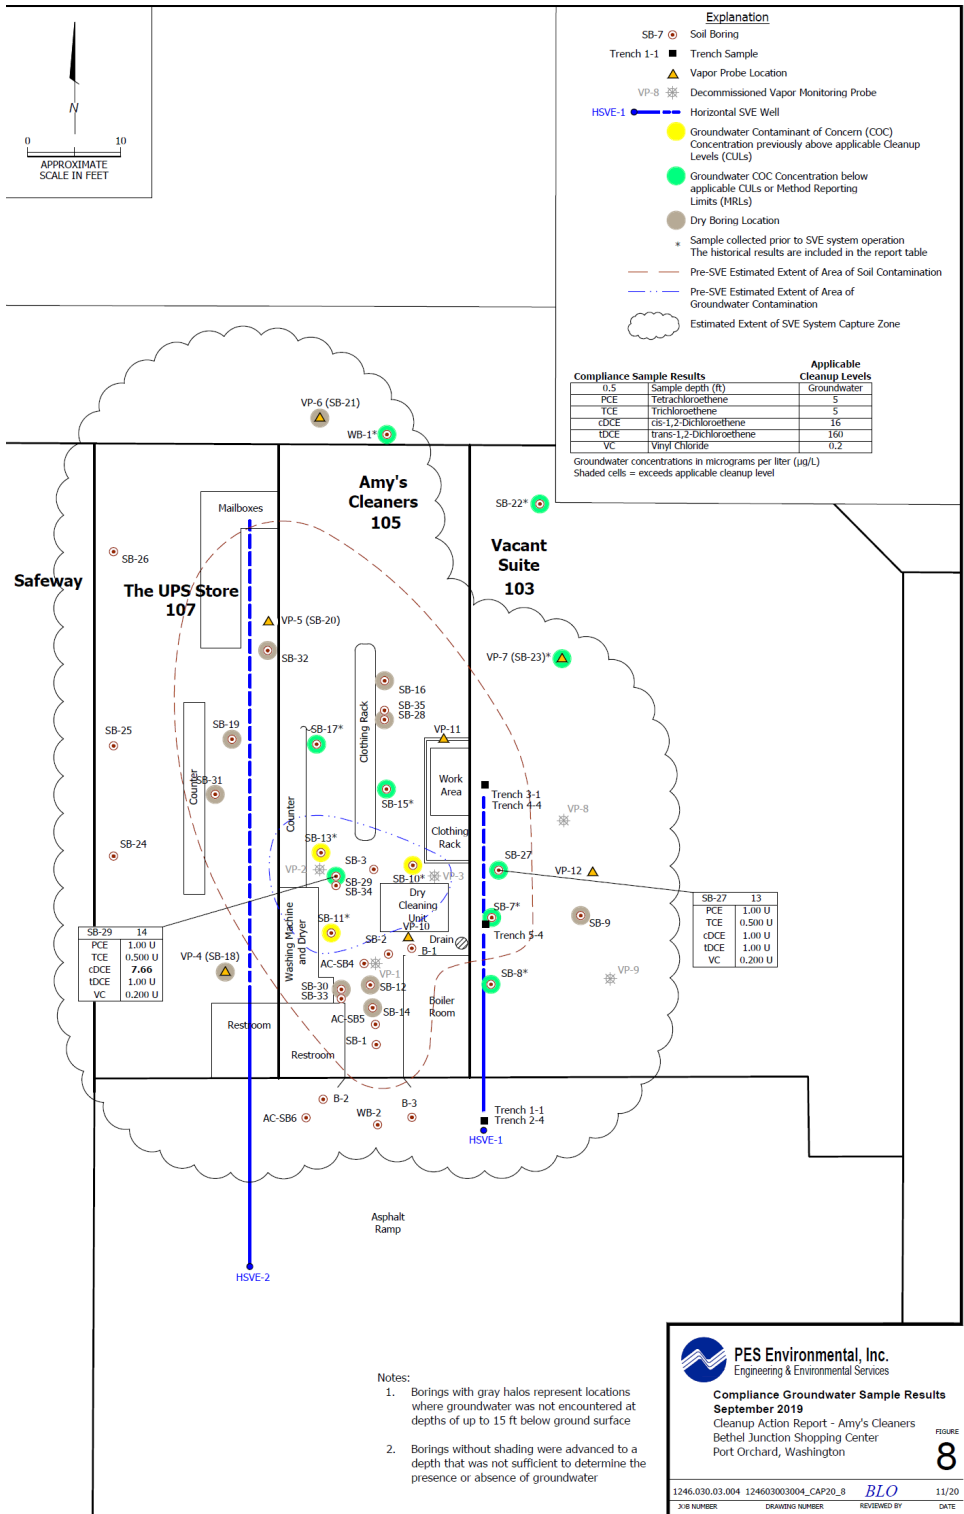
FIGURE
8

Compliance Groundwater Sample Results
September 2019
Cleanup Action Report - Amy's Cleaners
Bethel Junction Shopping Center
Port Orchard, Washington
