October 25, 2021

Re.: Shelton Yacht Club - US Army Corp Permit NWS-2021-668
MTCA Cleanup of Former Evergreen Fuel Facility Site

Subject: Evergreen Fuel retaining wall evaluation
661 East Pine Street
Shelton, WA

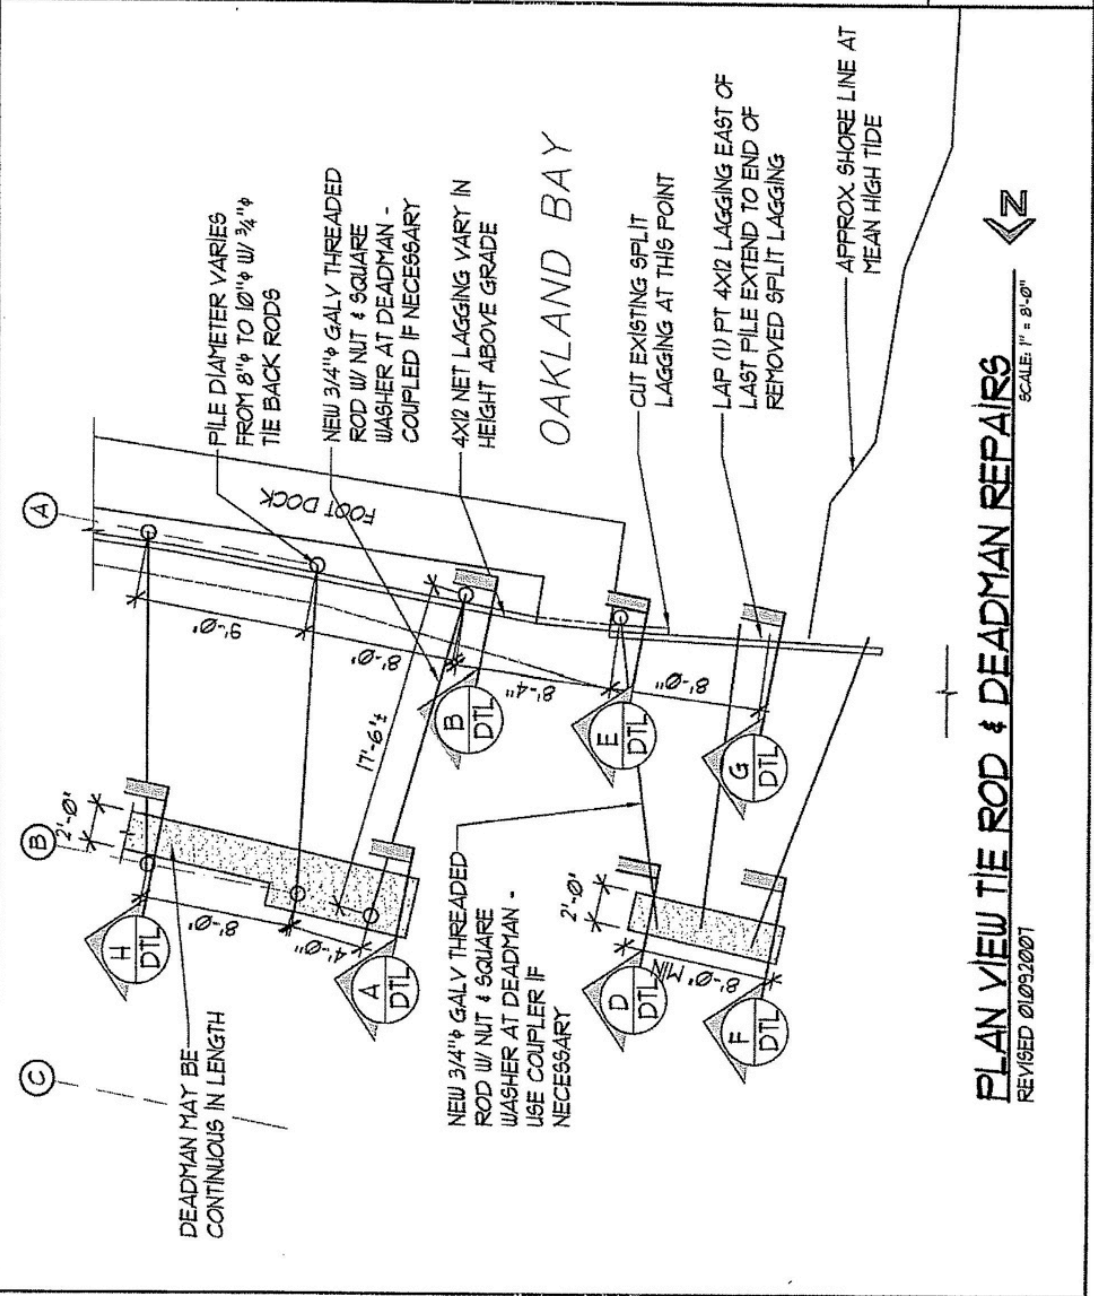
PLAN VIEW TIE ROD & DEADMAN REPAIRS
 REVISION 01092007
 SCALE: 1" = 8'-0"

behind the work they may have done. The first paragraph of the letter appears to describe the intent and scope of the effort which was to repair the damage done to existing tiebacks caused by the excavation work from the site cleanup. The plan view detail shows this repair being done to a few of the soldier piles that had their anchors inadvertently damaged. It does not appear that this is a repair that was done for the length of the wall.

Tension rods which have been damaged must be replaced in kind, with hot dipped galvanized steel, with new 4" diameter washers on both ends and nuts. Where the piles have split by the rods pulling thru, apparently due to impact during excavation, it is recommended that bolted, galvanized steel collars be installed to prevent further splitting of the piles.
