## REMEDIAL INVESTIGATION REPORT

**Cleaners #1 Property  
26112 Pacific Highway South  
King County Parcel #7950301480**

**June 7, 2021**

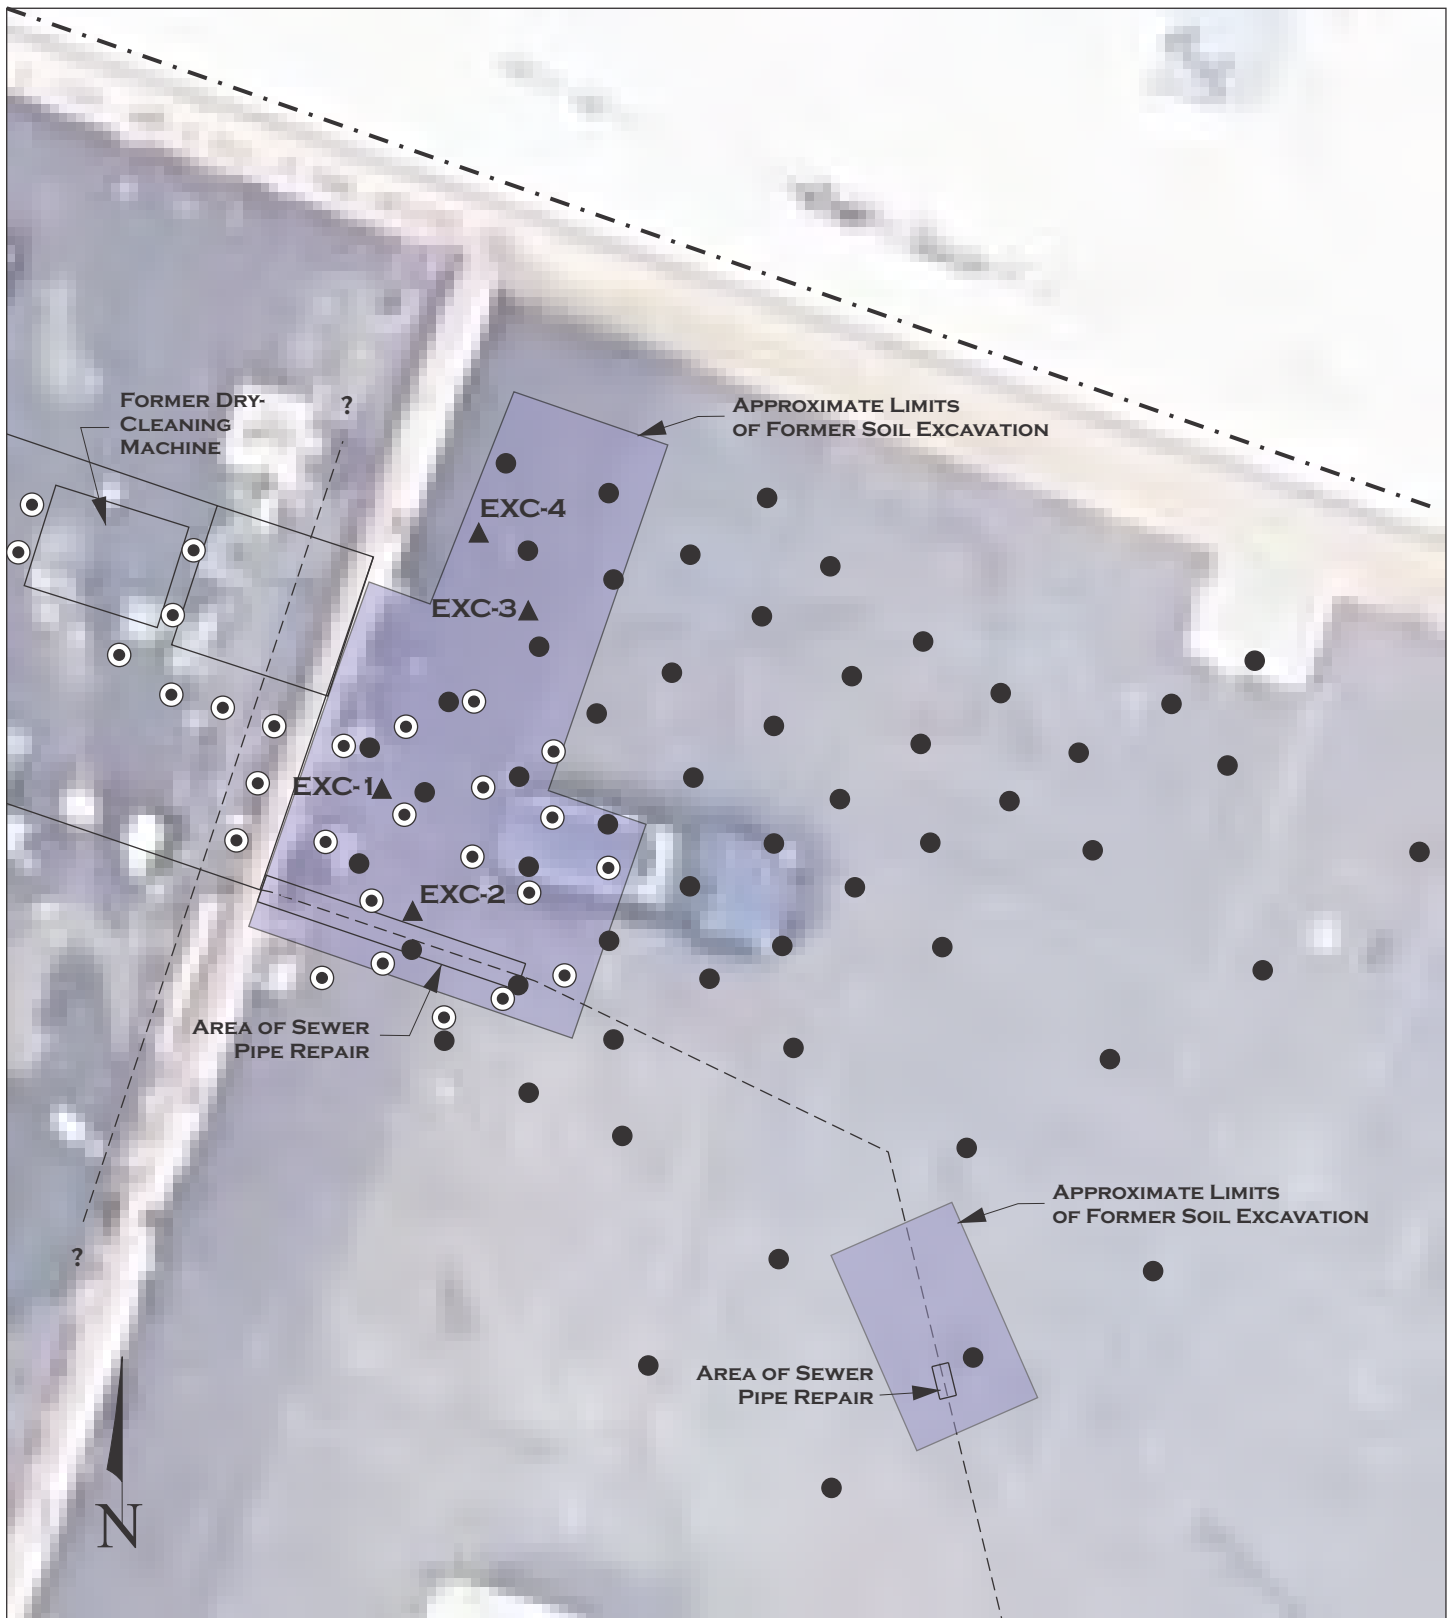
In December of 1998, EAI performed an in-situ chemical injection to reduce concentrations of PCE in soil and groundwater via enhanced reductive dechlorination. Approximately 1,140 pounds of hydrogen release compound (HRC) was injected into the subsurface through 55 geoprobe injection points located to the east of the dry-cleaning facility (Figure 5).

- The video scan revealed significant corrosion of the primary 4-inch metal sewer line leaving the building, in addition to possible leakage points at a junction between the 4-inch metal pipe and a 6-inch PVC connection on the eastern exterior of the building.
- The soil samples collected from B-11 did not contain concentrations of CVOCs in excess of their respective laboratory reporting limits and/or MTCA Method A/B Cleanup Levels.

During the recommended sewer replacement efforts in April of 1999, approximately 120 tons of PCE contaminated soil was excavated from adjacent to the sewer line and eastern wall of the dry-cleaning facility (Figure 5). Soil samples collected from the final limits of the excavation contained concentration of PCE below the MTCA Method A Cleanup at the time; however, one of the samples would not be considered in compliance with current Method A Cleanup Levels.

Based on these findings, EAI concluded that there was likely an ongoing release of PCE into the subsurface and recommended the replacement of the sewer lines and repair of the dry-cleaning machines.
