## SOIL & GROUNDWATER REMEDIATION SUMMARY

The Cleaners #1 (Woodmont Place) 26102 Pacific Highway South Kent, Washington 98032

EAI Job# JN-8392-2

Soll & Groundwater Remediation Summary

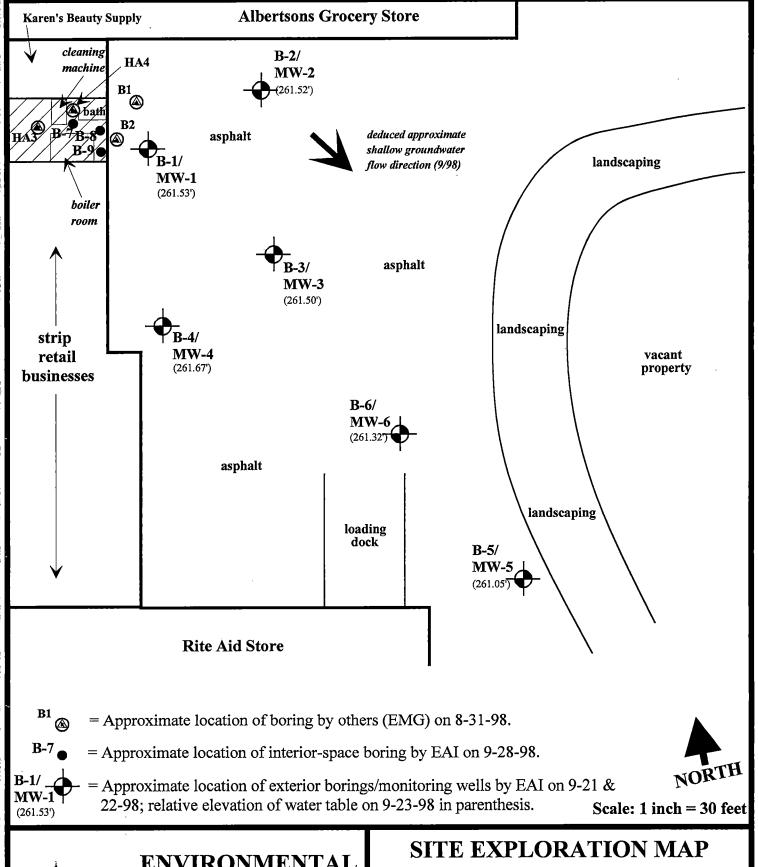
Plate 3: Site Exploration Map

In an effort to further evaluate the extent (areal and vertical distribution) of the cleaning solvent contaminants at the site, Environmental Associates, Inc. (EAI) made six (6) borings (designated as B-1 through B-6) in September of 1998, and constructed groundwater monitoring wells in each of the borings (designated as MW-1 through MW-6 respectively). In addition, EAI made three (3) supplemental borings in interior areas of the dry cleaner, along with soil sampling. These locations are depicted on Plate 3.

Relying upon the results of laboratory testing of selected <u>soil</u> samples from the six (6) exterior borings and the three (3) interior borings, although trace concentrations of PCE were detected in several of the soil samples, no chlorinated solvents (including PCE and TCE) were detected at concentrations exceeding WDOE Method-A cleanup levels in effect at that time for these contaminants in soil.

In contrast, groundwater sampled from three (3) of the six groundwater monitoring wells (the three wells closest to the back-door area of the dry cleaner, designated as MW-1, MW-2, and MW-3) revealed concentrations of PCE in excess of the WDOE Method-A cleanup level for PCE in groundwater, with the highest concentration detected in groundwater sampled from the well closest to the back-door area (designated as MW-1) of the dry cleaner. PCE-degradation by-products TCE and (cis)1,2-dichloroethylene [also known as (cis) 1,2-DCE] were also detected in groundwater sampled from two (2) of the wells at concentrations exceeding the WDOE Method-A (for TCE) and Method B (for DCE) cleanup levels for these contaminants in groundwater, and the degradation by-

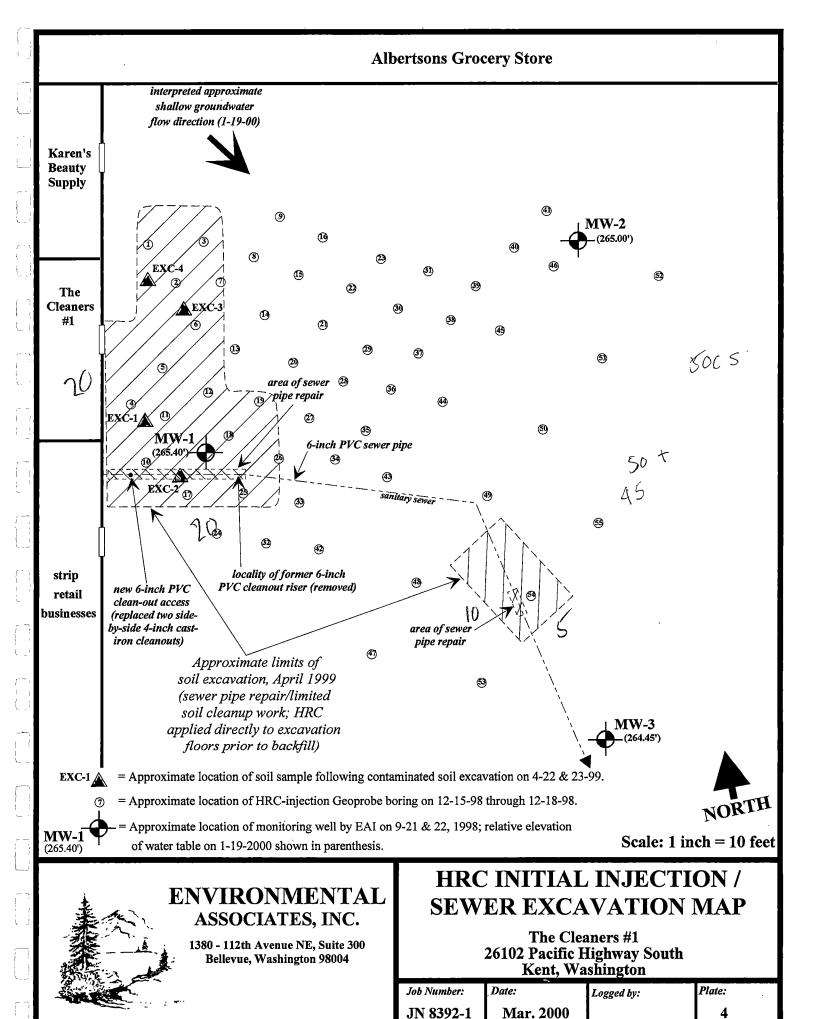
Plate 4: HRC Initial Injection / Sewer Excavation Map

In December 1998, a total of 1140 pounds of HRC (114 gallons) was injected into the site subsurface via 55 Geoprobe boreholes. The injection procedure consisted of driving the hollow-stem Geoprobe rods to the desired maximum depth (approximately 16 to 18 feet below the ground surface) using a truck-mounted, direct-push hydraulic system, thus facilitating injection of HRC over the desired depth range (approximately 18 feet below the ground surface to approximately 6 feet below the ground surface for this site). The approximate locations of these injection points are depicted on Plate 4, attached.

A subsequent video survey of the sewer system on March 24, 1999 revealed at least two (2) areas of potential leakage of the sanitary sewer system into the site subsurface, including a section of cast iron sewer pipe extending approximately 14 feet east from the east wall of the dry-cleaner facility and proximal to groundwater monitoring well MW-1, and another locality positioned approximately 45 feet east-southeast from the dry cleaner facility.

In an effort to prevent further releases of PCE to the site subsurface through the leaking sewer pipe, portions of the sewer pipeline were excavated and repaired in April, 1999. During and following sewer pipe repair work, approximately 80 cubic yards (120 tons) of soils containing low levels of PCE (less than the 0.5 parts per million or "ppm" WDOE Method-A cleanup level at that time) were excavated from the area adjacent to the east wall of the dry cleaner facility, and transported by truck to TPS Technologies, Inc. Tacoma, Washington facility for thermal desorption treatment. Soils were excavated to a maximum depth of approximately 12 feet below the ground surface. The approximate areal extent of excavation is depicted on Plate 4, attached.

Following excavation of soil and sewer pipe repair at the two (2) previously discussed localities, and prior to back-filling, approximately 15 gallons (150 lbs.) of HRC were applied to the floor of the excavation located adjacent to the dry cleaner facility east wall, and approximately 3 gallons (30 lbs.) of HRC were applied directly to the floor of the smaller excavation area located further to the east.

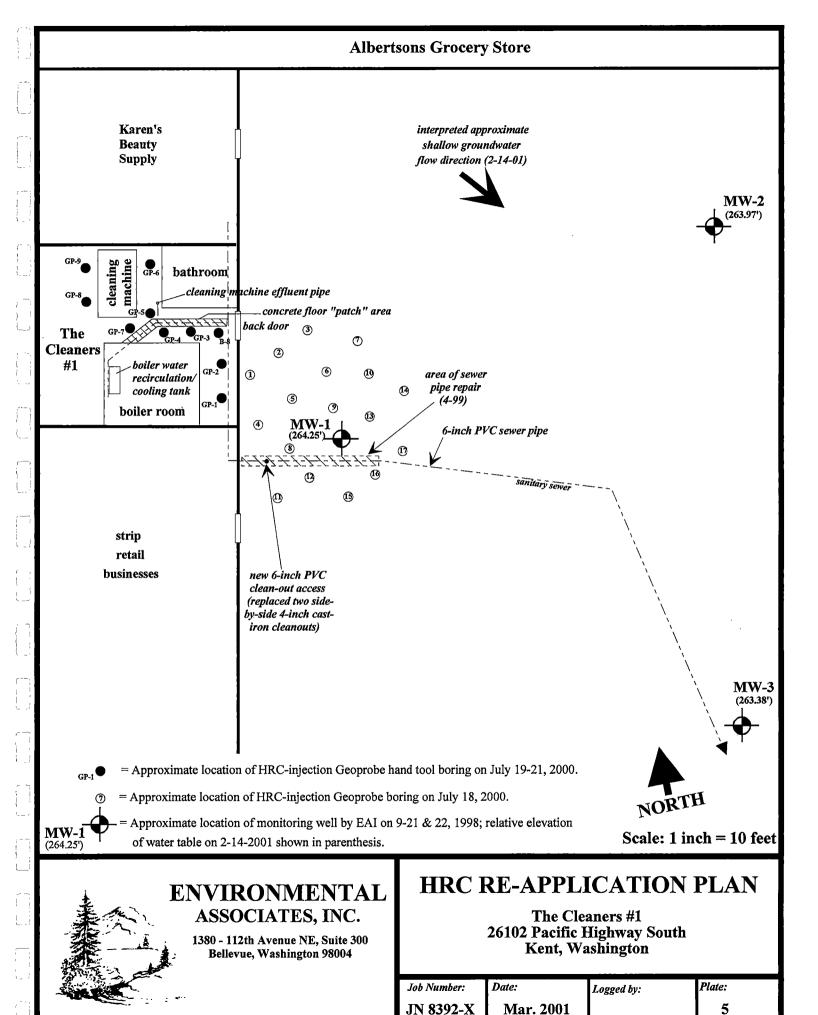
Plate 5: HRC Re-Application Plan

Following the repair of the sewer and limited PCE-impacted soil excavation, residual contaminant concentrations in the groundwater declined rapidly (Table 2 & Charts 2, and 3). However, beginning in early 2000, rebounding of contaminant concentrations appeared to be occurring. EAI suspected that residual concentrations of PCE within the soil underlying the dry-cleaner may have been contributing to the apparent rebounding of contaminant concentrations in the groundwater. Consumption and diminished "strength" of the initial HRC injection was also suspected to be contributing to the rebounding.

In July 2000, approximately 51 gallons or HRC and 18 gallons of HRC-Primer were re-injected in the study area to bolster and maintain the enhanced anaerobic bio-remediation. The additional HRC was injected through 9 interior borings within the dry cleaners lease space and 17 exterior borings in the parking lot east of the cleaners. The approximate locations of the HRC re-injection borings are depicted on Plate 5, attached to this report.

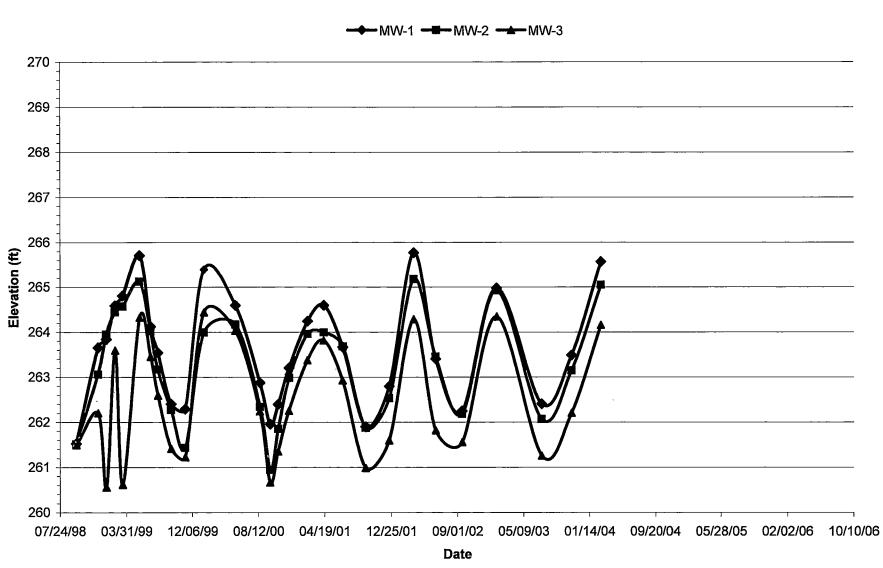
**Chart 1: Water Table Hydrograph**

Over the duration of the quarterly monitoring, the groundwater flow direction in the study area appears to have remained fairly constant towards the southeast. Chart 1, in Appendix-A presents a hydrograph for water table elevations measured within the core study area (MW-1, MW-2 and MW-3). An examination of the hydrograph suggests a fairly consistent cyclical rise and fall of the water table of approximately 3 to 4 feet between the wet and dry parts of the year.

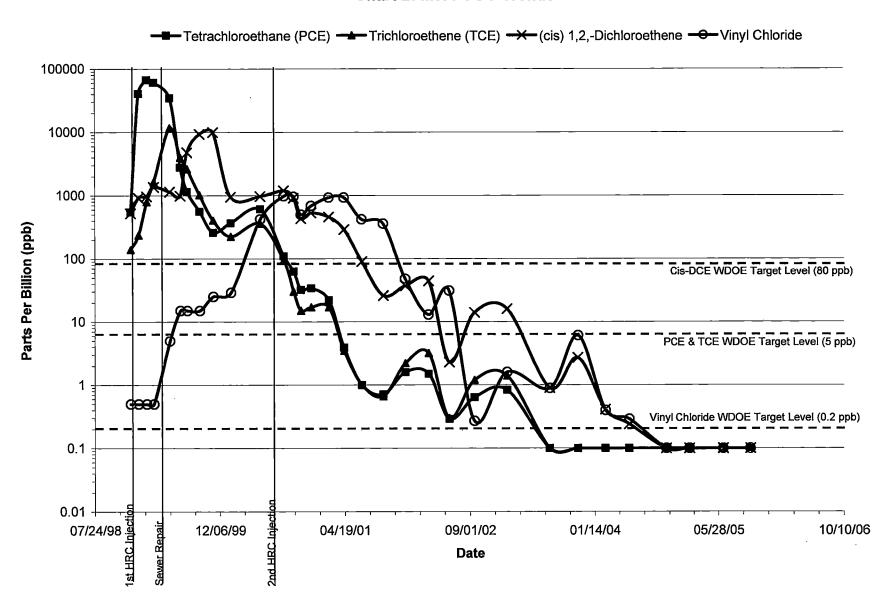
**Chart-2: MW1 VOC Trends**

A review of Chart 2 (MW-1) shows a fairly steady decline in PCE and TCE concentrations with some periodic cyclical rebounding, which may have been due in part to seasonal effects, such as rise and fall of the water table. Groundwater at MW-1 had achieved compliance with regard to PCE and TCE by the spring of 2001 and has remained in compliance for those compounds over the remaining 16 consecutive sampling events ending in October 2005.

The anaerobic bio-degradation of PCE and TCE resulted in a corresponding increase in concentration of cis-DCE and vinyl chloride in the groundwater, particularly at MW-1 and MW-3. At MW-1 and as depicted on Chart 2, the concentration trends for cis-DCE and vinyl chloride also declined with time. By the spring of 2001, the concentrations of cis-DCE at all monitoring well locations were in compliance with WDOE target levels and have remained so through the end of monitoring in October 2005.

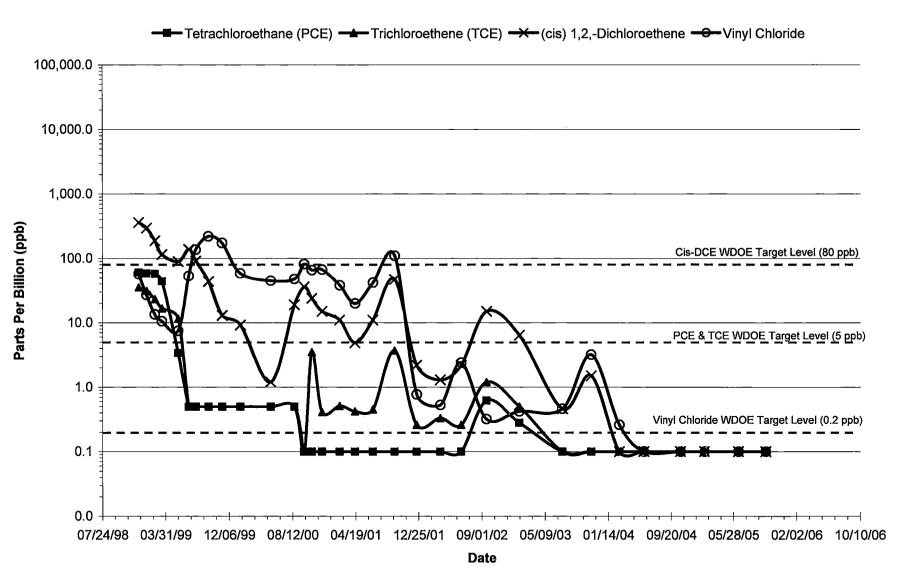
Chart 3: MW-3 VOC Trends

At MW-3 as depicted on Chart 3, concentrations of PCE and TCE declined to concentrations below WDOE target compliance levels within the first year following the initial injection of HRC and have also remained in compliance for PCE / TCE over the remainder of the study.
