UST ID#: 10140

Inspection Type: Unannounced UST inspection in response to **ERTS# 681199**

Inspector: Will Bergquist

Date: 5/17/2018

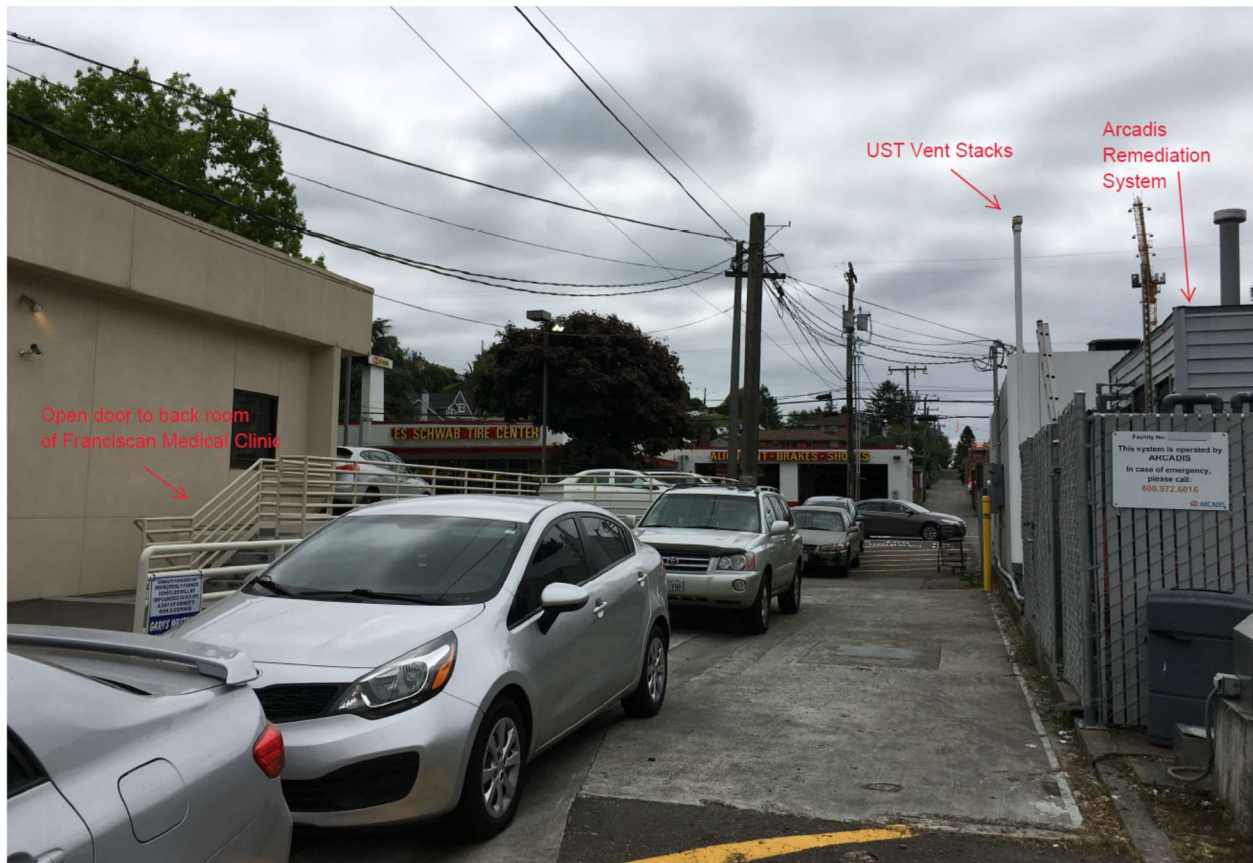
I arrived onsite at 1:08 pm. I immediately conducted a walk-around inspection of the entire property to determine if I could smell any strong petroleum odors. I paid special attention to the small alleyway between the UST facility (UST ID# 10140) and the Franciscan Medical Clinic (see *Photo 1*). Although the alleyway was immediately downwind of both the UST vent stacks, as well as the *Arcadis U.S., Inc.* operated remediation system, I was not able to observe any significant petroleum vapors. I then focused my attention to the area immediately downwind of the dispenser islands, but again, I was not able to detect any significant petroleum vapors other than what is normally produced during vehicle fueling operations.

Photo 1: Alleyway between the UST facility (UST ID# 10140) and the Franciscan Medical Clinic

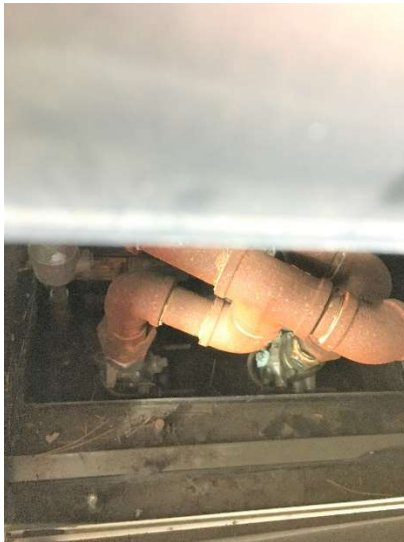
All of the dispenser sumps on-site were clean, dry, and presented no noticeable petroleum vapors (see *Photos 2, 3, and 3*). The dispenser filters were in good condition and no leaks or weeps were observed on any of the dispenser piping. All 4 spill containers on-site were also clean and dry (see *Photos 4 and 5*). Although there was some significant warping of the spill container side-walls, resulting from downward pressure of heavy vehicle traffic, there were no holes or cracking observed. Unfortunately, I was not able to visually observe the turbine sumps due to a lack of proper tools and man-power required to lift the large sump lids, however, the 'LIQUID STATUS REPORT' generated earlier in the inspection did indicate that the sumps were also in good operating condition. I will plan on visually observing the turbine sumps during a full Significant Operational Compliance (SOC) Inspection schedule for 5/22/2018. Upon completion of the inspection of observable UST equipment, I thanked the employee for his patience and cooperation and proceeded to the Franciscan Health Clinic.

Photo 2: Dispenser 1/2 Sump

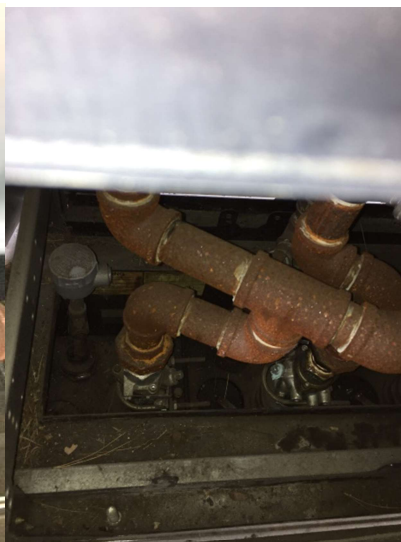
Photo 3: Dispenser 3/4 Sump

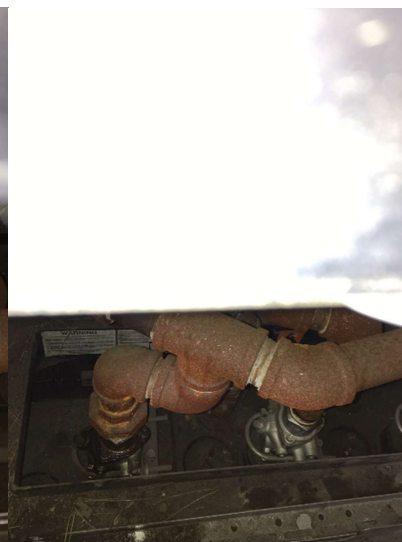
Photo 4: Dispenser 5/6 Sump

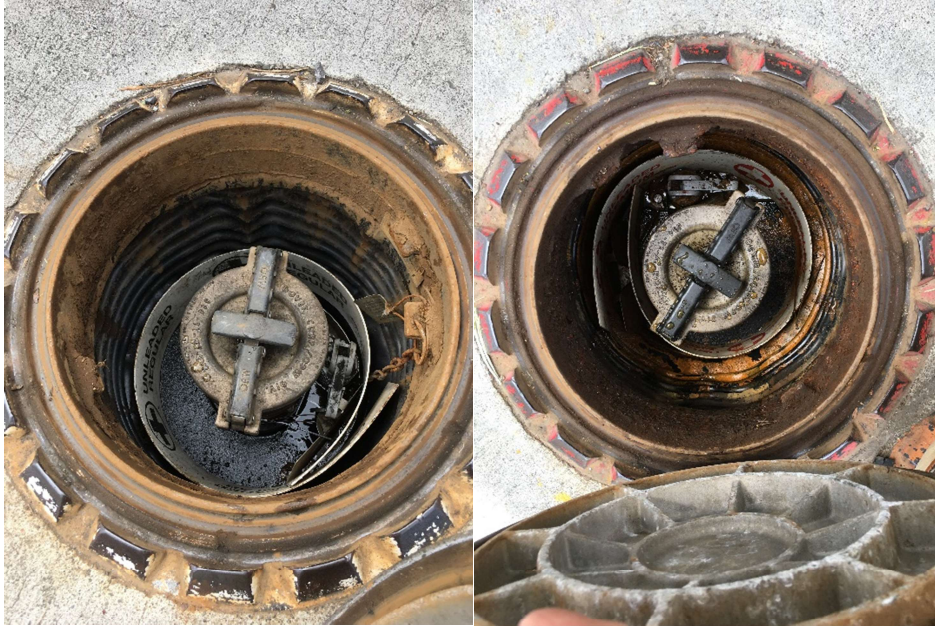
Photo 5: Reg Unleaded Spill Container

Photo 6: Premium Unleaded Spill Container
