RE: TECHNICAL MEMORANDUM – Vapor Mitigation System Installation
Franciscan Medical Clinic
4550 Fauntleroy Way SW
Seattle, Washington 98126-3471
AEG Project No. 18-172

Associated Environmental Group, LLC (AEG) has prepared this Technical Memorandum for the purpose of presenting a summary of the vapor mitigation system installation activities performed at the Franciscan Medical Clinic, located at the above-referenced address in Seattle, Washington (Site). The Site work was completed over a weekend to allow access to all areas within the lower level of the building and parking areas. The objective of work was to address health concerns and reduce the petroleum vapors detected within the building. This system is intended to operate until such time that BP West Coast Products, LLC (BP) finishes their investigation of the petroleum impact to Site subsurface associated with the adjacent Shell site to the west.

Sub-Slab Depressurization System Installation Activities

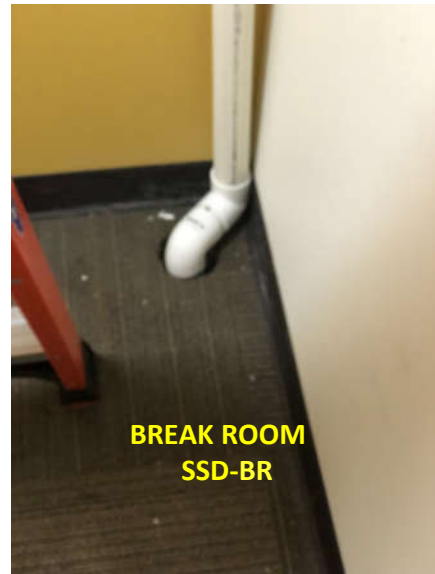
**BREAK ROOM
SSD-BR**

On November 3, and 4, 2018, AEG personnel along with a Washington licensed contractor and electrician installed three SSD points located in the Exam Room 3, employee break room, and the storage room, respectively, in the basement of the clinic building. The SSD points provide a pressure differential (vacuum) using vertical vapor collection points installed through the concrete floor, while connecting the points to air conveyance piping to a central point above the acoustic drop ceiling. The Site's current layout and SSD locations are illustrated in Figure 3, *Sub-Slab Depressurization Point Locations*, and photographs of the installation are included in Appendix A, *Site Photographs*.

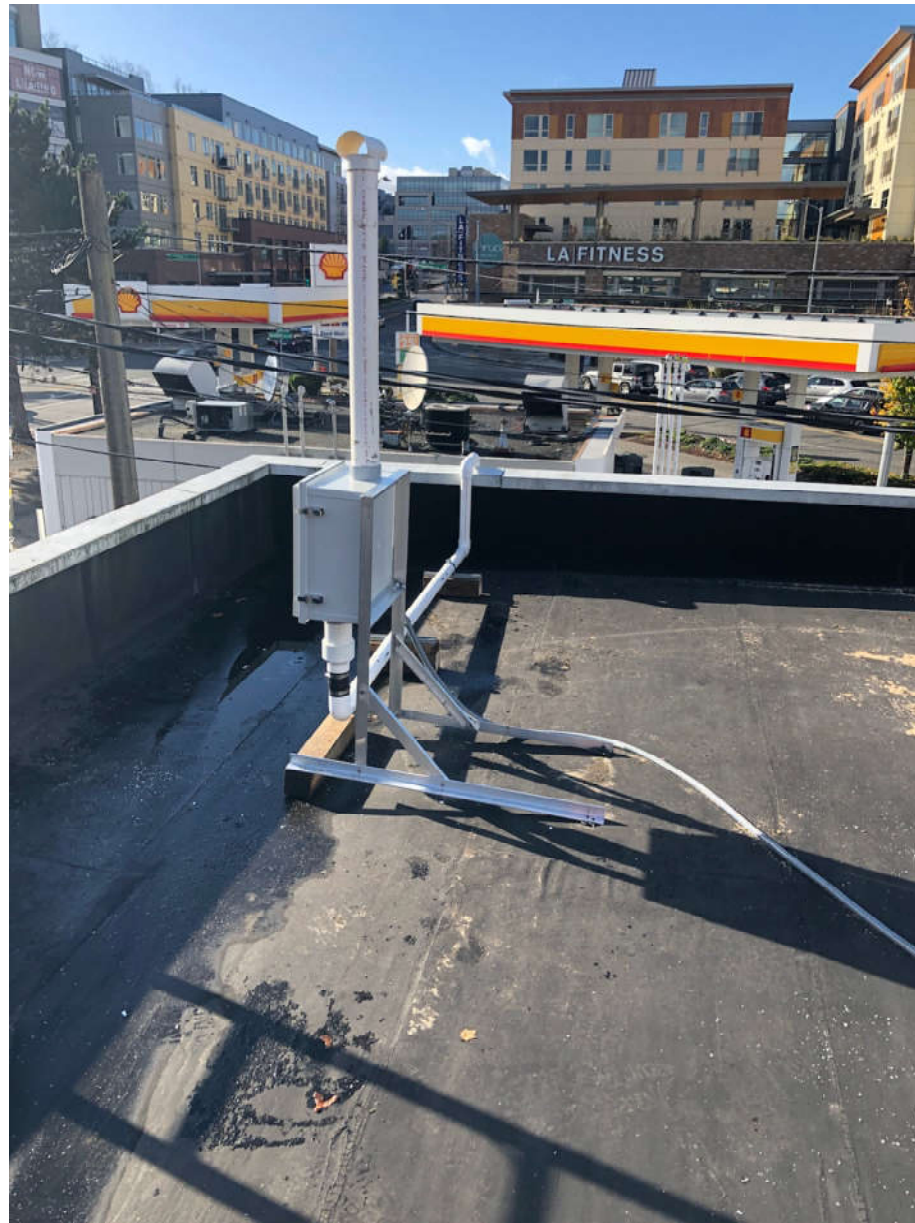
The system exhaust stack was located on the roof a sufficient distance from all windows, doors, heating and ventilation systems, and other exhaust points to prevent a reintroduction of extracted constituent vapors. The exhaust stack was terminated approximately 3 feet above the roof surface. The location and layout of the exhaust stack are illustrated on Figure 4, *Roof Locations for Vacuum Equipment*, and Figure 5, *Vacuum Blower Unit Roof Installation*, respectively.

- 4-Foot exhaust stack with rain cover
- Electrical connection (120 VAC, 1-ph, 15 amps)
- Removable inlet for maintenance
- Conveyance piping from SSDs in basement over the existing parapet wall.

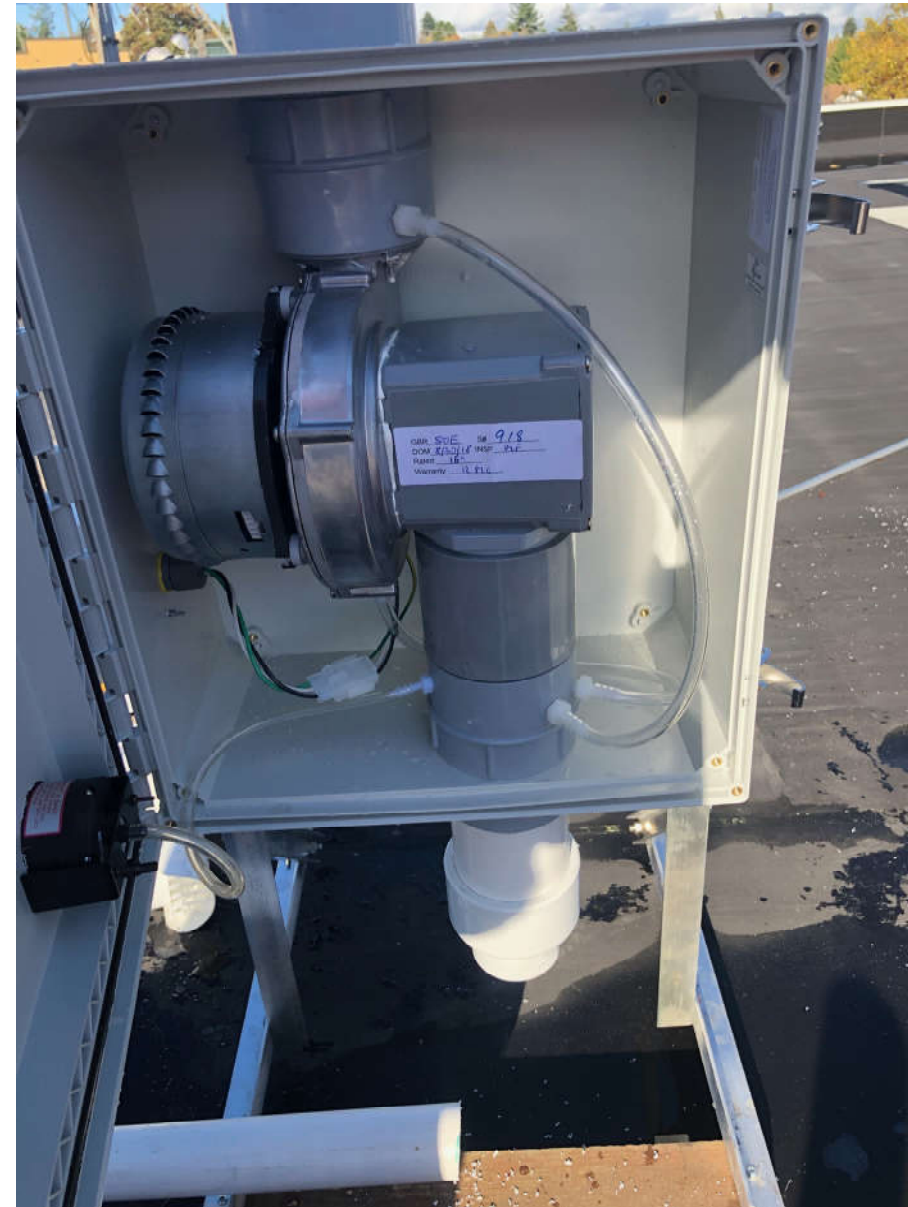
- Cut in wall penetration (2-inch diameter) and installed a 2-inch diameter schedule 40 PVC pipe from the conveyance piping an in-line weather-proof radial blower (Obar GBR78), equipped with a condensation bypass, explosion-proof motor, and control box on the roof surface.

- GBR76 SOE 16" WC @ 0 Max flow 155 CFM.
- Built in speed control to customize performance.
- Condensate bypass built in.

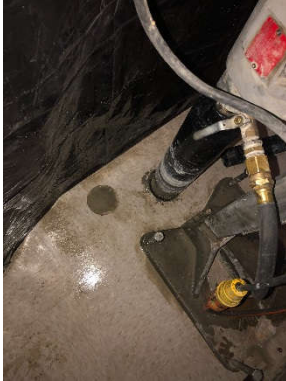
Photo #1:	Coring drilling for SSD-SR in Storage Room	Photo #2:	Removing base material for SSD-BR in the Employee Break Room.

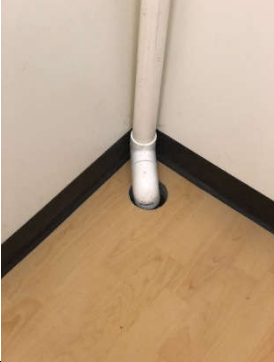
Photo #2:	SSD-E3 in Exam Room #3 conveyance pipe installed and ready for concrete seal.	Photo #4:	SSD-BR in Employee Break Room connected to conveyance piping in drop ceiling.

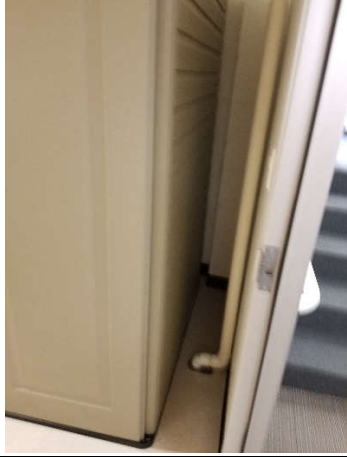
Photo #5:	SSD-SR in Storage Room completed.	Photo #6:	Typical piping installation in drop ceiling space showing the existing building utilities.
