2021 ANNUAL CAP INSPECTION REPORT

BNSF Northport Site

November 11, 2021

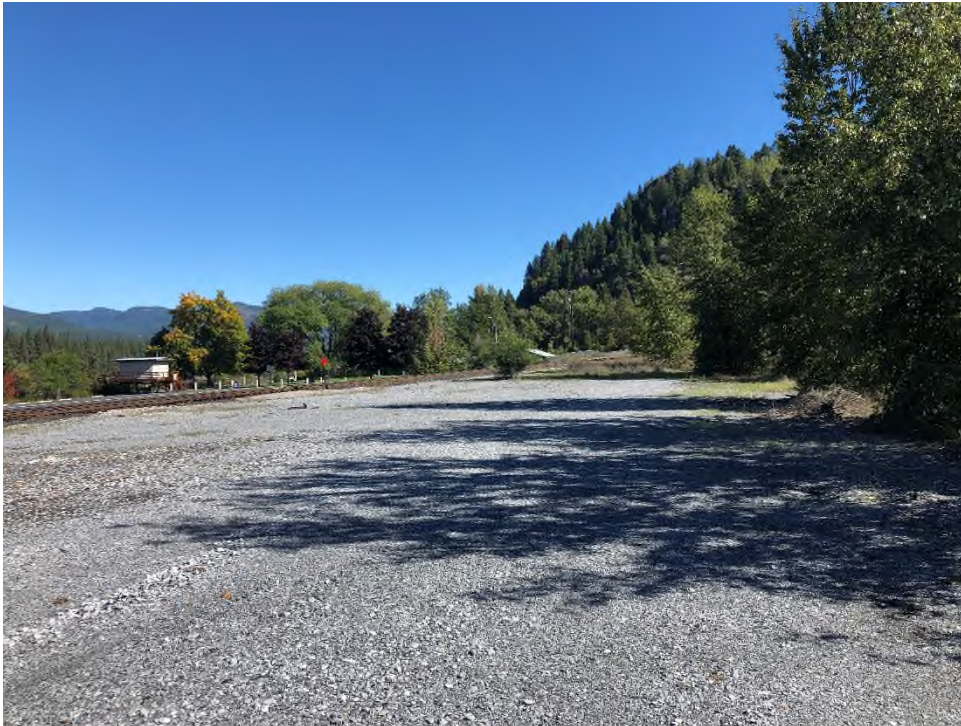
Photograph: 1

Description:
Gravel cap, looking east

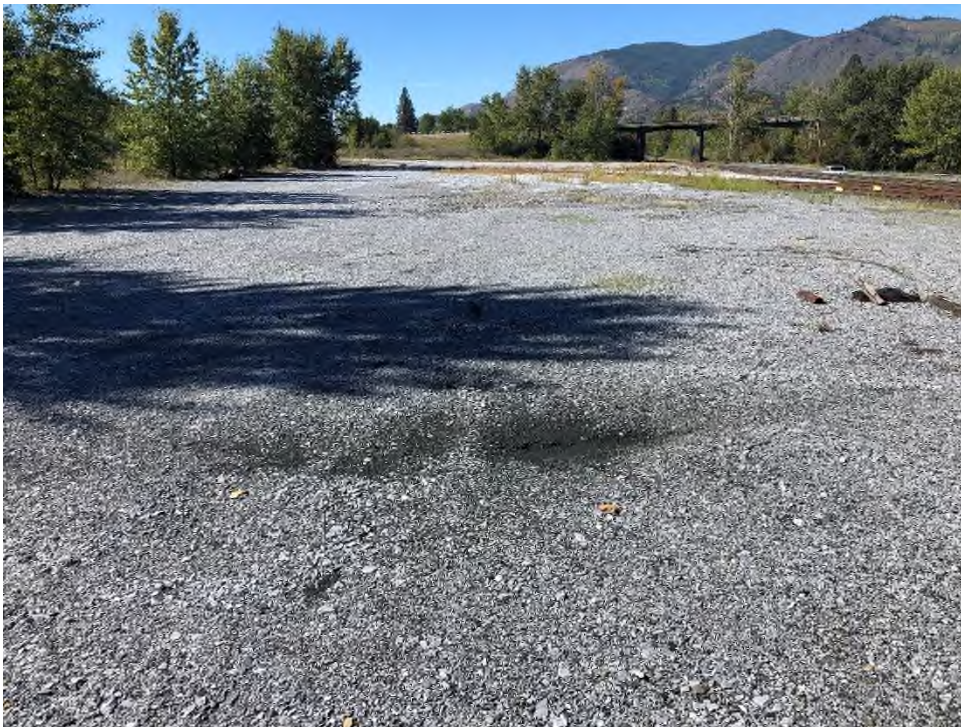
Photograph: 2

- A low spot in the central portion of the gravel cap (photograph #2 in Appendix A)
- Exposed geotechnical fabric in the southeast portion of the gravel cap (photograph #4 in Appendix A)
- Weeds established along fence line separating park from track area (photograph #6 in Appendix A)

Description:
Low spot in gravel cap, looking west

The low spot and exposed geotechnical fabric identified during the cap inspection were addressed on October 14, 2021 through the application of additional gravel cover. The weeds present along the fence line will be addressed through the application of an herbicide spray prior to the start of the next growing season. The next cap inspection will occur during the fourth quarter of 2022.

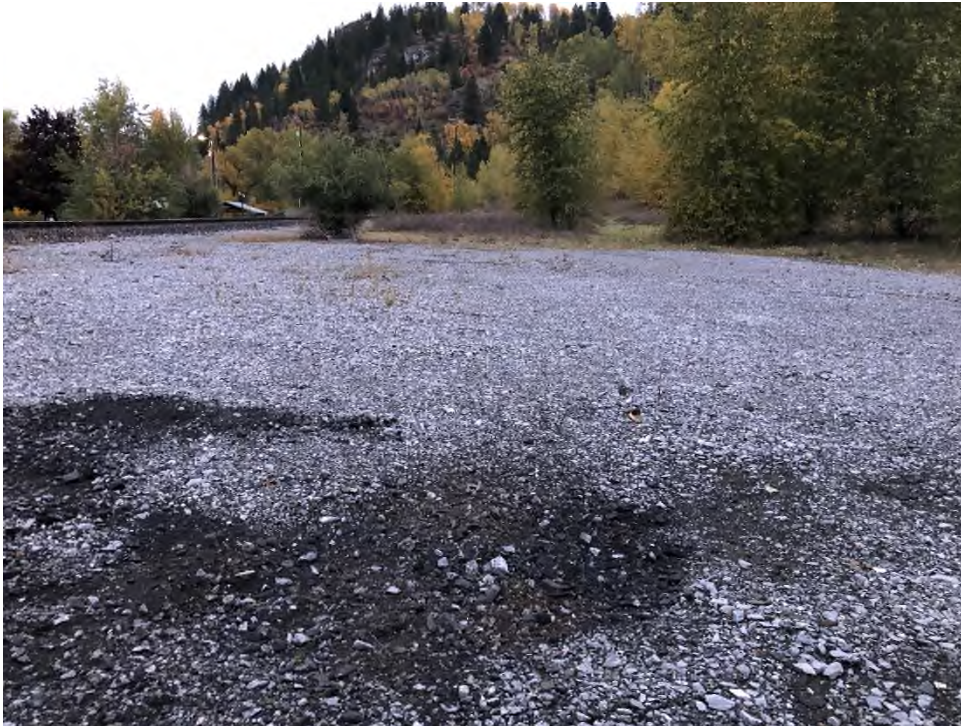
Photograph: 3

Location of low spot following addition of gravel, looking east

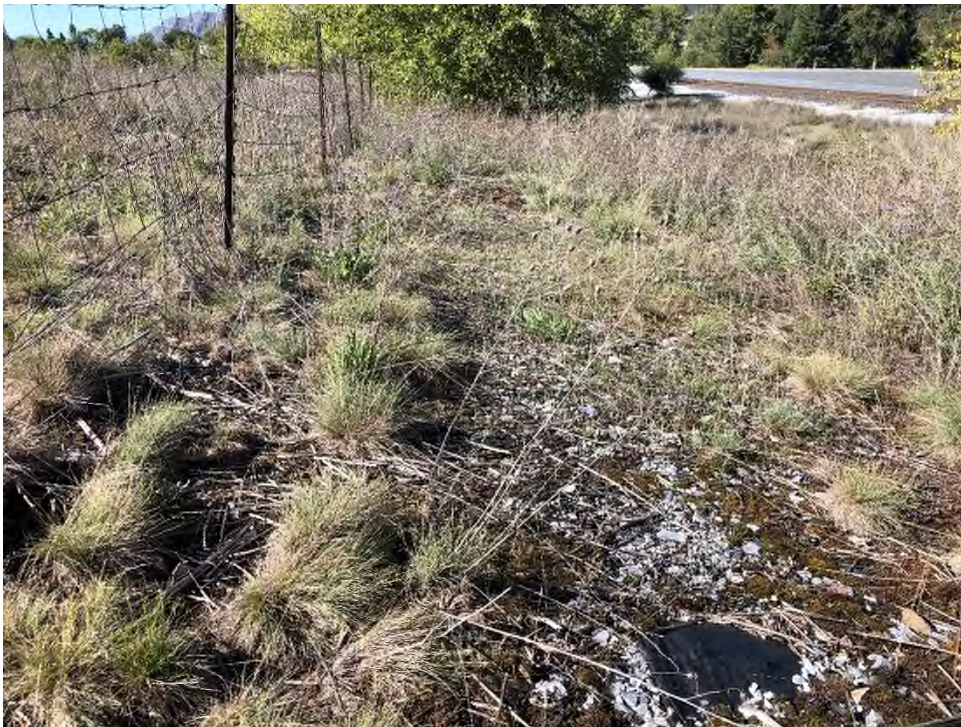
Photograph: 4

Exposed geotechnical in the southeast area of the cap, looking west

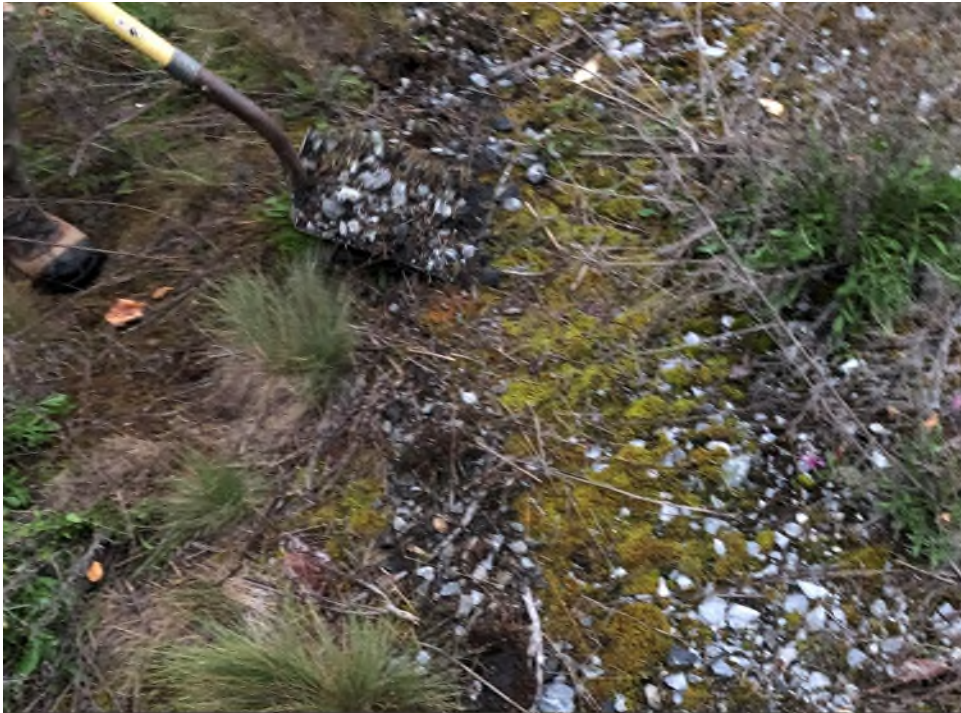
Photograph: 5

Description:
Covering exposed geotechnical fabric in the southeast area of the cap, looking east

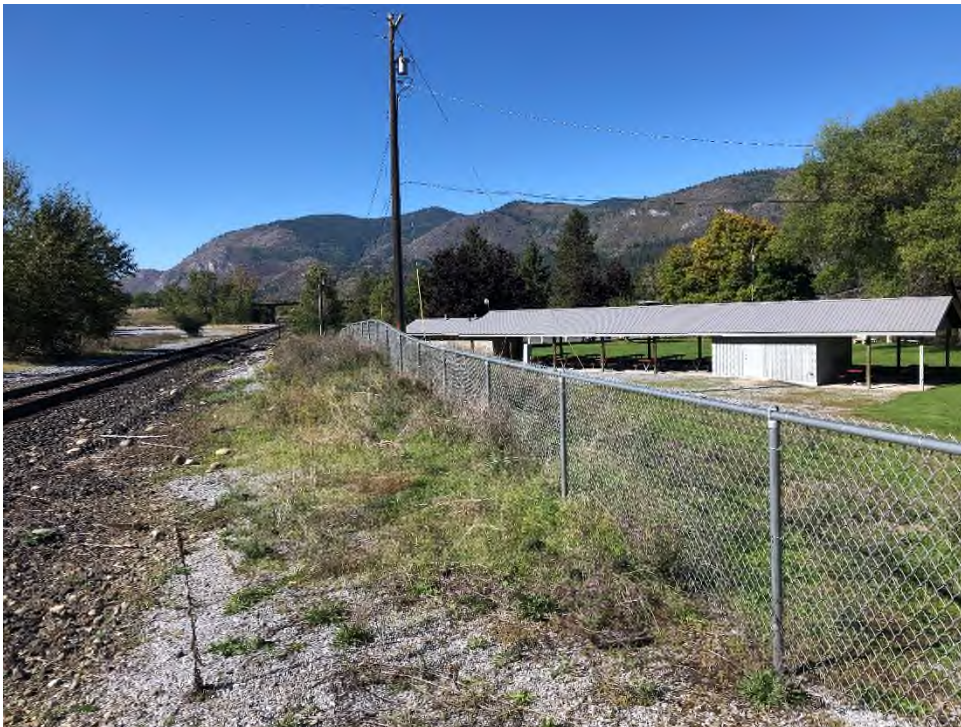
Photograph: 6

Description:
Weeds along the fence line between the park and the track area, looking west

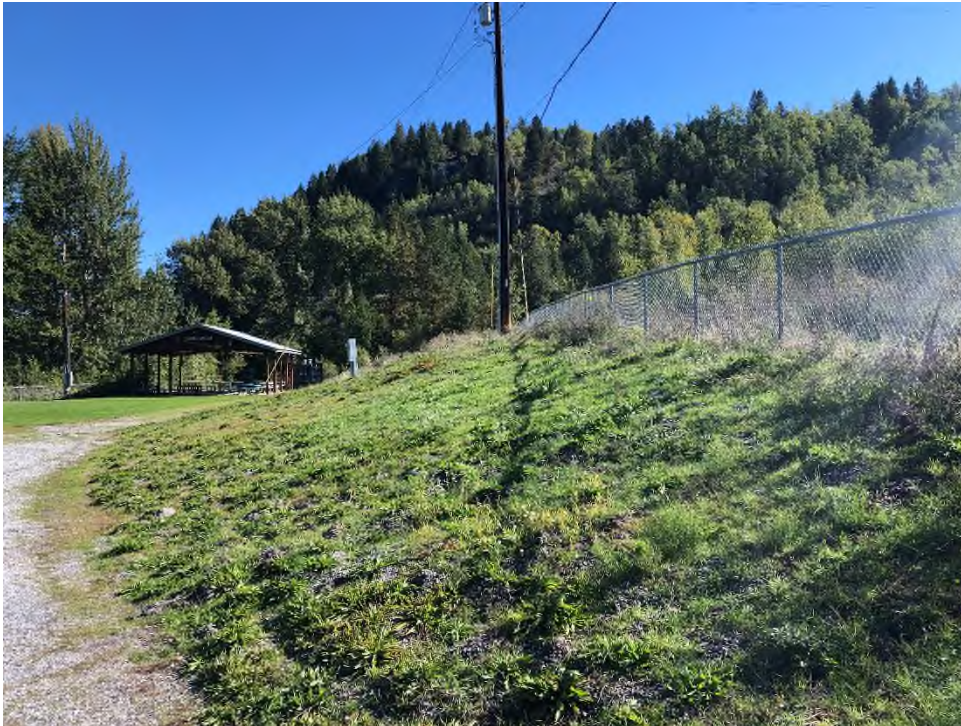
Photograph: 7

Description:
Fence between park and track area, looking east

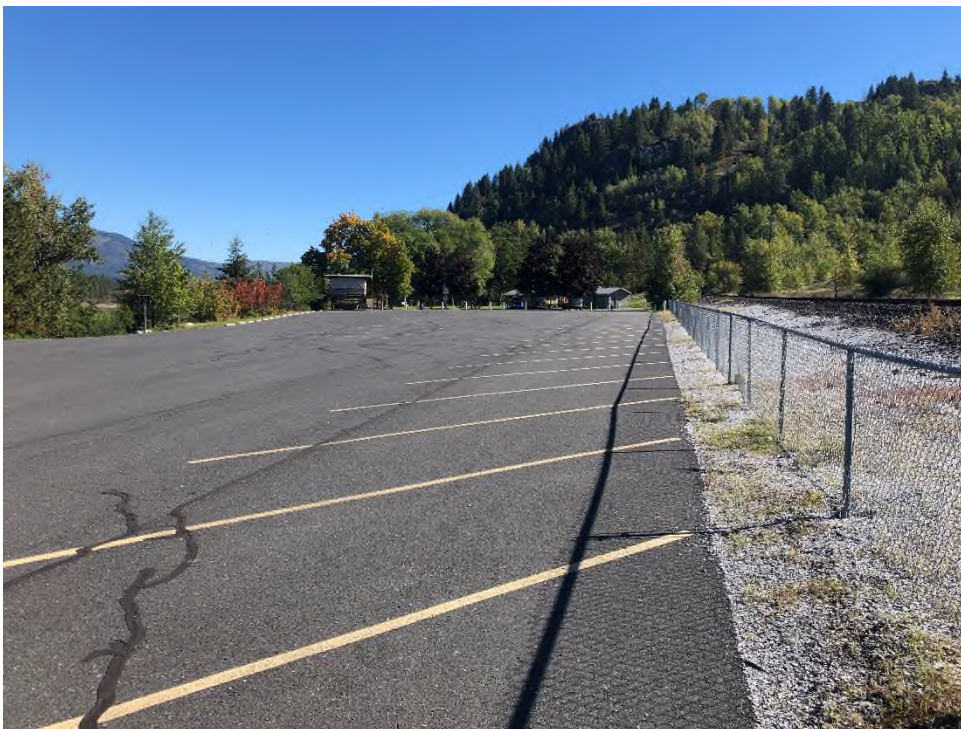
Photograph: 8

Description:
Fence between parking lot and track area, looking east

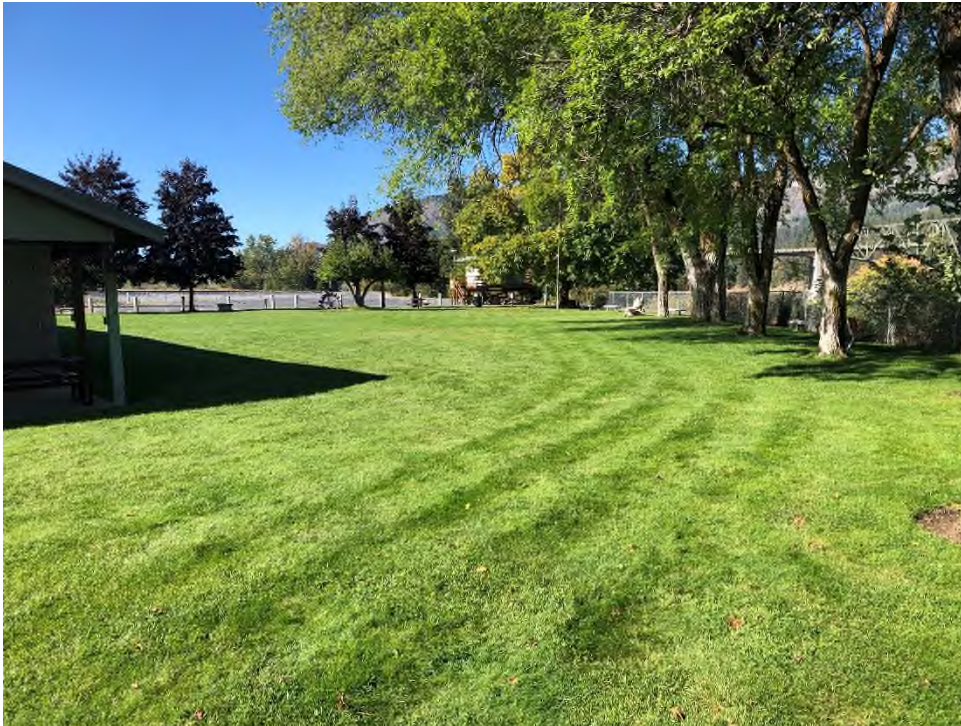
Photograph: 9

Description:
Park grass and trees,
looking west

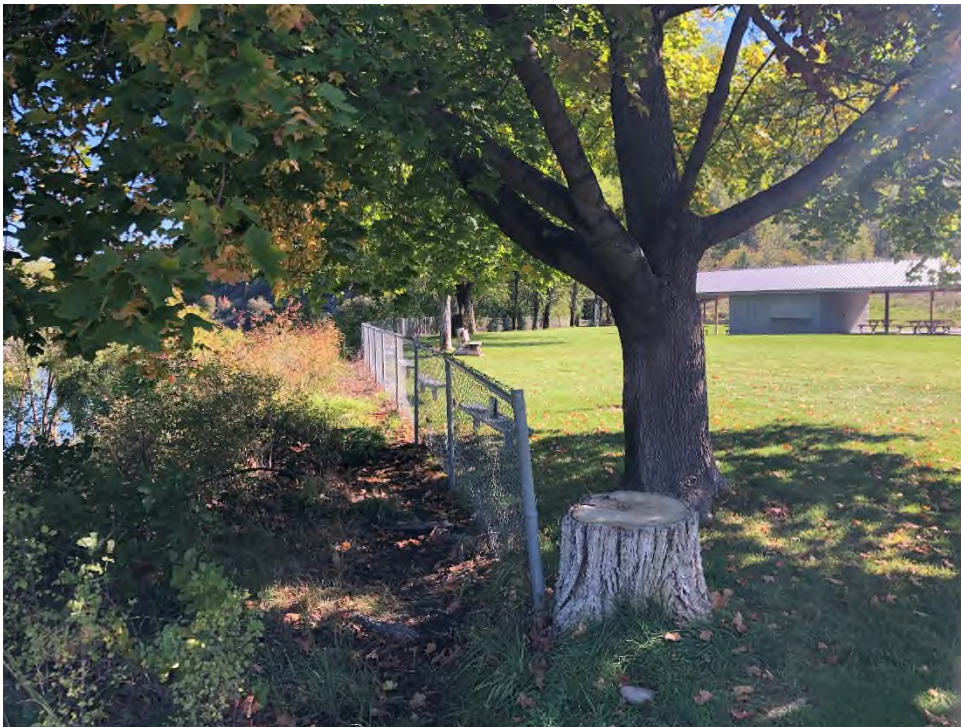
Photograph: 10

Description:
Fence between park
and boat launch,
looking east

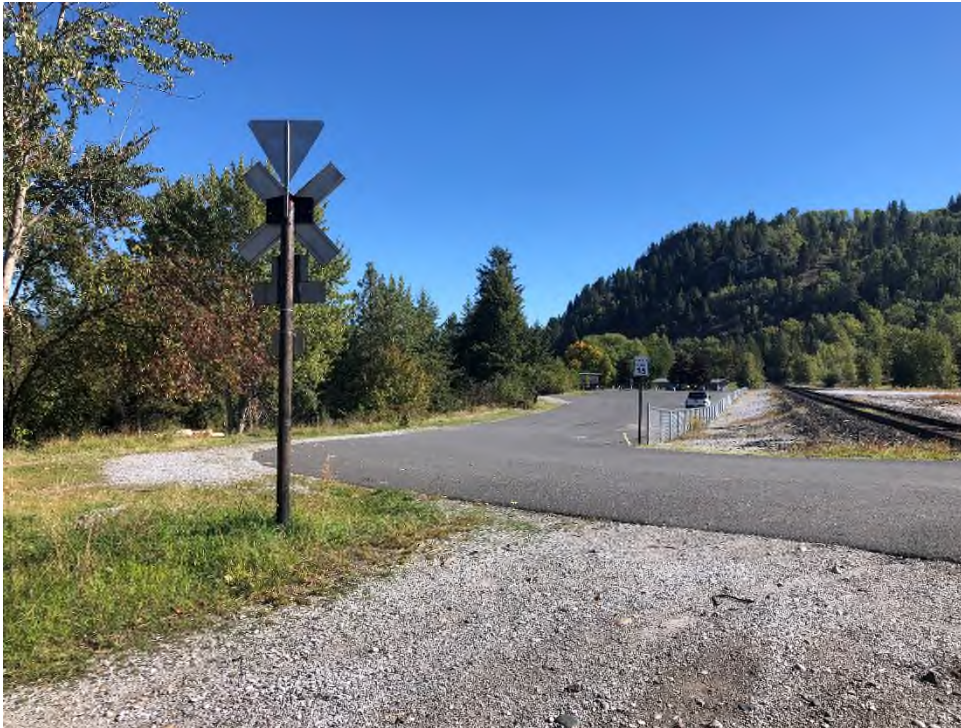
Photograph: 11

Description:
Entrance to parking lot,
looking east

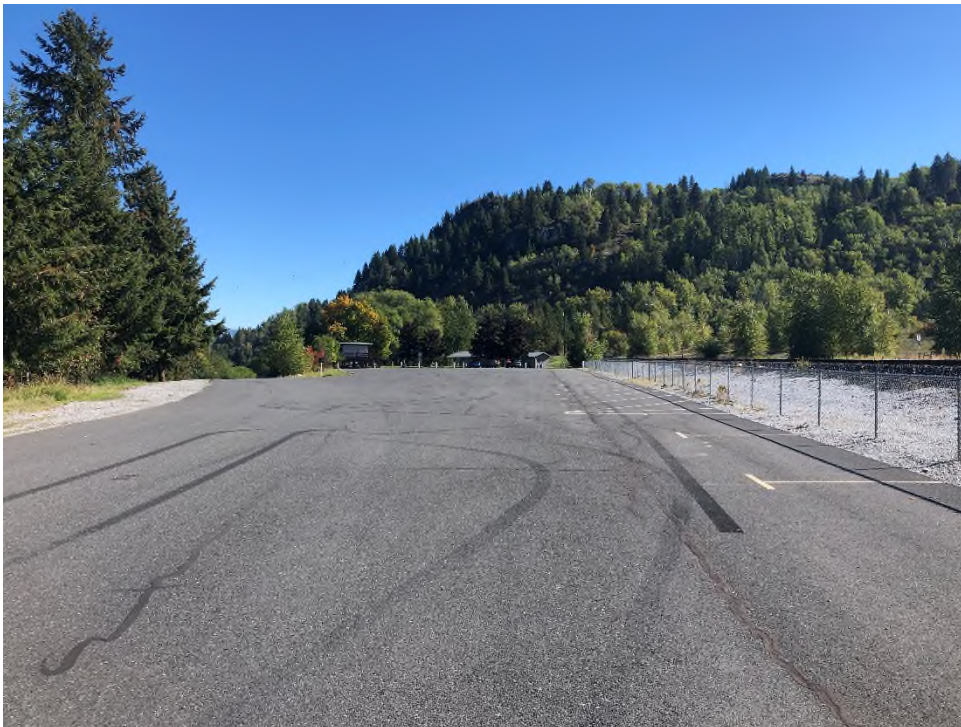
Photograph: 12

Description:
Parking lot, looking east

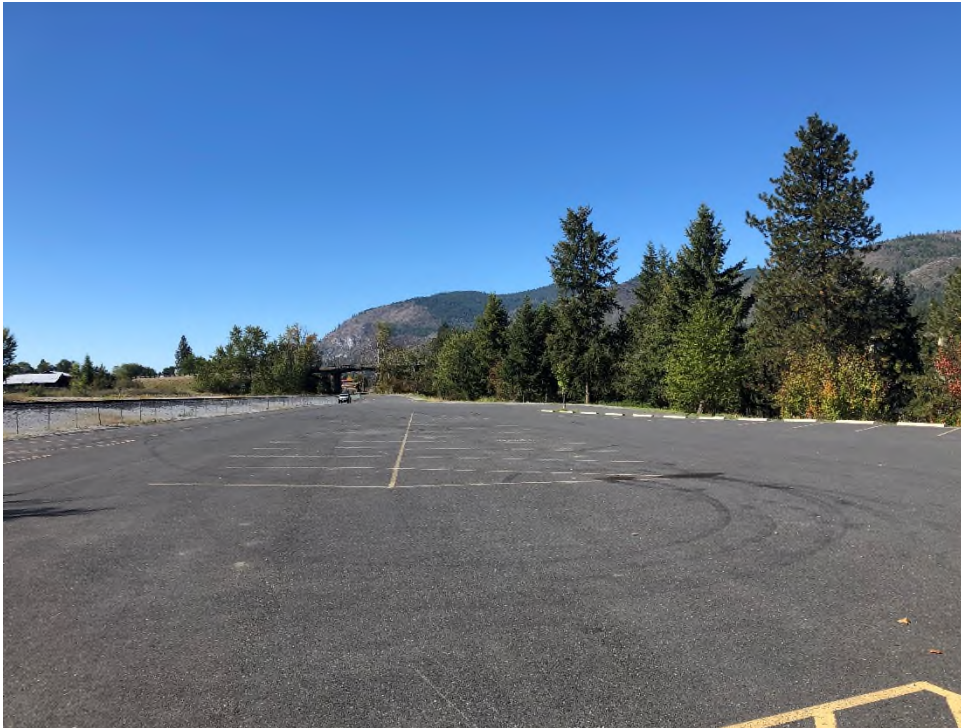
Photograph: 13

Description:
Parking lot, looking west
