BNSF Railway Company
605 Puyallup Avenue
Tacoma, WA 98421

12 January 2022

Subject: 2021 Cap Inspection and Repair
Hillyard Lead Soils Site, Spokane, Washington
FSID No: 960924; CSID No. 1371

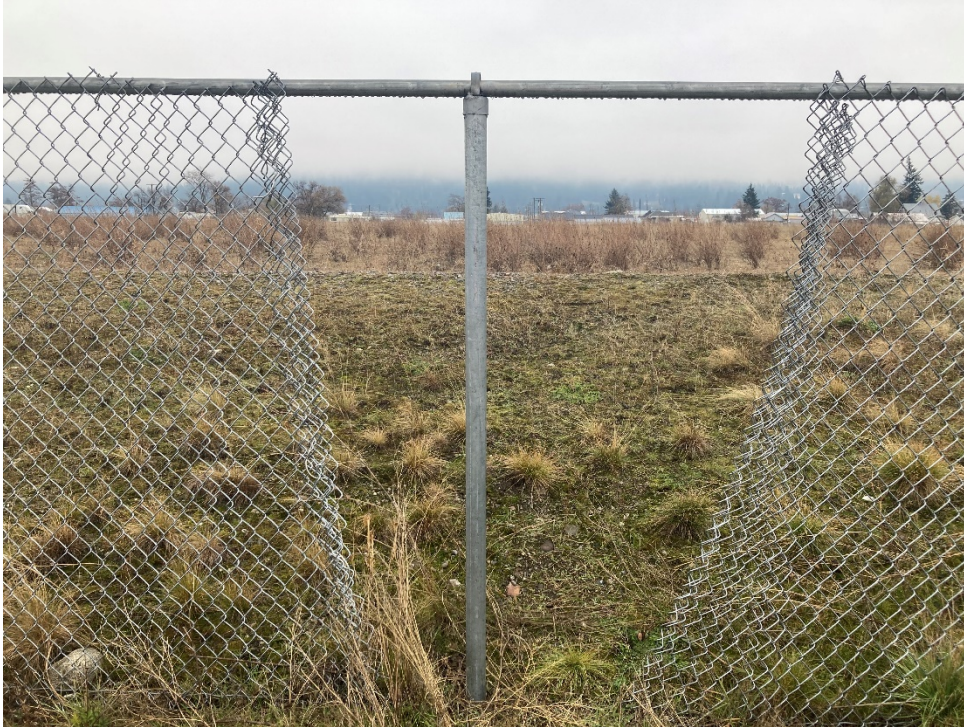
Photograph: 1

Description:
Cut portion of fence on western side of the site

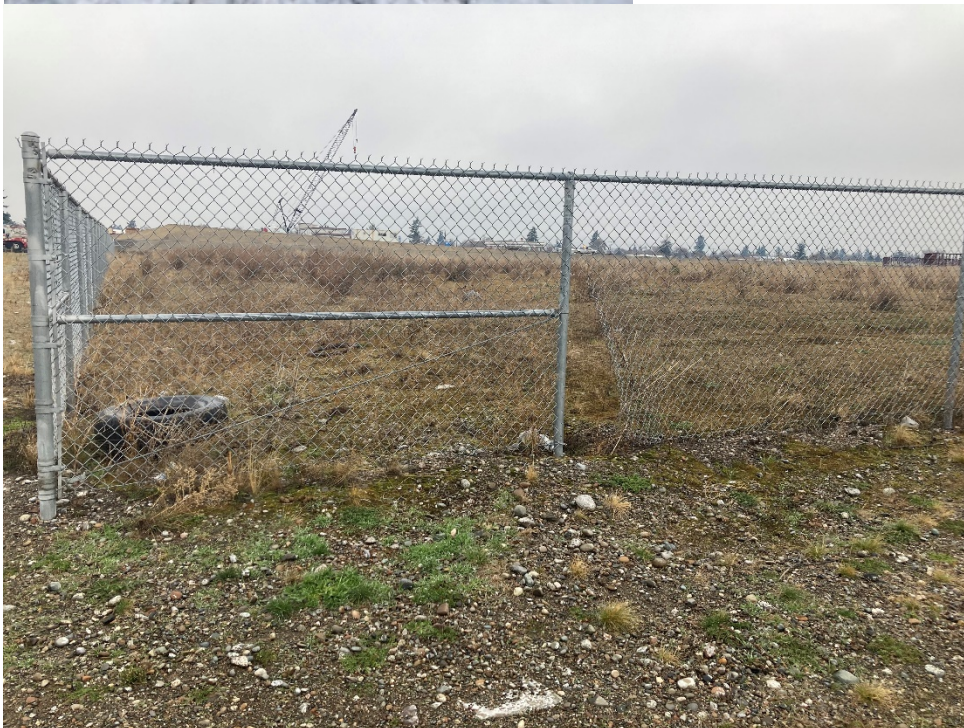
Photograph: 4

Description:
Cut section of fence on the southeast corner of the site.
