# **SITE ASSESSMENT ENGINEERING REPORT UNDERGROUND STORAGE TANK REMOVAL**

**GE AVIATION**

**2720 West Washington Avenue**

**Job No. J07299**

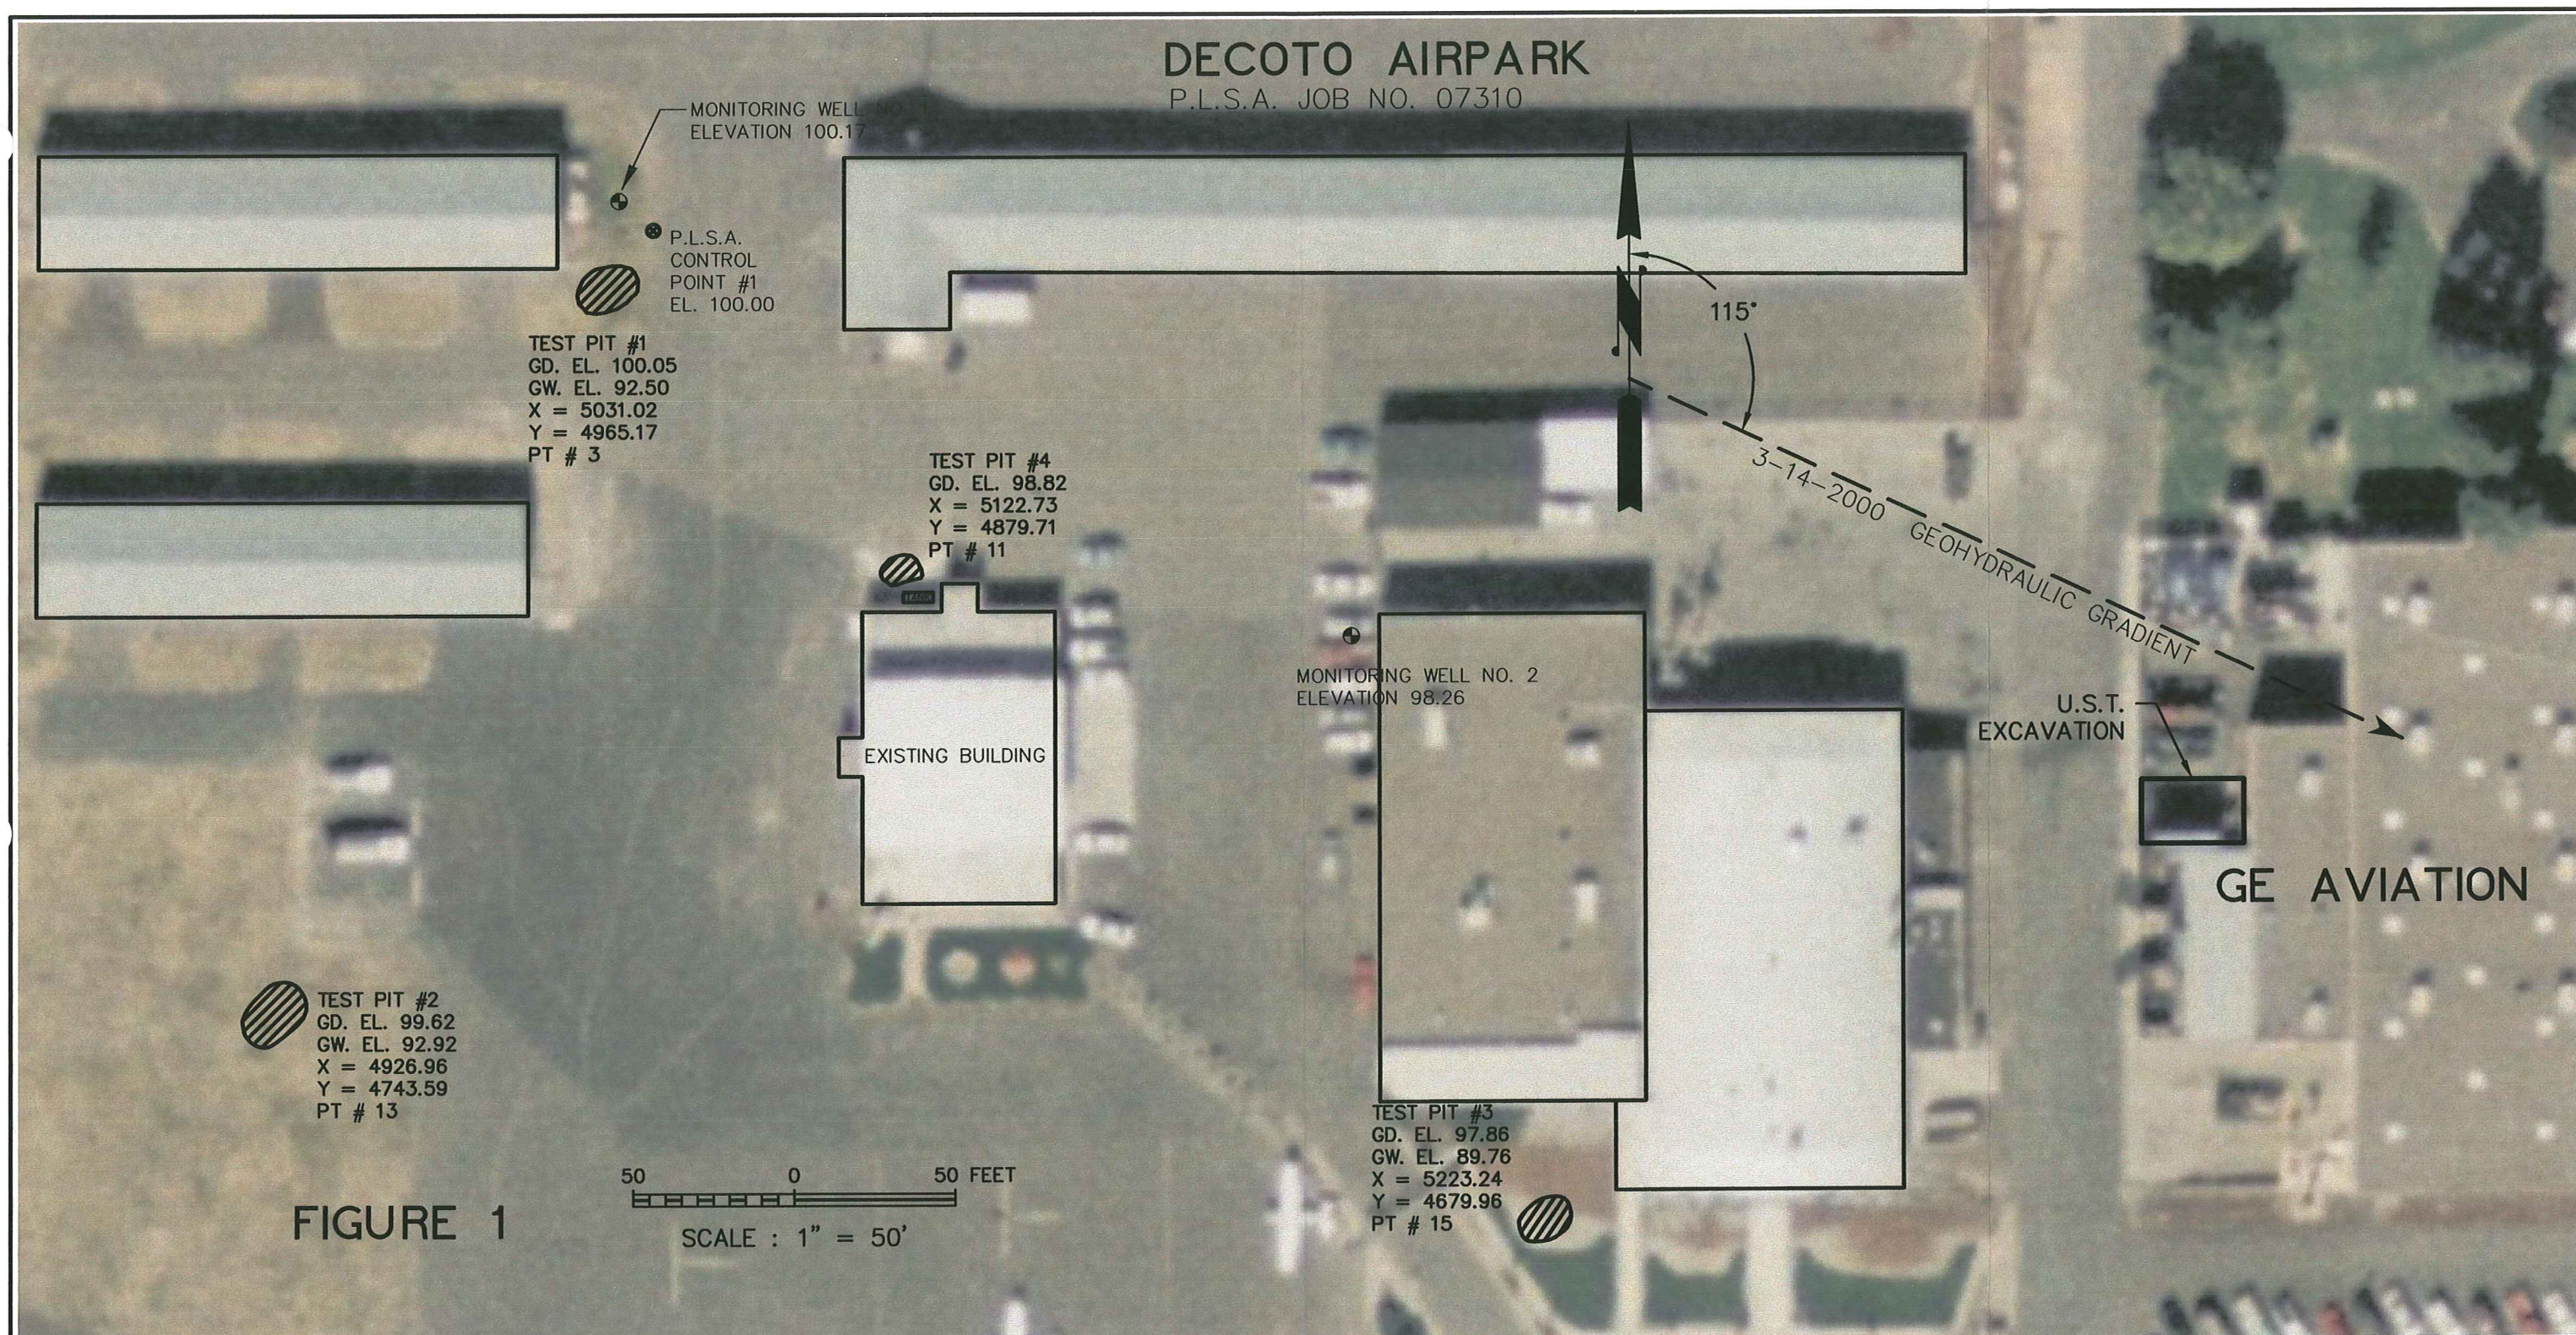
**FIGURE 1**  
PREPARED FOR  
**LEINGANG EXCAVATION**

PLSA has earlier performed the field measurements and calculations to determine the groundwater hydraulic gradient at the property located immediately west of the GE premises. The results may be found in Figure 1 which shows the groundwater hydraulic gradient to be toward the southeast where a release could migrate toward the GE premises. Because this is an airport location, the lighter petroleum fractions are likely associated with off-site aircraft fueling operations.

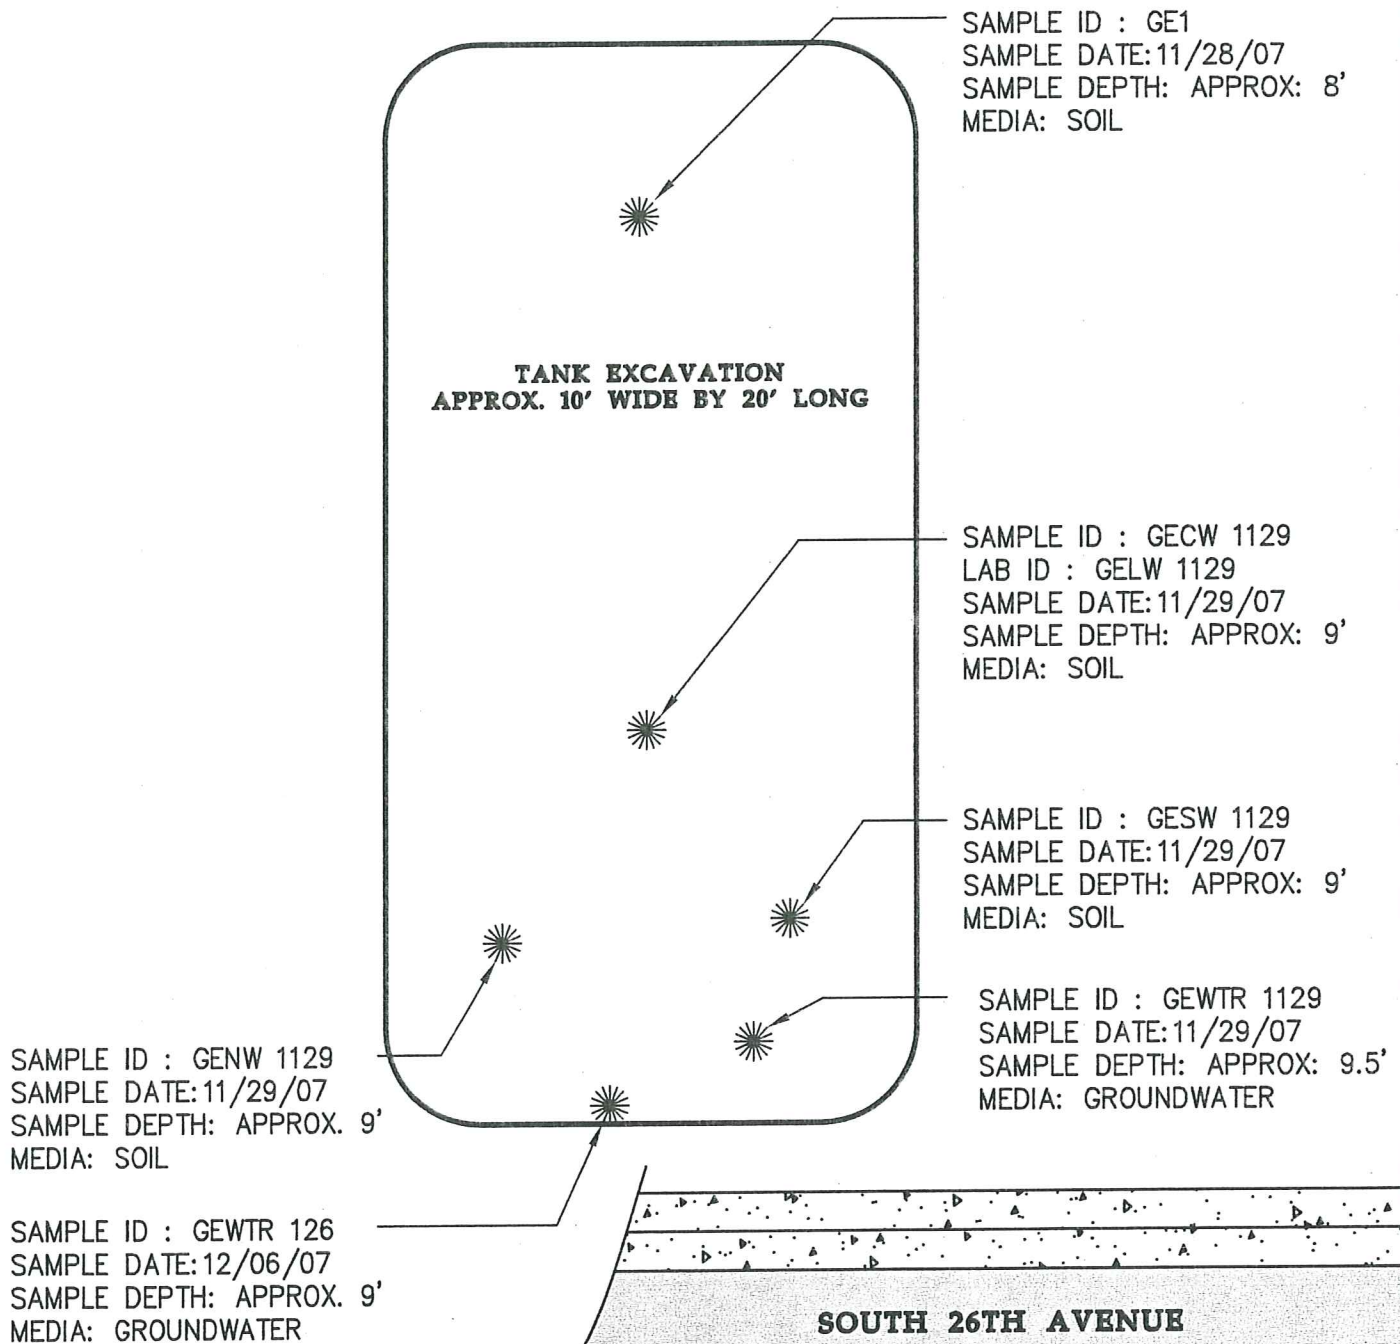
**FIGURE 2**  
**APPROXIMATE SAMPLE LOCATIONS**

A track mounted excavator was used to remove petroleum contaminated soil from the tank basin until no visual or olfactory indication of cooling oil contamination remained. Soil samples were then collected from the bottom of the tank basin at the edges. See Figure 2, Approximate Sample Locations. The soil samples were submitted to Valley Environmental Laboratory for analysis for WTPH-HCID. All final soil samples analyzed were within limits found in WAC 173-340-900, Table 740-1. A water sample collected from groundwater flowing into the bottom of the excavation was similarly submitted to the laboratory. The groundwater appeared to be flowing into the detwatered excavation from the upgradient side. This groundwater sample was found to contain lighter petroleum species, such as kerosene, that are not consistent with the cooling oil used in the GE Aviation operations. Since the water was flowing into the excavation on the upgradient side and that the petroleum contamination found was a lighter petroleum fraction not typical of that used in GE Aviation operations, it is believed that the contamination found in the groundwater is from an off-site source.
