## **PHASE I ENVIRONMENTAL SITE ASSESSMENT**

Poulsbo RV Property  
Parcels 1522049027, 7260200060  
23051 & 22951 Military Road South  
Kent, Washington 98032

**MILITARY ROAD INVESTMENTS LLC &  
POULSBO RV, INC.**

October 14, 2015

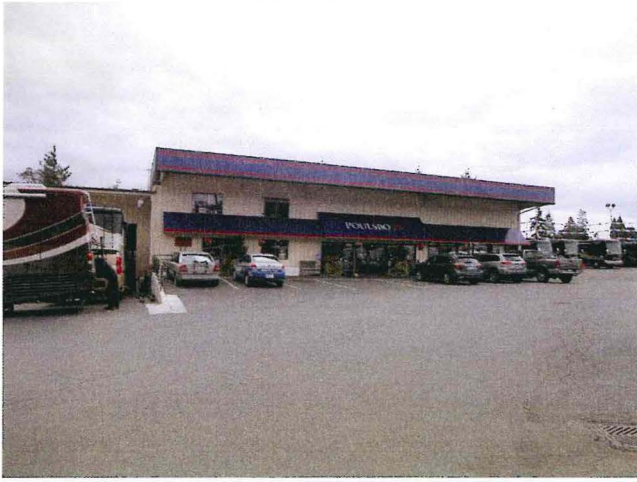
Northern exterior of 23051 building

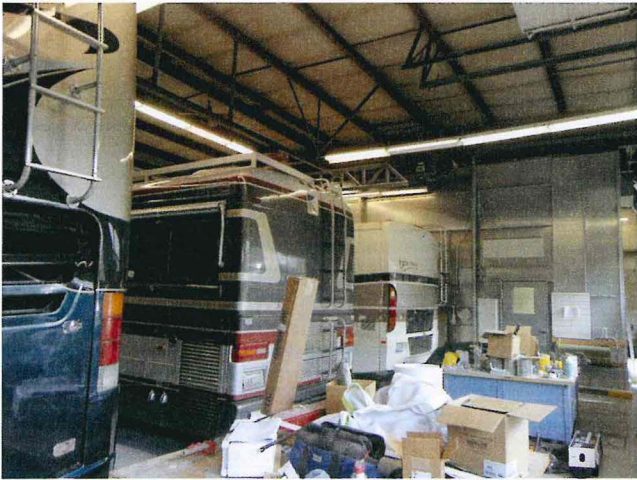
Shop area in 23051 building

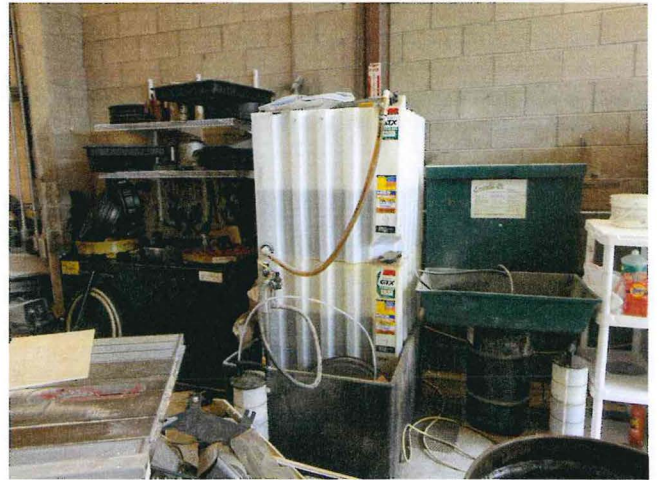
Oil tanks and parts cleaner in shop

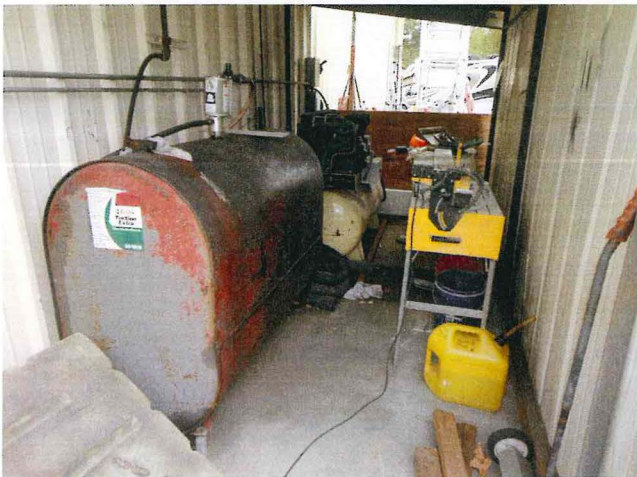
Oil storage tank on southern exterior of 23051

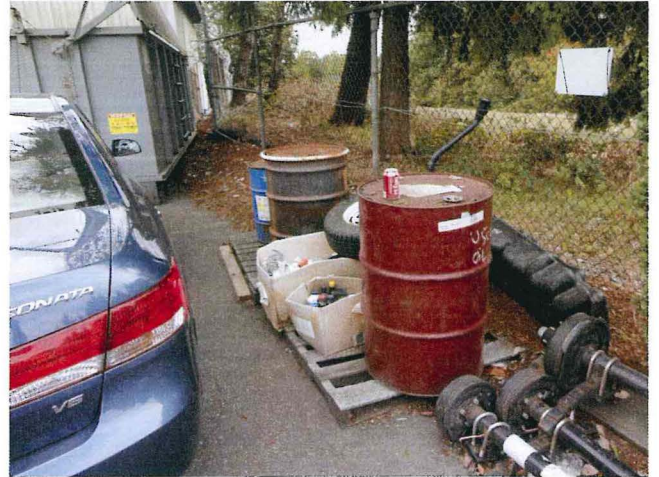
- An exterior, above-ground propane tank was noted along the western property line. An emergency shut-off switch was seen to the north of the tank.
- Five (5) sealed drums and a box of small plastic containers containing various fluids (drums were labeled as containing used oil, lubricants, and undercoating) were observed along the western property line on a wooden pallet. Mr. Scott Twomey, the general manager of Poulsbo RV advised that these materials were awaiting pick-up from a contracted recycling service.

Waste materials awaiting removal

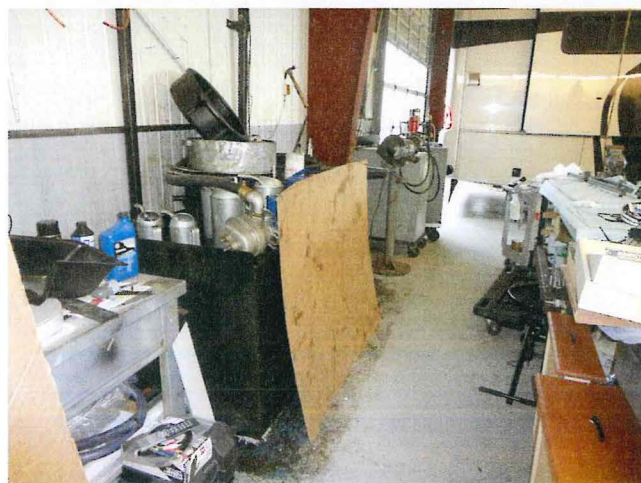
- Two (2) plastic box ASTs were stacked within a secondary containment bin within the shop area. The tanks were labeled as containing motor oil. Various small containers of oil and other automotive and/or cleaning fluids were observed around the shop area, in fire-safe cabinets, or on storage racks in their commercially labeled containers.

Oil tanks and materials in 22951 shop

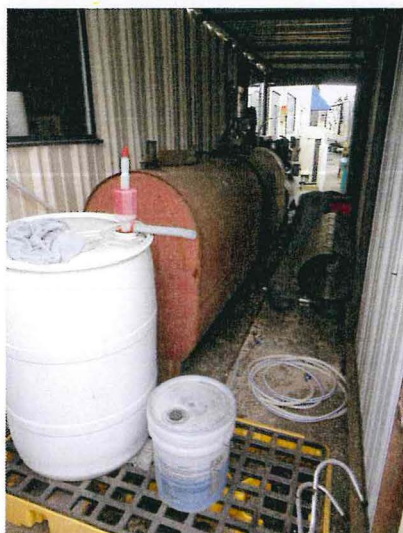
Oil and material storage tanks/containers on northern exterior of 22951

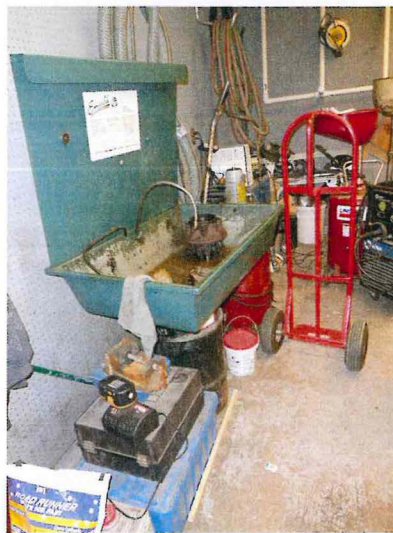
- Natural gas fired HVAC and suspended heaters provide heating.
- Referring to the lower right-hand photo panel of Plate 4, a parts washer which is serviced by Emerald Services was observed in a storage room.

Parts washer in 22951 shop

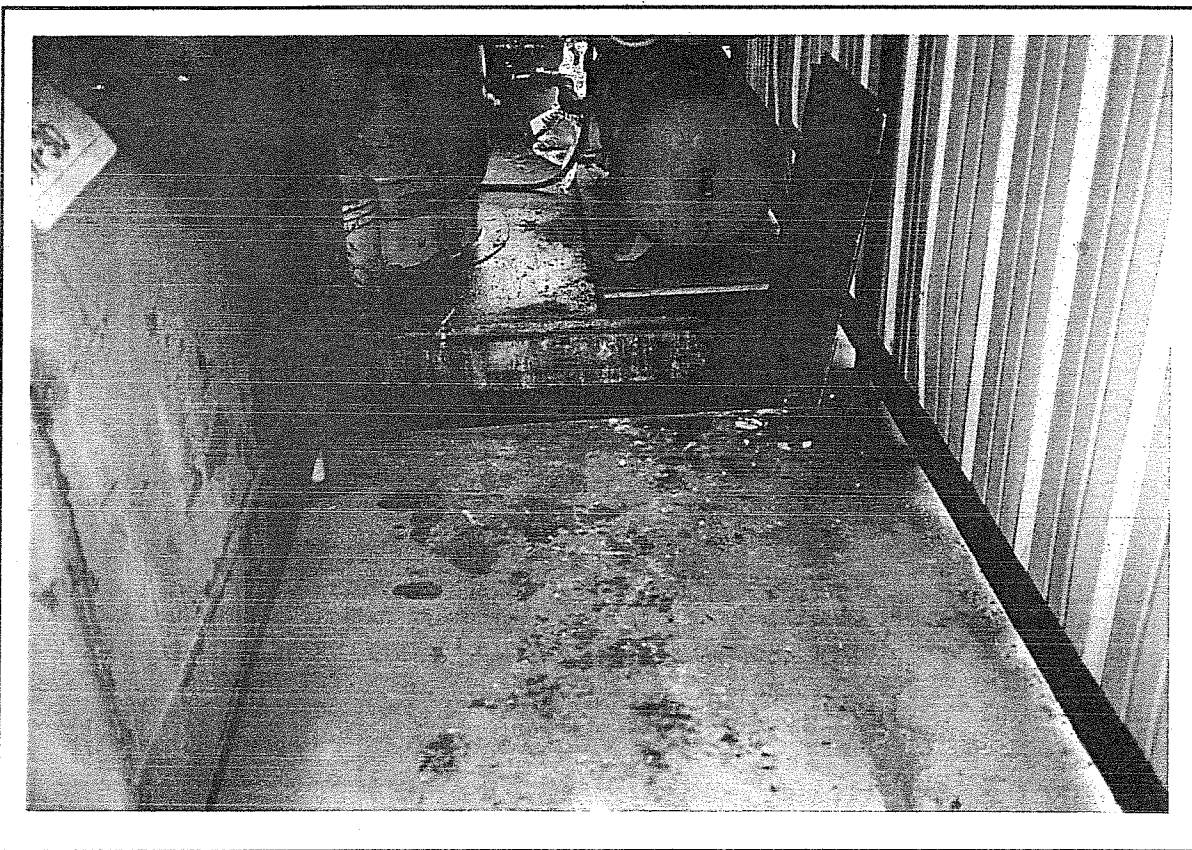
**Plate 1. Oil/Water Separator Inside Shed on South Side of Building.  
(View to NE).**

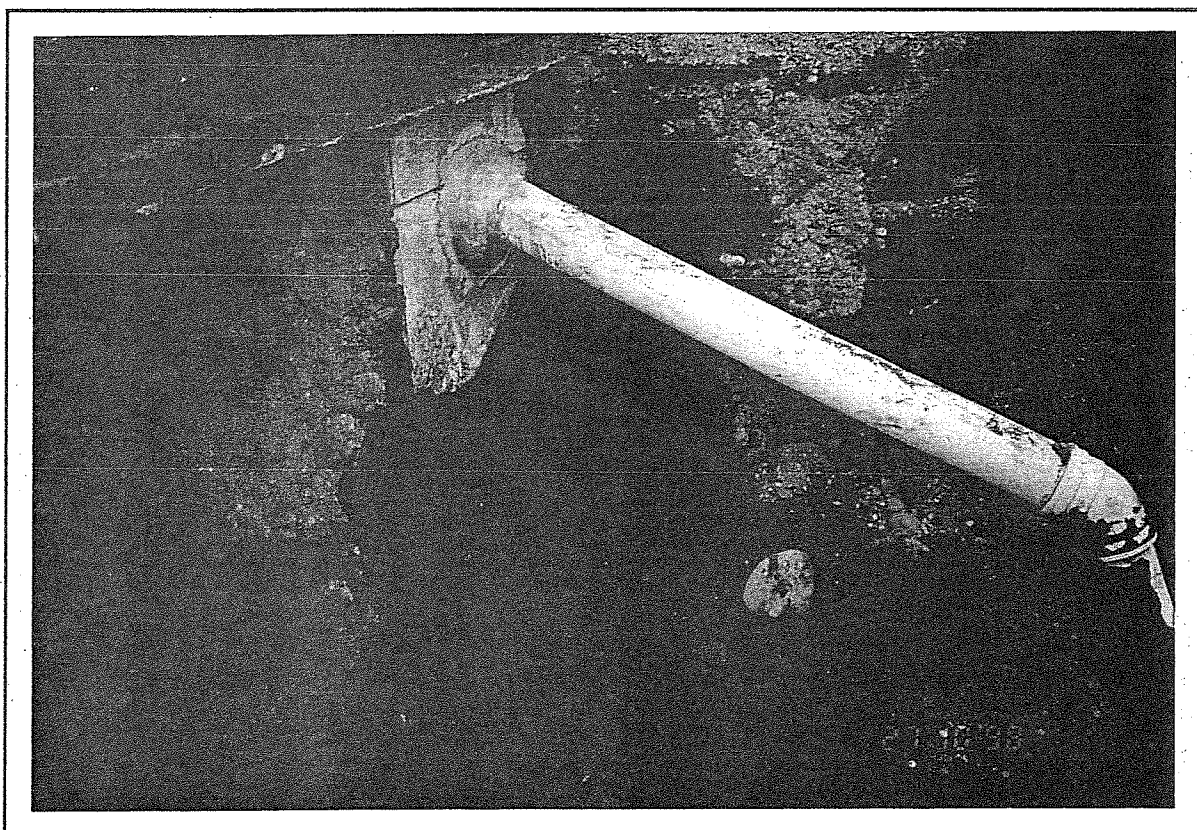
**Plate 2. Patch Repair on Discharge Pipe Below O/W Separator.**

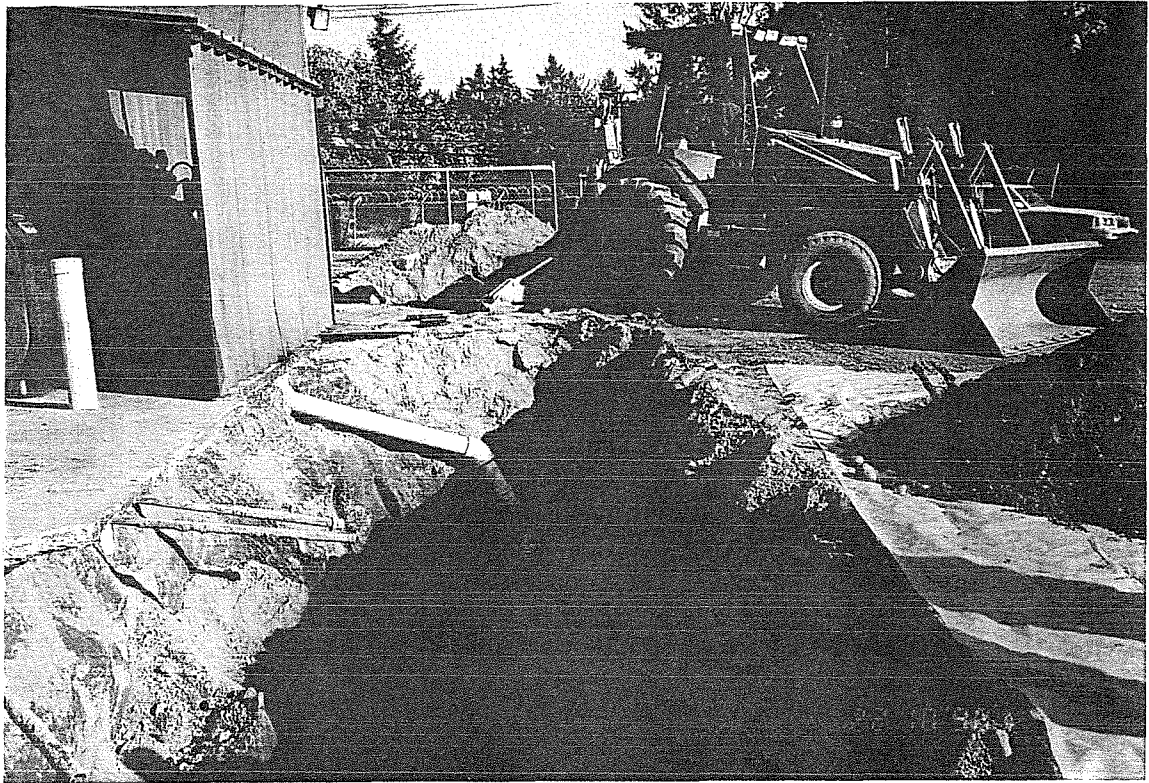
**Plate 3. Excavation 2, after Removing (2)-2,000-g Gasoline USTs. O/W Discharge Pipe at NE End of Excavation. (View to NE).**

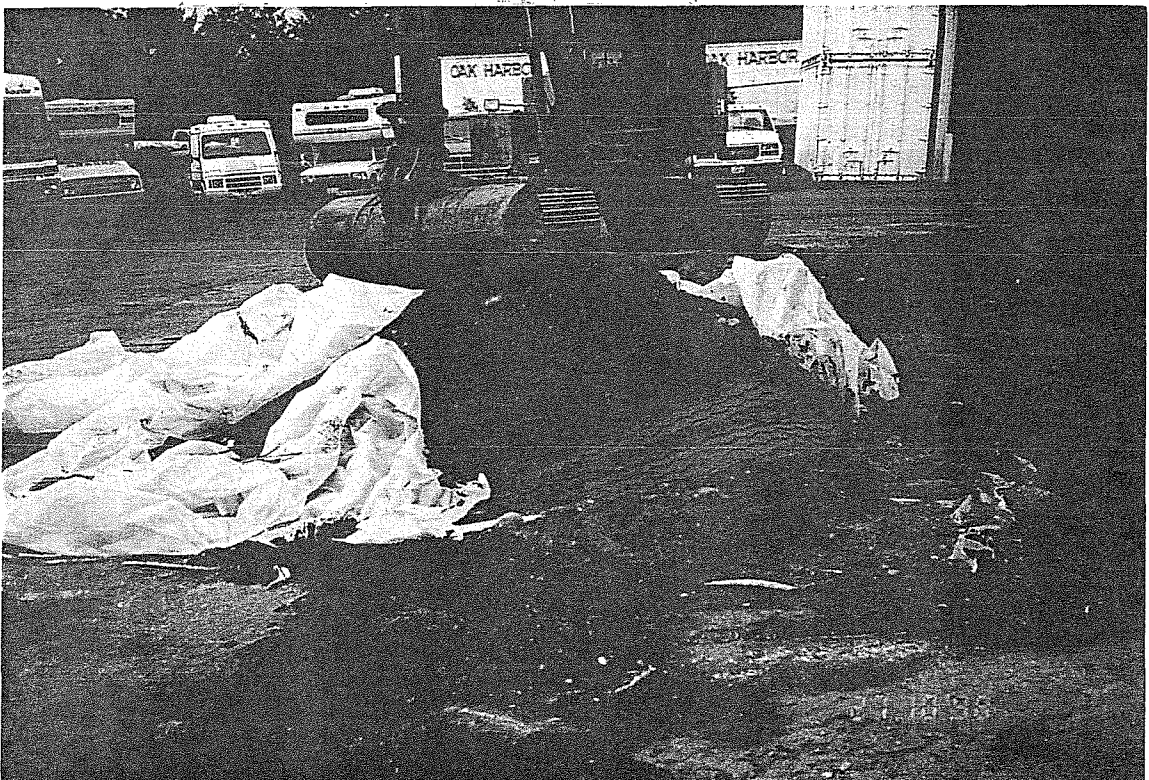
**Plate 4. Contaminated Soil from Below the O/W Separator. Note 1,000-g Waste Oil Tank in Background.**
