**CSID No. 3512 Avista Service Center Garage  
Remedial Action**

Spokane Service Center Garage  
1411 East Mission Avenue  
Spokane, Washington

*for*  
**Avista Utilities**

March 22, 2019

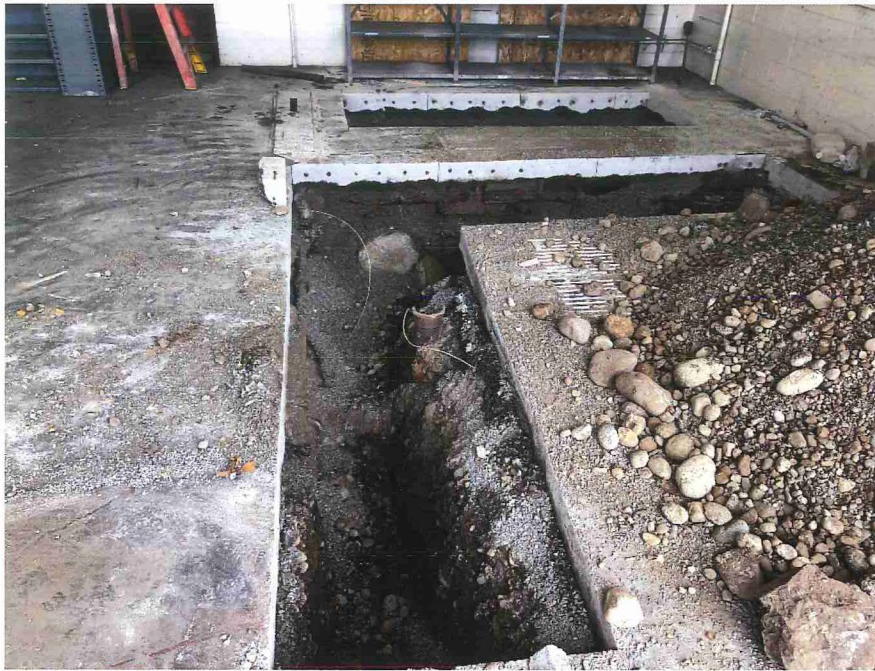
Photograph 3. Sawcut test pit in Bay-7. Looking East.

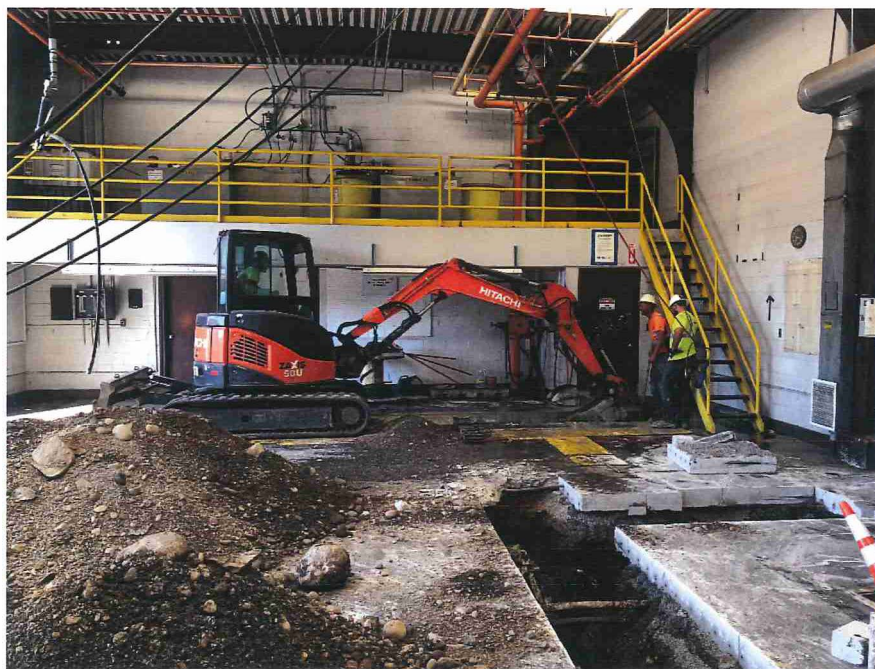
Photograph 4. Sawcut test pit in Bay-5 and sawcut test pits exposing buried hydraulic lines from reservoirs, looking north.

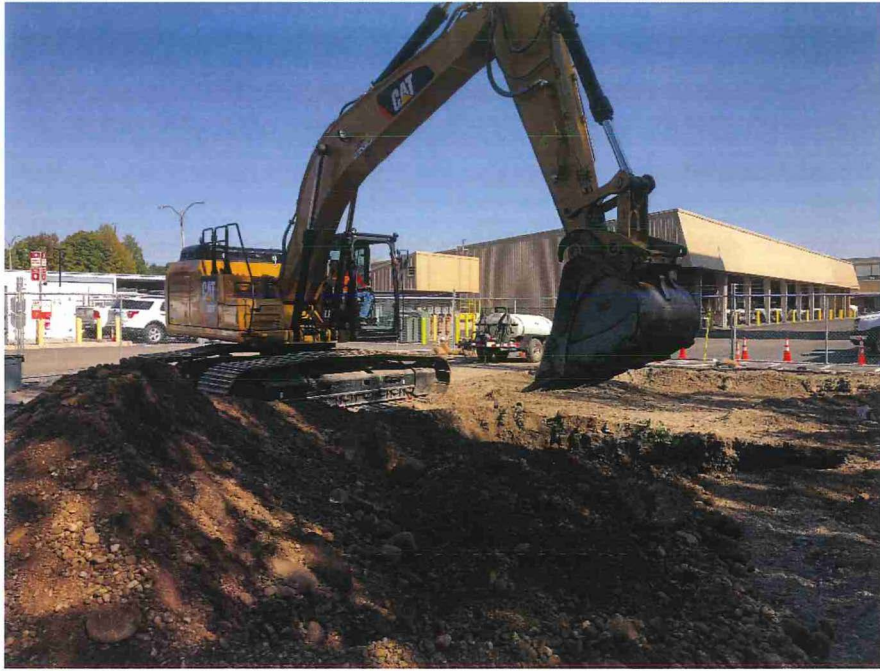
Photograph 5. SES excavates test pit TP-1 in highbay area, looking northwest.

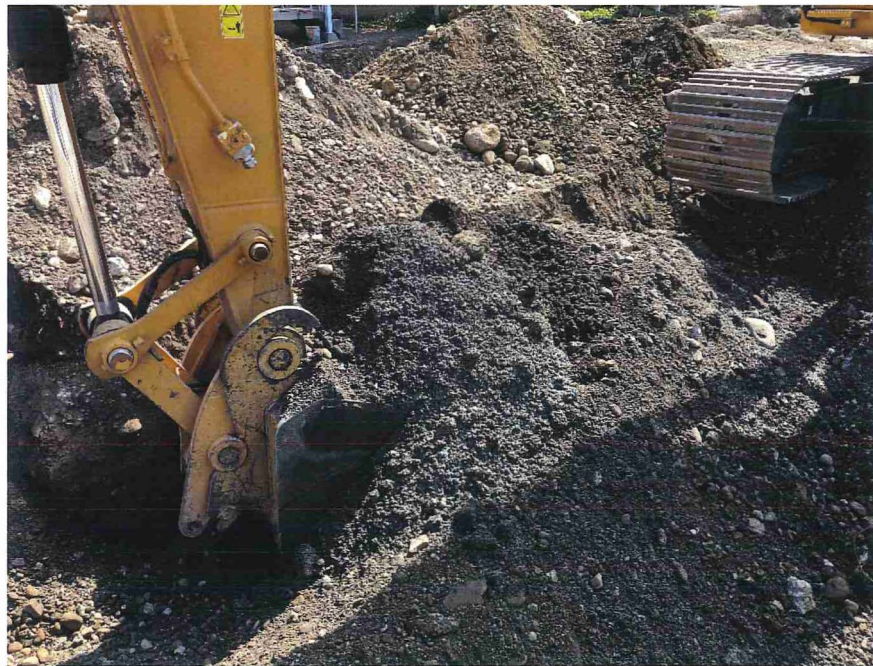
- Test pit TP-5 was excavated in the west side of Bay-7. Field screening indicated that petroleum-related contamination was present from 9 to 16 feet bgs in soil from test pit TP-5 with moderate sheen and photoionization detector (PID) measurements of 0.9 to 4.0 parts per million (ppm). One sample [TP-5(9-10)] was submitted to TestAmerica for chemical analytical testing. TP-5 was terminated at 16 feet and the Bay-7 location was noted as a focus area for the remedial excavation.

Photograph 6. SES excavates test pit TP-5 in Bay-7 area, looking east.

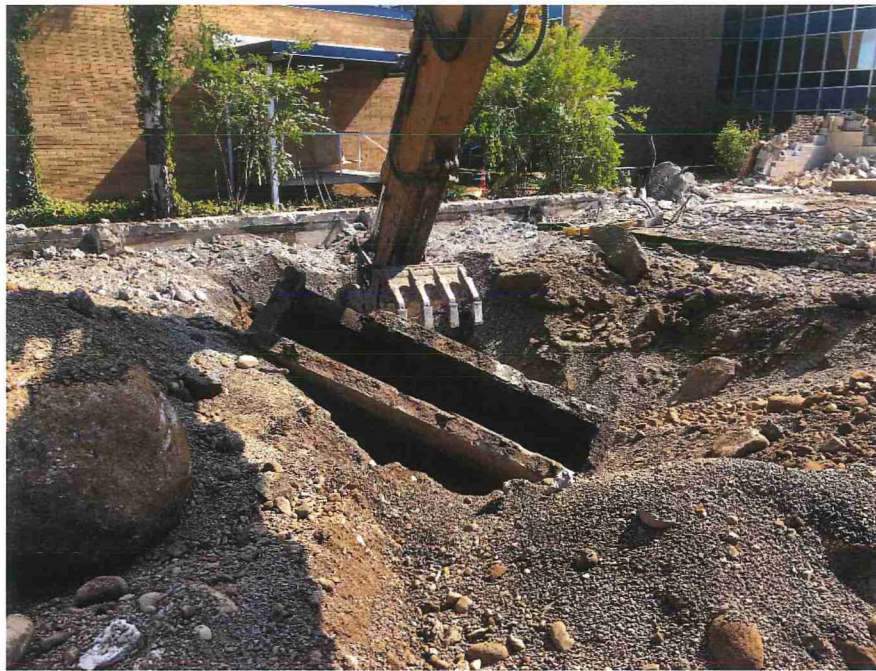
Photograph 7. SES removes hydraulic lift concrete secondary containment from Bay-2.

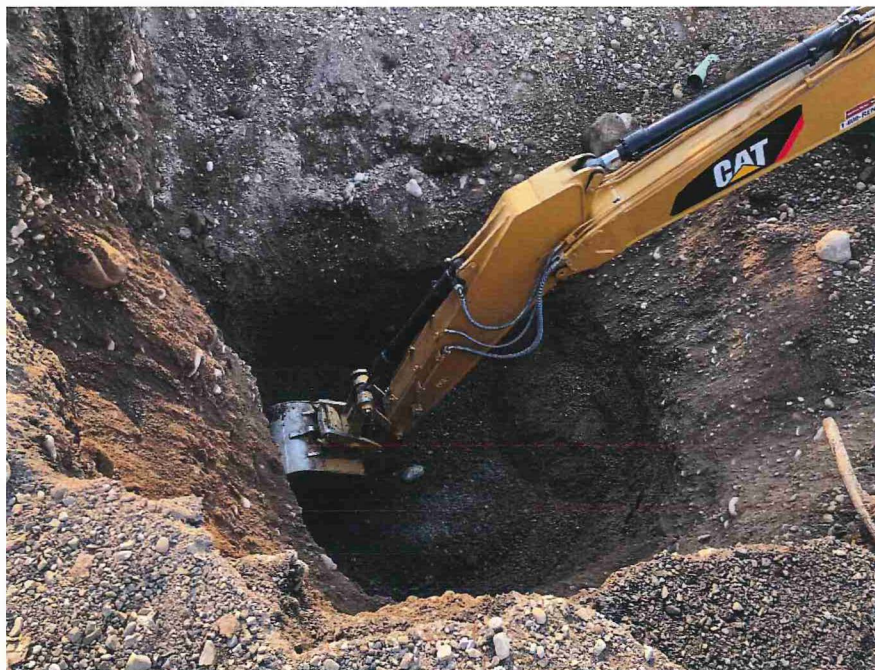
Photograph 8. SES excavates PCS to a maximum depth of 24-feet bgs from beneath Bay-7 area, looking east.

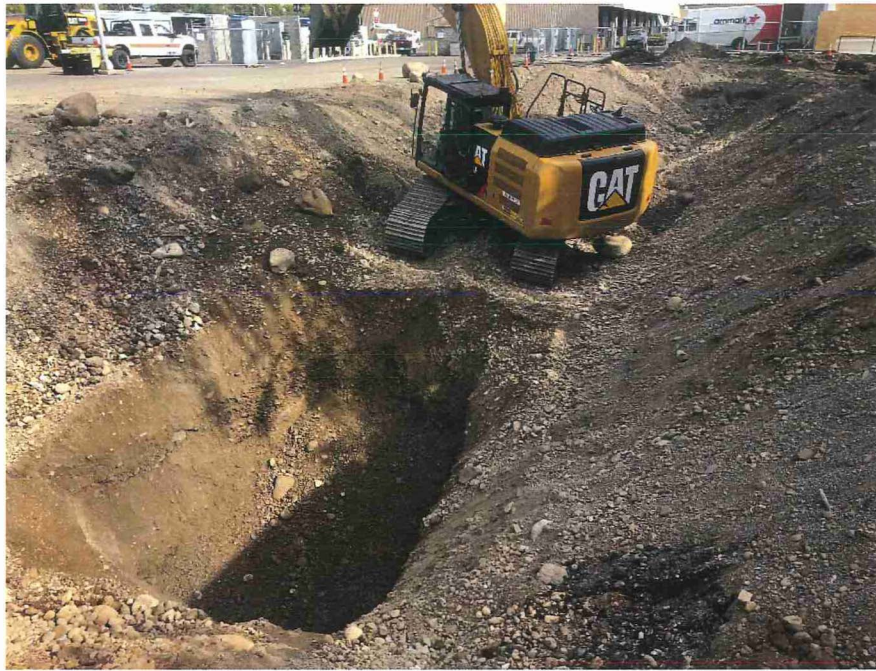
Photograph 9. SES excavates PCS from beneath Bay-1 and Bay-2 areas, looking North.

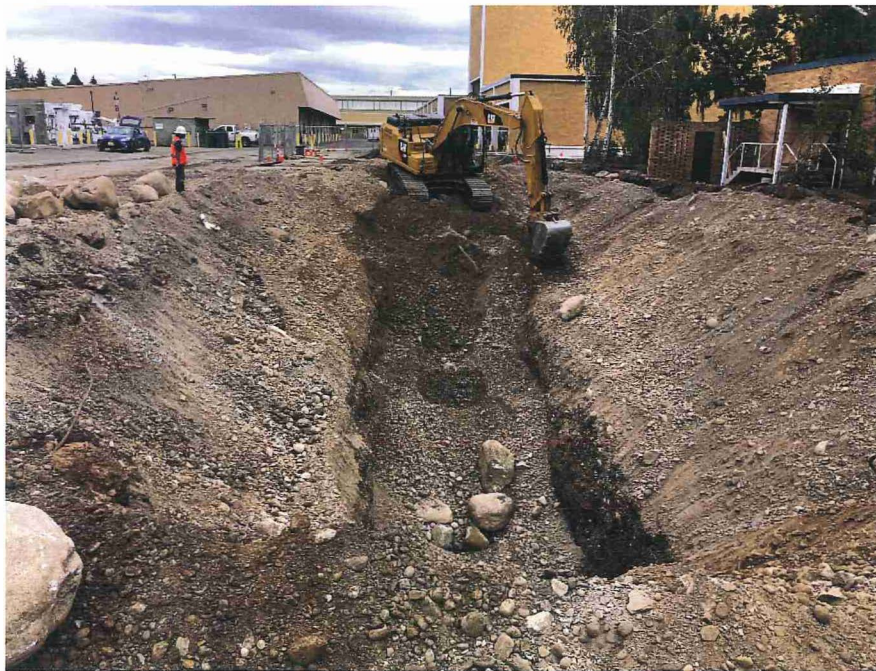
Photograph 10. SES excavates PCS from beneath Bay-3 and Bay-4 areas, looking North.

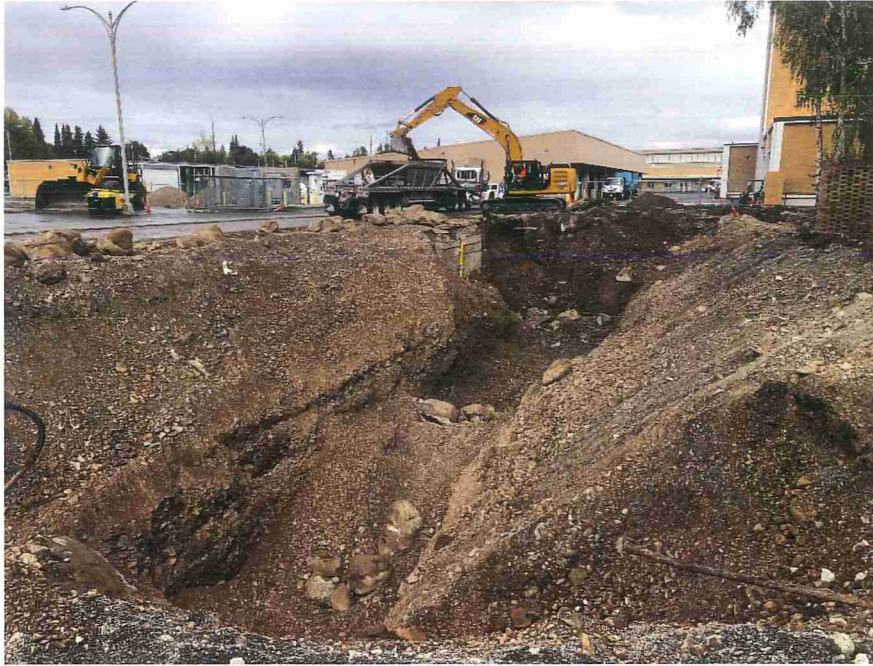
Photograph 11. SES excavates PCS from beneath Bay-5 area, looking North.

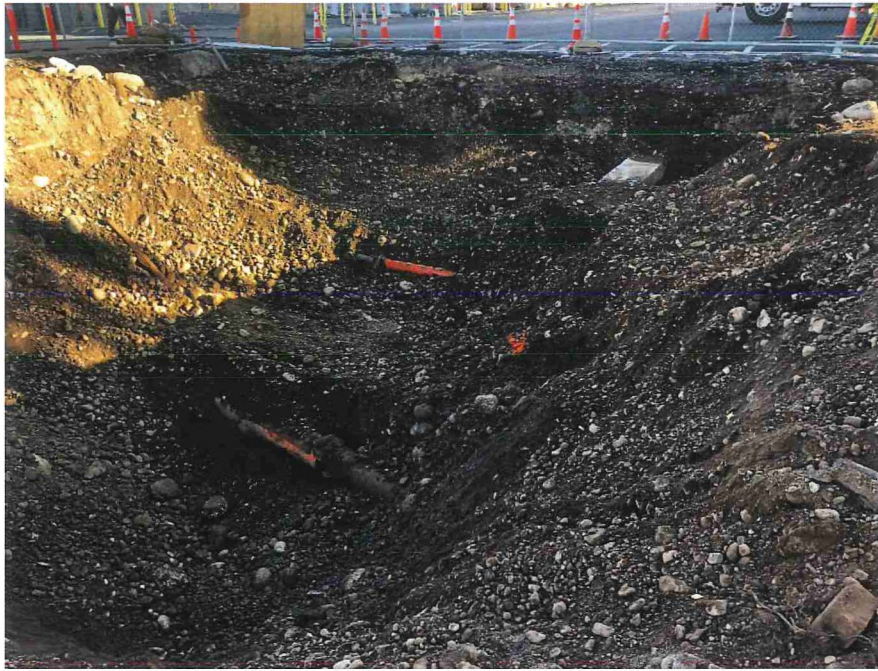
Photograph 13. Highbay area excavation of PAH contaminated soil. SES marked daylighted utilities with orange paint.

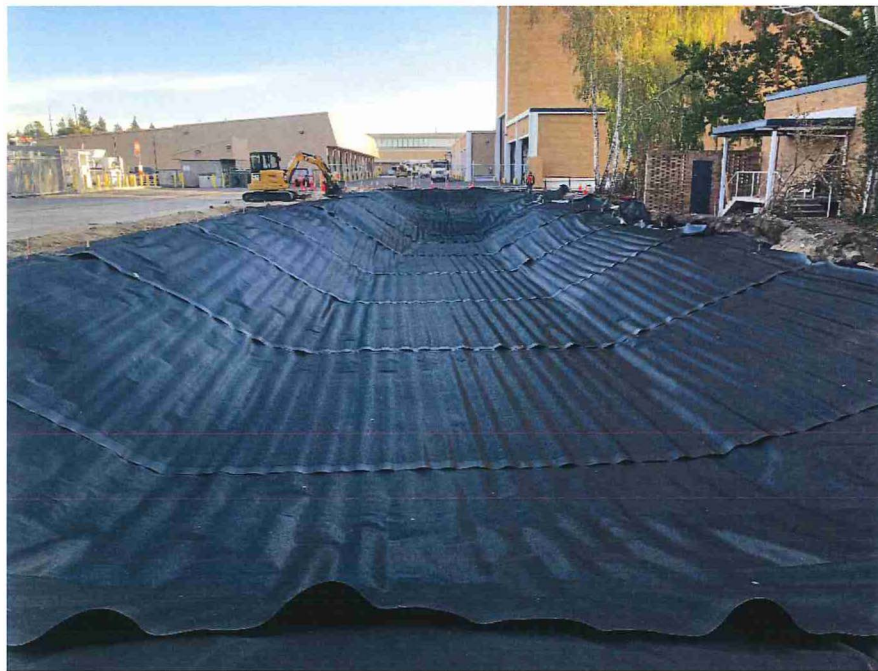
Photograph 18. ACF West places 40-mil thick LLDPE geosynthetic liner over fabric, looking North.

A geosynthetic liner was placed within the excavation to serve as a cap above the remnant contaminated soil to minimize the potential for contamination to reach groundwater. The cap was positioned to divert stormwater infiltration into a drainage pipe trench and into Avista’s stormwater system.

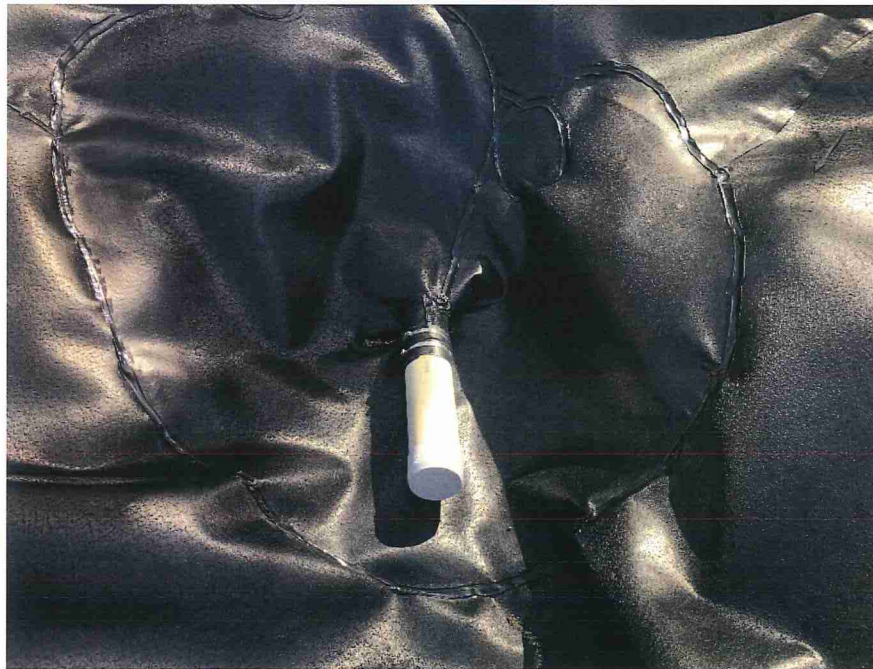
Photograph 20. ACF West completes pipe stub penetration for drain pipe through geosynthetic liner, looking East.

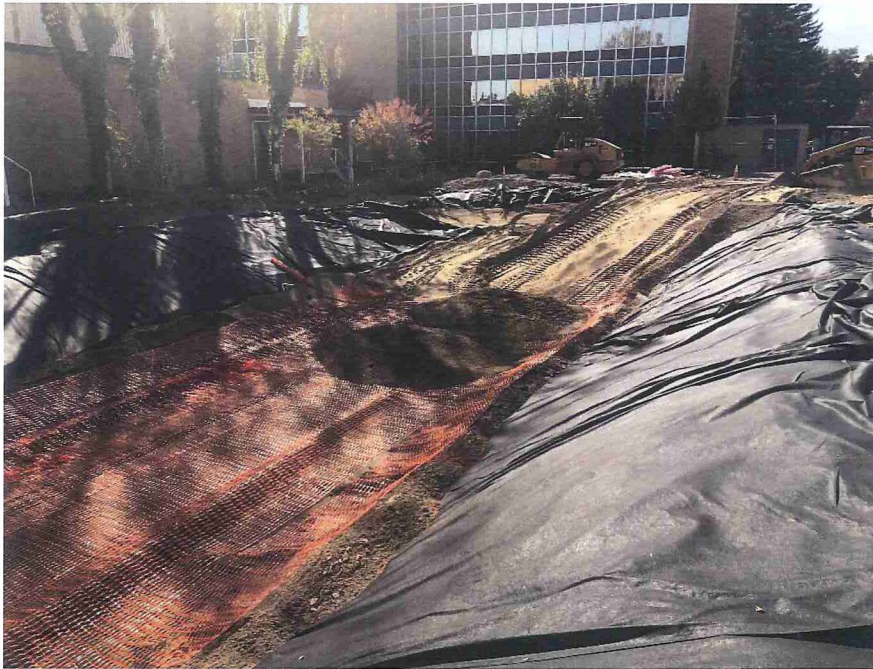
Photograph 26. SES backfilled the excavation and placed orange construction fencing approx 1-foot above the liner as an indicator layer for future construction.
