SITE HAZARD ASSESSMENT

SITE NAME: Block 79 East

Completed on 2/7/2022 for inclusion

on the February 2022 Hazardous Sites List.

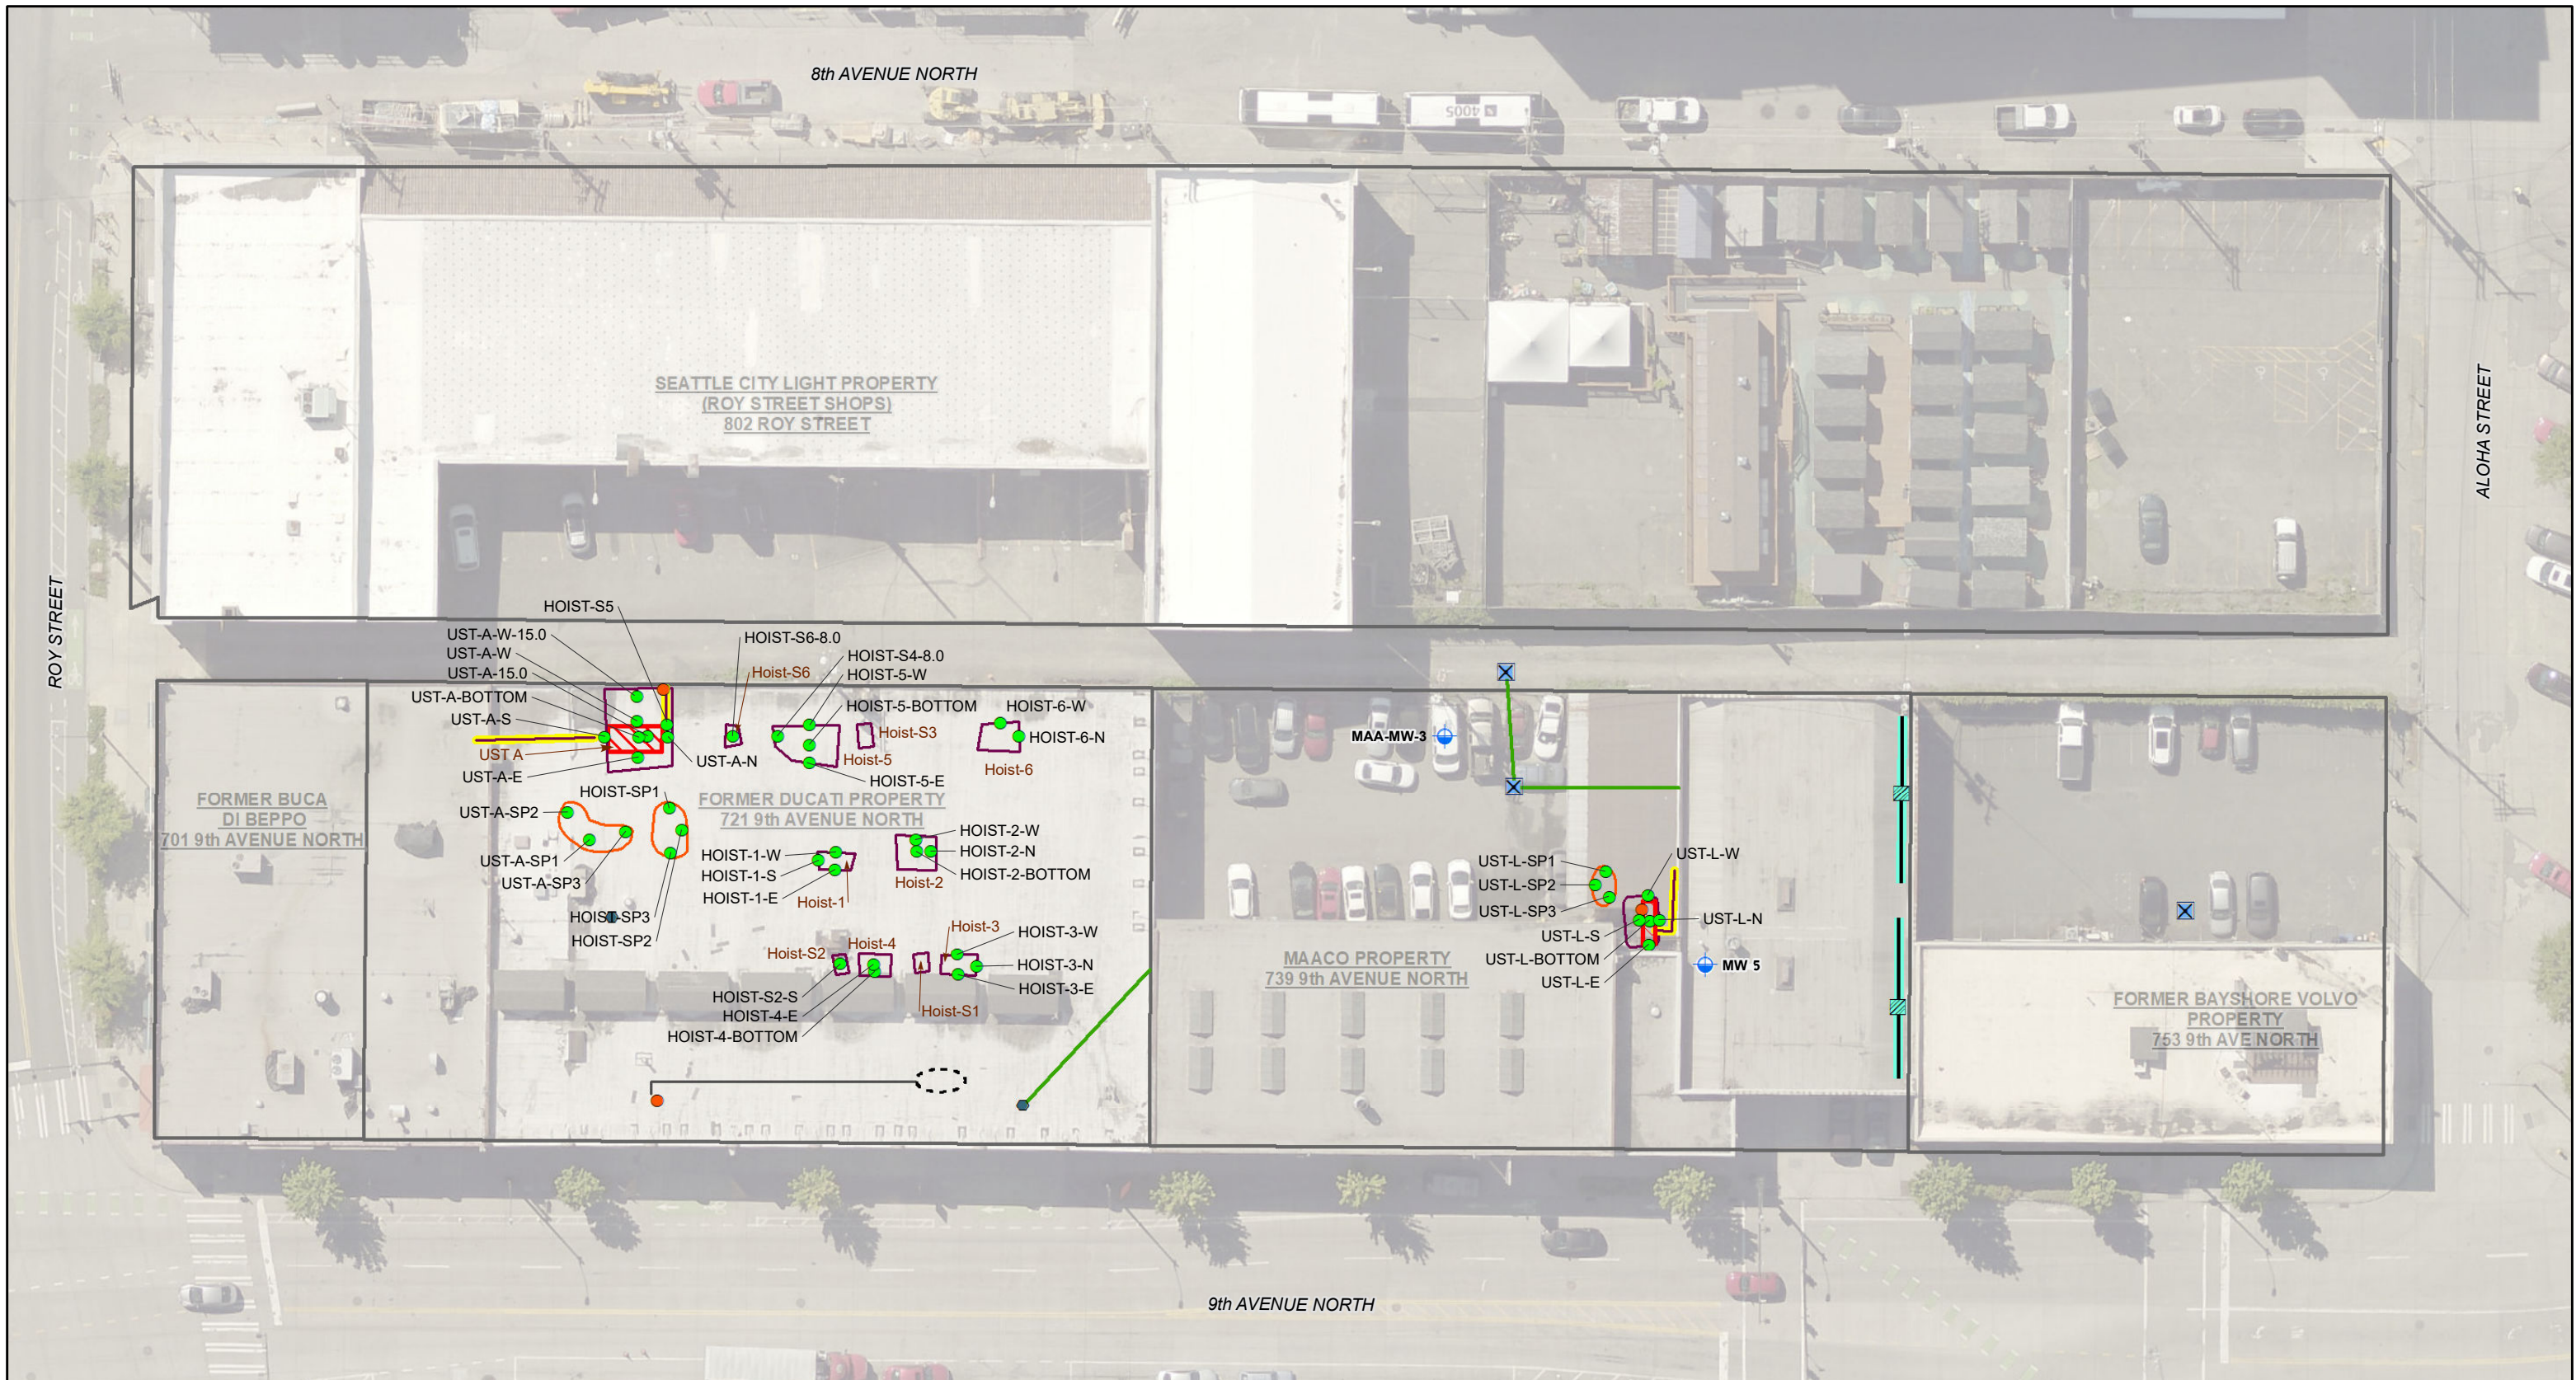
FIGURE 2

The four parcels are shown in Figure 2. The northern-most parcel (former Bayside Volvo site) was used for auto repair. Three USTs were removed in 1992 (Geotech 1992). Five soil samples were analyzed for gasoline range organics (GRO) and benzene, toluene, ethylbenzene, and xylenes (BTEX).

The middle parcel (former Maaco Auto Painting Bodywork site) was used for truck body assembly, painting, and servicing. Portions of the property have been filled; decaying trash and debris have been observed in the soil. An underground storage tank (UST) was closed in place (Figure 2). During a Phase II investigation conducted in 2014, 12 direct-push borings were advanced (GeoEngineers 2014b). Four hollow-stem borings were advanced, three of which were completed as monitoring wells. Six soil vapor probes were installed. A total of 36 soil samples collected at depths ranging down to 20 feet bgs, 3 groundwater samples, and 6 soil vapor samples were analyzed for petroleum hydrocarbons, metals, PAHs, polychlorinated biphenyls (PCBs), and VOCs.

The southern-most parcels (former Seattle Motor Sports site) were historically used for truck repair. There were six hoists and a UST (Figure 2). Later the property housed a restaurant and a motorcycle dealership. A preliminary assessment conducted in 1988 included four soil borings and one groundwater sample (SoundEarth 2015). Samples were analyzed for total petroleum hydrocarbons (TPH), BTEX, and extraction procedure toxicity metals. A Phase II investigation conducted in 1992 involved eight soil borings and one monitoring well (SoundEarth 2015). Samples were analyzed for GRO, diesel range organics (DRO), oil range organics (ORO), BTEX, and VOCs. Another Phase II investigation conducted in 2014 involved seven soil borings (SoundEarth 2015). Samples were analyzed for GRO, DRO, ORO, BTEX, chlorinated VOCs, and five metals.

In March 2021, two USTs and multiple hydraulic hoists were removed from the Maaco Auto Painting Bodywork and Seattle Motor Sports parcels, along with contaminated soils associated with these features (Figure 2) (Farallon 2021). After the decommissioning, 44 soil samples collected at depths ranging down to 15 feet bgs were analyzed for petroleum hydrocarbons; BTEX; chlorinated VOCs; metals; PAHs; and PCBs. The parcels are currently vacant in preparation for property redevelopment (Figure 3).

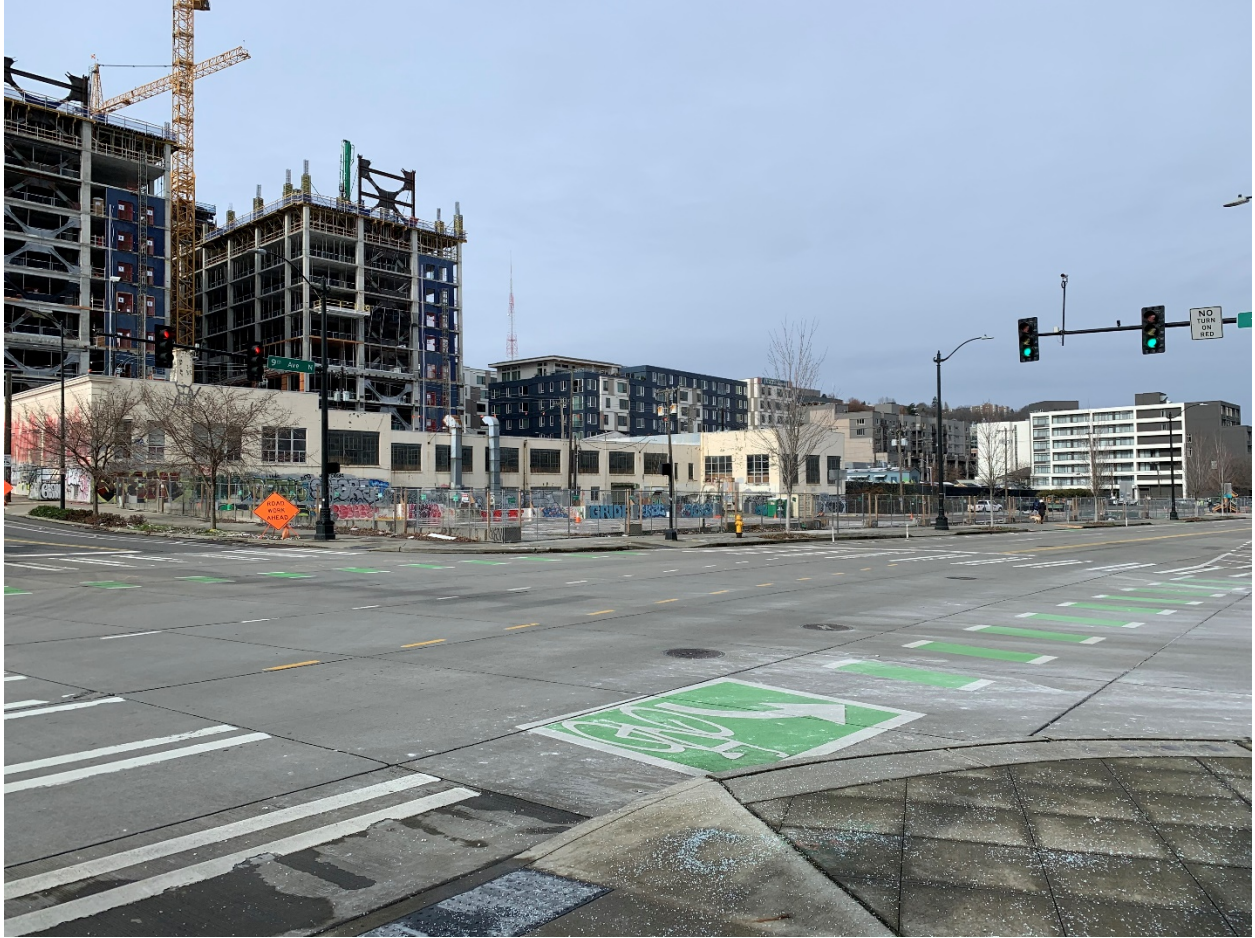
Figure 3. Block 79 East Parcels Looking Northwest (photo taken by Ecology on February 12, 2021)

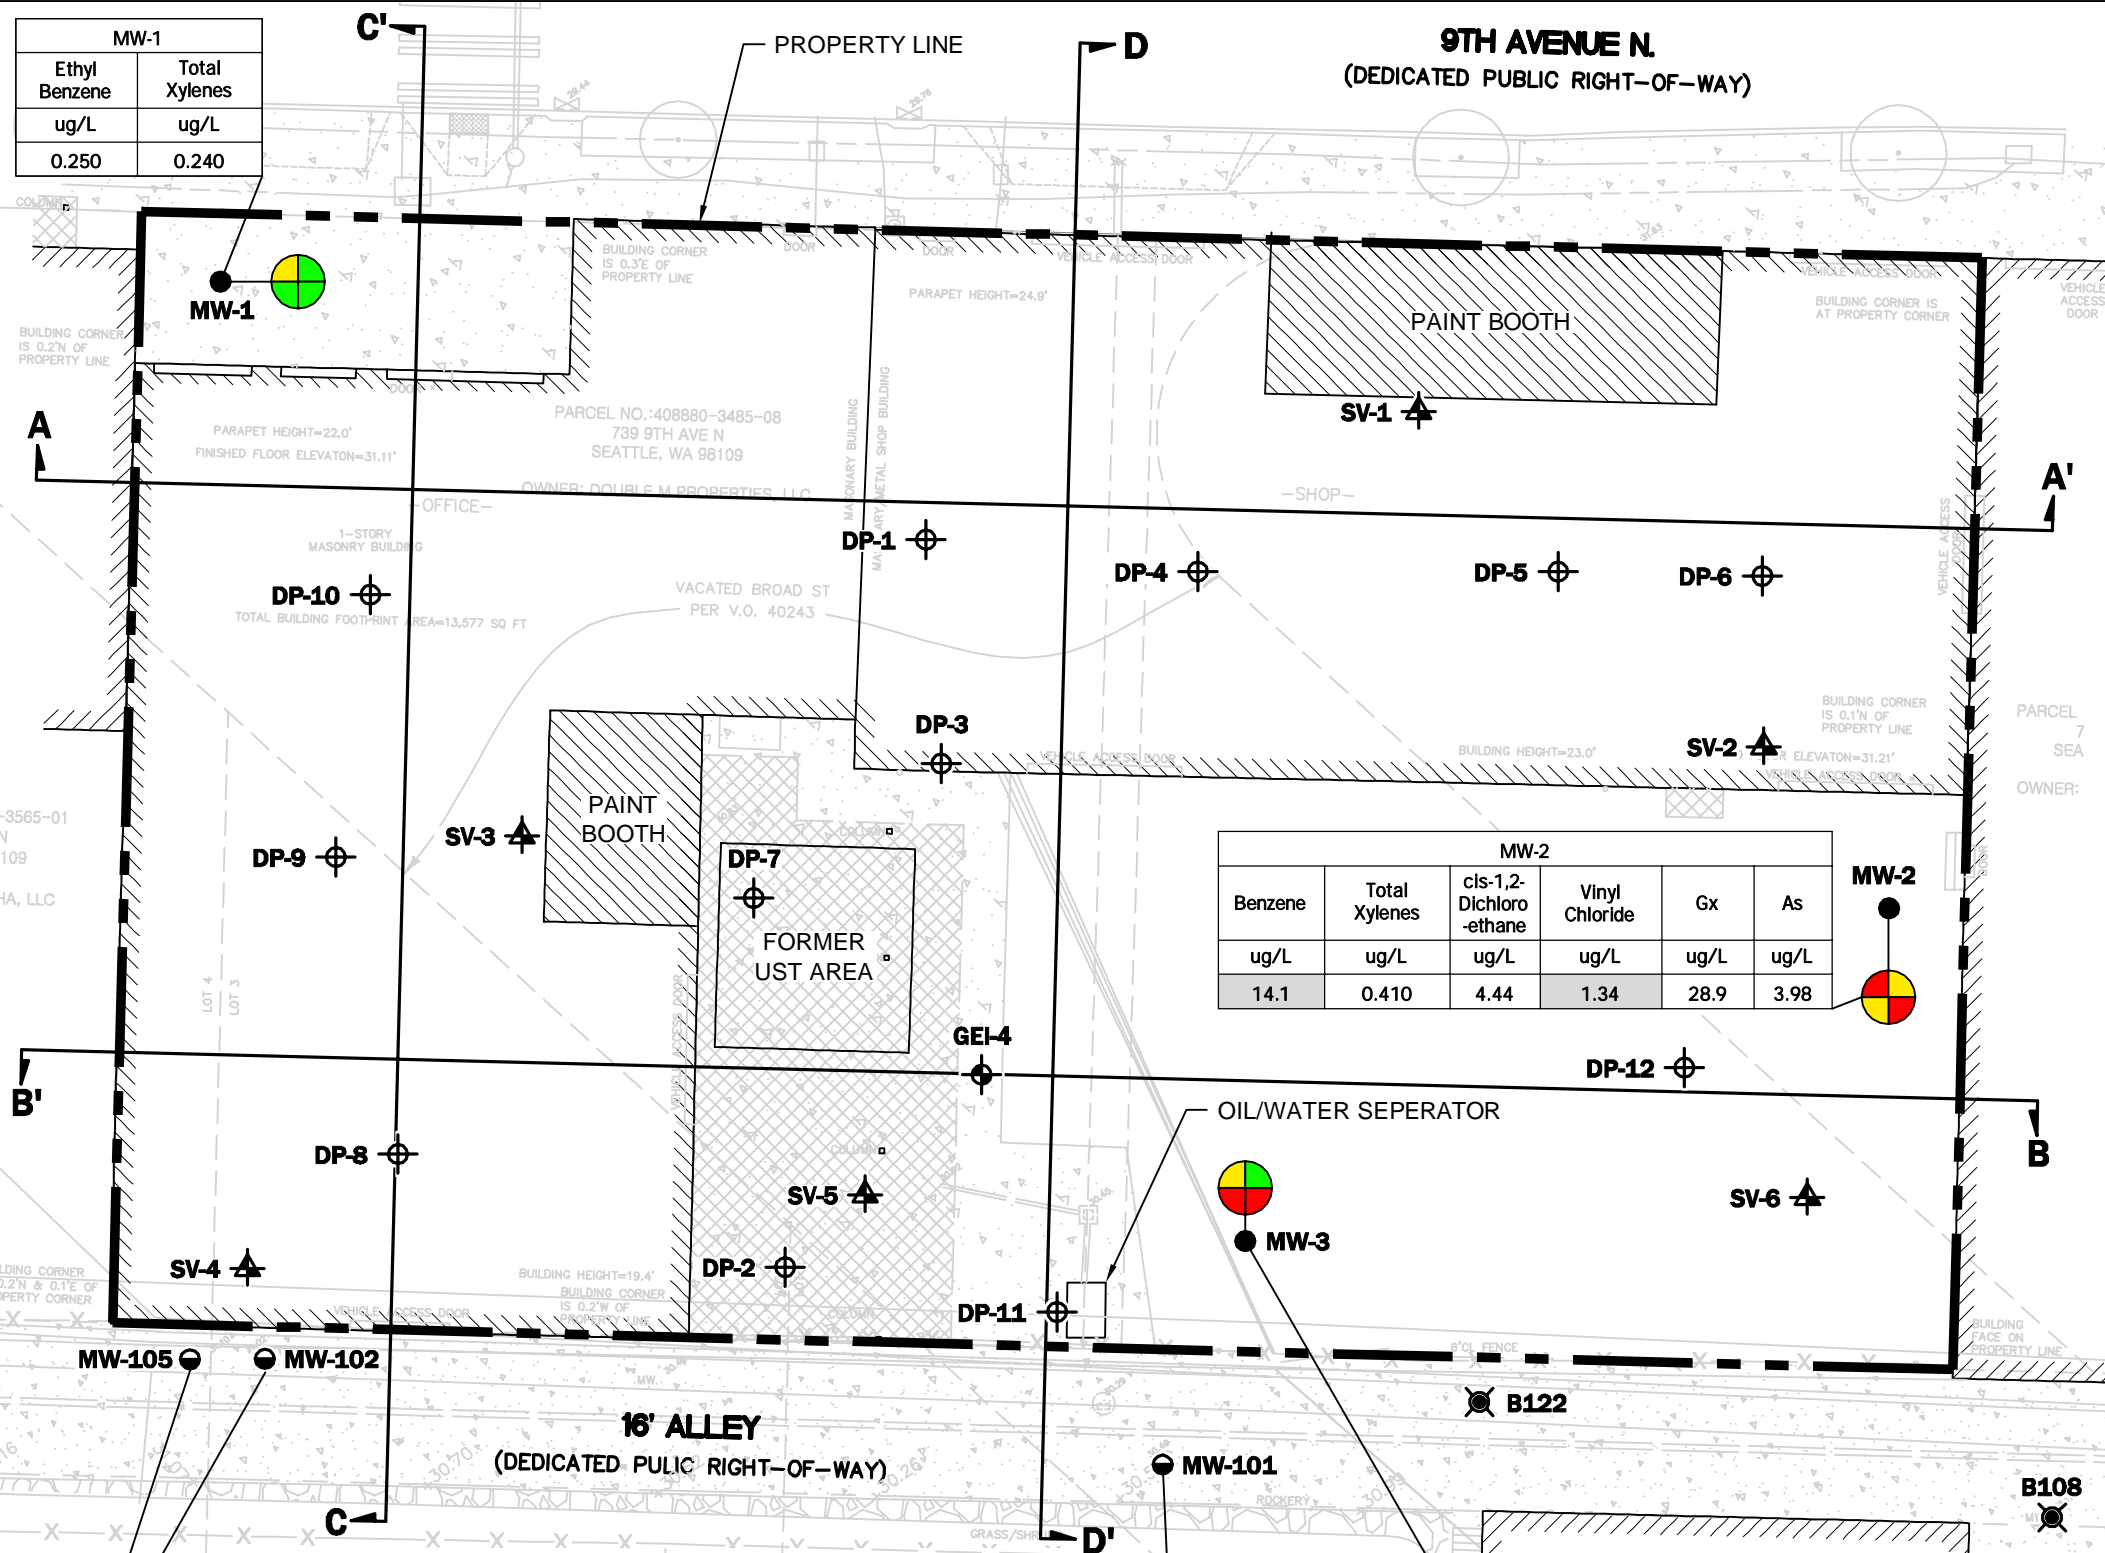
Groundwater Chemical Analytical Results	
South Lake Union Marriott AC Seattle, Washington	
	Figure 4

Benzene exceeds Method A in MW-2, was detected below Method A in MW-3, and was not detected in MW-1 (Figure 4). Vinyl chloride exceeds Method A in MW-2 and MW-3 and was not detected in MW-1. The groundwater source was assumed to be a circle with radius 70 feet (half the distance from MW-3 to MW-1), which corresponds to 16,300 square feet. The source was assumed to be three feet thick, a default assumption when exact dimensions are not known.

Benzene exceeds Method A in soil and groundwater. Vinyl chloride exceeds Method A in groundwater and there is a source of PCE, which degrades to vinyl chloride, in soil

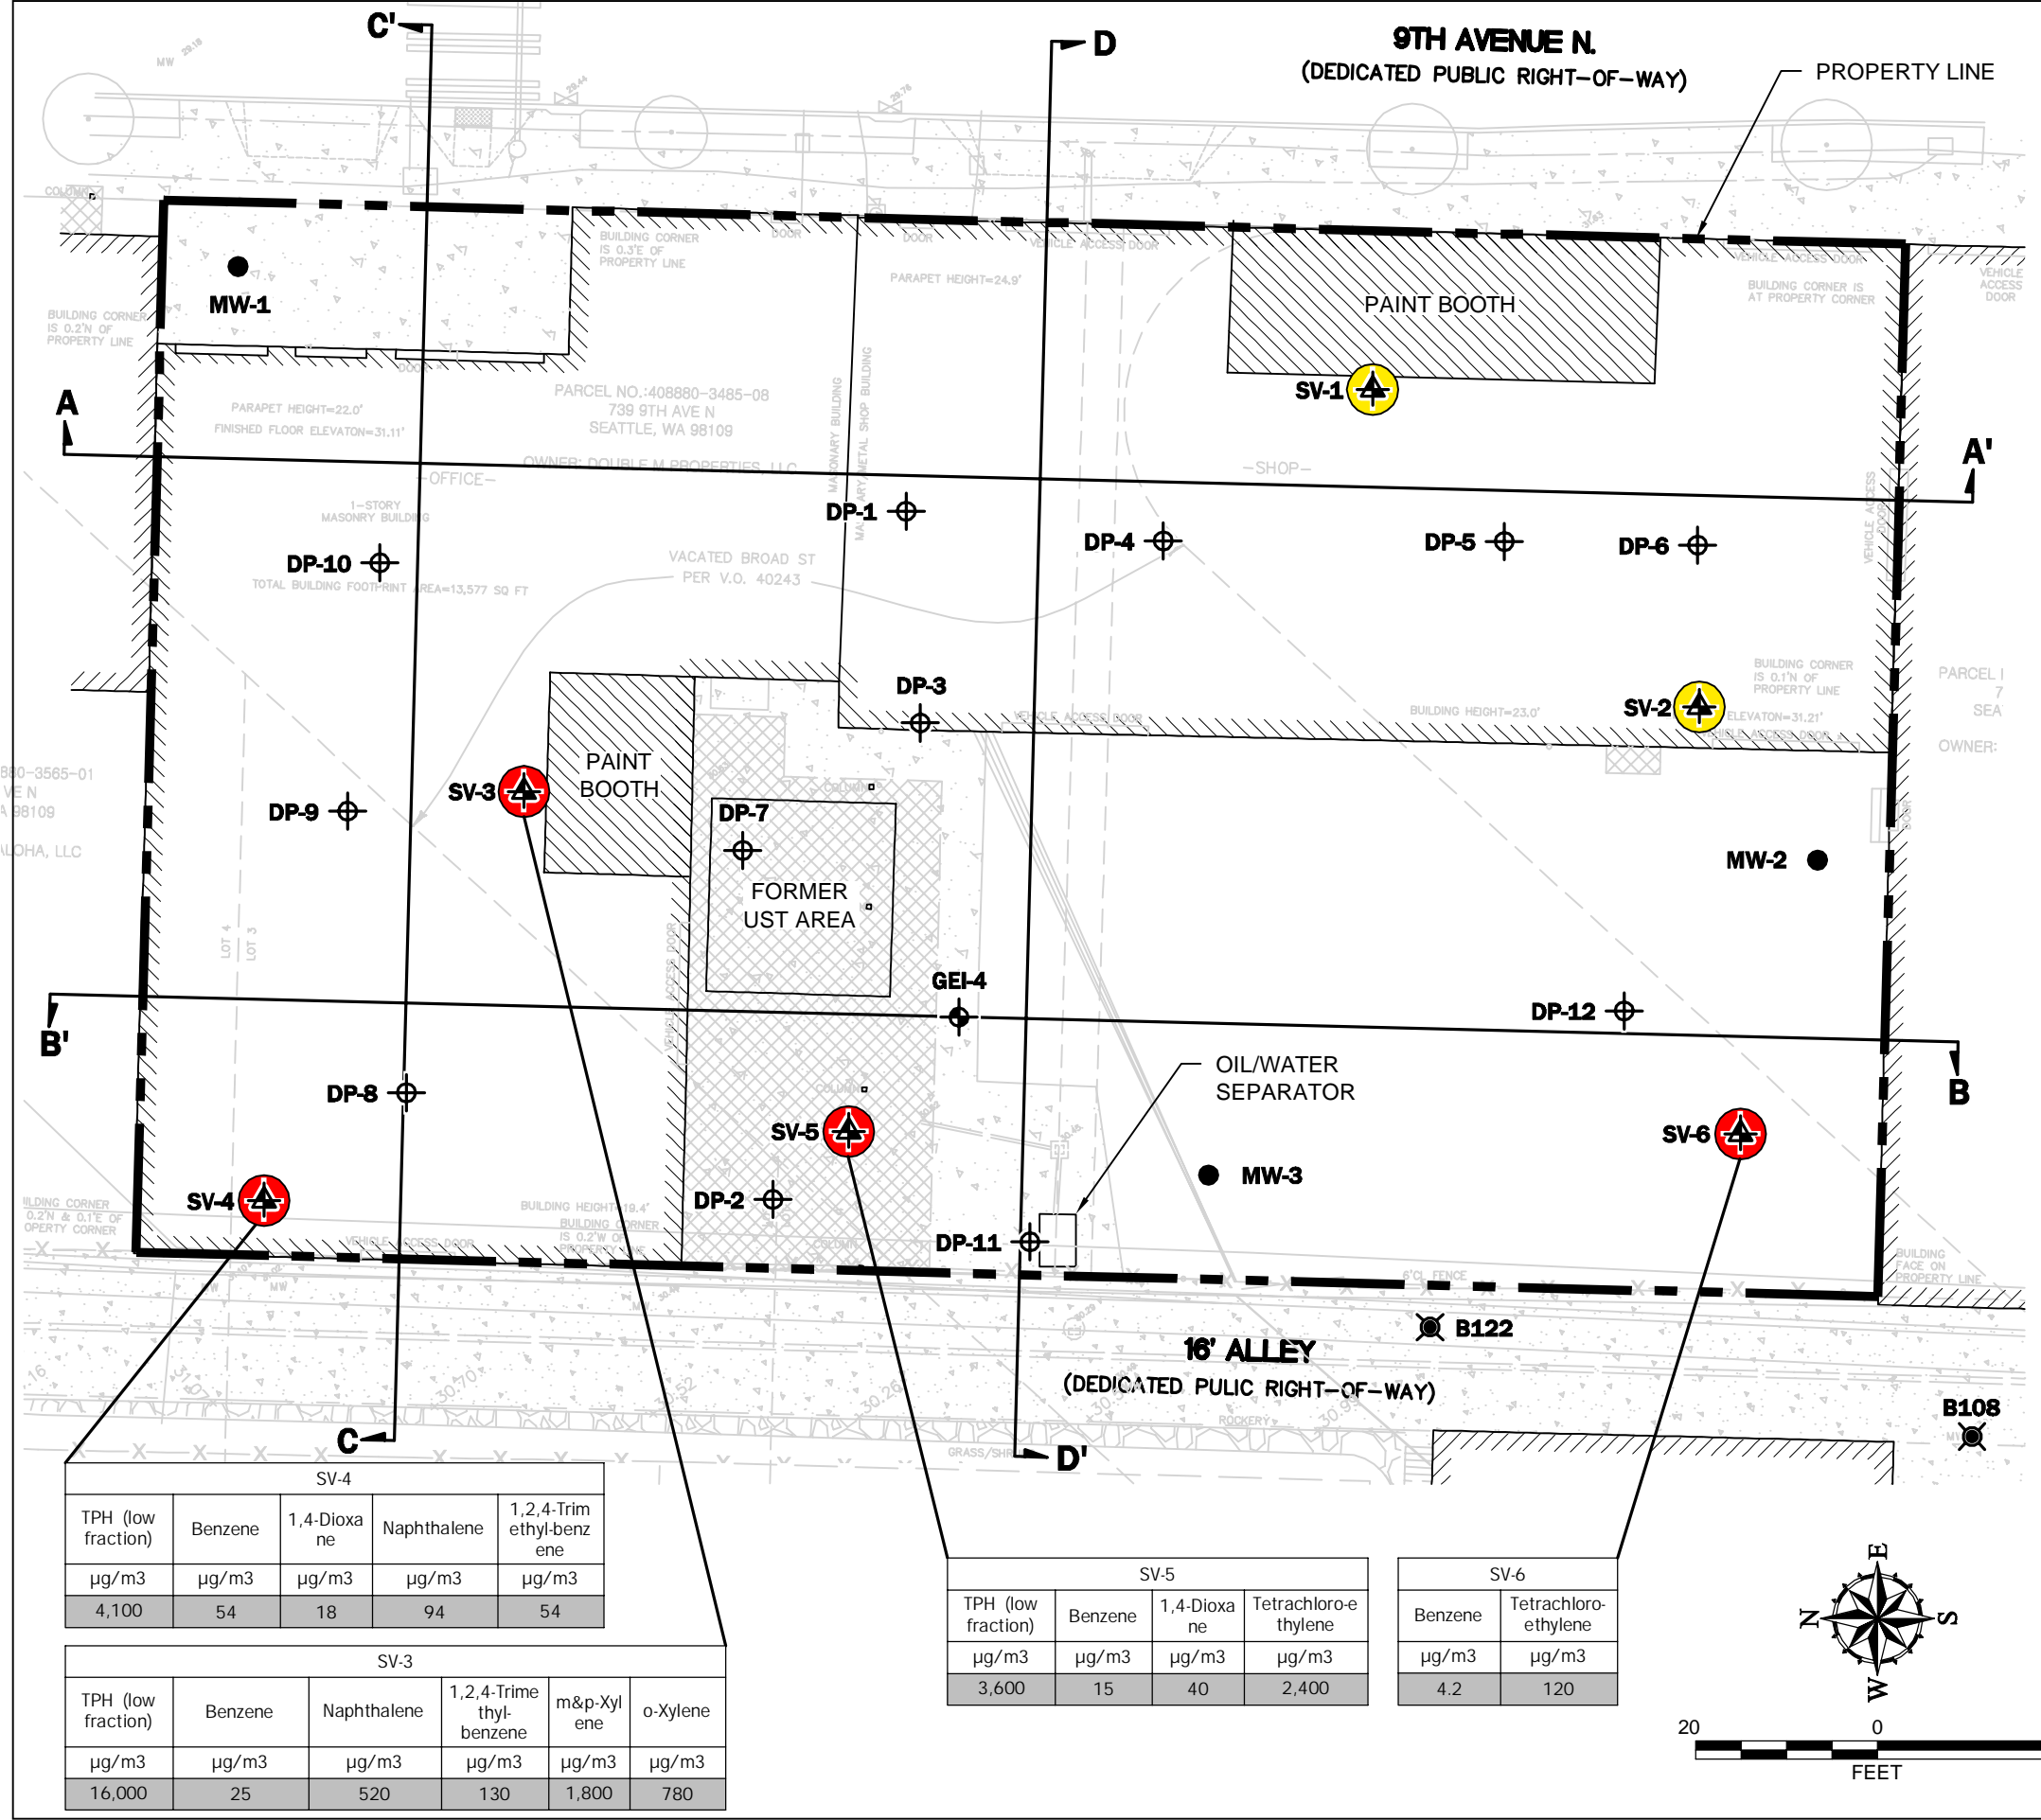
Soil Vapor Chemical Analytical Results	
South Lake Union Marriott AC Seattle, Washington	
GEOENGINEERS	Figure 5

Benzene exceeds its Method B screening level in soil vapor probes (SV) 3 through 6, PCE in SV 5 and 6, naphthalene in SV 3 and 4, and xylenes in SV 3 (Figure 5). The air source was assumed to be the eastern half of the property, which is approximately 65 x 190 feet, which corresponds to approximately 12,300 square feet.

SV-4				
TPH (low fraction)	Benzene	1,4-Dioxane	Naphthalene	1,2,4-Trimethylbenzene
µg/m ³	µg/m ³	µg/m ³	µg/m ³	µg/m ³
4,100	54	18	94	54

SV-3					
TPH (low fraction)	Benzene	Naphthalene	1,2,4-Trime-thylbenzene	m&p-Xylene	o-Xylene
µg/m ³	µg/m ³	µg/m ³	µg/m ³	µg/m ³	µg/m ³
16,000	25	520	130	1,800	780

SV-5			
TPH (low fraction)	Benzene	1,4-Dioxane	Tetrachloroethylene
µg/m ³	µg/m ³	µg/m ³	µg/m ³
3,600	15	40	2,400

SV-6	
Benzene	Tetrachloroethylene
µg/m ³	µg/m ³
4.2	120
