**Former Cascade Timber #1 Site, Tacoma, Washington
2021 Annual Operations & Maintenance Report**

Date February 25, 2022

PHOTOGRAPHIC LOG – SEPTEMBER 2021 INSPECTION

Annual Inspection Report (2021)
Former Cascade Timber #1 Facility
2502 Marine View Drive, Tacoma, Washington

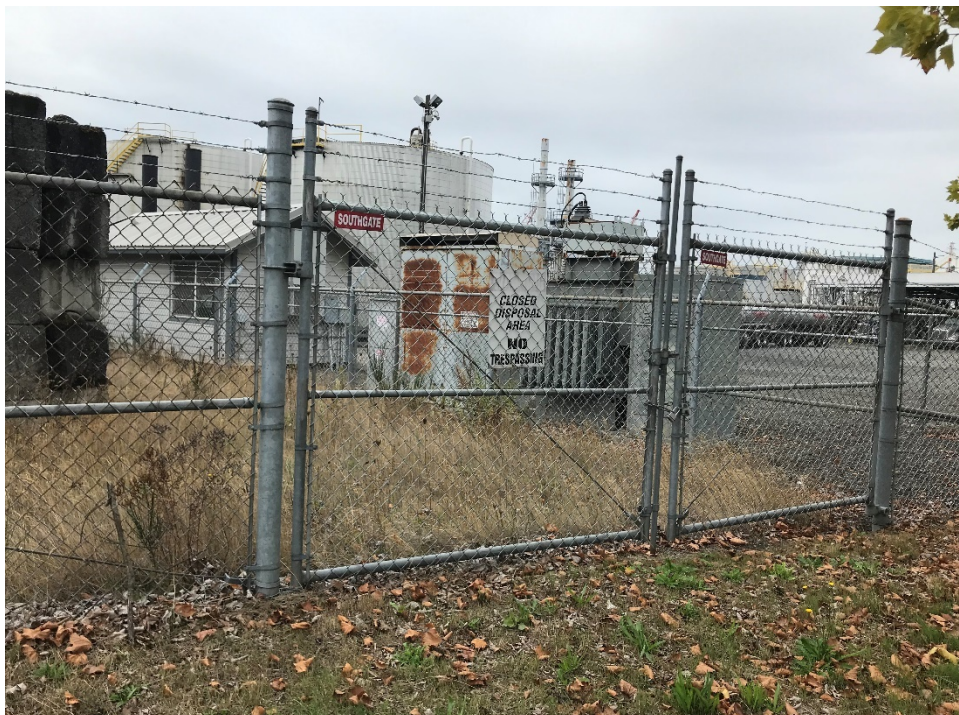
Photo 1: View of the north gate (main entrance) facing Marine View Drive.

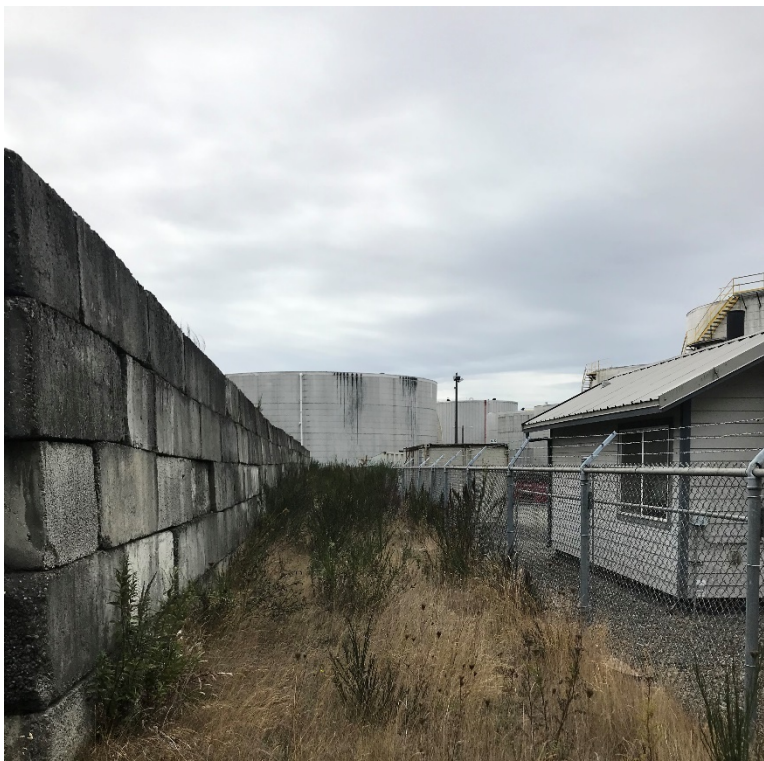
Photo 2: View of the walkway west of containment cell (facing south).

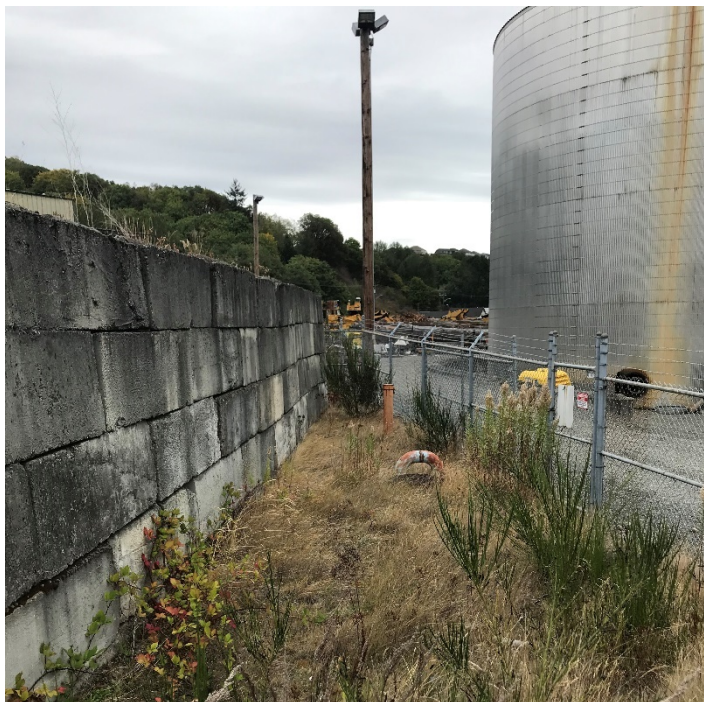
Photo 3: View of the south gate to the right and containment cell to the left (facing east).

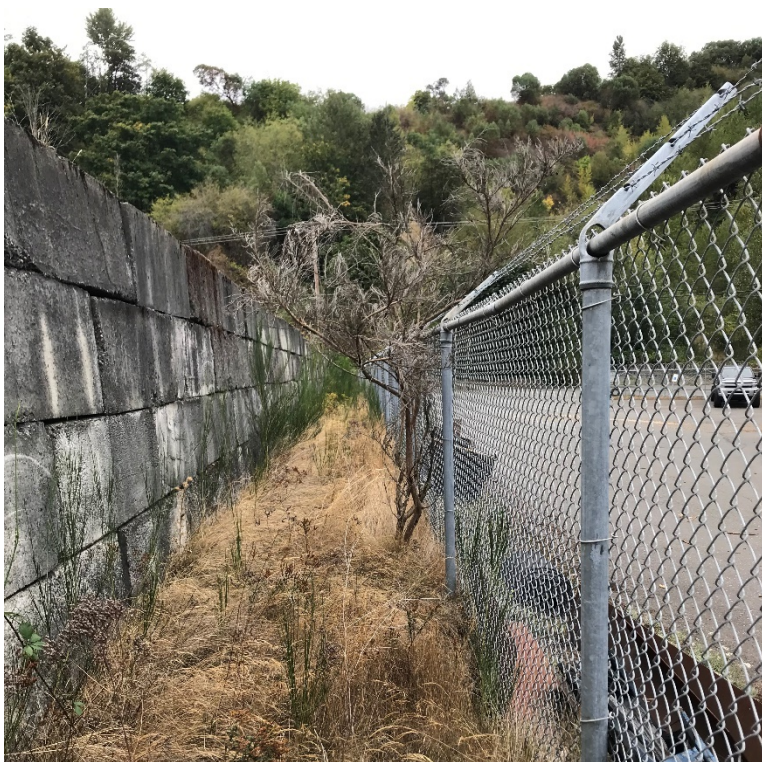
Photo 4: View of the walkway east of containment cell (facing north) with overgrowth of weeds and dead tree.

Site Inspection Field Notes	
	Notes/Actions Taken or Needed
General Site Conditions	
Perimeter walk observations	The site was properly secured without any signs of vandalism. Both gates were locked at the time of inspection. Overgrowth of weeds (approximately 2 to 3-foot tall) was observed on the east and west sides of the containment cell.
Condition of manholes, locks, gates, fencing, signage, monitoring wells	Manhole is covered and lid is secure. Perimeter fence is functional with secure locks. Signs are present and readable on perimeter fence. Monitoring wells were intact and locked.
Containment Cell Inspection	
Cap vegetation (e.g., weed growth, distress, dead, inadequate)	No disturbance of earth, erosion, cracks, or mounds was observed from cell perimeter. Vegetative cover was observed on the containment cell (as viewed from cell perimeter). Minor weeds were observed on the western section of the cap and near vent pipes; the presence and nature of the weeds does not appear to have resulted in an erosion issue or damage to the cap.

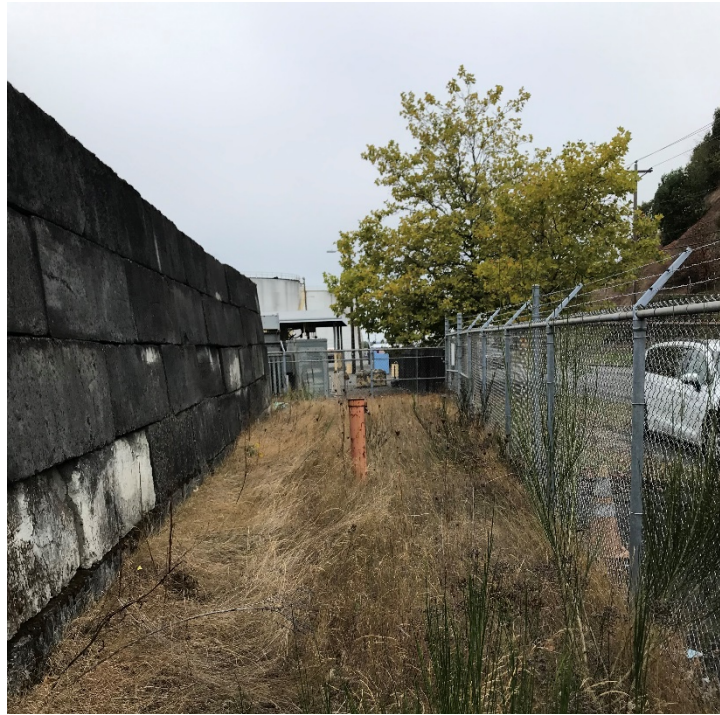
Photo 5: View of the walkway north of containment cell with monitoring well (MCW-3, facing west).

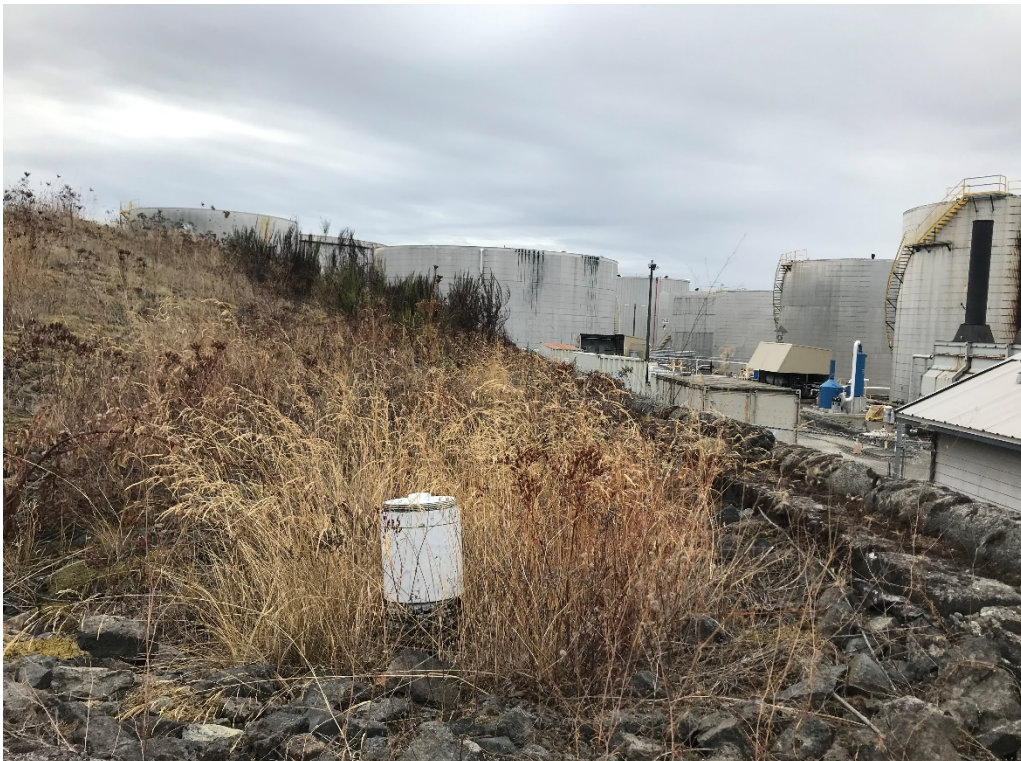
Photo 6: View of the northeast corner containment cell with a vent pipe (facing southwest)

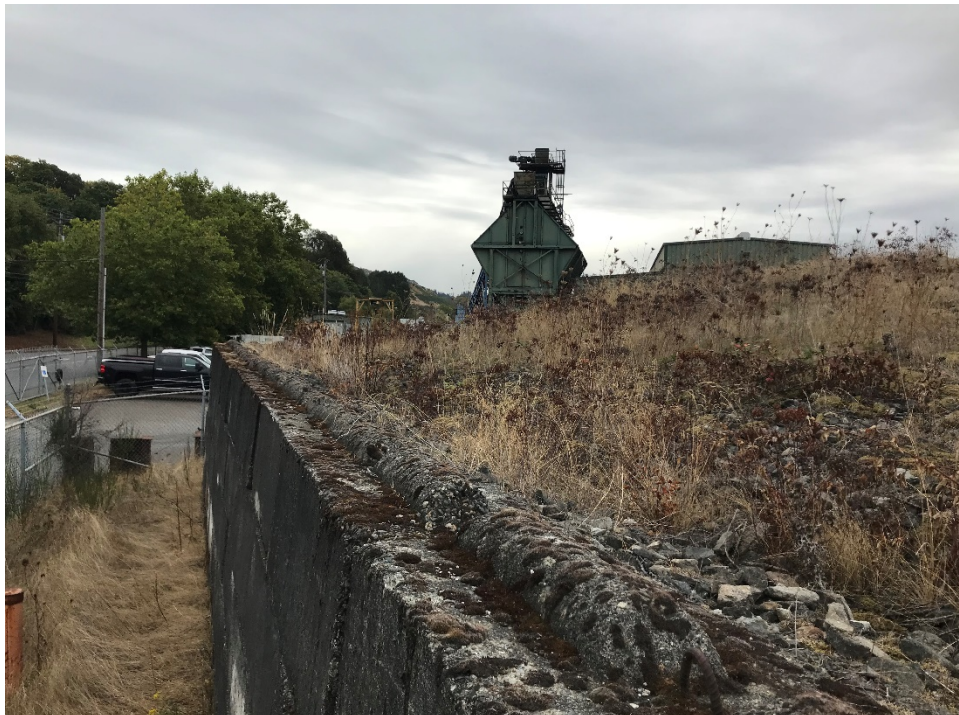
Photo 7: View of the north side of containment cell (facing east).

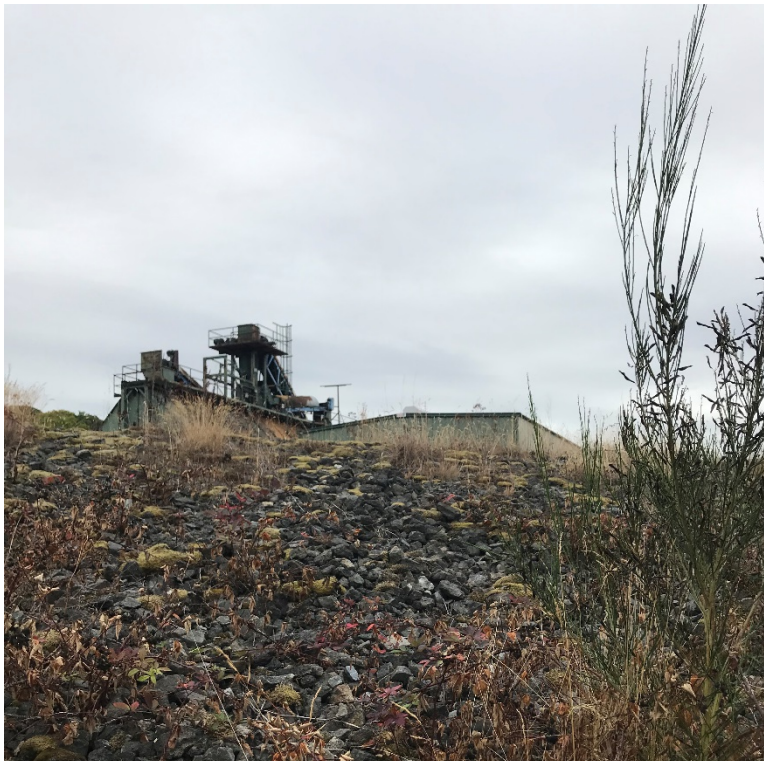
Photo 8: View of the centre of containment cell (facing east).

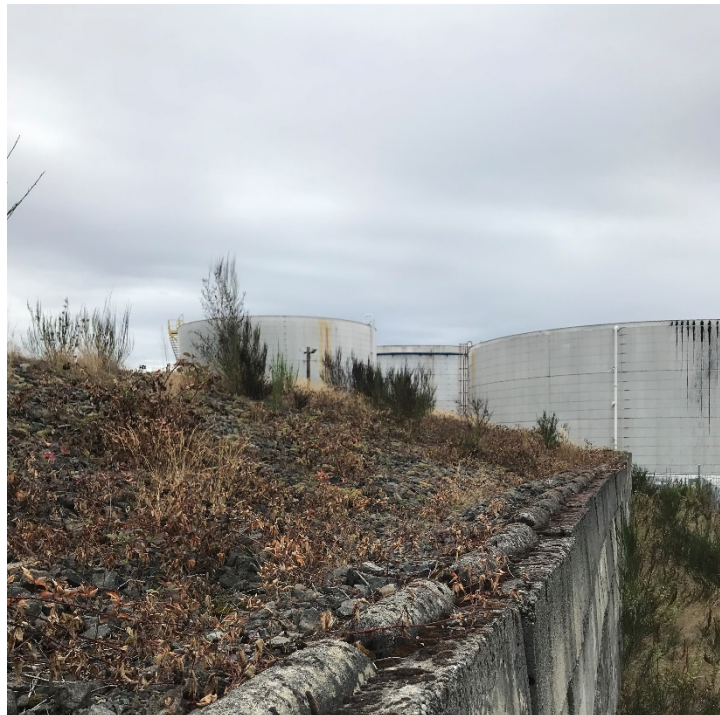
Photo 9: View of the east side of containment cell (facing south).

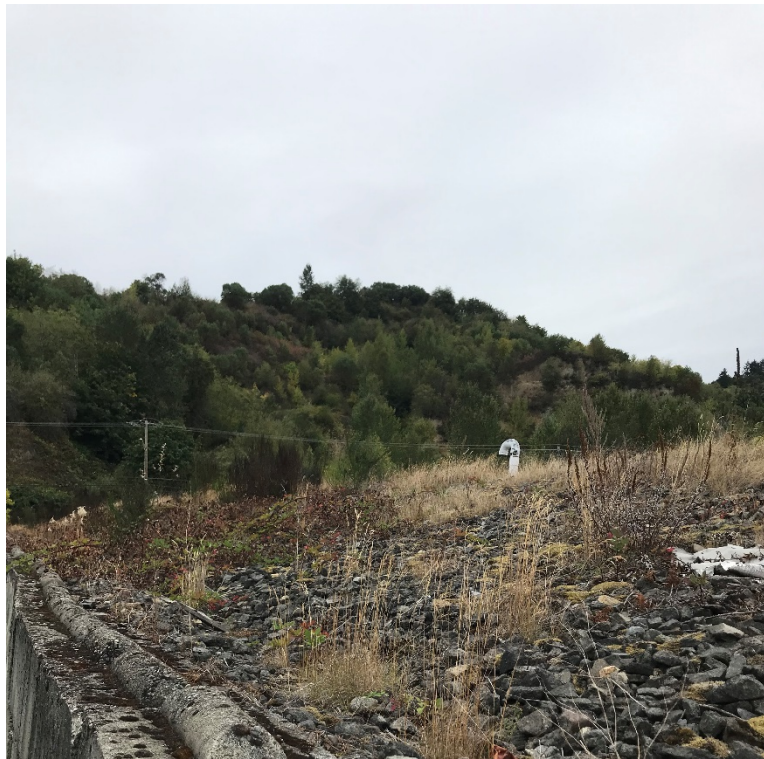
Photo 10: View of the west side of containment cell (facing north).

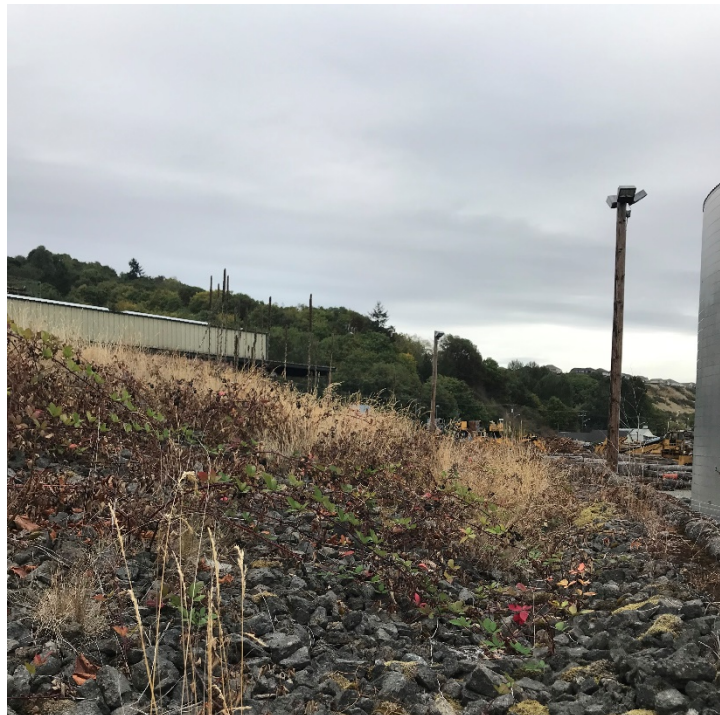
Photo 11: View of the south side of containment cell (facing east).

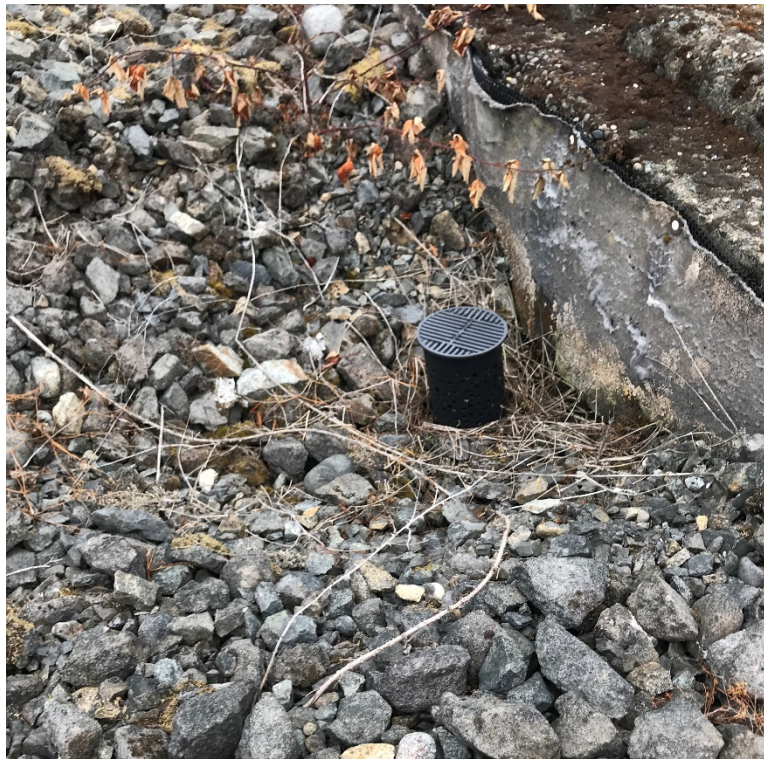
Photo 12: View of drain located at southeast corner of the containment cell.

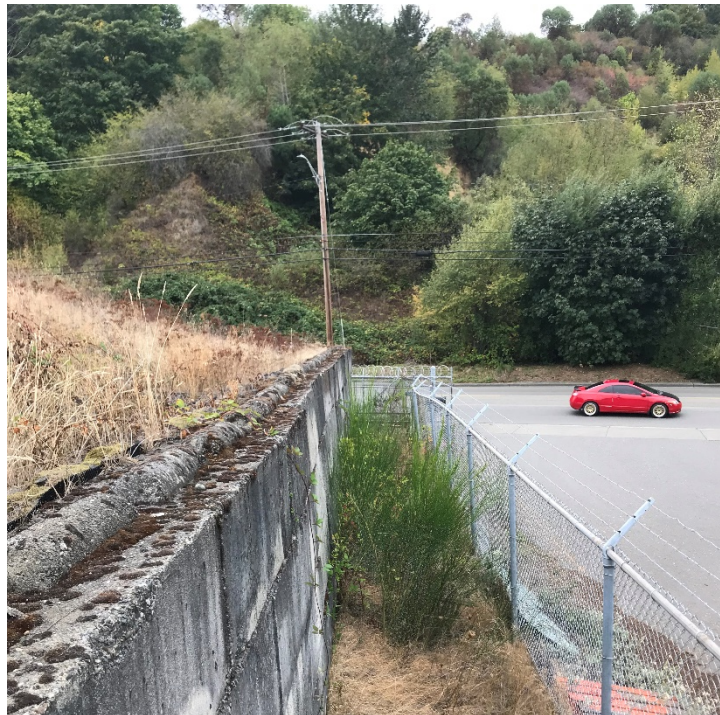
Photo 13: View of the east side of containment cell (facing north).

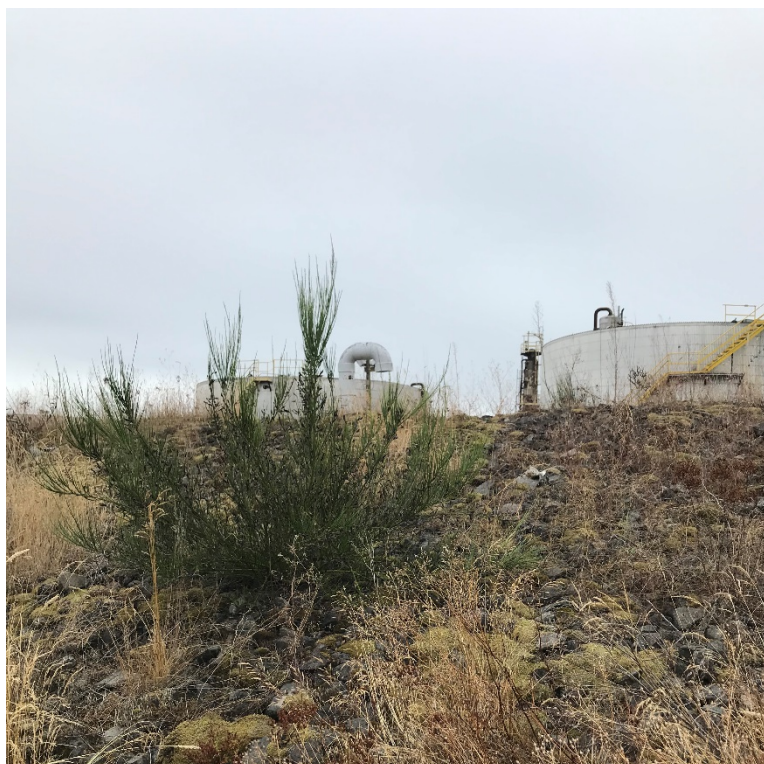
Photo 14: View of the center of containment cell (facing west).

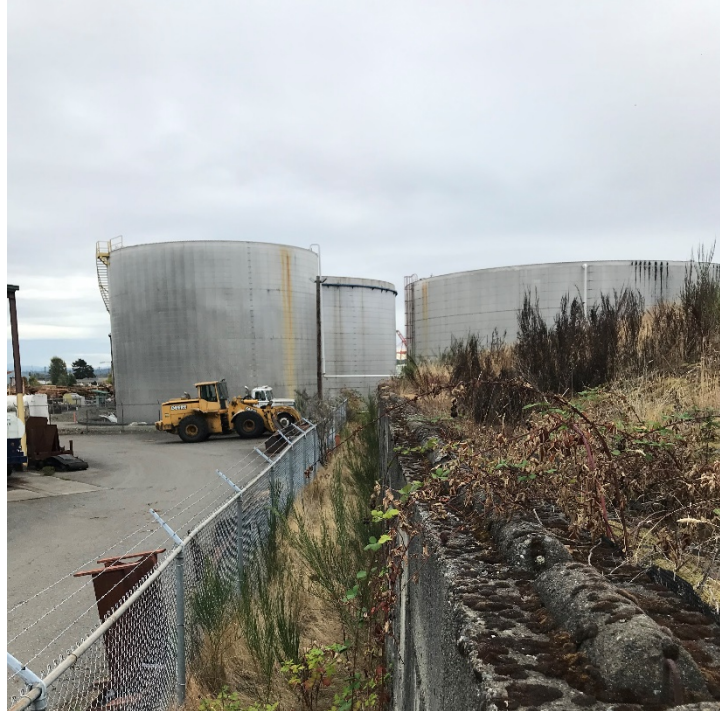
Photo 15: View of the east side of containment cell (facing south).

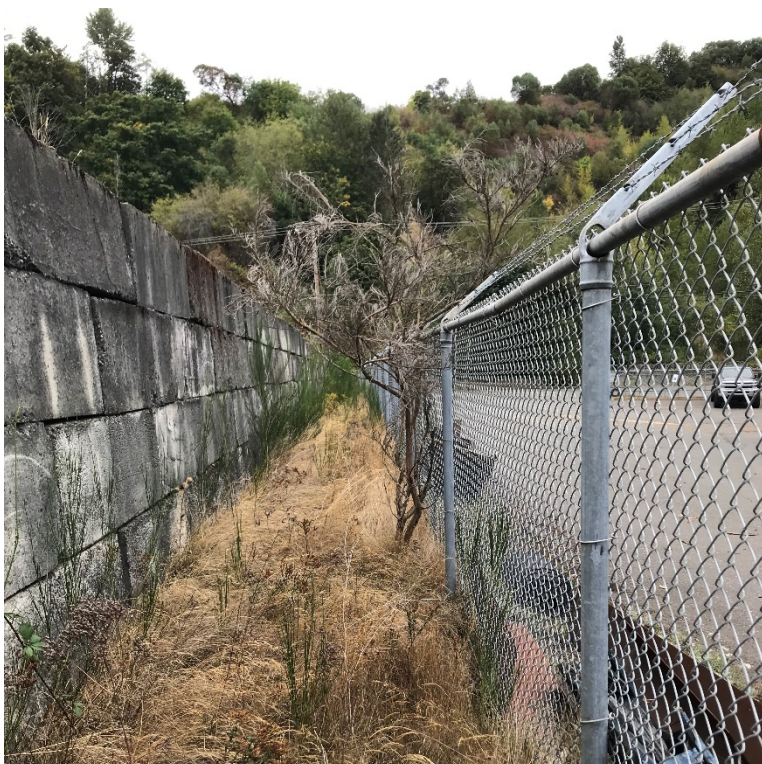
Photo 16: View of dead tree east of containment cell (facing south).

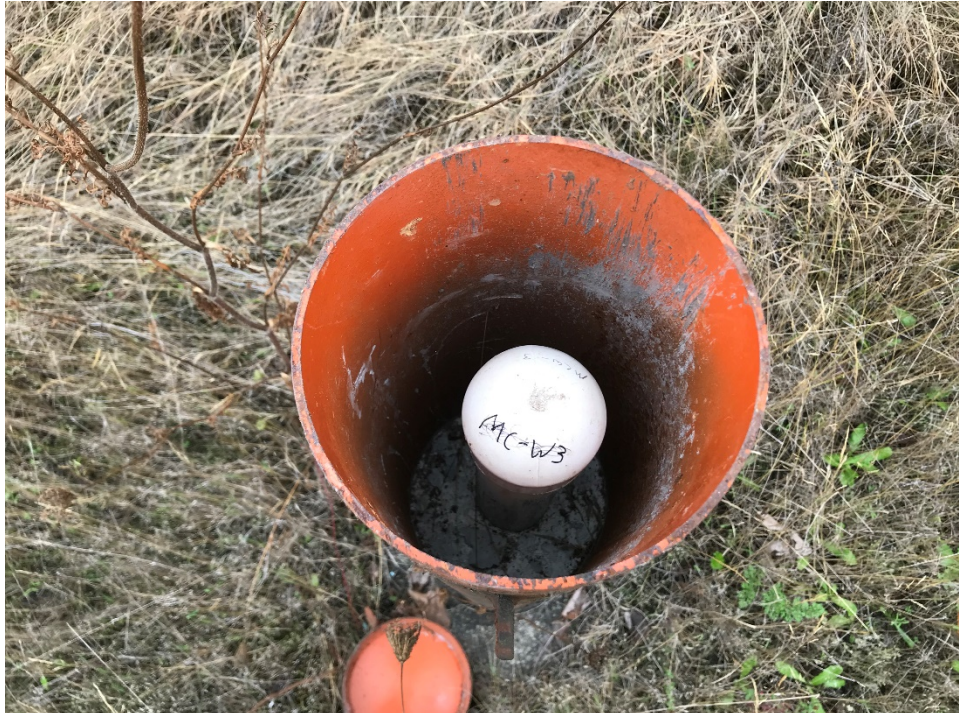
Photo 17: View of monitoring well (MCW-3) with an inner cap.

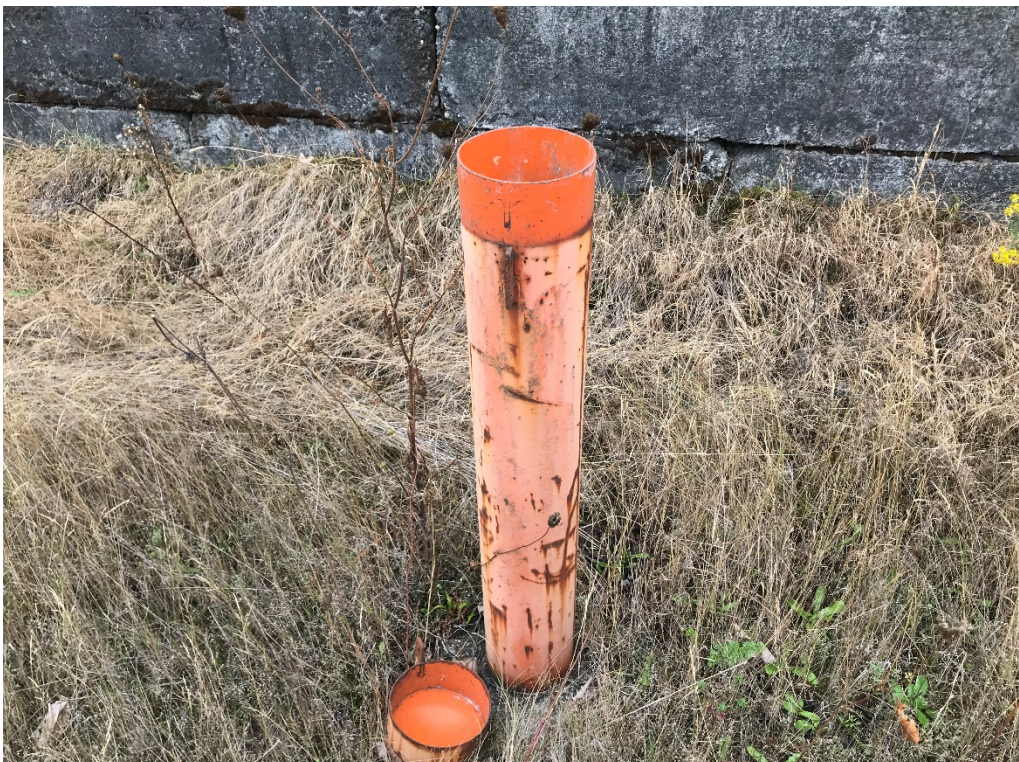
Photo 18: Monitoring well (MCW-3).

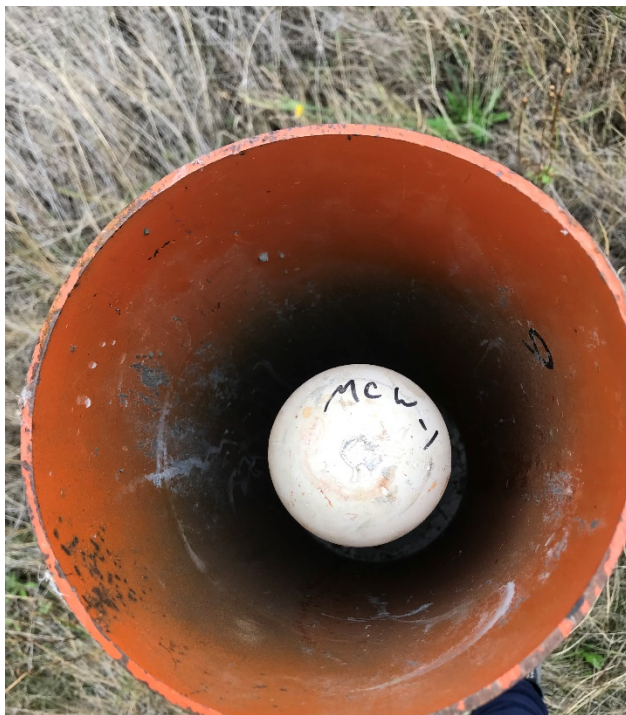
Photo 19:View of monitoring well (MCW-1) with an inner cap.

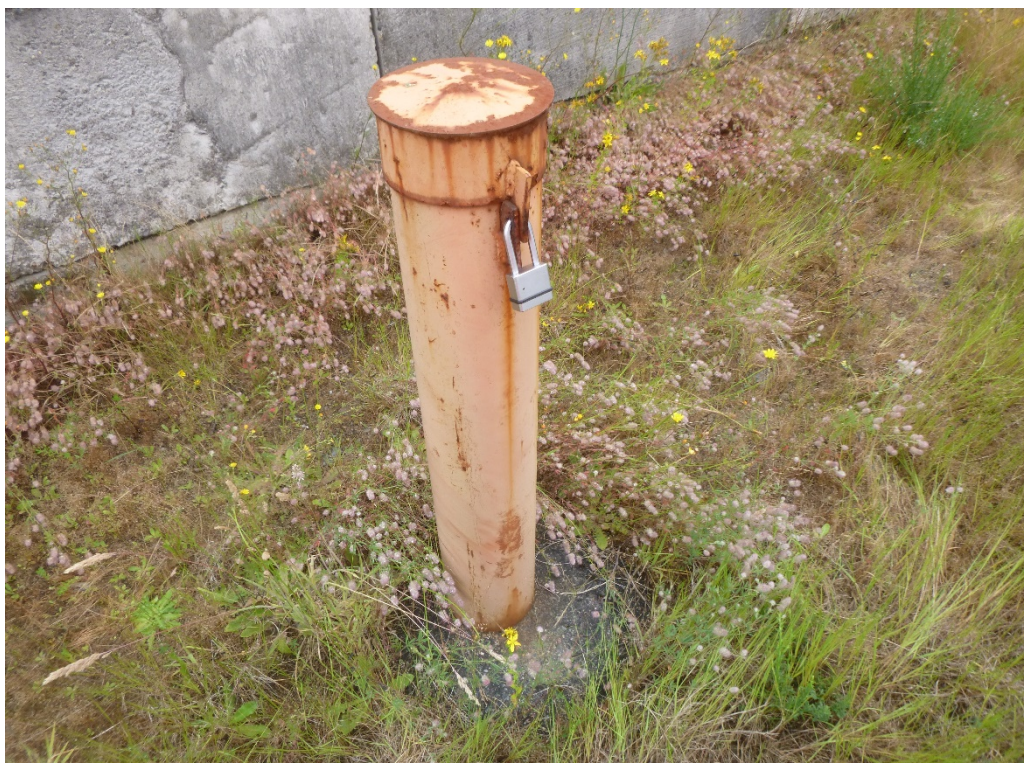
Photo 20: Monitoring well (MCW-1).

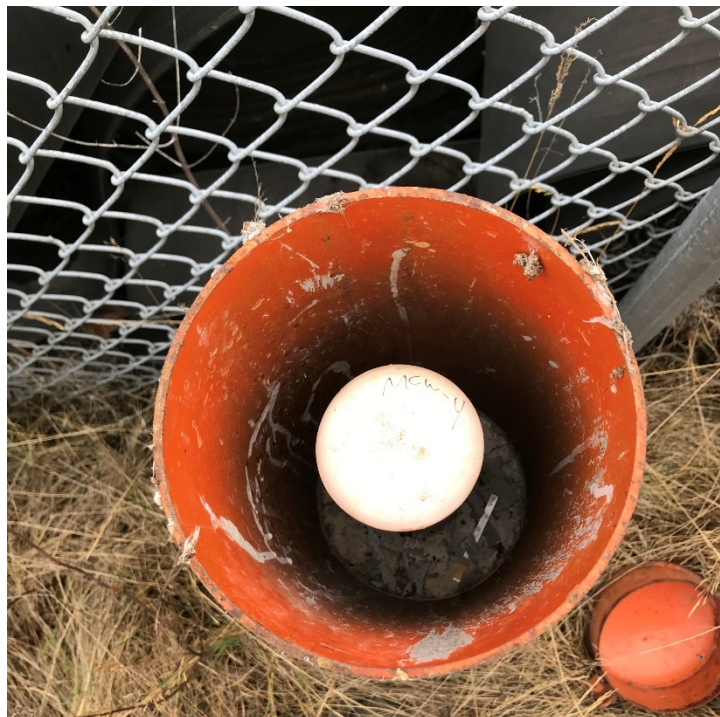
Photo 21: View of monitoring well (MCW-4) with an inner cap.

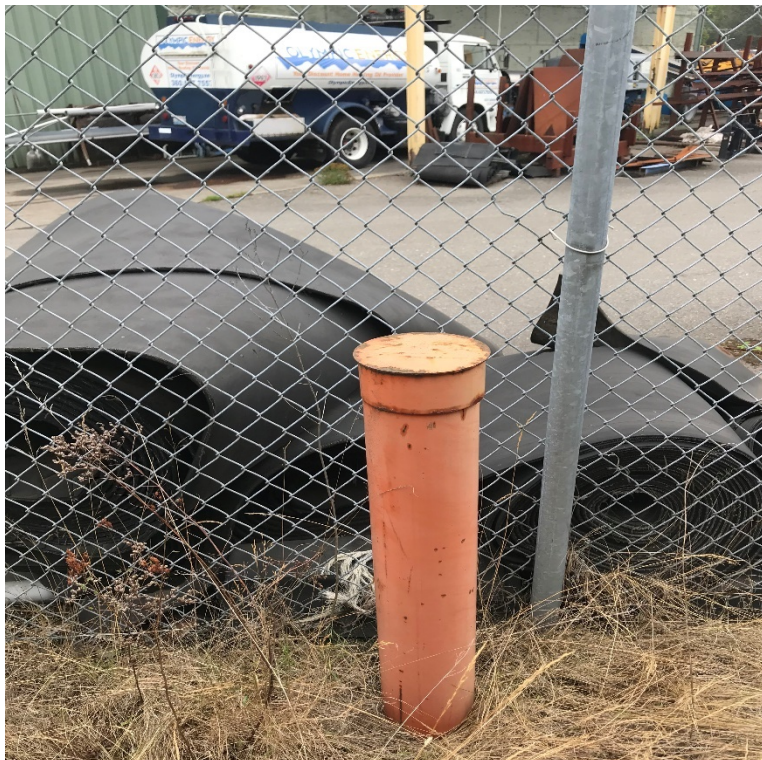
Photo 22: Monitoring well (MCW-4).

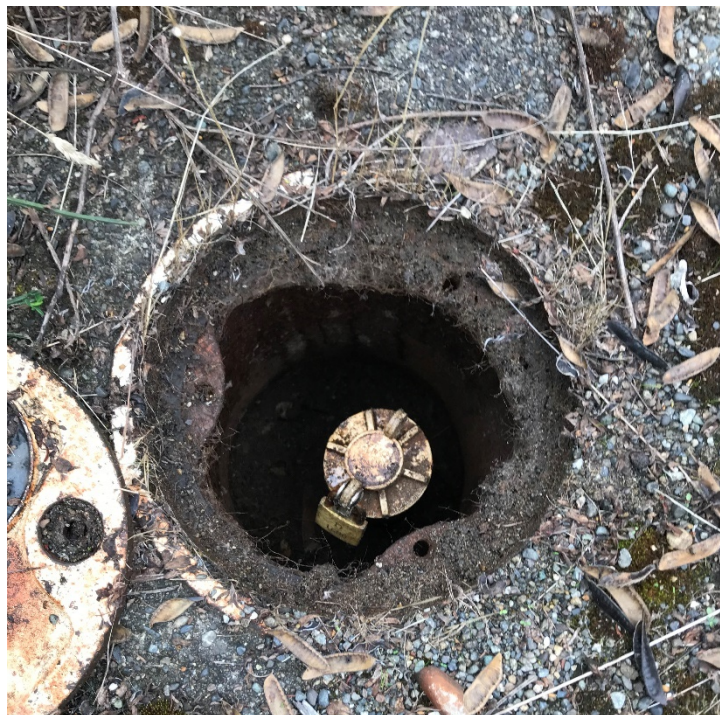
Photo 23: View of the monitoring well (MCW-2) with an inner cap.

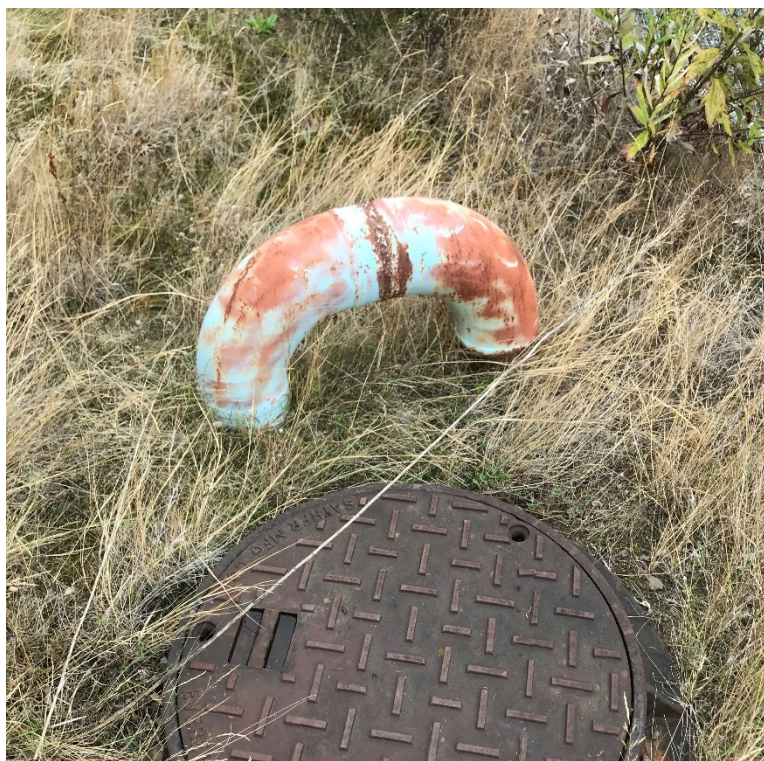
Photo 24: View of a manhole and vent pipe located south of the containment cell.

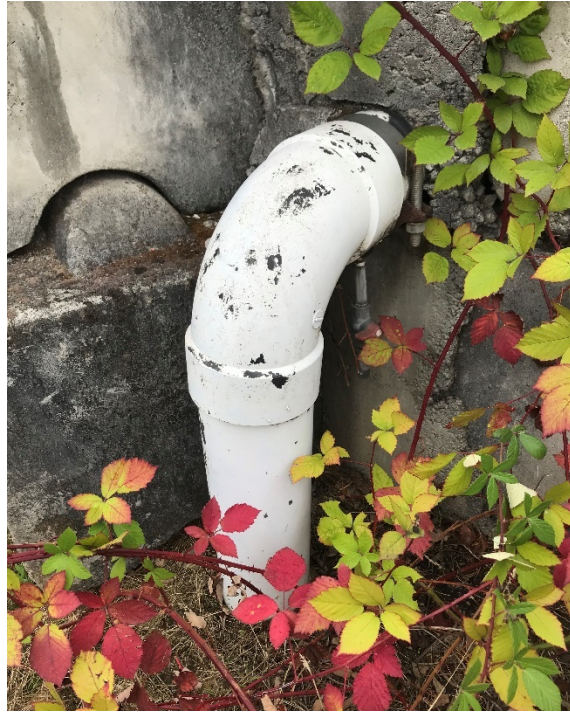
Photo 25: View of the drain pipe southeast corner of the containment cell.

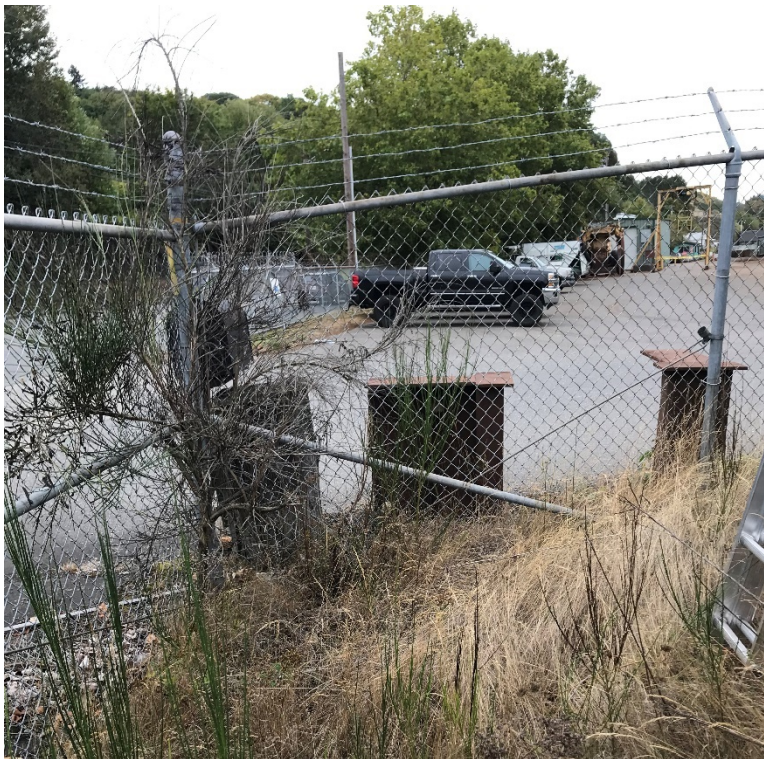
Photo 26: Dead tree observed in the northeast corner of the containment cell perimeter.
