Ramboll US Corporation

OPERATION & MAINTENANCE PLAN

FORMER CASCADE TIMBER #1 SITE TACOMA, WASHINGTON

ATTACHMENT 1
BASELINE CAP CONDITION – SITE INSPECTION REPORT AND
PHOTOGRAPHIC LOG

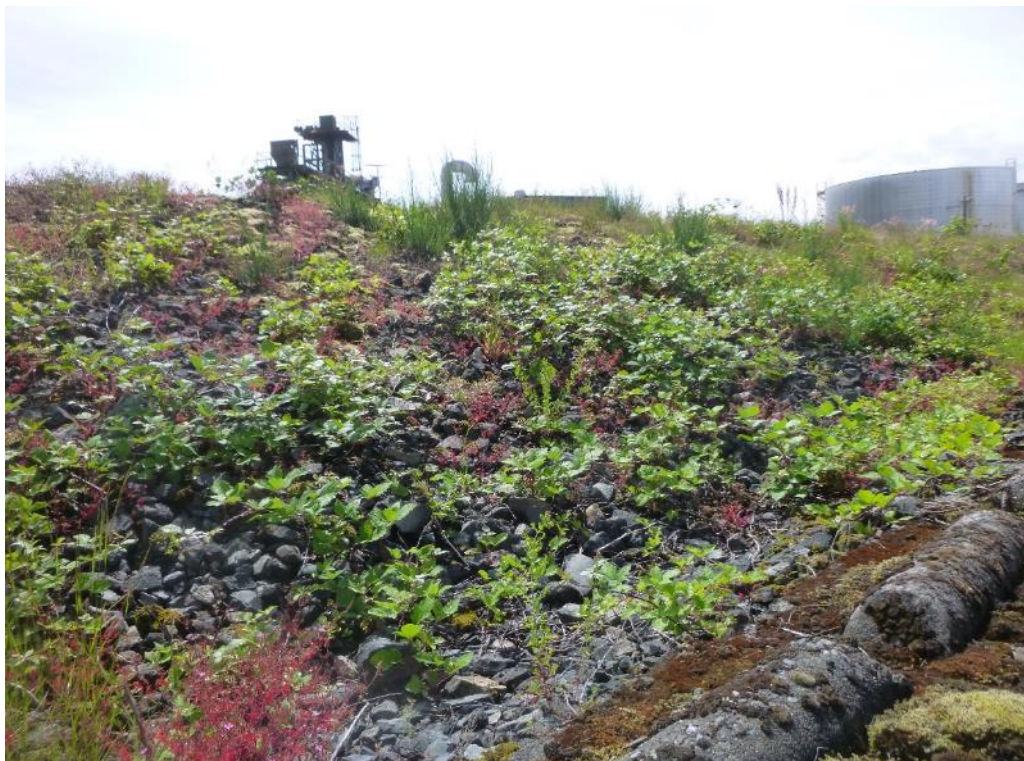
Photo 8: View of the center of containment cell cap with weed growth around a vent pipe (facing east).

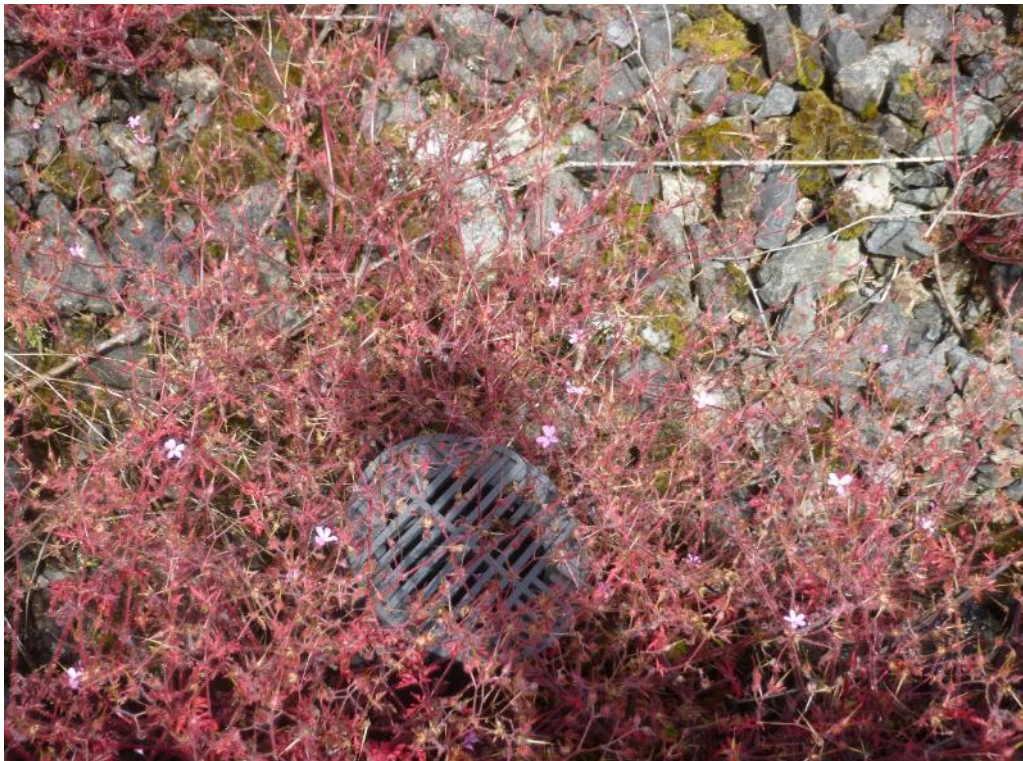
Photo 12: View of a drain located at southeast corner of the containment cell cap with weeds.

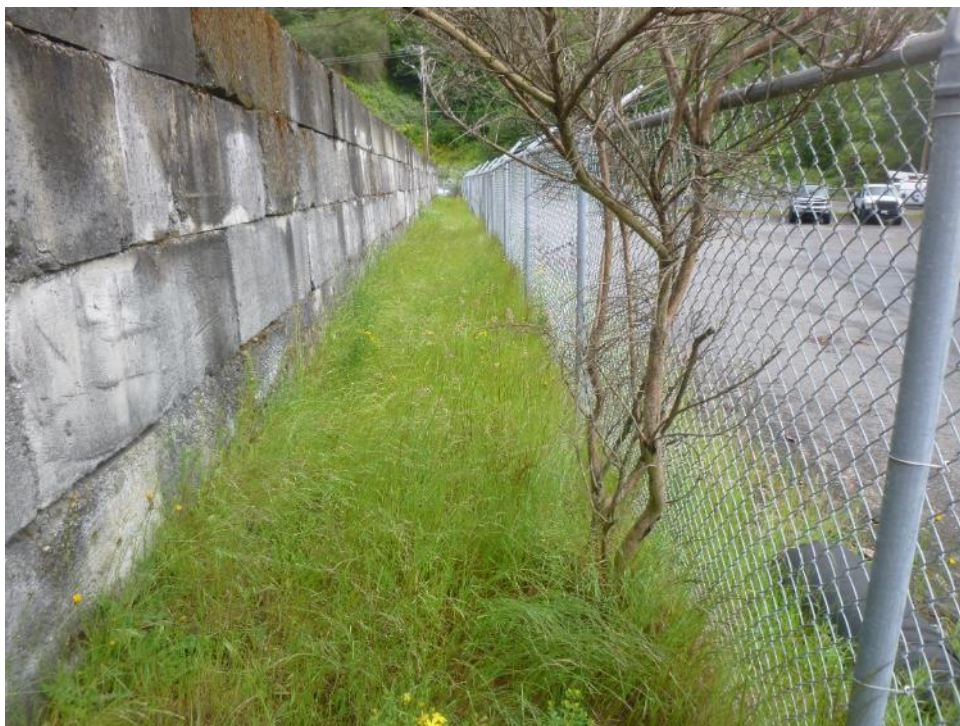
Photo 16: View of a possibly dead tree east of containment cell (facing north).

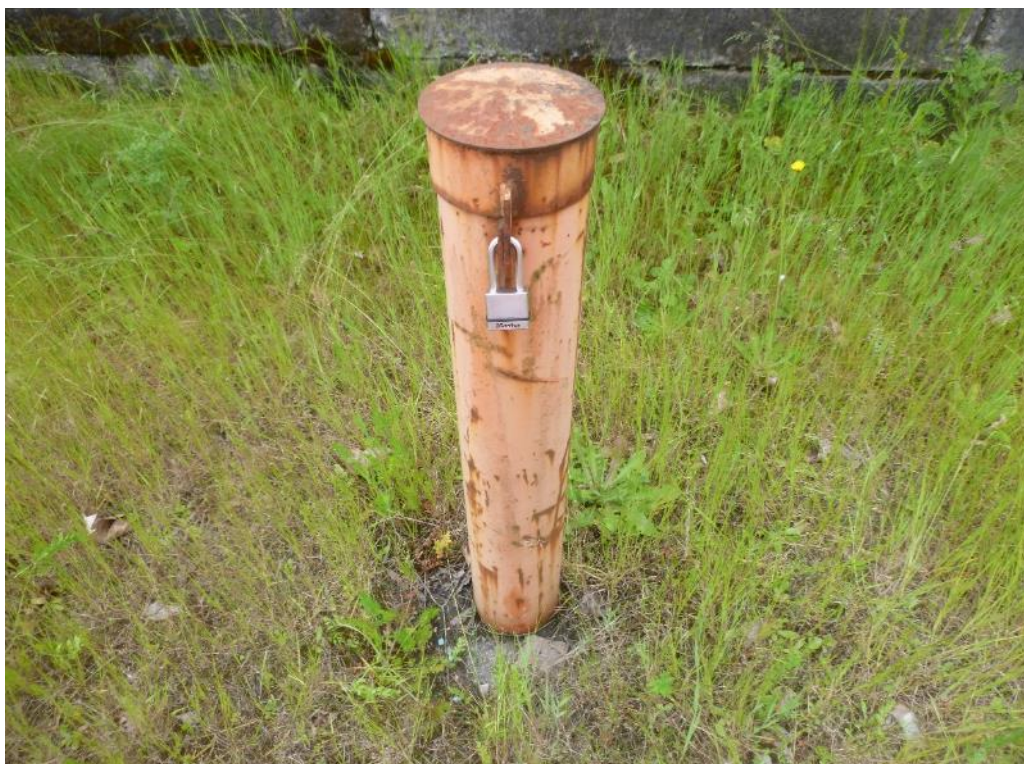
Photo 18: Monitoring well (MCW-3) with a new padlock.

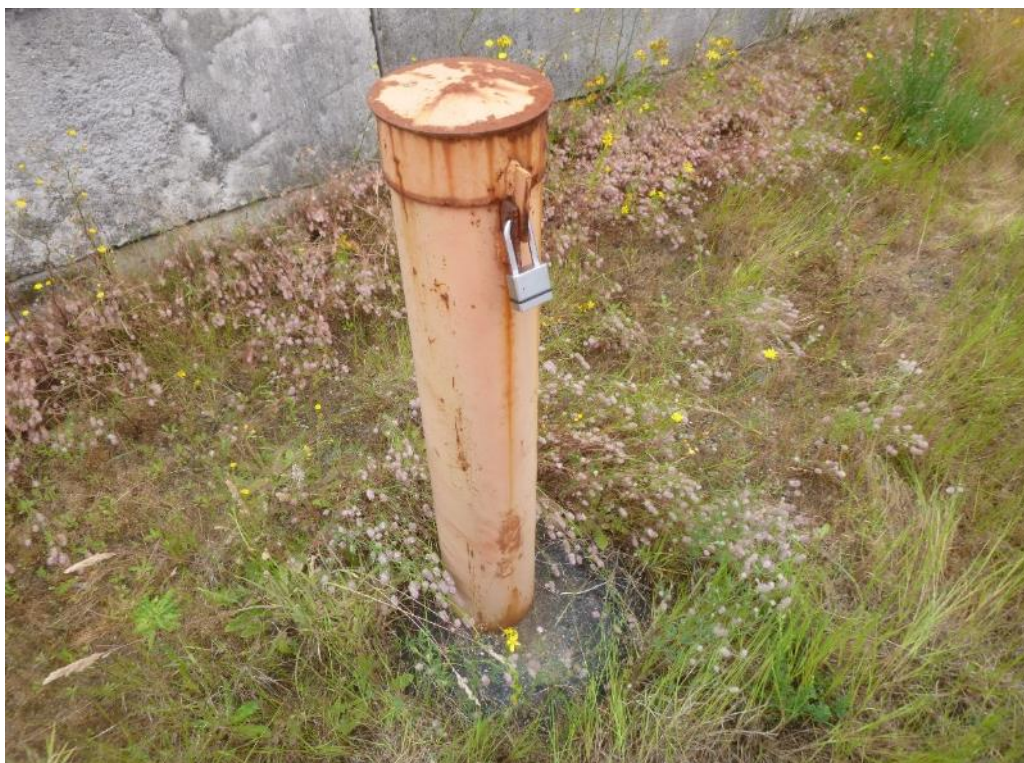
Photo 20: Monitoring well (MCW-1) with a new padlock.

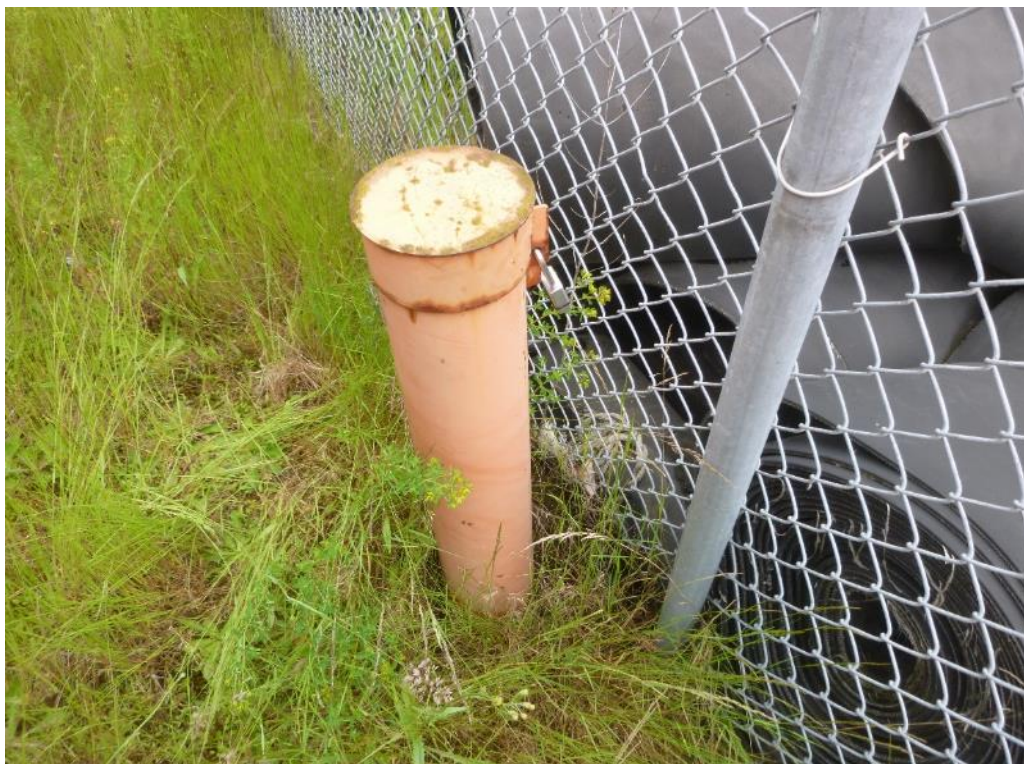
Photo 22: Monitoring well (MCW-4) with a new padlock.
