STATE OF WASHINGTON  
DEPARTMENT OF ECOLOGY  
4601 N Monroe Street • Spokane, WA 99205-1295 • 509-329-3400

**Re: No Further Action at the following Site:**

**Site Name:** Sundance Golf Course  
**Site Address:** 8725 N Nine Mile Falls Rd, Spokane  
**Cleanup Site ID:** 15358  
**Facility/Site ID:** 78213  
**VCP Project ID:** EA0357

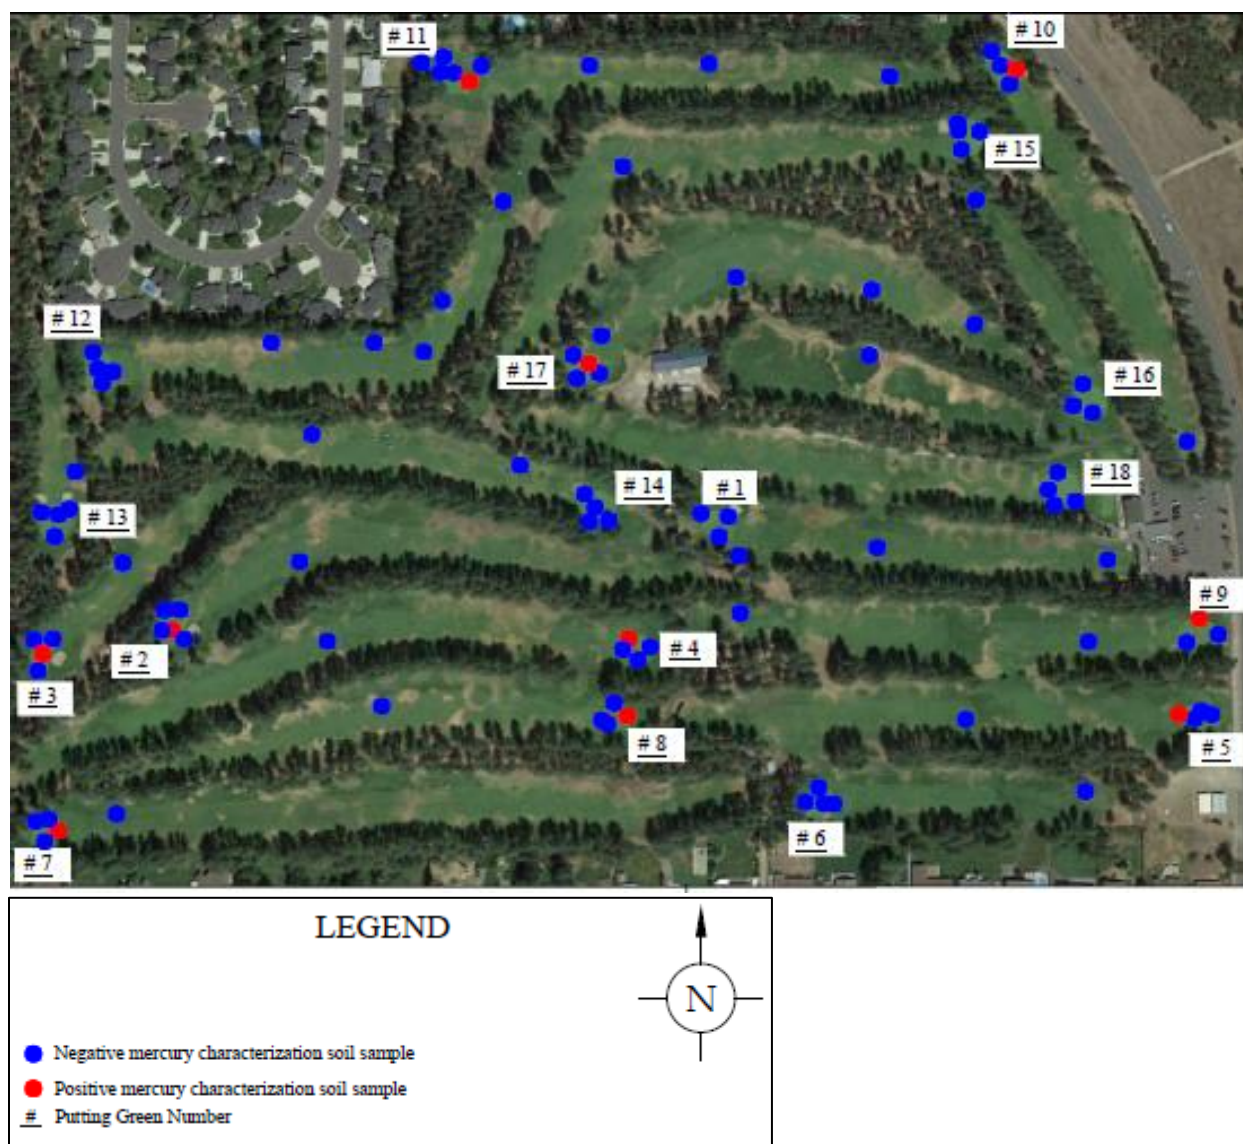
Figure 2. Soil sampling locations.

An additional 181 surface samples were collected from 73 locations throughout the golf course, including the fairways, putting greens, and teeboxes. These samples were analyzed for arsenic, cadmium, chromium, lead, mercury, organochlorine pesticides, and herbicides. Mercury was detected in 10 locations exceeding the MTCA Method A cleanup level for unrestricted land use, and chlorinated pesticides, including chlordane and alpha-BHC, were detected below the MTCA Method B non-cancer cleanup levels. All other analytes were non-detect or did not exceed the respective cleanup levels. Please refer to **Figure 2** in **Enclosure A** for soil sample locations.
