Report
Hazardous Building Materials Survey
Jack's Auto Service Station
Olympia, Washington

July 26, 2021

Hazardous Building Materials Survey Report Jack's Auto Service Station Olympia, Washington

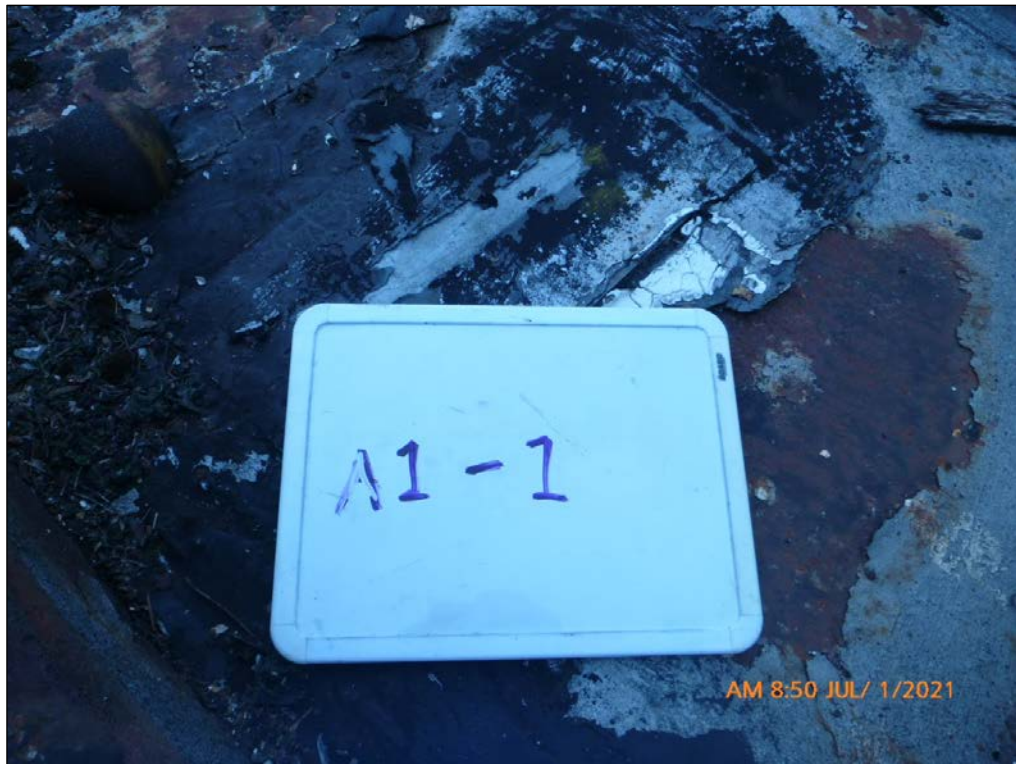
6. Asbestos sampling location A1-1.

- The black asphaltic roofing material (samples A1-1 and A1-3) on the canopy and main building roofs contains a maximum concentration of 5% chrysotile asbestos.
- The silver paint (samples A1-2, A1-3, and A2-2) associated with the black asphaltic tar roofing on the canopy and main building roofs contains a maximum concentration of 5% chrysotile asbestos.
- The white woven gaskets (samples A3-1 and A3-2) within the incandescent light fixtures (three total) that are attached to the interior and exterior of the building structure contain a maximum concentration of 81% chrysotile asbestos.

Sampling and analysis of suspect materials in the survey areas identified three ACMs in the planned project work areas: black asphaltic material on the canopy and building roofs, silver paint on the canopy and building roofs, and white woven gaskets inside the incandescent light fixtures. The materials are not considered friable under AHERA. LAI recommends that, prior to building demolition, the materials be abated as a Class I Asbestos Project under AHERA and in accordance with appropriate state and federal regulations.

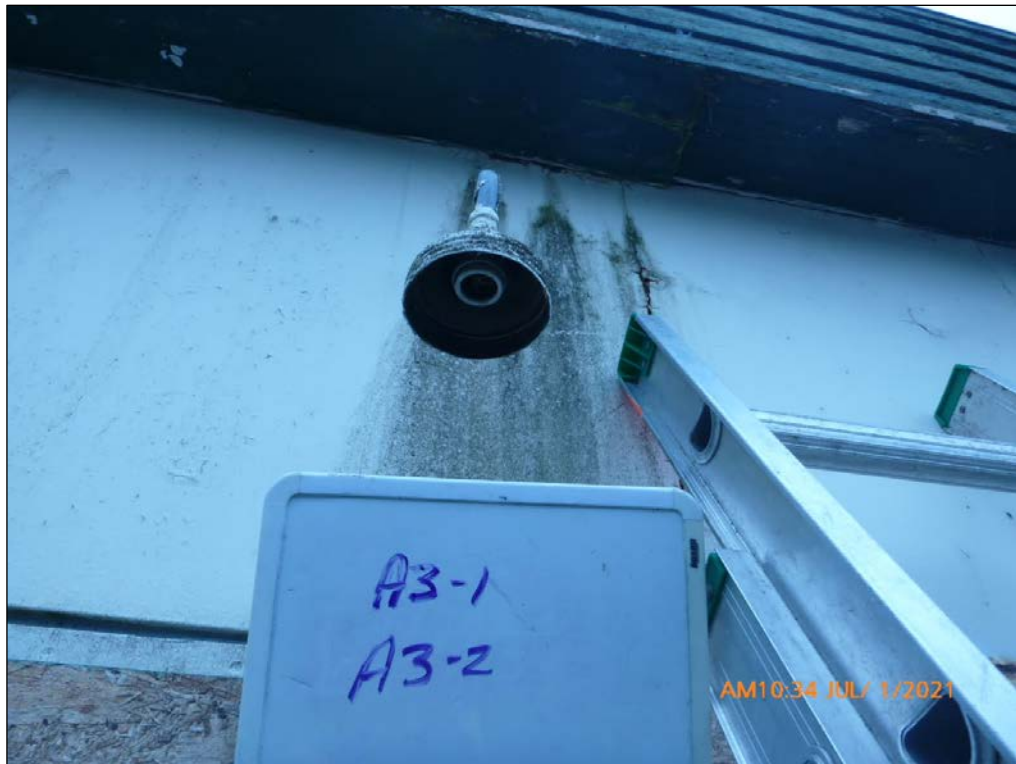
10. Asbestos sampling locations A3-1 and A3-2.

A3-1	Electrical rope gasketing	Exterior and interior light fixtures	Layer 1 (White/brown interwoven fibrous material): 75%	2 LF	No
A3-2	Electrical rope gasketing	Exterior and interior light fixtures	Layer 1 (White/brown interwoven fibrous material): 81%	2 LF	No
A4-1	Orange spray foam	Exterior wall, under canopy	Layer 1 (Yellow spongy material): ND	N/A	N/A
A4-2	Orange spray foam	Exterior wall, under canopy	Layer 1 (Yellow spongy material): ND	N/A	N/A
Building Interior					
A5-1	White window glaze	On windows in building	Layer 1 (Gray crumbly material with paper): ND	N/A	N/A
A5-2	White window glaze	On windows in building	Layer 1 (Beige crumbly material with paint): ND	N/A	N/A
A6-1	Black window sealant	On windows in building	Layer 1 (Black rubbery material): ND Layer 2 (Gray rubbery material with paint): ND	N/A	N/A
A6-2	Black window sealant	On windows in building	Layer 1 (Black rubbery material): ND Layer 2 (Gray rubbery material with paint): ND	N/A	N/A

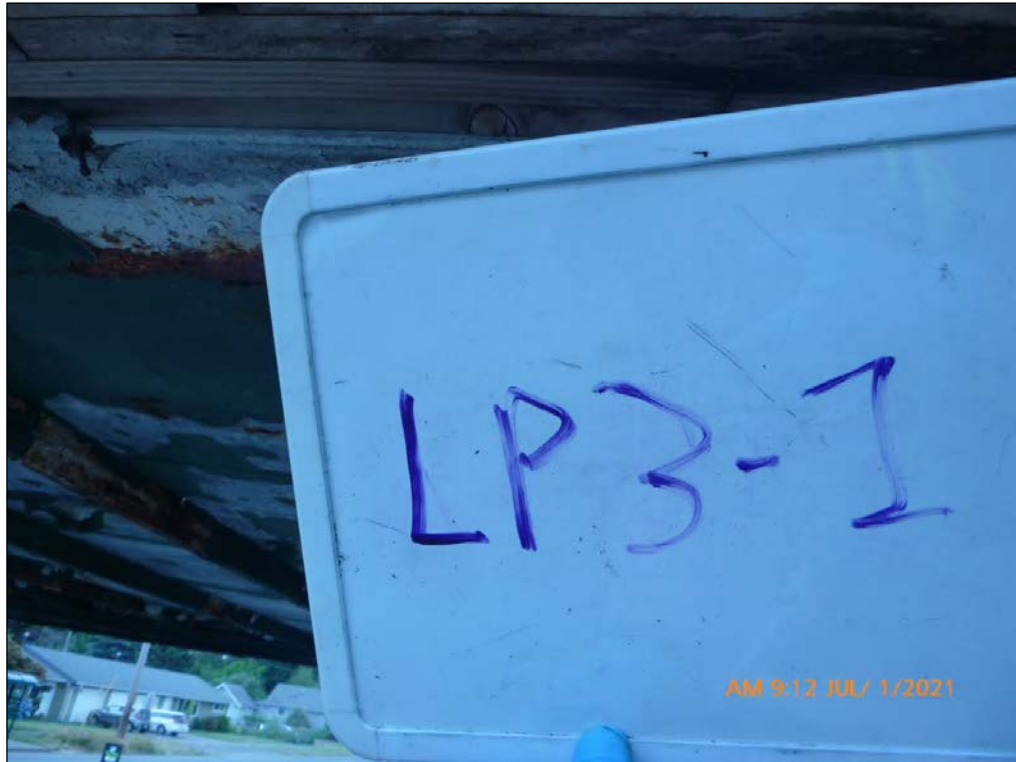
11. Lead paint sampling location LP3-1.

- LP1-1: Silver paint on the canopy and main building roofs contained lead at a concentration of 380 mg/kg.
- **LP3-1**: White paint on the canopy roof wall contained lead at a concentration of **5,000 mg/kg**.
- **LP4-1**: Green paint on the building siding contained lead at a concentration of **9,100 mg/kg**.
- LP5-1: White paint on the canopy struts contained lead at a concentration of 3,100 mg/kg.
- LP6-1: Green paint on the canopy underside contained lead at a concentration of 2,500 mg/kg.

Lead was detected in 20 paint chip samples. During demolition activities, precautions should be taken to address worker safety (particularly, generation of dust through cutting, sanding, grinding, or other destructive activities on materials coated with LCP should be avoided), to protect human health and the environment, and to dispose of demolition debris in accordance with applicable state and federal regulations. In situations where workers may be exposed to lead, it is the employer's responsibility to ensure that work practices comply with the Washington State Department of Labor and Industries' lead in construction rule (WAC 296-155-176). The property owner should ensure that the public does not have access to the property during demolition activities. Prior to disposing of building or demolition debris, a representative sample of those materials that will be sent for disposal should be collected and submitted for toxicity characteristic leaching procedure analysis; these data will aid the contractor in determining whether the lead concentrations characterize these materials as hazardous waste.

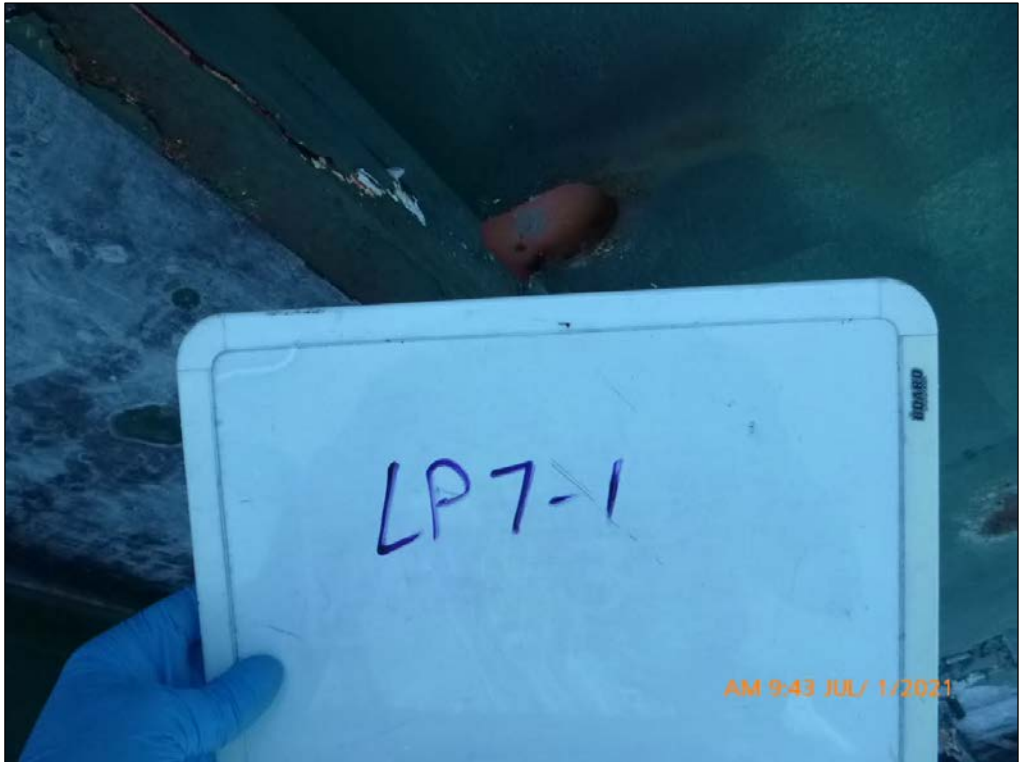
13. Lead paint sampling location LP7-1.

- **LP7-1:** Orange paint on the canopy underside contained lead at a concentration of **33,000 mg/kg**.
- **LP8-1:** Orange paint on the concrete medians contained lead at a concentration of **120,000 mg/kg**.

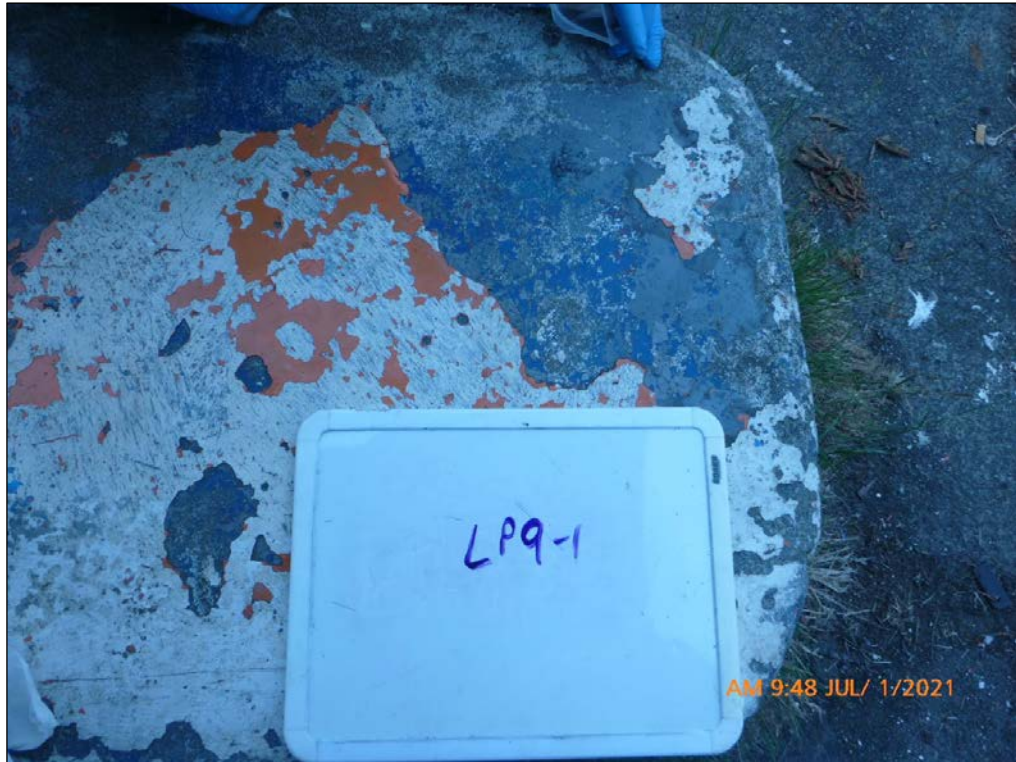
15. Lead paint sampling location LP9-1.

- **LP9-1:** Blue and gray paints on the concrete medians contained lead at a concentration of **6,700 mg/kg**.
- **LP10-1:** Blue and white paints on the building exterior contained lead at a concentration of 1,800 mg/kg.

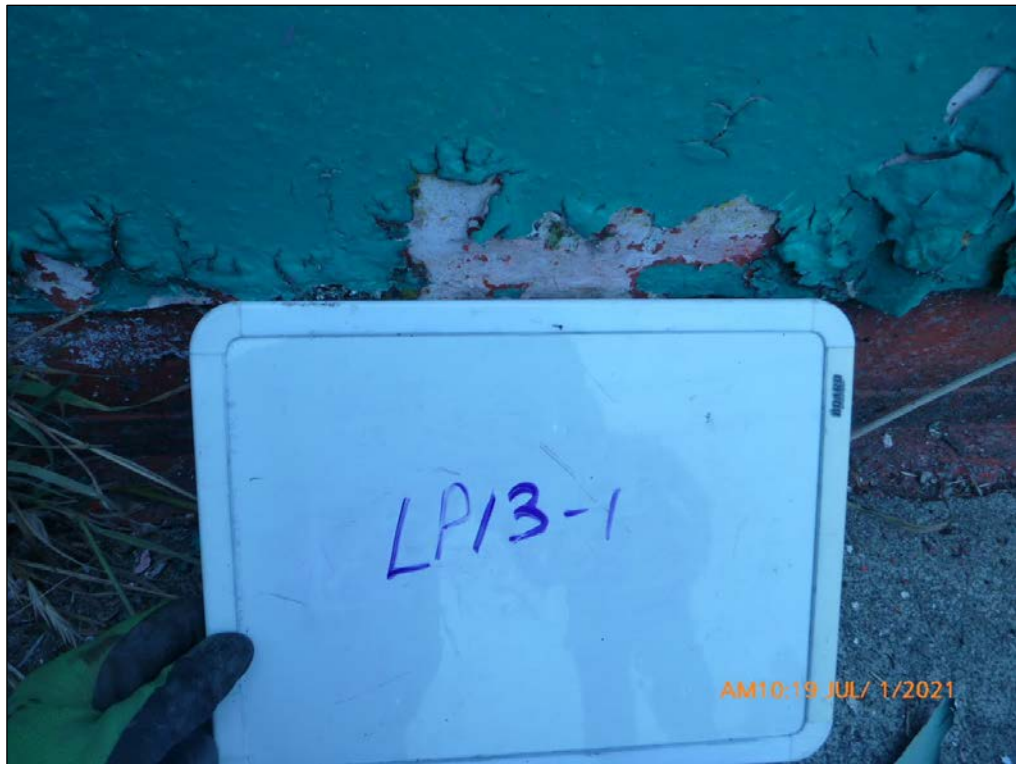
16. Lead paint sampling location LP13-1.

- **LP13-1:** Red and white paints on the canopy and main building roofs contained lead at a concentration of **110,000 mg/kg**.
- **LP14-1:** Red paint on the concrete building foundation contained lead at a concentration of **66,000 mg/kg**.

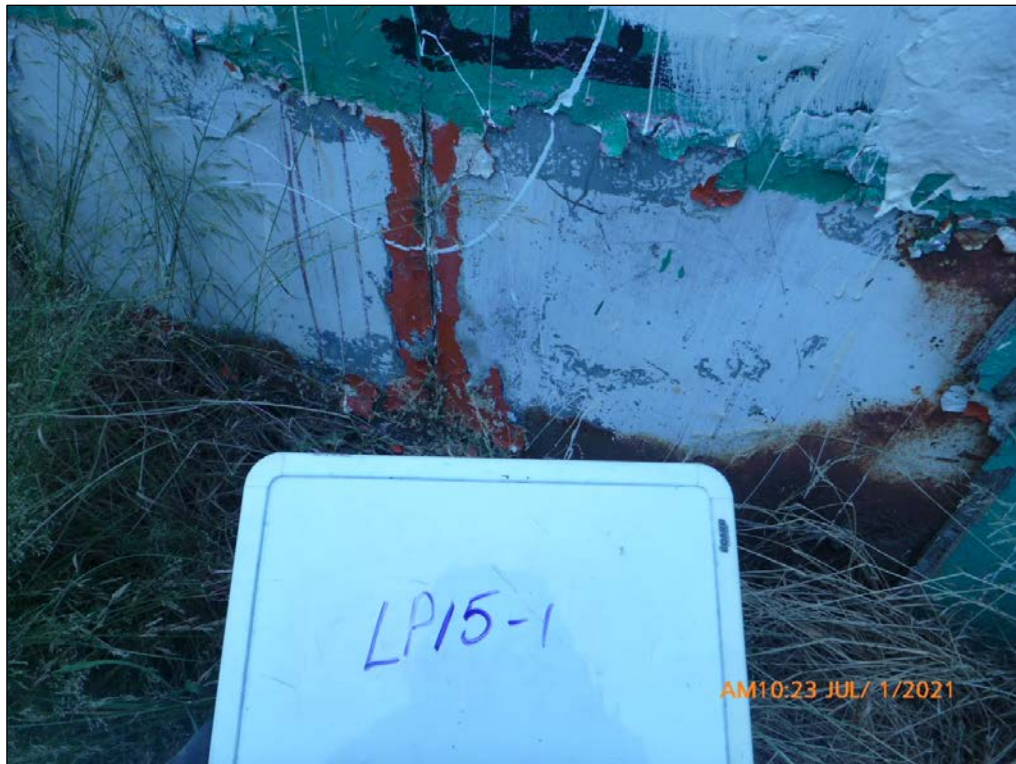
18. Lead paint sampling location LP15-1.

- **LP15-1:** Orange paint on the building exterior contained lead at a concentration of **59,000 mg/kg**.
- **LP16-1:** White paint on the building exterior contained lead at a concentration of 2,800 mg/kg.

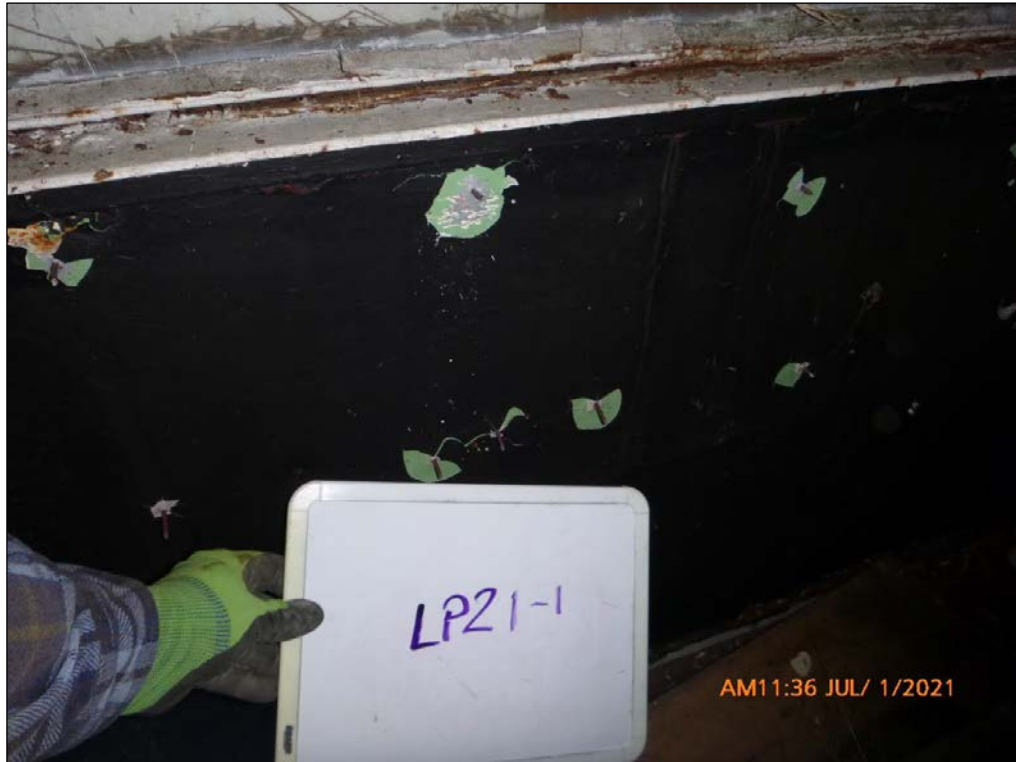
19. Lead paint sampling location LP21-1.

- **LP21-1:** Green paint on the interior office walls contained lead at a concentration of **6,400 mg/kg**.
