March 4, 2022

HWA Project Number: 2019-054-21

SUBJECT: Bentonite Wall Barrier Inspection
Aegis Kirkland
21 – 10th Avenue South
Kirkland, Washington
City Permit Number 18-3127

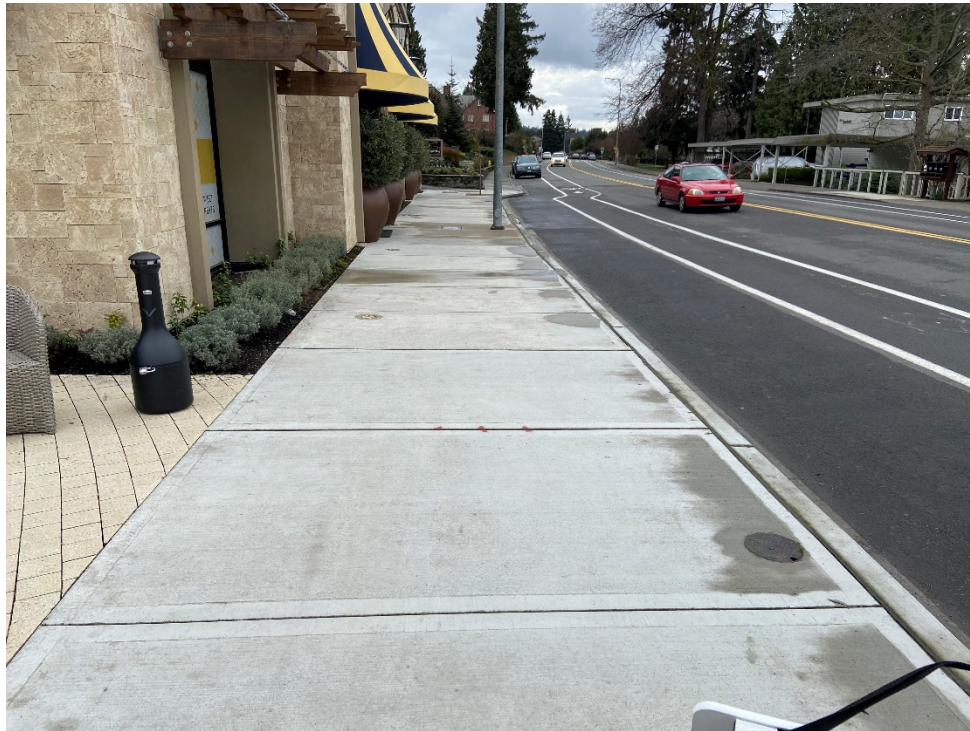
Photo # 1: North End of Site Looking South

The area in question has in covered by concrete sidewalk. No cracking was observed in the sidewalk nor evidence of recent work in this area was noted. No conditions were noted during our site visit to raise concerns of the integrity of the bentonite wall barrier on the site western boundary. A filled out Inspection Checklist form and photos taken during our site visit are attached to this letter.
