STATE OF WASHINGTON
DEPARTMENT OF ECOLOGY
4601 N Monroe Street • Spokane, WA 99205-1295 • 509-329-3400

Re: Opinion on cleanup at the following Site:

Site Name: City of Spokane Maintenance Shop

Site Address: 127 W Mission Ave, Spokane

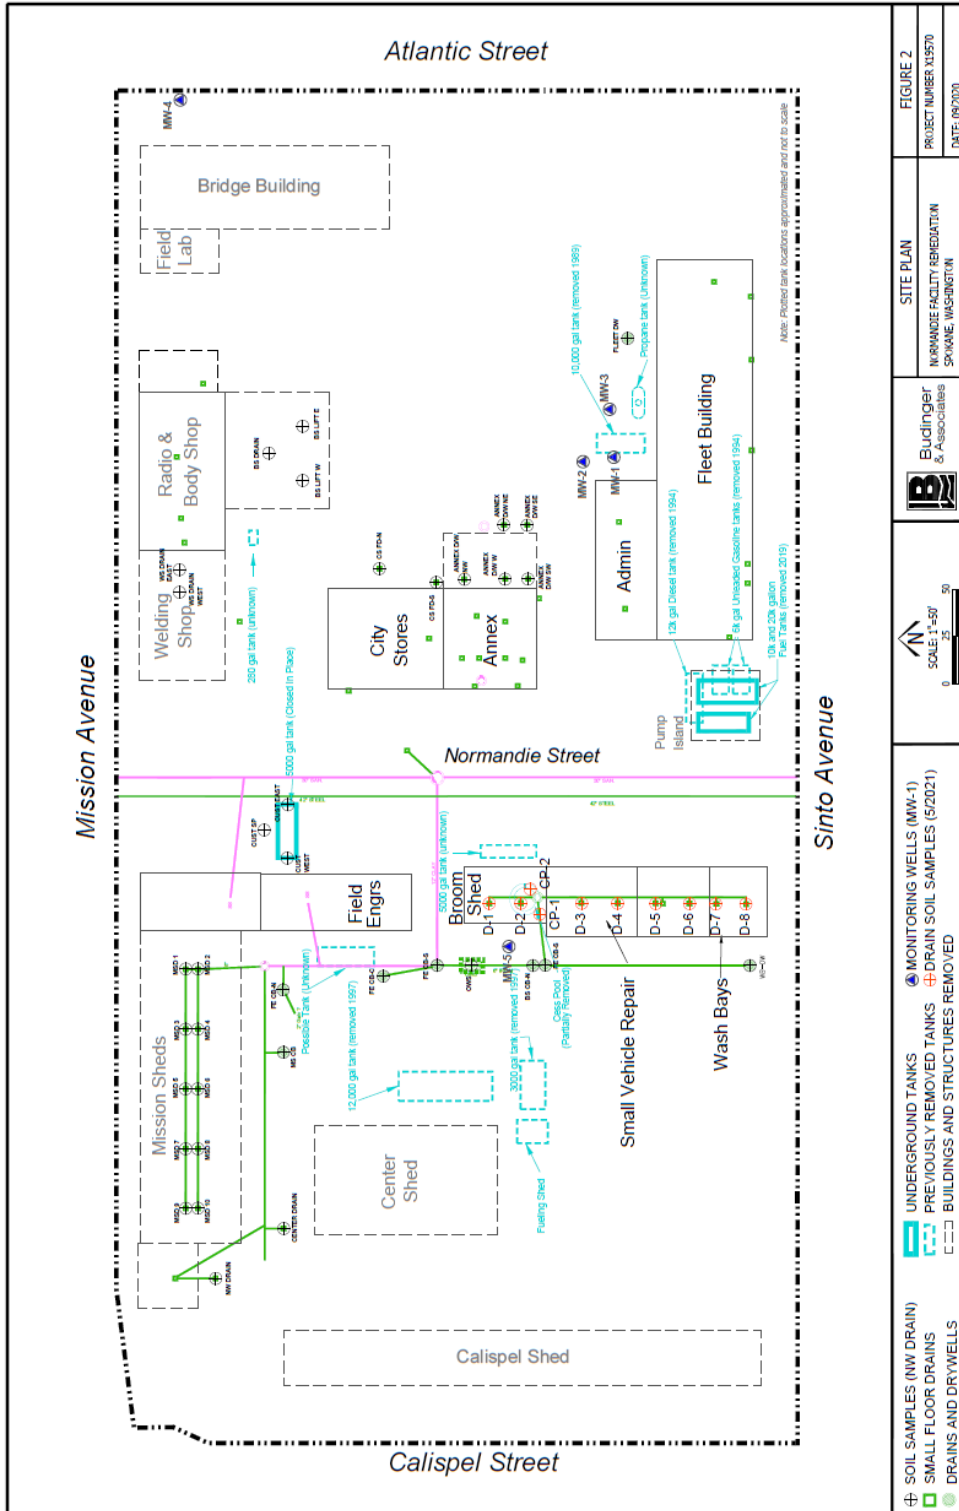
Site Diagram

- All of the USTs were properly decommissioned and removed, including those active at the time of site closure, previously closed in place, and previously unknown tanks discovered during the current cleanup activities. All other areas of concern were excavated and confirmed below MTCA Method A soil cleanup levels. Please refer to the Site diagram in **Enclosure A** for the former locations of the USTs, drywells, floor drains, piping.
